## ULTRASONIC ATTENUATION COEFFICIENT DETERMINATION AND PROBABILITY OF SIZING ANALYSIS

ACEA7013: Structural Integrity & Materials Evaluation  
M.Sc Automotive Engineering  
Lecturer: Peter Charlton

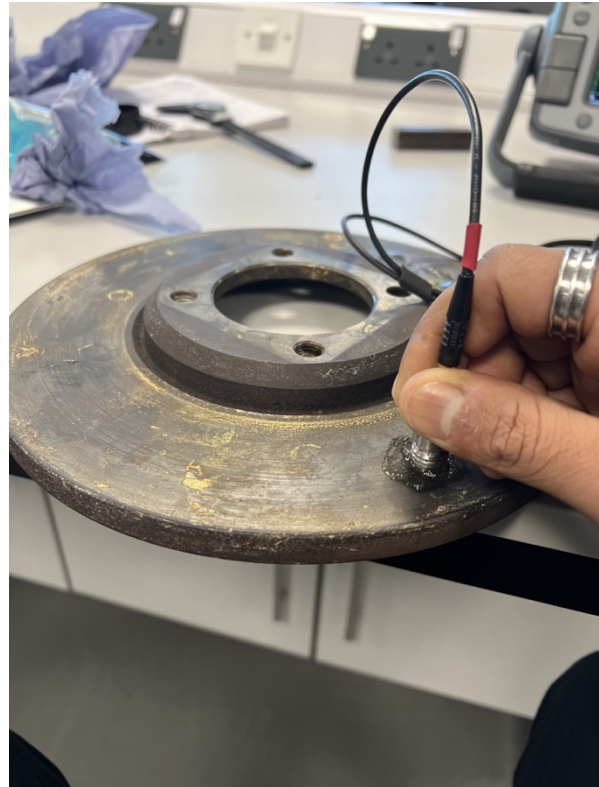
Figure 6: Apparatus connections for experiment for disc brake

The schematic set up is showing in figure 4. In this experiment, as a coupling agent I use gel which is work as ultrasonic gel. The function of this coupling agent is to prevent the probe contact surface from friction and wearing. This coupling agent is not considered as delay. Experiment setup in lab is shown in the figure 5 and 6.

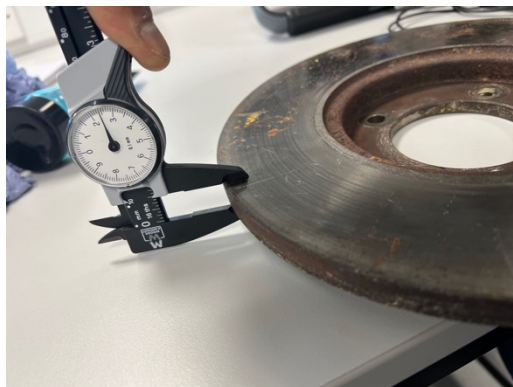
Figure 8: Thickness measurement of brake rotor

In this experiment of measuring the ultrasonic attenuation coefficient, I first measure thickness of the mild steel rectangular block, which average thickness is measured 18.9 mm using vernier calliper. I took 4 measurements for measuring the thickness of the block as shown in the figure 7. Then I measured the thickness of the disc brake rotor, which average thickness through the rotor is 12.3 mm as shown in the figure 8. At last, I measured the thickness of the brake hub which average thickness is measured 0.83 mm as shown in figure 9.

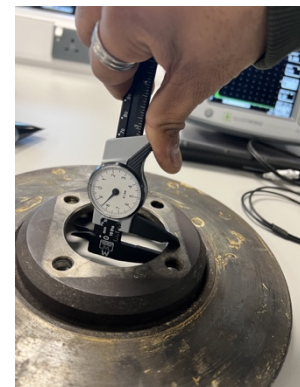
Figure 9: Thickness measurement of brake hub
