Technical Report

Motorcycle Engineering

| 4 | Engine Disassembly (October 23,2017) ..... | 3 |

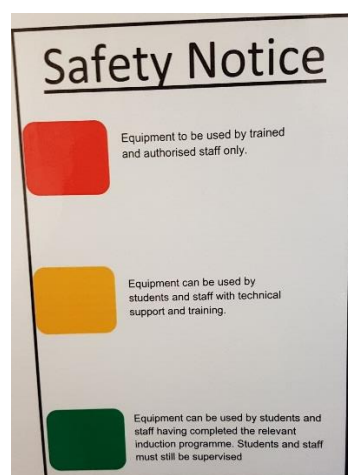
*Figure 1- Workshop Colour Coding System (Sorg, 2018)*

- Absolutely no food or drink in the workshop space
- While lifting heavy objects (over 20kg) two people must complete the lift, also using your legs while lifting is very important
- Keeping your individual and overall workspace of the workshop in a very clean and tidy manner to avoid any unnecessary accidents
- Be aware of your surroundings and always know who you are working with
- Use all tools and equipment correctly - meaning that all the correct training has been completed for that specific tool
- Report any accidents immediately and to stop work during these times
- Identify all fire exits and where the muster point is located
- Colour coding system must be followed, reference Figure 1

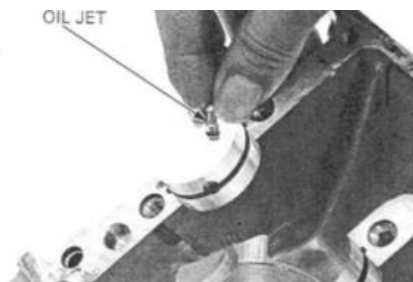
2. All the bearing caps and bearings were numbered so that they can be assembled in the same location on the crankshaft
3. All the connecting rod bolts and bearing caps were loosened and removed using a 8mm socket with a ¼ inch drive ratchet (Honda, 2006, p. 187)
4. The Crankshaft was then removed by lightly tapping the caps to loosen the crankshaft
5. The oil jets were then removed and inspected for clogged jets, all of them showed no problems, reference Figure 3.

*Figure 3- Oil Jet Location (Honda, 2006, p. 192)*

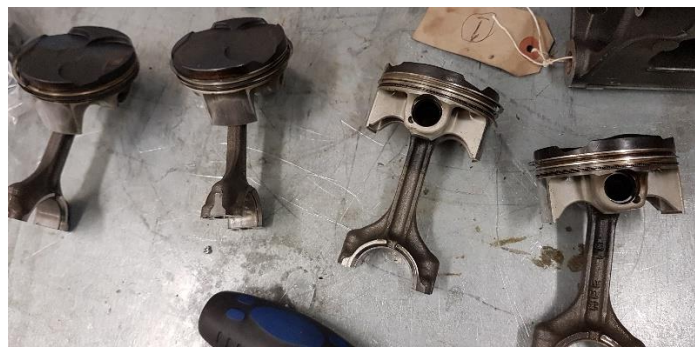
3. Then the pistons were then numbered to make sure which cylinders the pistons were removed from reference Figure 5.

*Figure 5-Pistons Removed and Numbered (Sorg, 2017)*

These particular pistons and cylinder walls displayed a large amount of scoring- indicating that the pistons were not being properly lubricated.

The most important discovery made while inspecting the engine was that the pistons and cylinder walls had a large amount of scoring and that adjacent parts such as the cylinder head and crankshaft also showed signs of significant usage. This lab session demonstrated that in order to be successful in diagnosing and removing parts from an engine you must be very detail oriented and make sure to never overlook the smallest of details.

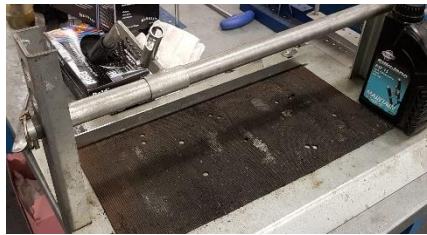
1. From the top of the cylinder head a homemade spring compressing tool (see Figure 6) was used to evenly apply pressure to the outer and inner springs so that the cotters can be removed

*Figure 6- Homemade Spring Compressor Tool (Sorg, 2018)*
