# MSc Motorsport Engineering

## Through Wall Sizing Accuracy Analysis Report

## Ultrasonic Attenuation Coefficient Determination

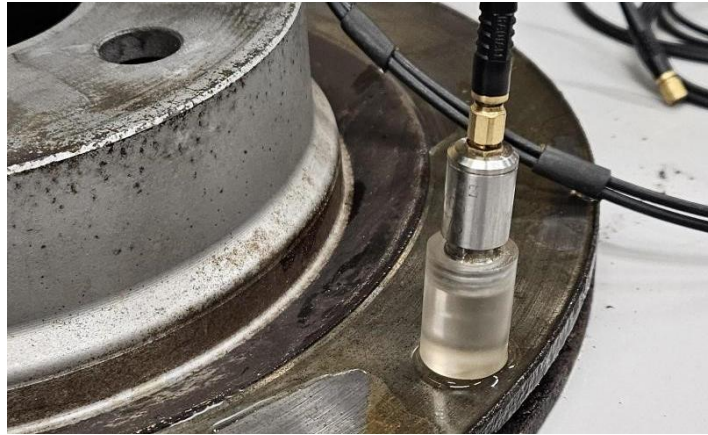
In the industry, it is common to use a wedge to take the surface of the material outside of the nearfield range, which increases the accuracy of the measurement. This required further calibration and so was not carried out in the experiment but would look similar to the below photo captured during the experiment.

**Figure 26 - UT Probe with a block affixed**
