# University of Wales Trinity Saint David School of Engineering

Ultrasonic Attenuation Coefficient Determination and  
Probability of Sizing Analysis

Structural Integrity & Materials Evaluation

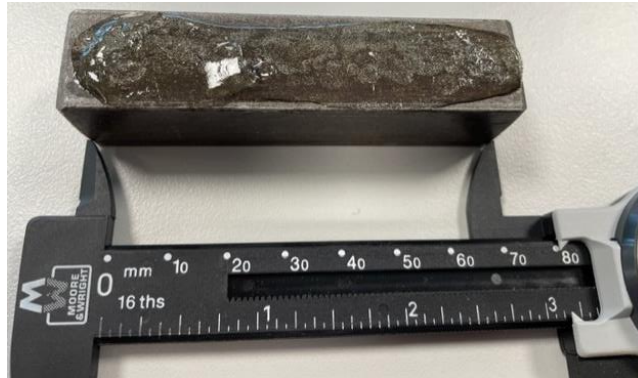
**Figure 2-** Mild steel rectangular block sample with coupling gel applied.

6. A fair amount of coupling gel, enough to lightly cover the entire top face of the sample was applied. It is important that there is couplant between the end of the probe and the sample to match the acoustic impedance of the probe to the sample, therefore maximising energy transfer. It was important not to drag the probe along the face of the sample, as the probe didn't have a wear face, the crystal would wear away at significant speed.

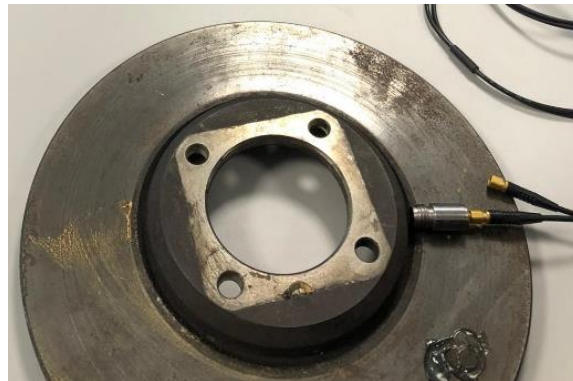
**Figure 3 -** Brake disc sample

7. By pressing the probe end to the face of the sample, the flaw detector displayed three backwall echoes as specified by the range value. By adjusting the gain (+ or -), it was possible to manipulate the backwall echoes so that they fit within the scale shown on the flaw detector. When a suitable reading was displayed, the freeze button was used to freeze the reading to the screen, so that those results could be recorded.
8. Once all readings had been taken for each desired position on the sample, it could then be wiped clean with tissue to remove any excess coupling gel, this sample was then complete.
9. This process was repeated with the brake disc sample, measuring 4 positions on the main face of the brake disc, and 4 positions on the mounting part of the brake disc. Therefore 8 positions total were tested, and the results recorded for further use.
