University of Wales Trinity St David

# Riverine Habitat Management at Colby

GIS and Habitat Management

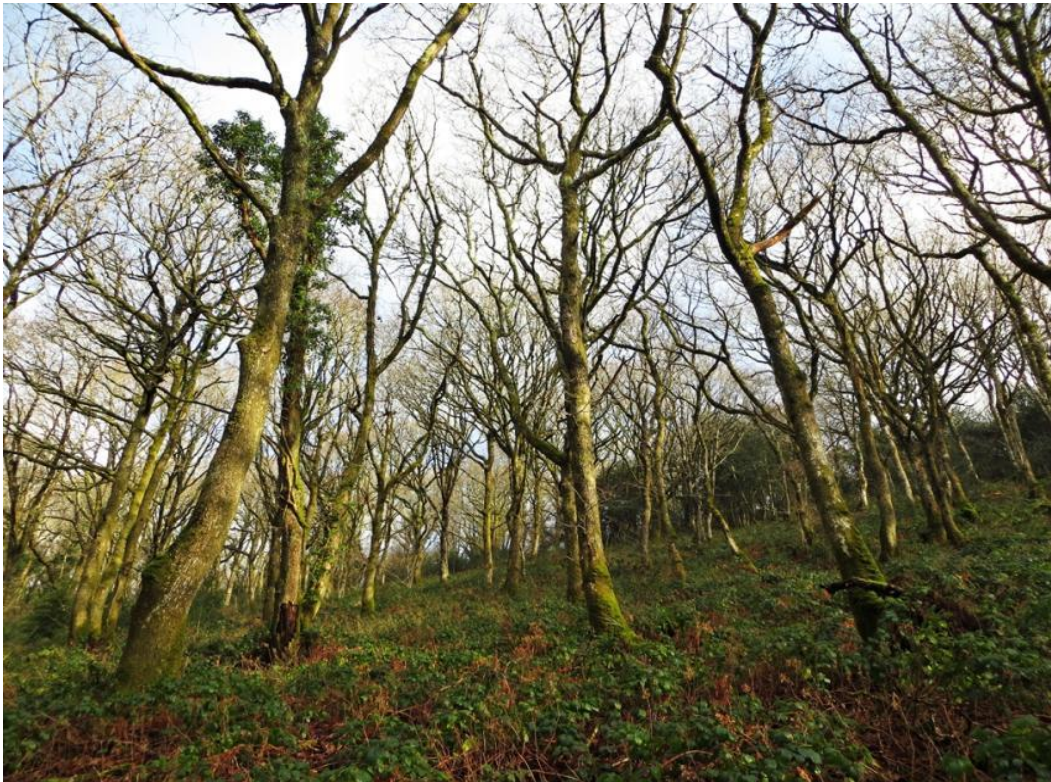
Photo 1: Typical oak grove in CYB wood showing narrow age profile (NT)

| Age structure | Lack of very old specimens, oak coppice of around 50-60 years old but good regeneration of oak, ash and birch seedlings. | Identifying future specimen/veteran trees to protect from crowding | Very uneven age profile which only time can improve (Photo 1). Important to identify and clear around potential veteran trees throughout the woodland. |

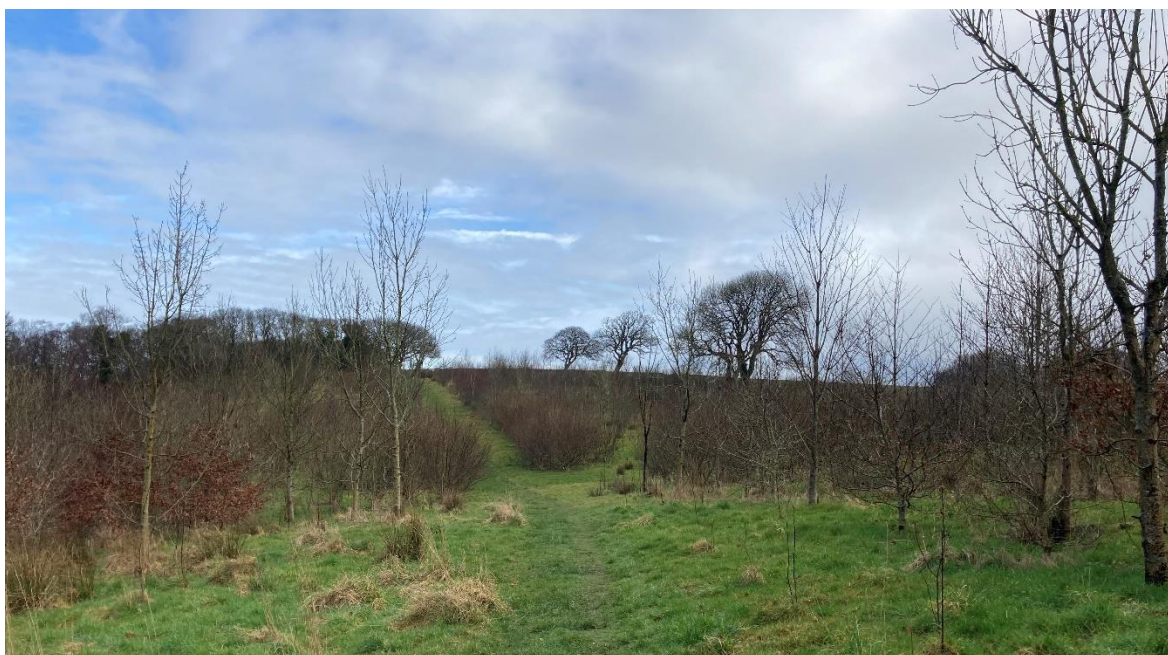
*Photo 2: 15-year-old plantation*

| Extent of wooded areas | An area of new woodland was created approx. 15 years ago on improved grassland to join up existing woodland. (Photo 2) Mixed plantation of oak and ash with pockets of hazel, birch, field cherry, crab apple. The condition of the oak and ash is poor, with the ash especially suffering from squirrel damage. | Leave alone for 20 years and review.<br><br>Significant additional native tree planting has taken place along field boundaries on slopes to expand existing woodland. Resulting protected re-gen more successful than planted trees. | The trees have struggled to establish in a very thick and vigorous sward with significant losses. The field slopes and is wet at the lowest point and did not seem to have been planted with willow and alder. Most ash and oak have lost their leader which suggests they are never going to make good specimens. Maybe a better approach would have been planting a majority of birch and hazel (or adding now to replace losses) which have thrived and later adding oak and ash seedlings.<br>New areas protected from livestock gives natural re-gen a chance. |

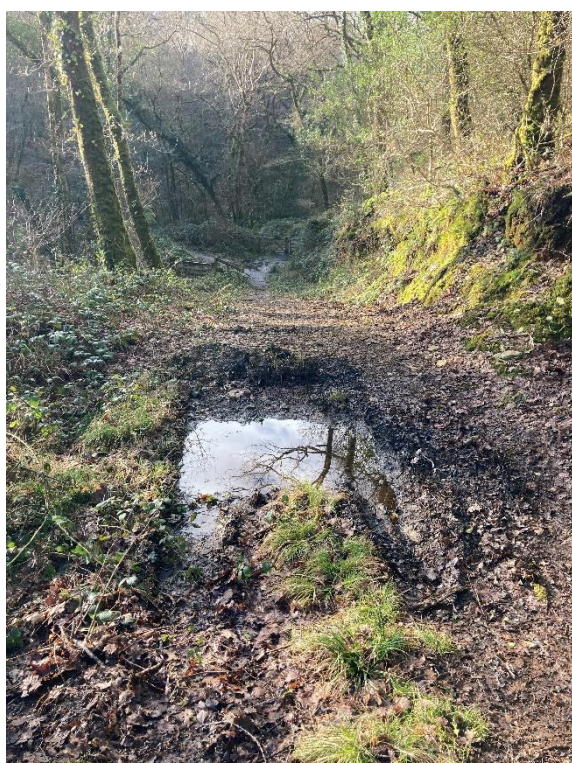
*Photo 3: Scrape to prevent water running down steep path*

| Paths/Access | The main stone track in LCYB runs alongside the stream and is increasingly being flooded each winter. All unsurfaced paths suffer from either flooding or waterlogging. Steps on steep rises made from compacted soil and stone behind pinned logs. | Replacement of log steps when rotted but otherwise little maintenance. Given up replacing stone on main track because of frequency of flooding. On steep tracks some scraps have been dug to hold back water and slow water running | This area is primarily for walkers and dogs and does not receive the footfall of the garden areas. This is a natural habitat and there is not the same expectation for clean and level path surfaces.<br>Good interpretation boards and map panels have been placed at the entrance to LCYB. The scraps are an effective way of preventing paths being washed away although they will remain waterlogged long after the rest of the path has dried out. (Photo 3) |

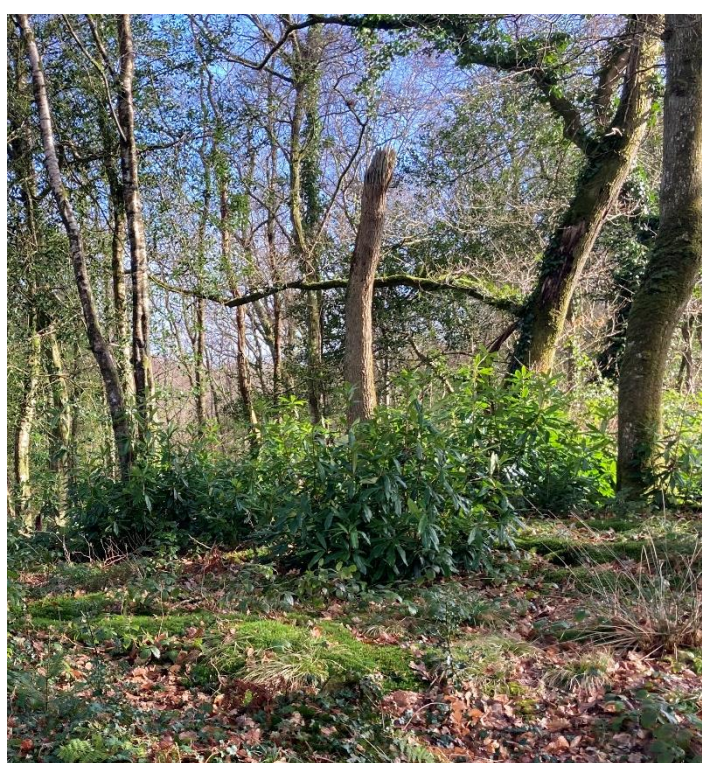
*Photo 4: Rhododendron regeneration, standing deadwood and mossy ground flora in LCYG*

| Concern / Attribute | Status | Current management | Critique/Comments/Improvements |
|---|---|---|---|
| Invasive Species – <i>Rhododendron ponticum</i> | Found throughout the wood. (Photo 4) | Eradication where found. Digging out/cutting down and stem injection with herbicide. Use of working parties/volunteers and staff. | The <i>Rhododendron</i> removal is an ongoing battle. It is also a host of the disease Sudden Oak Death <i>Phytophthora ramorum</i> . |

| Dead wood | Increasing levels of deadwood in coppiced areas although severely lacking in areas that were clear-felled. (Photo 4) | Leaving all fallen trees and branches and standing dead trees except where hazardous. | Extremely valuable habitat for birds, invertebrates, lichen and fungi but also vital for increasing carbon content and health of soils, improving soil biodiversity. There is a need to inform the public of this strategy because they are used to seeing 'tidy' woods and will assume that the woods are neglected. |

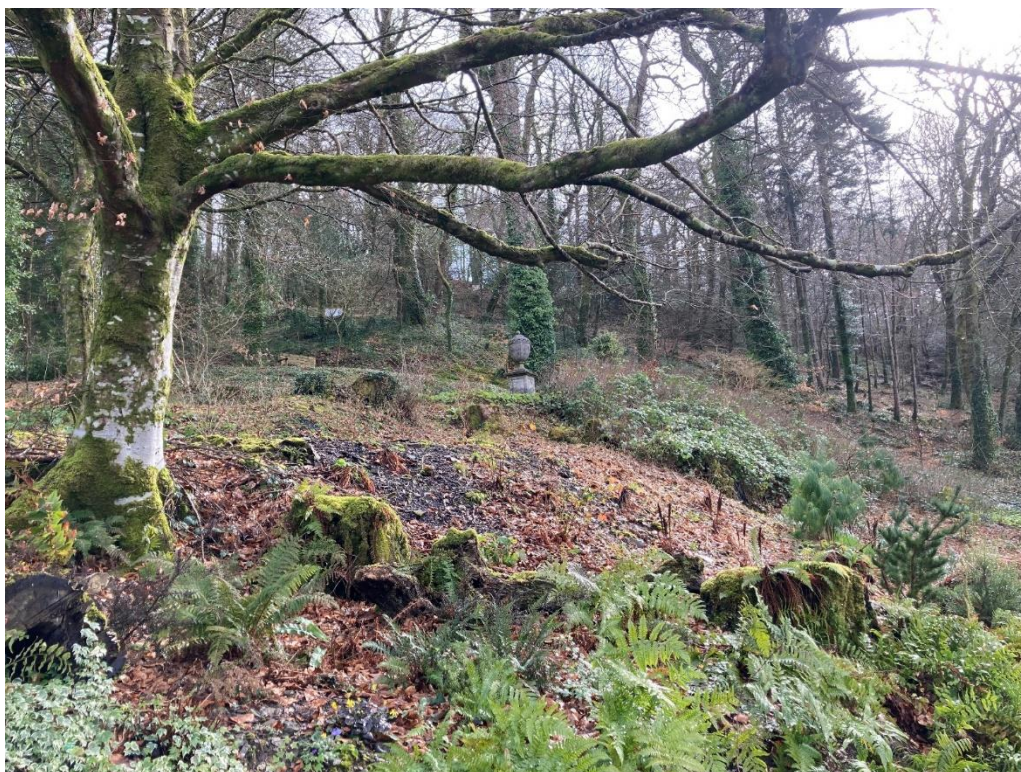
Photo 5. View across East Woods showing stumps of removed conifers and garden urn linking to formal garden

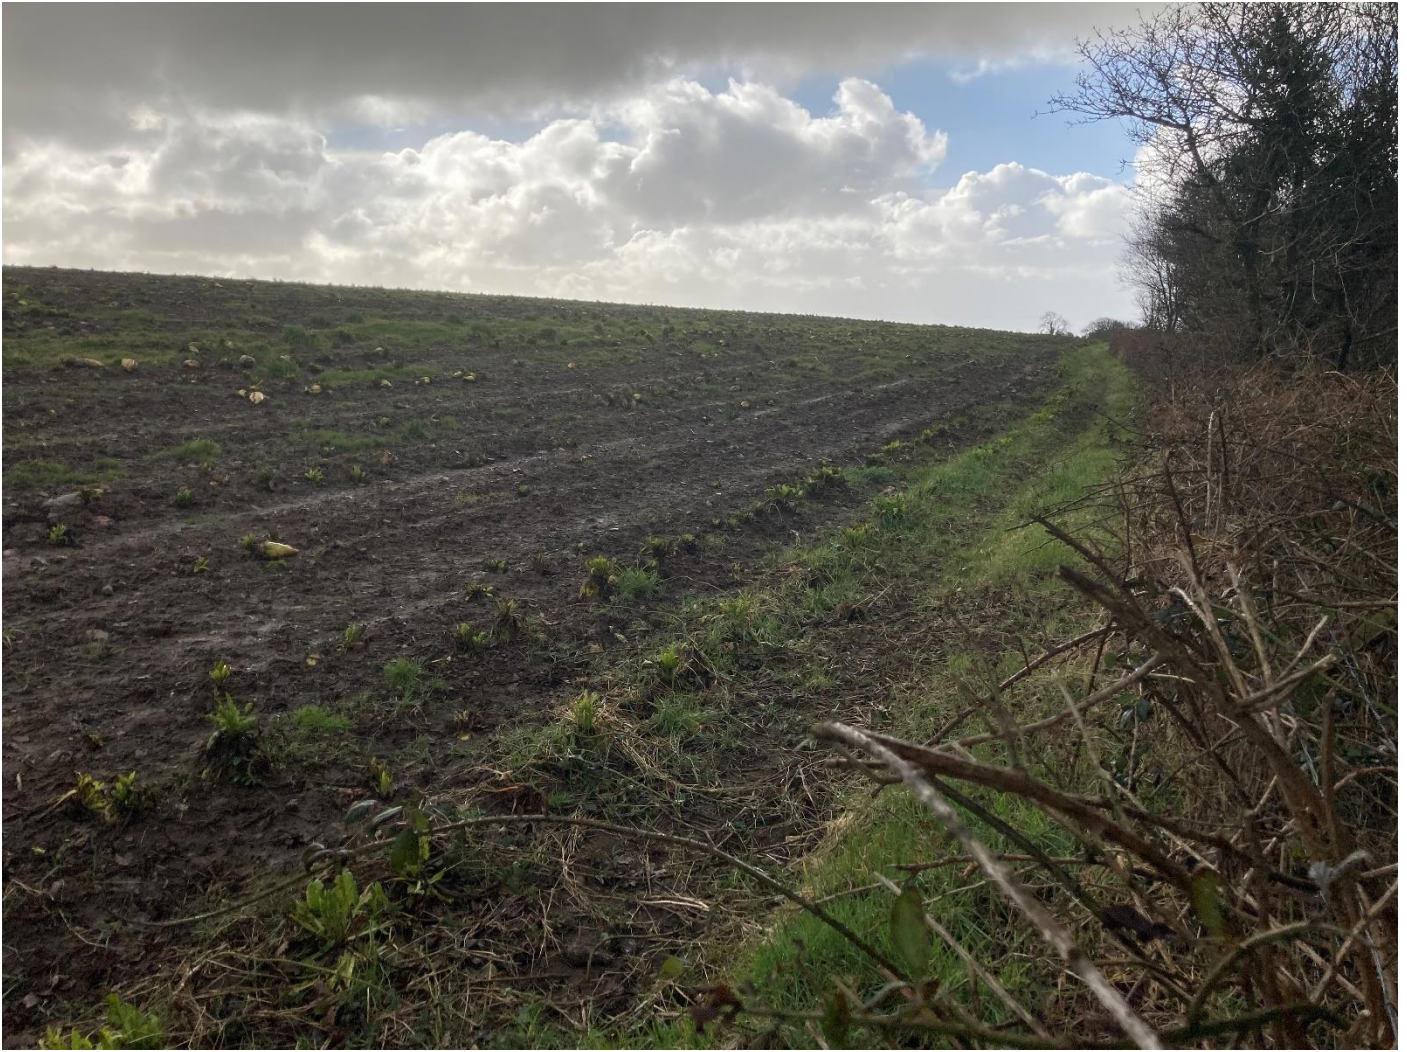
*Photo 6: Poor agricultural practice (bare soil in winter vulnerable to soil erosion)*

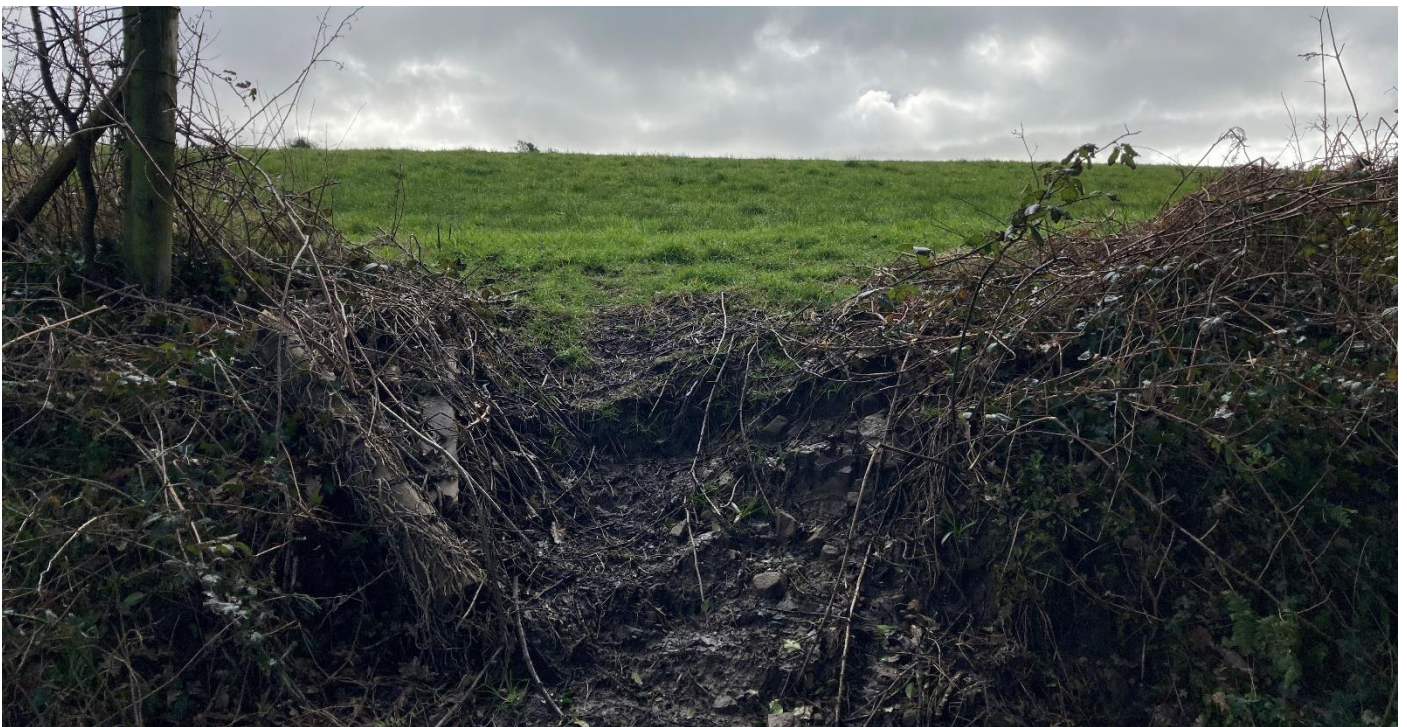
*Photo 7: Soil erosion from field run-off*

| Water quality | According to monitoring, despite run off and soil erosion from farmland upstream (Photo 7), there are good populations of river flies, larvae, trout is present and otters range along the estate streams. | The work of planting steep-sided valleys and agricultural fields has reduced soil erosion and run off.<br>The use of boulders (Photo 9) within the meadow section of the stream and the leaving of fallen trees within across the streams in woodland (Photo 8) slows down the flow of the streams and spreads water out over the meadow allowing it to drop sediment. | The control of stream flow with boulders and fallen trees, use of the flood meadow and ponds by very simple measures has had an impact within the site and benefits the marine environment less than a mile downstream.<br>The Head Gardener would also like to introduce beavers to the estate in the future which could also help control the streams. |

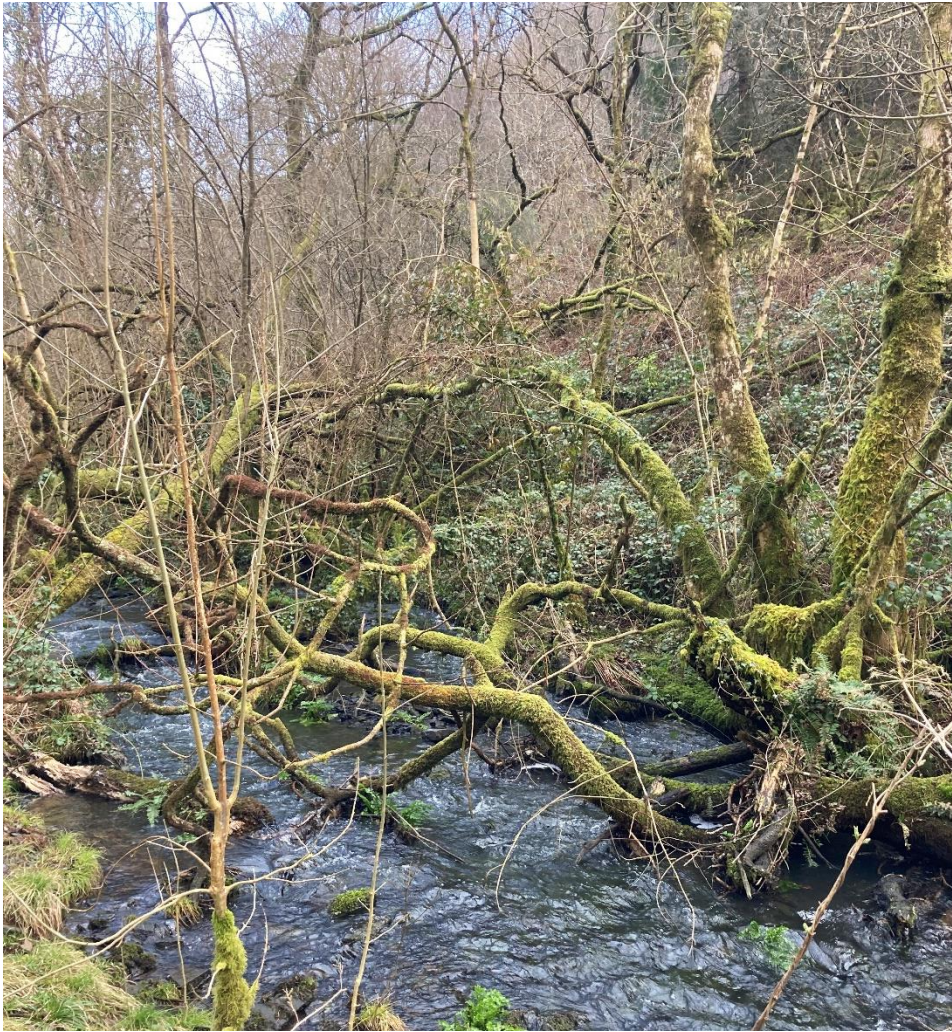
*Photo 8: Fallen trees and branches left to slow flow of stream in LGYB*

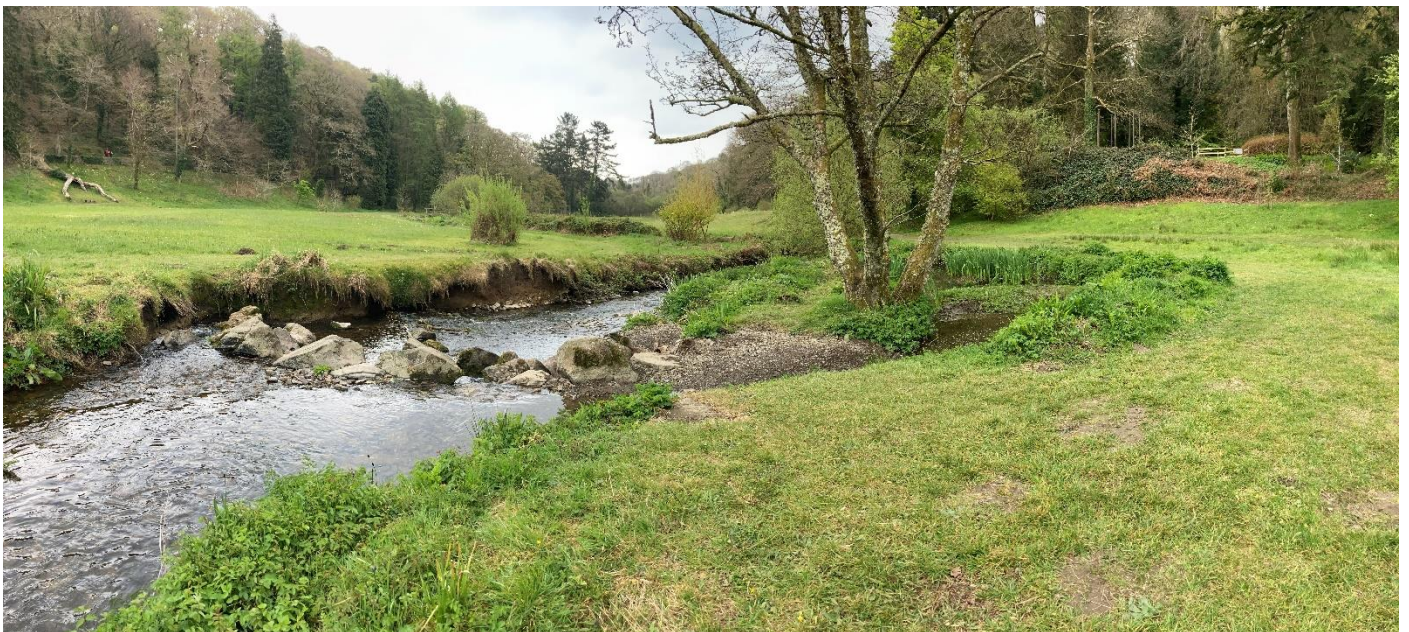
*Photo 9: Effective use of boulders to slow stream and direct some flow into pond*

| Stream-fed ponds | There are two stream fed ponds. | The old trout pond has been enlarged and the second pond is recently created and fed by a pile of boulders channelling stream water into it. These ponds are regularly desilted to maintain their extent and depth. | There is a case for extending these ponds (they are both not more than 5m in diameter) to protect nearby paths and provide further wetland habitat but this must be balanced against the loss of species rich meadow and the increased maintenance and removal of quantities of silt which currently is spread over sections of the meadow (increasing nutrients and weed species such as dock and nettle). |

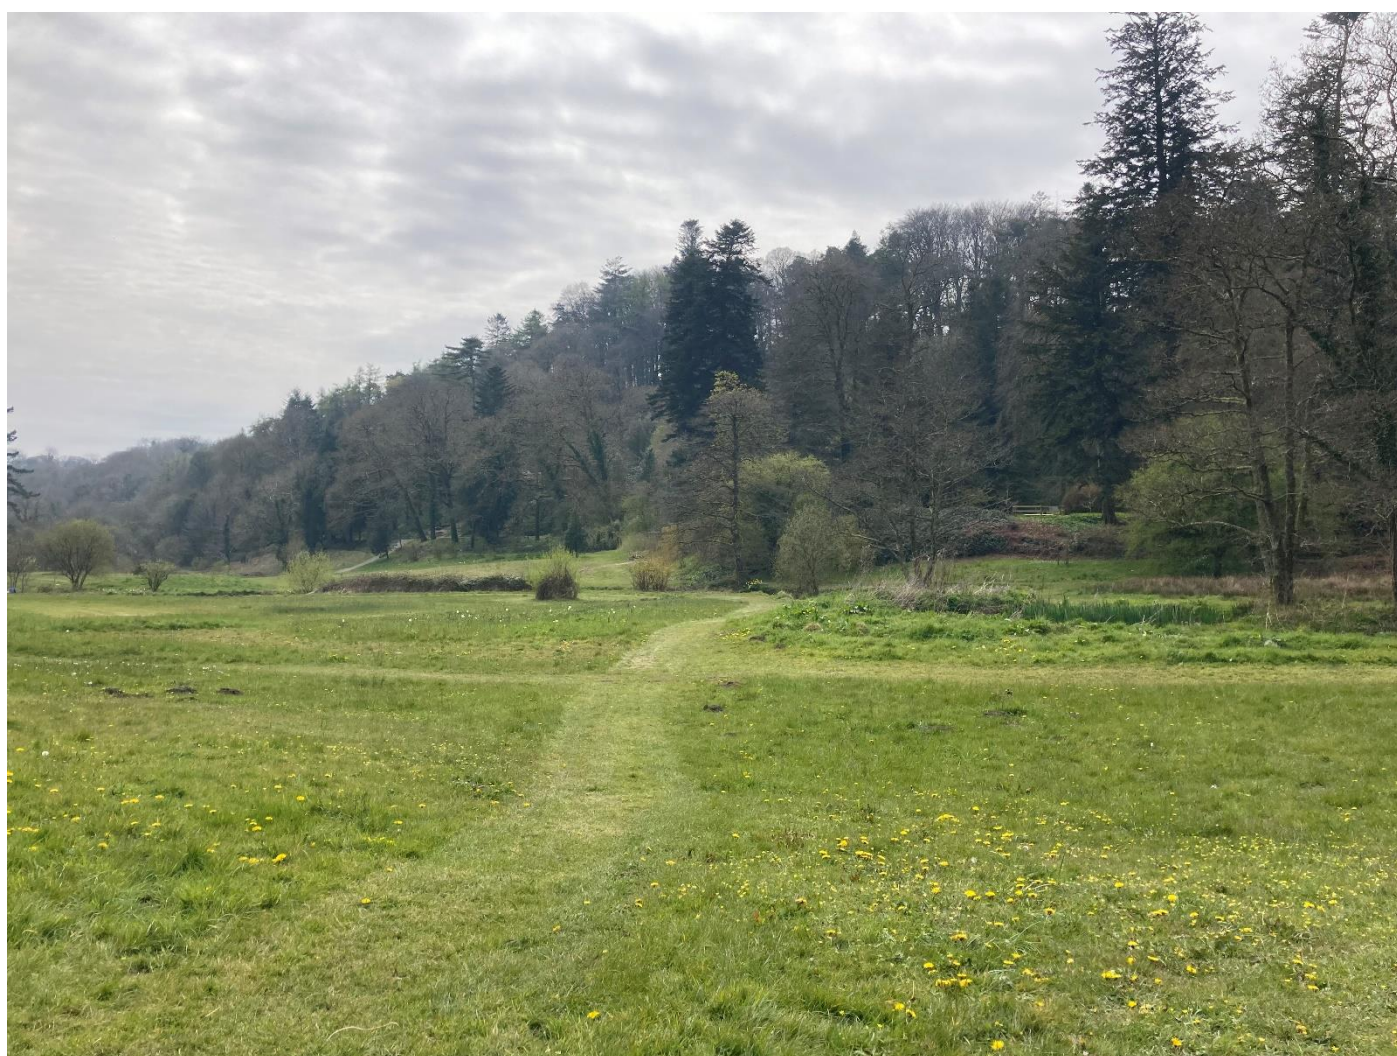
*Photo 11: Even in early April mosaic of meadow habitats is visible*

| Concern / Attribute | Status | Current management | Critique/Comments/Improvements |
|---|---|---|---|
| Biodiversity | Meadow diversity is high with a mosaic of meadow habitats (Photo 11) depending on the wetness of the soil. A lack of vigorous coarse grasses such as perennial ryegrass although some thistle and dock. | Each habitat type is managed slightly differently. After 4 years of single hay cuts, the meadow was seeded with yellow rattle and a flower rich seed mix from another NT site. Annual hay cut in late summer with | The meadow is closely monitored and interventions are made to areas such as cutting earlier if docks are increasing. Experience from NBGW suggests that application of green hay can dramatically speed up the increase of biodiversity in newly establish meadows and the NT could use hay from this meadow to improve other grassland areas.<br>To establish orchids from green hay the later the cut, even into September the better as the orchid seed takes a long time to mature. |
