BEng Mechanical & Manufacturing Engineering  
Wales Institute of Science & Art

# **Blast Furnace Skip Hoist – Wire Rope Life Extension**

The University of Wales Trinity Saint David

2023

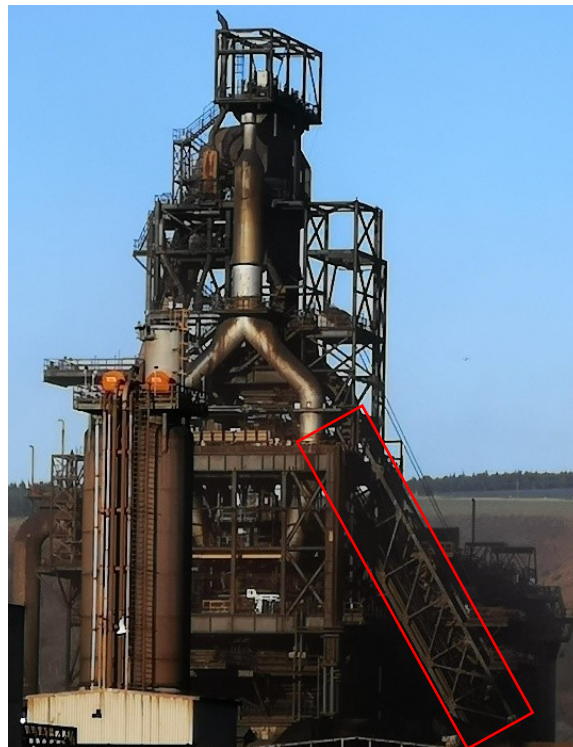
*Figure 1 - Port Talbot blast furnace showing skip car incline*

The following drawing shows the blast furnace hearth location in relation to the skip hoist trestle which for context and can be compared with Figure 1.

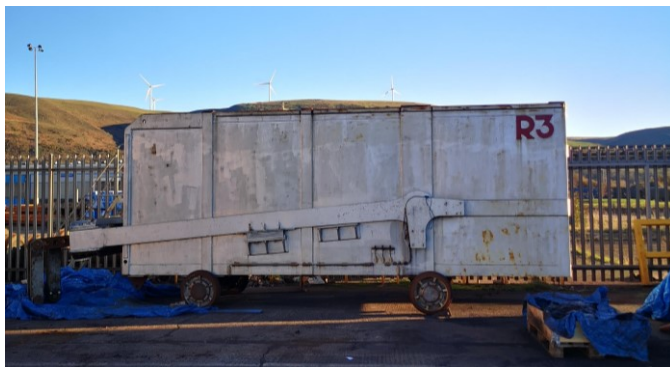
*Figure 2 - Skip car for material hoisting and wire rope drum [2]*

The skip car hoist system consists of two skip cars (as seen in Figure 2) working in tandem which are capable of transporting loads up to 25t per car that are hoisted up a 55° inclined rail track to a height of 73.56m. The skip hoist operation is implemented upon a Qualter Hall wire rope drum and hydraulic brake unit powered by 2 x ABB motors. The skip hoist is a position control system that follows a pre-determined speed profile (as seen in Graph 1) which starts at the skip pit, located at the bottom of the skip bridge, and ends at a known tipping point above the furnace receiving hopper. The winch drum, skip pit and tipping point are shown as A, B and C respectively in Figure 5.

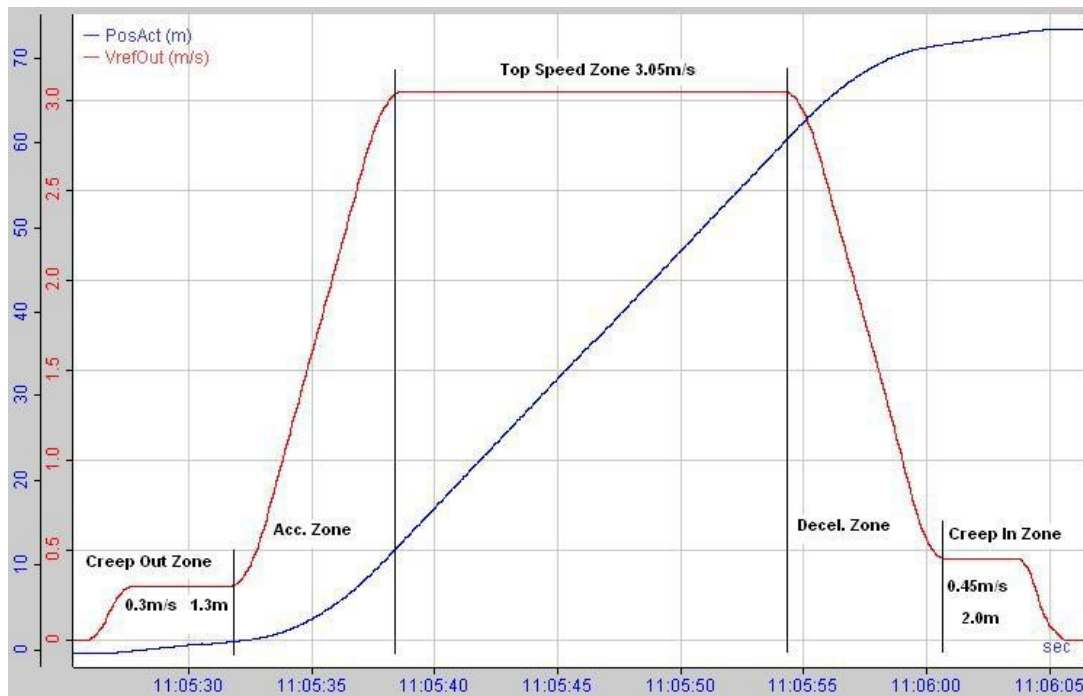
Graph 1 - Skip car speed vs Position [3]

As a loaded skip car moves away from the holding hopper, the second skip moves away from the tipping point, hence the creep out zone and speed is equal in value for the initial movement at either the top or bottom of the skip bridge. Once the skip clears the creep out zone, it accelerates to its full speed of 3.05m/s. After a set period, the system will then decelerate the skips to the creep in zones, to a speed of 0.45m/s. This zone starts 2m away from the final 55° tipping angle stopping position of 73.56m [3]. The skip bridge is at a 60.5° incline.

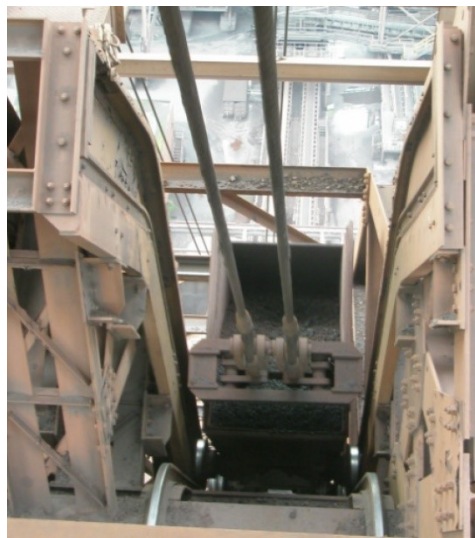
Figure 3 - Skip car terminations and compensation arm

There are a total of 4 wire ropes that act as the lifting media for the skip cars. There are two wire ropes per skip car in order to offer an adequate safety margin to the given minimum breaking load of the wire rope. Again, due to safety margins, the load could still be hoisted with a single wire rope. The specification of the wire ropes is 48mm Dyform 6 at 195m long as can be seen in Appendix A. The skip cars are connected to the wire ropes via solid thimble eyes with a hand spliced end termination via a compensation system to equalise the loading on each wire rope as seen in Figure 3. The termination is secured to the car using a load pin which allows the wire rope termination transverse movements which helps prevent fatigue. This also allows ease of maintenance on the skip cars.

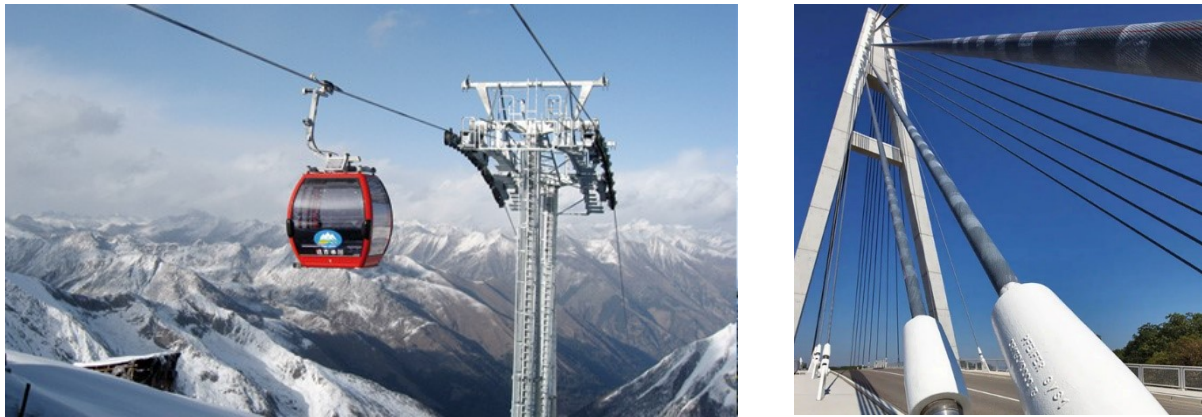
*Figure 6 - Examples of wire rope use [9] [10]*

Steel wire ropes are utilised by most industries throughout the world in a multitude of applications, from bridges, mooring, cranes, National Grid power lines and transmission of mechanical power, as can be seen in Figure 6. They consist of several steel wires twisted together to make a structure with mechanical properties combining axial strength and stiffness with bending flexibility. In the great majority of applications, steel wire ropes are subjected to several mechanisms of damage. These mechanisms can lead to the premature break of the rope components causing its sudden and unexpected failure. However, in general, due to their structure, they tend to show signs of fatigue prior to total failure [8].

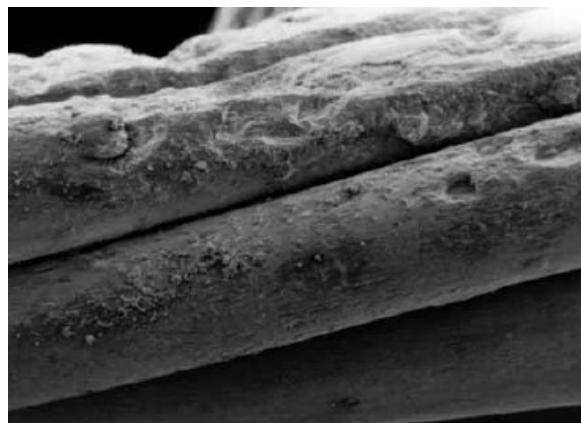
*Figure 17 - Pitting on individual wires due to loss of galvanic protection [20]*

The second kind is localised corrosion such as pitting corrosion, seen in Figure 17, by which holes or cavities are produced in the place where the protective coating breaks down. The corrosion pit gradually deepens on the wire rope surface, inducing stress concentration, fatigue crack and decrease of strength and flexibility. The stress concentration will accelerate the propagation of cracks, and finally result in mechanical rupture [23].

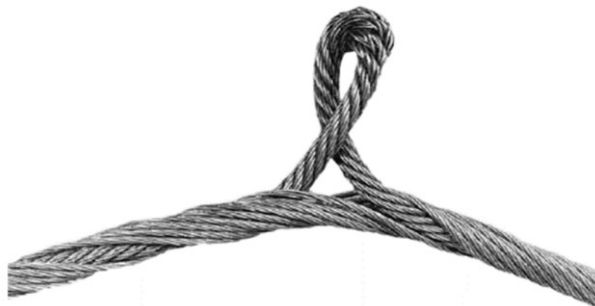
*Figure 22 - Example of core protrusion due to torsional effects [32]*

**Rotation** – A steel wire rope is made from helical elements and if the rope is twisted in the opening sense, these helixes will be opened up and lengthened. If it is twisted in the closing sense, the helixes will be shortened. These changes in geometry will change the properties of the wire rope and in some cases, considerably. In order to prevent the effect of rotation on a wire rope, both ends must be terminated and correct installation is vital. Twisted rope sections have a tendency to get rid of some of their twist by sharing it with previously non twisted sections of rope and as such, cause the twist to travel through portions of wire rope [20] [31].

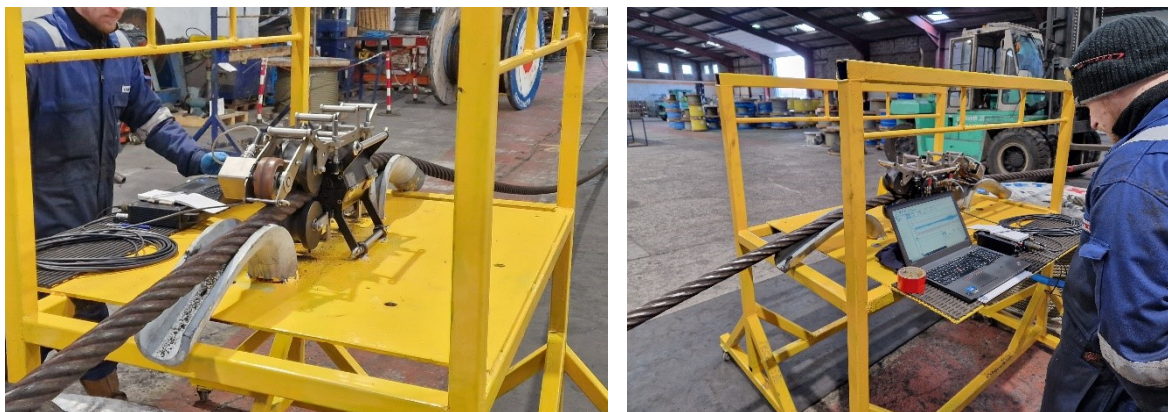
*Figure 35 - MRT testing at the Certex facility*

The MRT inspection was carried out by a level one inspector and the results were subsequently verified by a level two inspector with a larger range and duration of experience. Once the reports were approved and submitted to Tata Steel, the results were then scrutinised to ascertain the forward direction of the project.

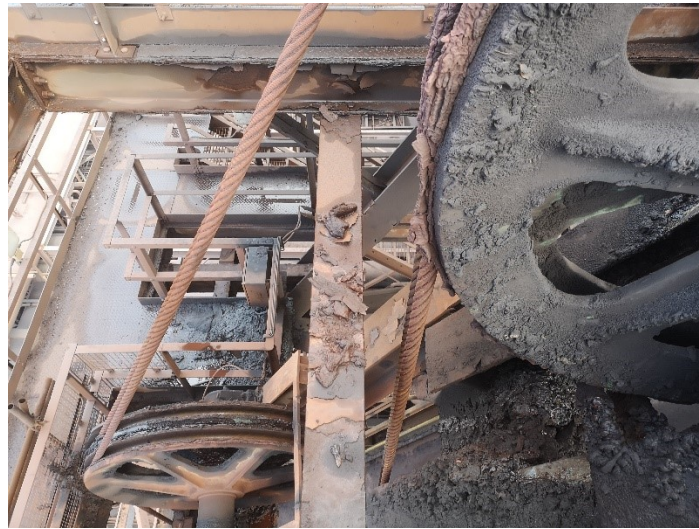
*Figure 37 - Evidence of poor cleaning/lubrication*

sheaves were being steam cleaned on a periodic basis. This method of cleaning can have an impact on the lubrication of the wire rope and can cause early signs of corrosion.

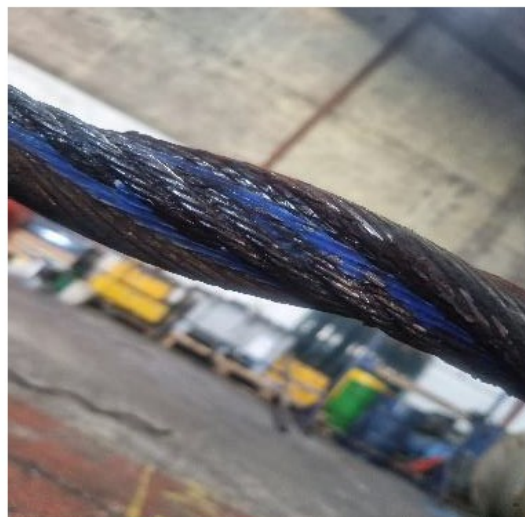
Figure 40 - Destructive testing of the wire rope at 42m

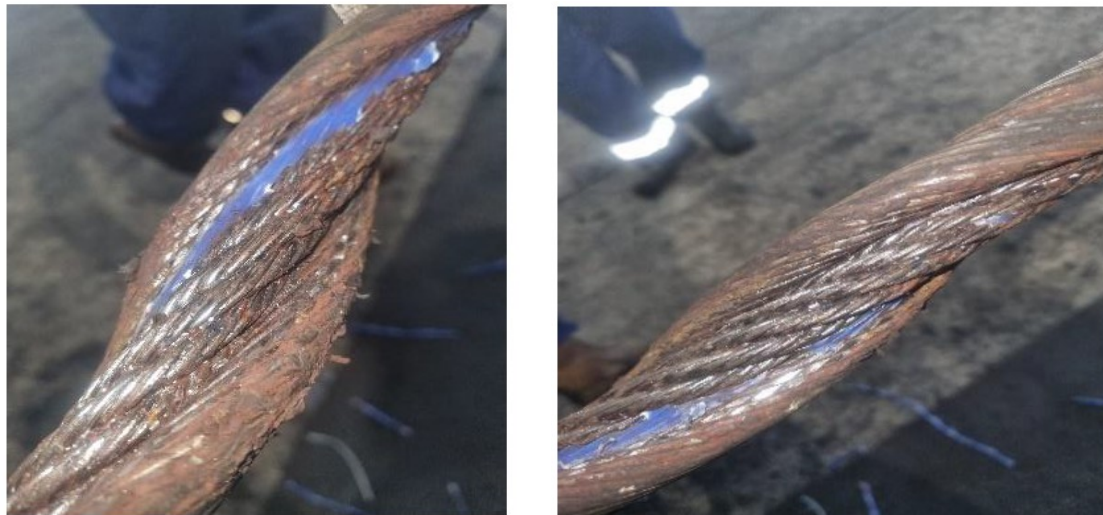
Figure 41 - Wire rope one and two showing internal corrosion at 55m and 53m

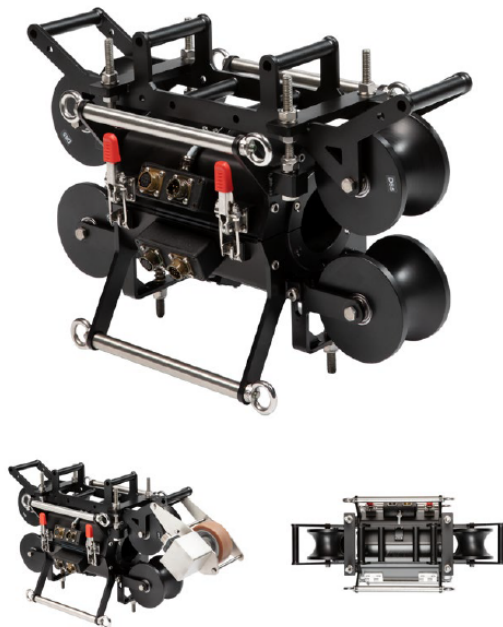
# ROPE 65

AMC ROPE 65 device, able to perform Non-Destructive-Tests on wire ropes with diameter ranging from 20 to 65 mm. The device works on ferromagnetic ropes.

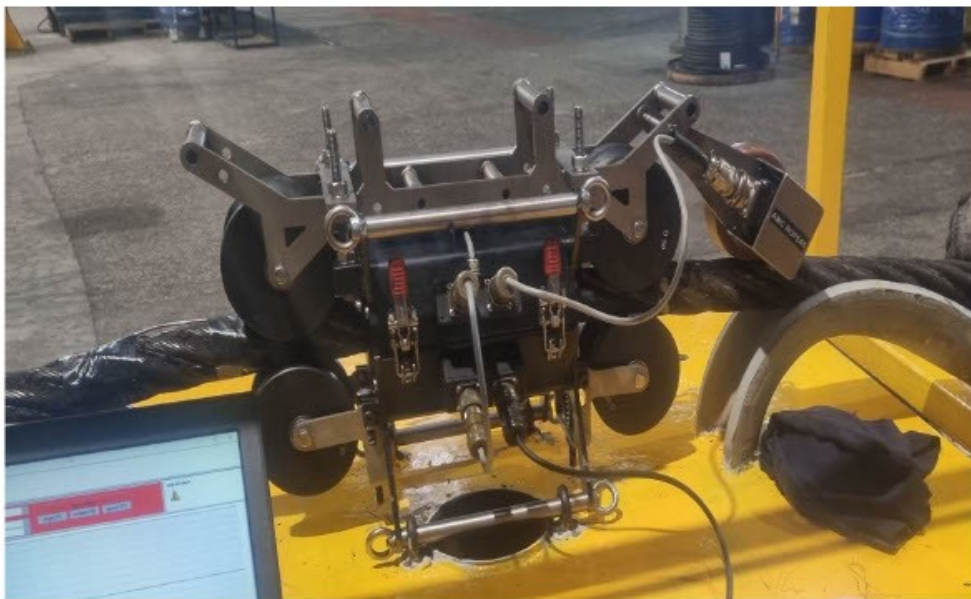
**MRT REPORT / JOB NUMBER- 7001384-1**

Date of Inspection: 19/01/23  
Order Number: 7001384-1  
Rope ID Number: N/A  
Engineer: Mateusz Jopa

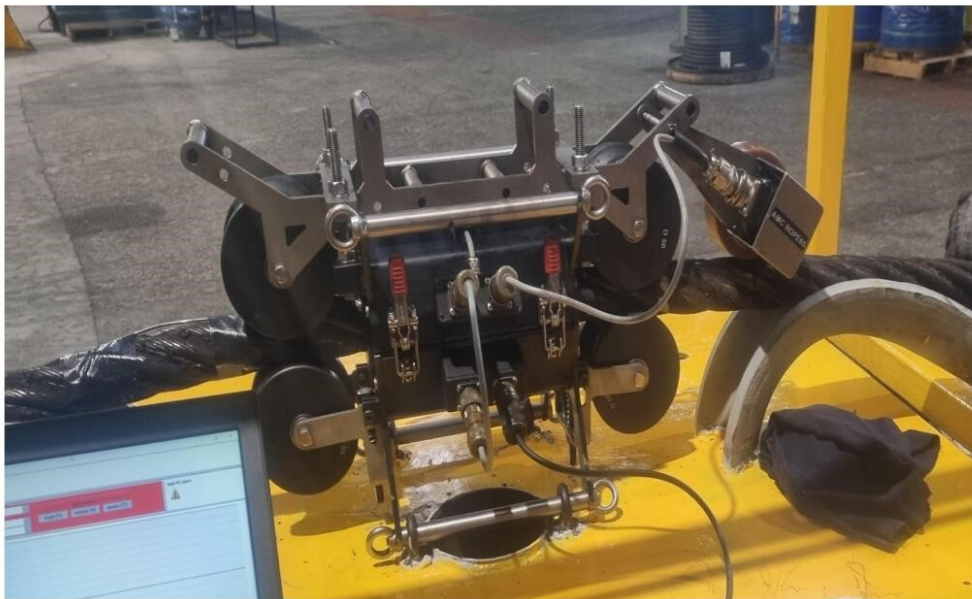
**MRT REPORT / JOB NUMBER- 7001384-1**

Date of Inspection: 19/01/23  
Order Number: 7001384-1  
Rope ID Number: N/A  
Engineer: Mateusz Jopa
