# THE EFFECTS OF SURFACE QUALITY OF MACHINED SPECIMENS FOR TENSILE TESTING ON MECHANICAL PROPERTIES

University of Wales Trinity Saint David  
Faculty of Applied Design and Engineering  
BEng Materials Science (Hons)

This report details an investigation into the effects of milled surface quality of automotive grades of steel by evaluating tested mechanical properties. Automotive grades account for a significant portion of the Tata Steel order book, and mechanical property specification tolerances required by automotive customers are rigid. It is crucial that the Metallurgical Testing Laboratory has confidence in mechanical properties tested to ensure the products are being manufactured and sold within specification.

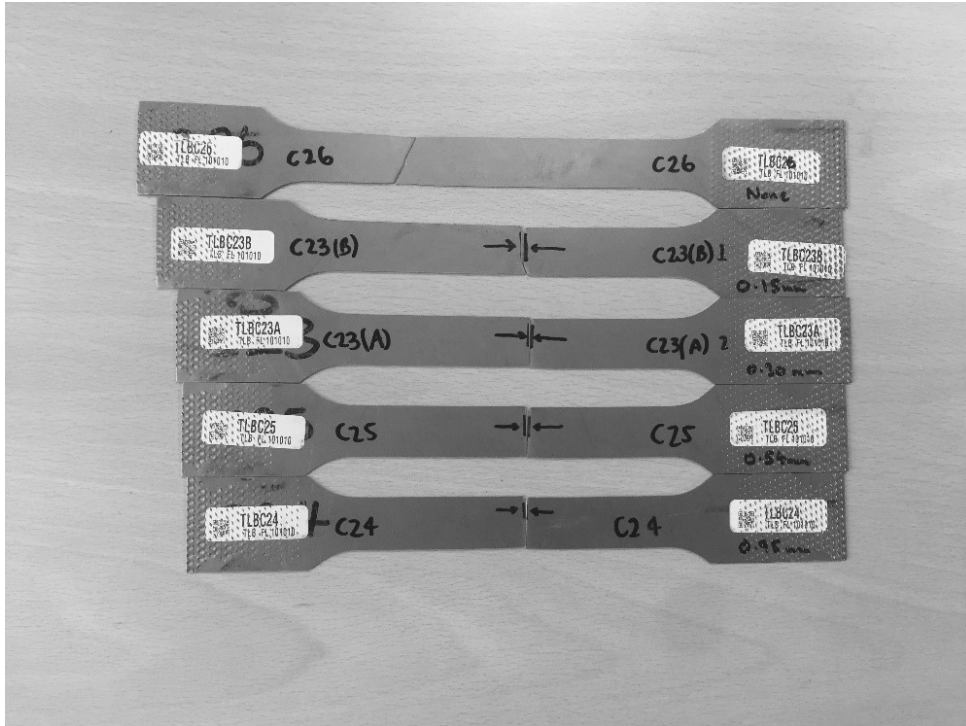
FIGURE 24 BROKEN SPECIMENS MARKING TEST FRACTURE AT THE POINT OF EACH NOTCH.

Markers were made before at the notch location before tensile testing, so that their location could be identified after the specimens had broken. The broken ends were kept for inspection.

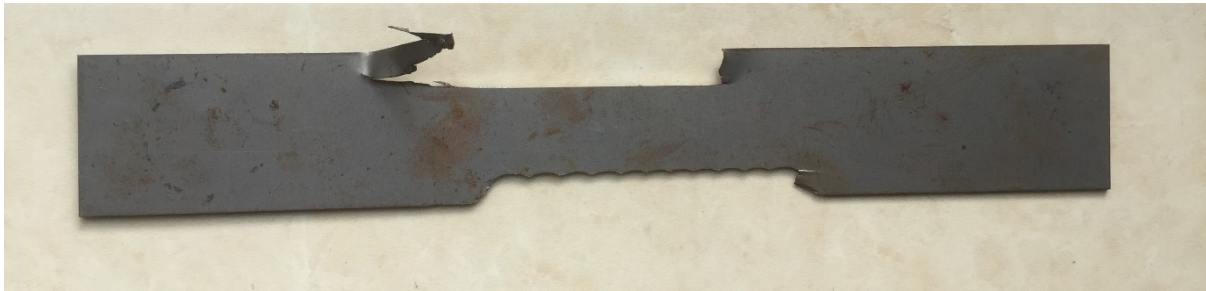
FIGURE 28 ATTEMPTED TENSILE SPECIMEN PRODUCED BY MILLING WITH NO PACKING MATERIALS AND A TOOL WORN TO ABOVE 5MM OF WEAR.

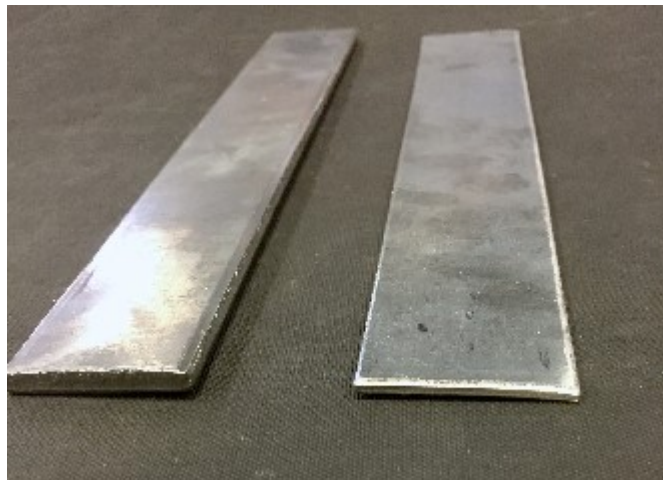
FIGURE 36 EXAMPLE OF THICK PACKING OF 5MM GAUGE AND THIN PACKING OF 2MM GAUGE.

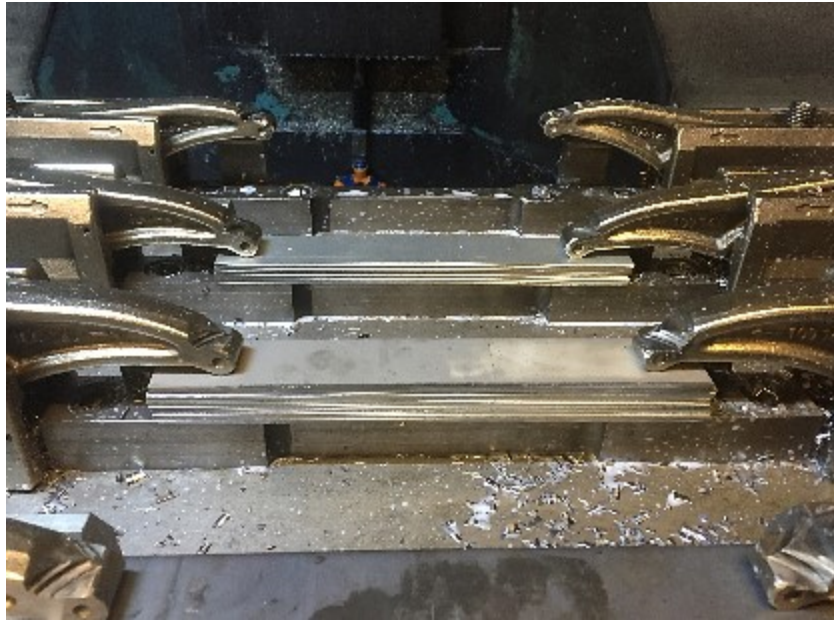
FIGURE 73 CURRENT CLAMPING SYSTEM FOR MILLING IN THE METALLURGICAL LABORATORY.

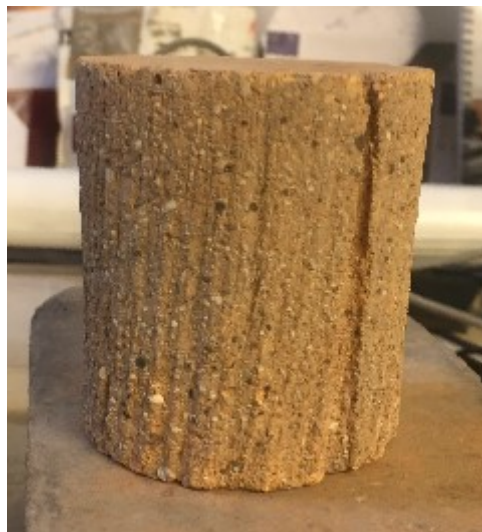
FIGURE 96 A CYLINDER OF BRICK CUT BY WATERJET AT UWTSD, EXHIBITS THE “DRAG” PHENOMENON
