# INDEPENDENT PROJECT

HANEL LEAN LIFT

CAMERON DICKSON

UNIVERSITY OF TRINITY SAINT DAVIDS

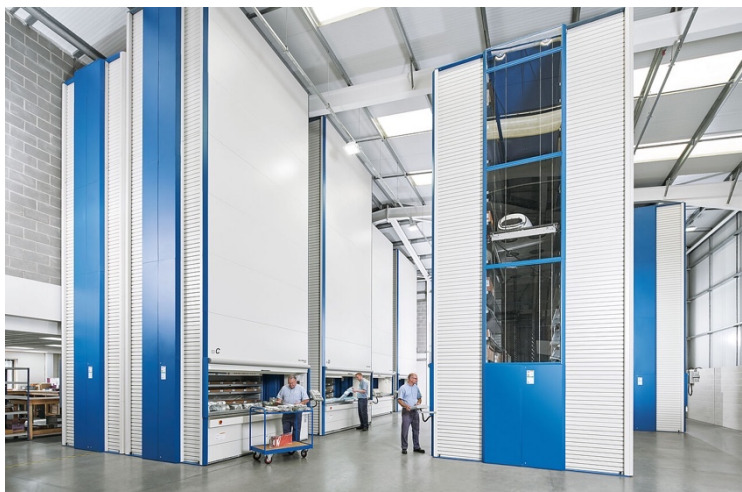
The project that will be undertaken is a modification on the Hanel Lean lift. The Hanel lean lift is a rational way of storing parts. The lean lift is a closed system that is computer operated. The computer stores the data of parts that are stored within the machine. By calling the shelf number of where the part is located the controlled lift called the extractor, which moves up and down via the smooth action rollers. Collecting and returning items to present to the operator at the front access point. Within Renishaw we have 11 lean lifts on site in Miskin. However, these are located in other Renishaw sites all around the UK. These lean lifts across Renishaw hold stock worth millions and are very essential to Renishaw. In fig.1 an example of a lean lift is shown.

Fig.1 Example of a Lean Lift

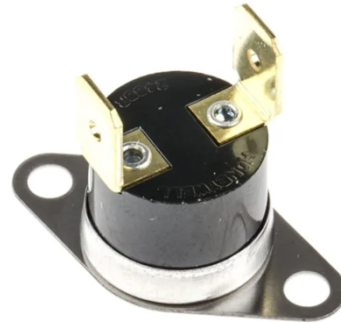
through the relay. In fig.2 the siemens temperature relay is shown and in fig.3 the temperature sensor that attaches to the motor is shown.

Fig.3 Motor Temperature Sensor

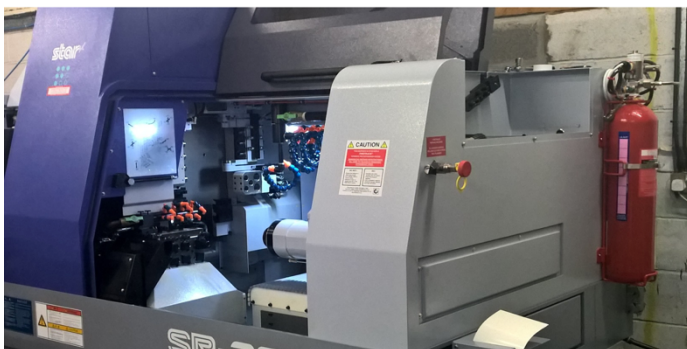
My second solution will be fitting Firetrace Equipment to the Lean Lift. Renishaw does a lot of work with firetrace and it is used on a lot of our CNC machinery within the machine shop. It is mainly used on our lathes. The fire trace solution will detect and stop any fire that is caused by the motor. The Firetrace systems use detection tubing which is installed around the risk area and connected to a cylinder valve. The tubing is then charged with nitrogen and this pressure is utilised to hold the valve in the closed position. Should a high temperature or fire occur then the pressurised tubing will burst, and the cylinder valve will activate deploying the extinguishant immediately onto the fire. You can also add a control switch to the system that will in turn not just stop the fire but will also be integrated into the safety circuit to stop the machine. Below in fig.4 you can see the fire trace system on one of our star lathes.

Fig.4 Star Lathe with Fire Trace system integrated

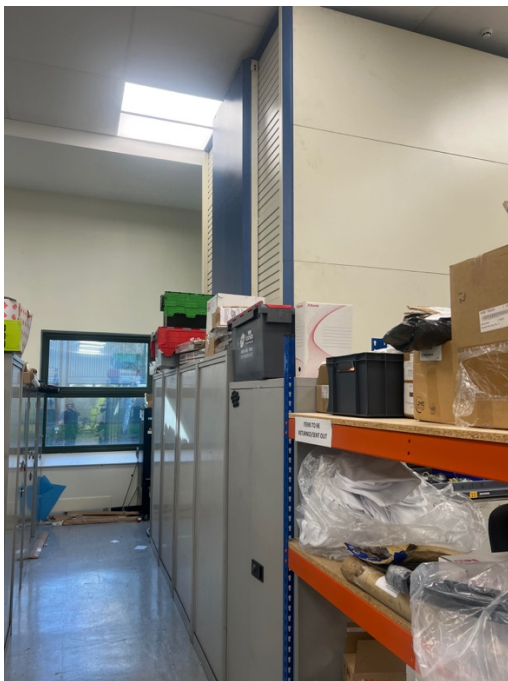
Within the set of hazards for a risk assessment a big hazard is the environment in which the equipment is surrounded by. Upon inspection of the lean lifts environment currently the service panel is being blocked by cupboards. With the PPM schedule and testing the motor sensor it is a lot safer for the service panel to be easily accessible. The image Fig.5 below shows the side of the lean lift blocked.

Fig.5 Lean lift service hatch blocked

Deeming this as a safety concern the cupboard has been moved so that full accessibility is granted. By having this accessibility upon PPM inspections, it is a lot easier to inspect the chains and motor without having to climb into the lift itself. As you can see below in Fig.6 the service door is now accessible, and the chains are easily visible for checks.

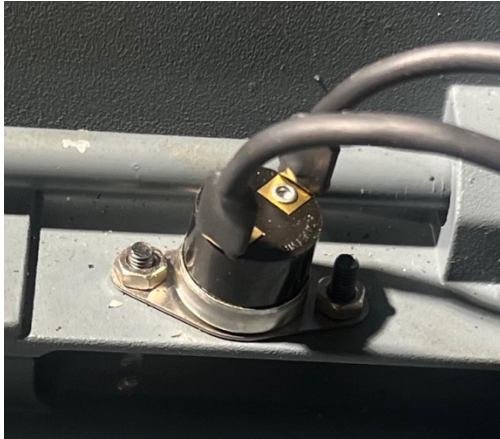
The motor already had predrilled and tapped holes to mount something like this sensor to it. The thermal sensor is able to read the temperature from the motor windings. The image below in fig.15 is the sensor secured to the motor.

Fig.15 Temperature sensor secured to motor

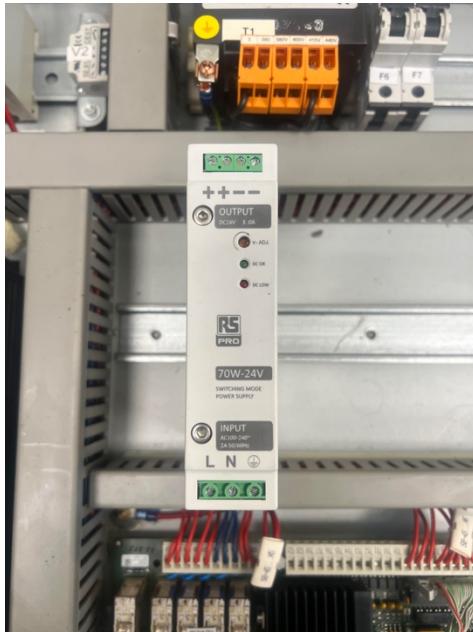
After fitting the breaker, the next step was fitting and wiring up the 24v Power supply. The power supply is what gives the 24vdc output and powers the relay siemens temperature monitoring relay. Below in Fig.17 is an image of the power supply fitted to the din rail.

Fig.17 Power supply mounted

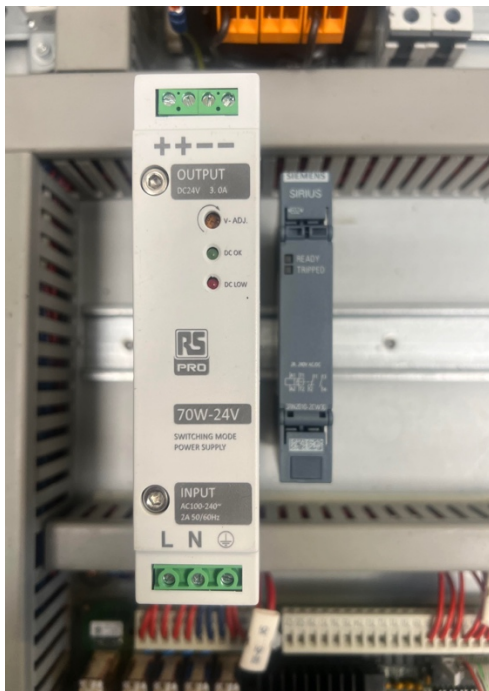
Now that the power supply is fitted the next step was to insert and wire up the siemens temperature monitoring relay. Below in Fig.18 is an image of the relay next to the power supply.

Fig.18 Temperature relay

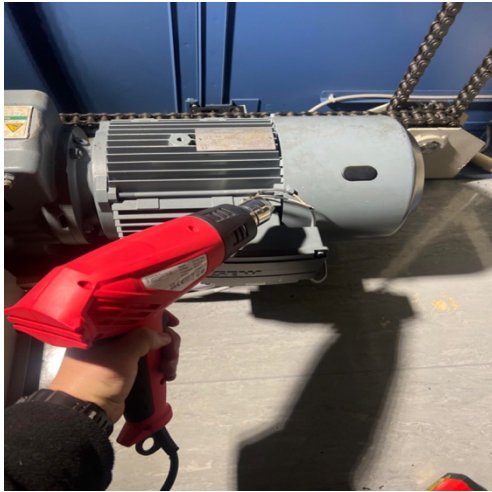
To test these a heat gun that was set at 100°C was used and also a calibrated temperature probe to ensure that the heat gun is working efficiently and correctly. Choosing this temperature sensor, the understanding from the technical specification of the sensor was that at a 100°C then the sensor should have an open signal triggering the design and wiring and alarming out the machine and putting it into a state of emergency. Applying direct heat onto this sensor simulates if the motor is overheating. Below the testing of the temperature sensor with the probe and heat gun is shown. Heat gun test is shown as Fig.20 and calibrated temperature probe is Fig.21

Fig.20 Heat Gun Test

After heating the sensor to 100°C the relays activated, and the machine shut off. To confirm that the modification had worked correctly, a check on lean lift HMI screen was needed. Checking the HMI screen showed that the machine had alarmed out. Fig.22 below is the alarm message on the screen.

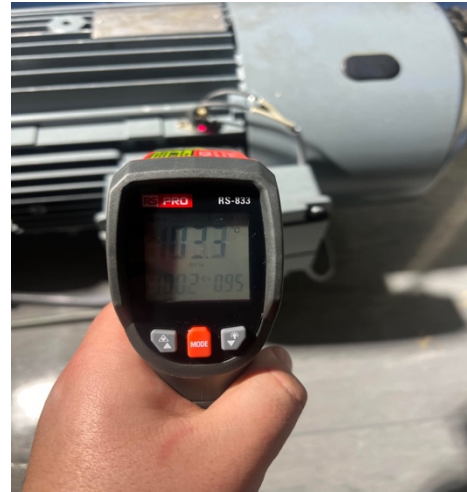
Fig.21 Temperature Probe Readings
