# Investigation of the effect UV Radiation has on Polypropylene Polymers

Mohammed Alsadhan

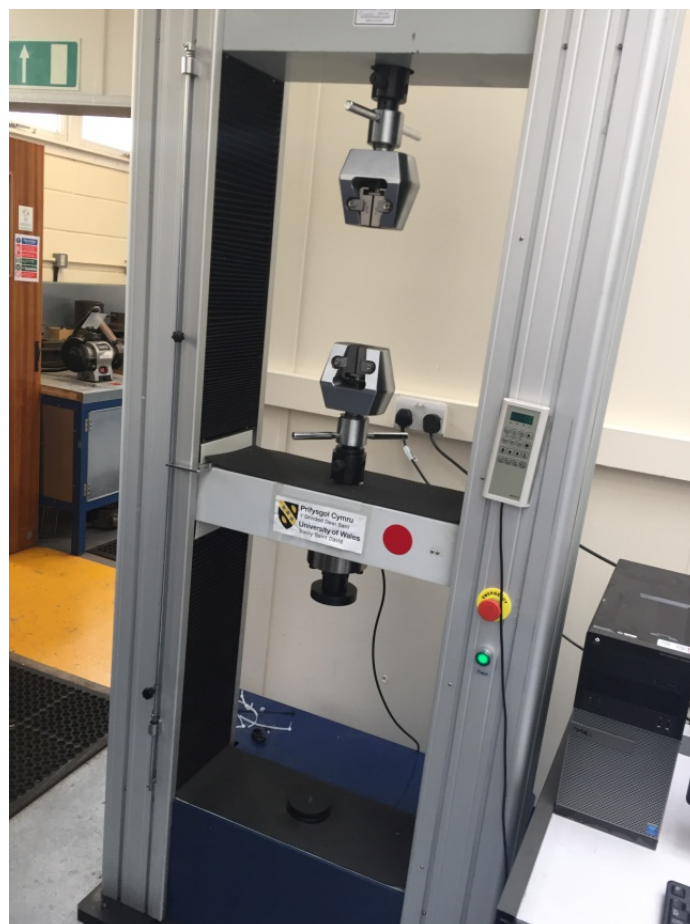
*Figure 4 - Tensile testing apparatus*

A tensile test consists of two mechanical arms which either side of the testing material is attached to. The function of these mechanical arms is to pull the material apart in either direction until it fails under the opposing forces. This will inform us of the materials tensile strength, whether it is brittle, ductile or a mixture of the two properties **(Gharagozlou, 2017)**.
