Engineering Materials

*Materials and Manufacturing (ACHA4025)*

The aim of this report is to investigate a suspension failure during a rally by way of a tensile test carried out on a test sample. A recent change to supplier means that the team is confident that the failures are a material issue. The parts were manufactured the exact same way as the old parts supplied by the previous company. The results of the test have been analysed to calculate the yield strength, ultimate tensile strength and Young's modulus. These values will indicate the properties of the material and provide insight into the cause of the failures, ultimately allowing for solutions either to solve the problem or advise measures that will increase the longevity of the component.

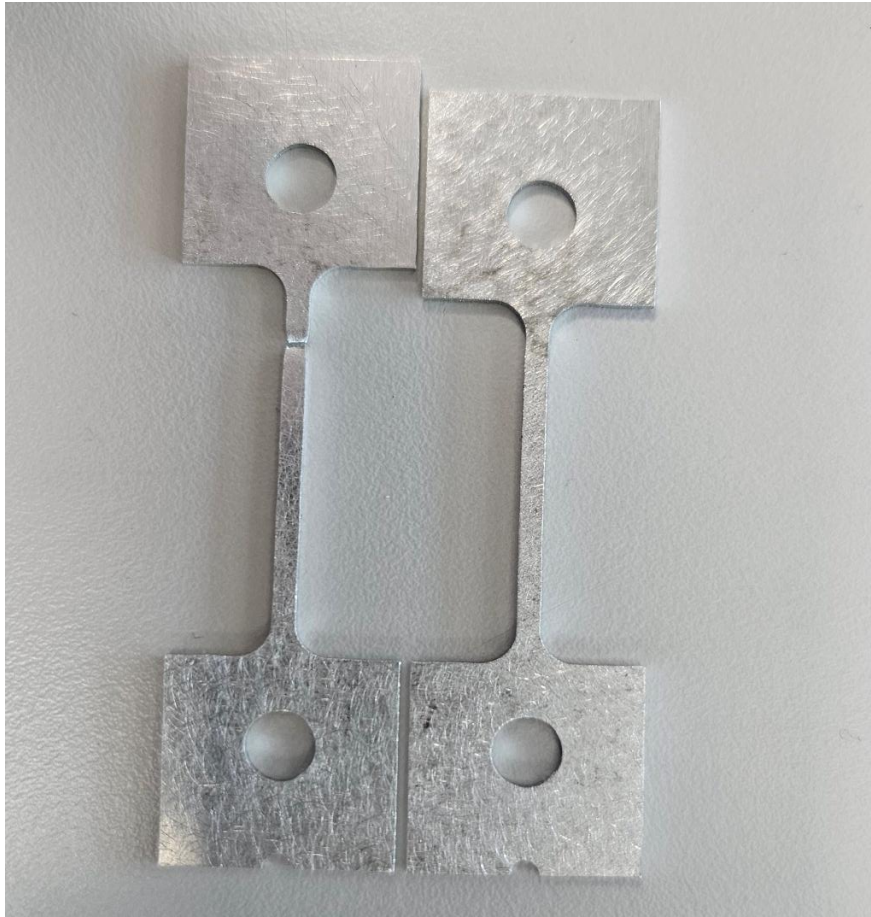
*Figure 5 - Tested Sample vs Untested Sample*

The elongation was calculated by subtracting the amount of movement of the top chuck and plate by the reading on the dial indicator respectively. This gave a final extension value of 2.08mm. This is shown in figure 5 where a tested sample is compared with a sample that hasn't been tested, it is clear that the tested sample has changed in length. Visually it looks like the sample has been stretched a couple of millimetres, confirming that the value found for final extension is correct. This happens because the material plastically deforms before breaking.

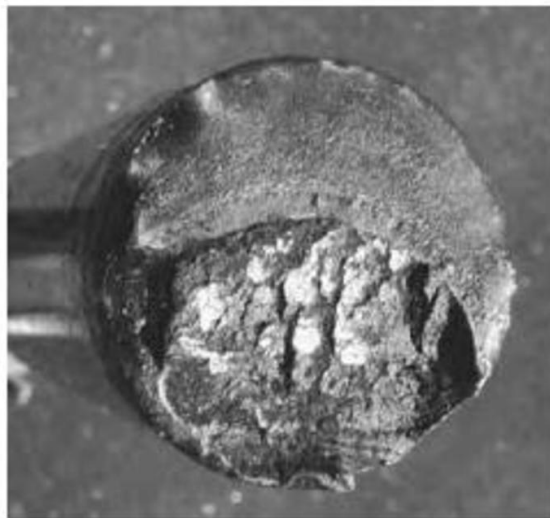
*Figure 8 – Failed Component*

In conclusion the material chosen seems to have all the suitable characteristics that would enable the component to operate effectively under the given conditions. However, the cause of the failure was definitely fatigue. In the figure below there are clear striations at the bottom of the photo. If there was some sort of weakness created in the material through stress concentrators such as chips or damage to the part, then the material becomes significantly weaker. To prevent this happening in future a visual inspection should be conducted at regular intervals to ensure that the part isn't damaged in anyway. Through vibrations and torque being transmitted the striations would have grown larger and larger until the part became weak enough that it would have broken. From the analysis it is clear that the part was strong enough to withstand significant tensile stress however if a stress concentrator caused the force to overload in one part of the component, then it is feasible that the stress could have exceeded the yield strength and plastically deformed. Once a part plastically deforms it does not return to its original shape. Therefore, continued use of the component and continuous torque being transmitted through the part would have continued to deform the part and enlarge the striations. Further research should be conducted to investigate if it would be worth changing these components at an appropriate interval that would prevent and stop the component failing and causing retirements during the races.

Other solutions could be to incorporate composites into the design, so the torsional vibrational forces have less impact on the aluminium. This would be a costly way of preventing any further failures in the future however it would reduce any possible way that torsional vibrations could impact the striations. Although this is not a direct cause of the failure it may increase the longevity of the part.
