## **Reducing Lost Production from Process Control Valves**

**Mathew Rowlands**

Bachelor of Engineering: Mechanical & Manufacturing Engineering

Major Project

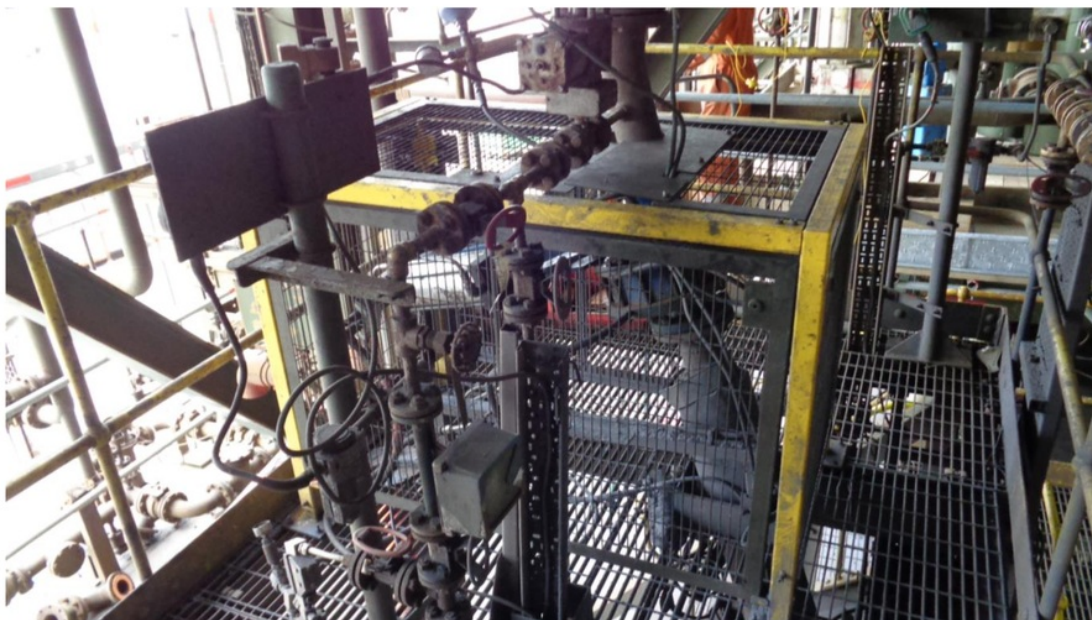
Better access to the valve would allow hands-on maintenance to be executed quicker. Currently, a machine guard has to be removed to complete the maintenance seen in Figure 2.4. This guard could be simplified or replaced with an interlocking gate that complies with BS EN ISO 12100:2010 (British Standards Institution, 2010). Currently removal and reinstallation of the guard takes a total average time of one hour, this could be completely eliminated with an interlock gate. The area around the valve is small and overcrowded making some of the valves flange bolts hard to access. The platform could be extended, and all auxillary instrumentation could be relocated to a different area that does not limit access. This improvement cannot be quantified with the current data provided.

*Figure 2.4 – Machine guarding in place around PV345*

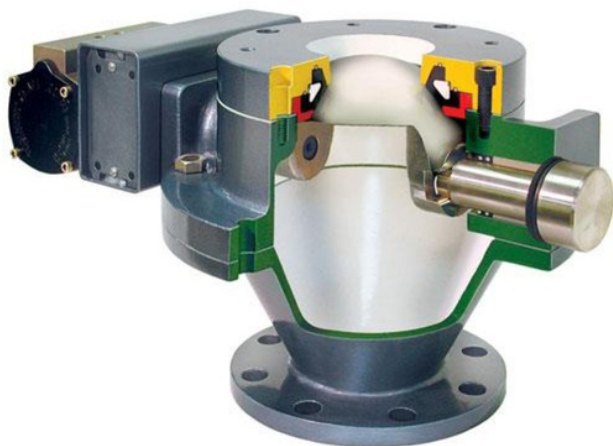
Figure 2.6- Cross-section of a Clyde Dome Valve  
(Macawber, 2019)

Another model of valve used on the site is a Dome valve shown in Figure 2.6. The Dome valves are most commonly used in applications with abrasive powder materials. The Dome valve has a similar operation to a ball valve although its ball is cut away. Unlike the ball valves, the dome valve does not have metal seats, it has a sealing bladder. After the dome rotates into the closed position the bladder inflates forming a tight seal. This sealing method is an advantage over the ball valve as the dome does not carry abrasive material across the sealing face when it rotates. However, the dome valve is suited to applications with a low actuation frequency due to the

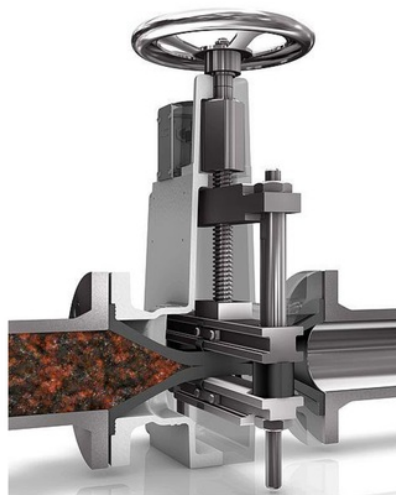
Figure 2.7 – Cross-section of a Pinch Valve (Pinch-valve, 2018)

Another type of valve commonly used on Silicon powder duty is a pinch valve. A pinch valve has a boot (rubber lining) that contains the process material. The boot is compressed with a t-bar to close the valve. The t-bar can be closed manually through the use of a lead screw as seen in Figure 2.7. In actuated applications a bladder and spring mechanism is employed. The rubber lining provides sufficient wear resistance to contain the Silicon powder and can maintain its integrity through a high volume of actuations. However, a pinch valve takes a long time to compress the boot making it inadequate for precision process control.

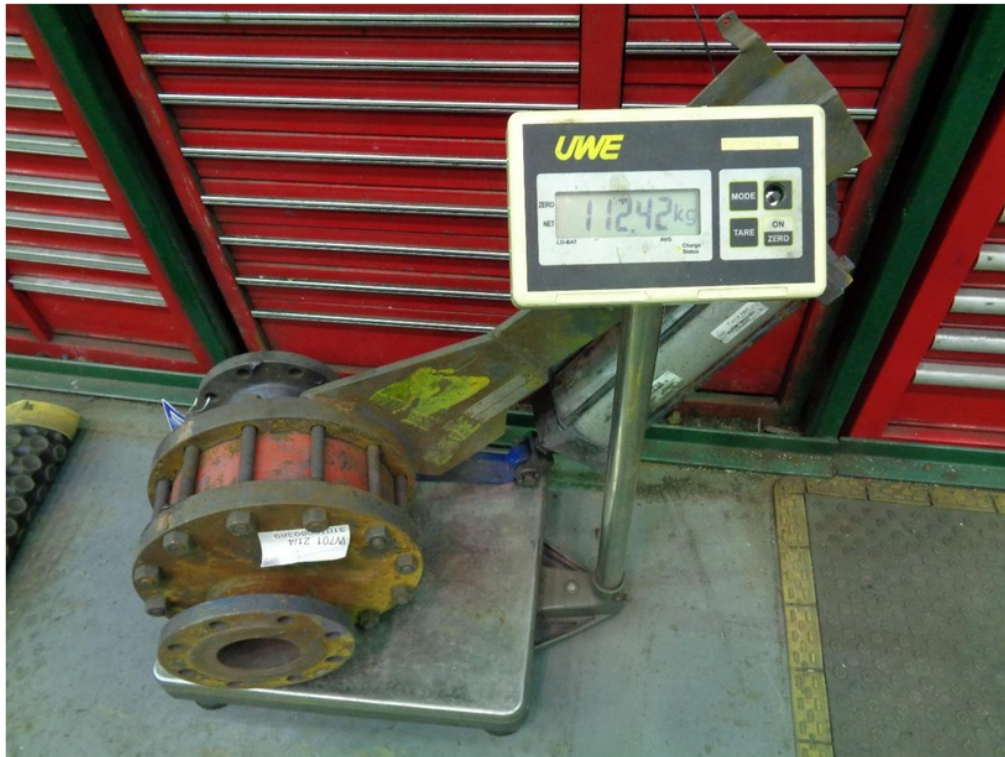
Appendix 1.3 – Weight of 4" Everlasting valve before installation

The manual handling of the valve is another hazard that could be reduced by improving the reliability of the valve. The 4" Everlasting valve weighs 112.42kg (Appendix 1.3), this means it has to be transported by pallet with a forklift truck to W930 plant. During installation, the valve is lifted onto the raised platform over the handrail using a forklift truck with an extendable lifting arm. Although the forklift truck supports the weight of the valve; it still requires some manual adjusting to position it correctly to align with the pipework.

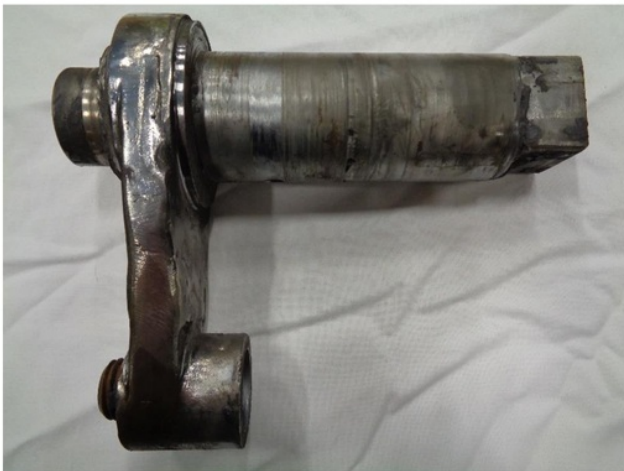
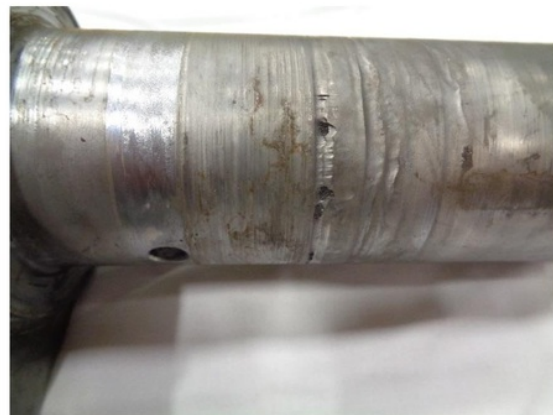
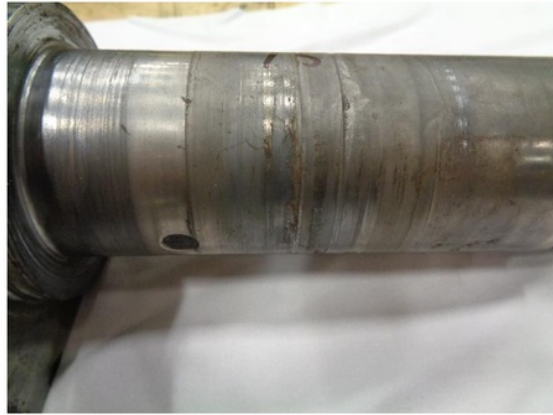
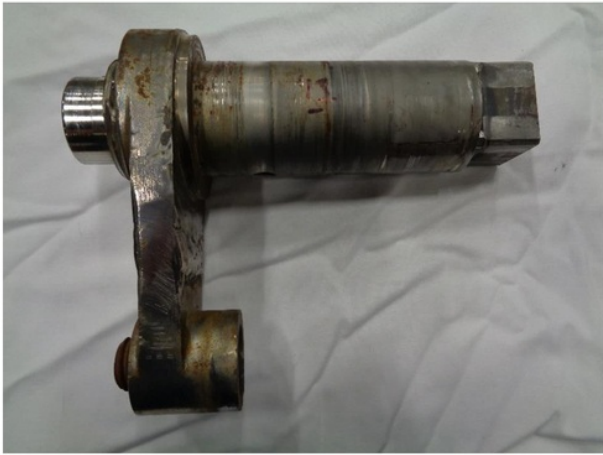
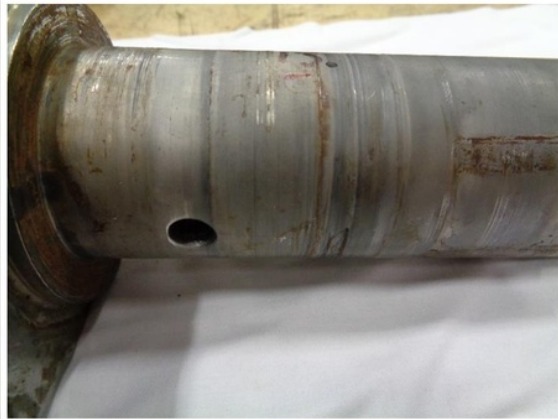
Appendix 1.4 – Wear on lever arm shaft that causes valve failures

The area in Figure 1.7 denoted as A is the location of the bearing bush on the shaft. Area B shows the location of gland packing on the shaft. Wear is present in both these areas. This wear is repeatedly the cause of failures detailed in the Technical Findings (Appendix 1.5) Further images of wear in this location are shown in Appendix 1.4.

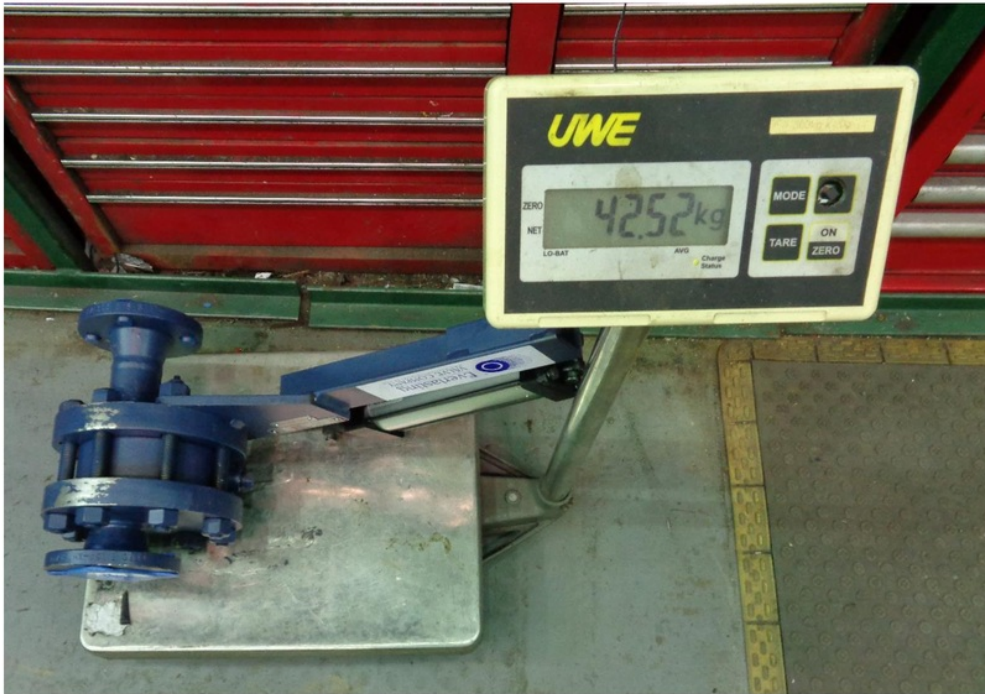
Appendix 4.1 – Weight of 2" Everlasting valve before installation
