Analysis and recommendations for the minimisation of  
material failures

Mechanisms of Materials Failure  
ACEA7010

This work focuses on the analysis and recommendations for the minimization of material failure of gear train WD200 (Figure 1), which is widely used in the maritime and agricultural industries (all the WD200 gear train data are included in the appendix).

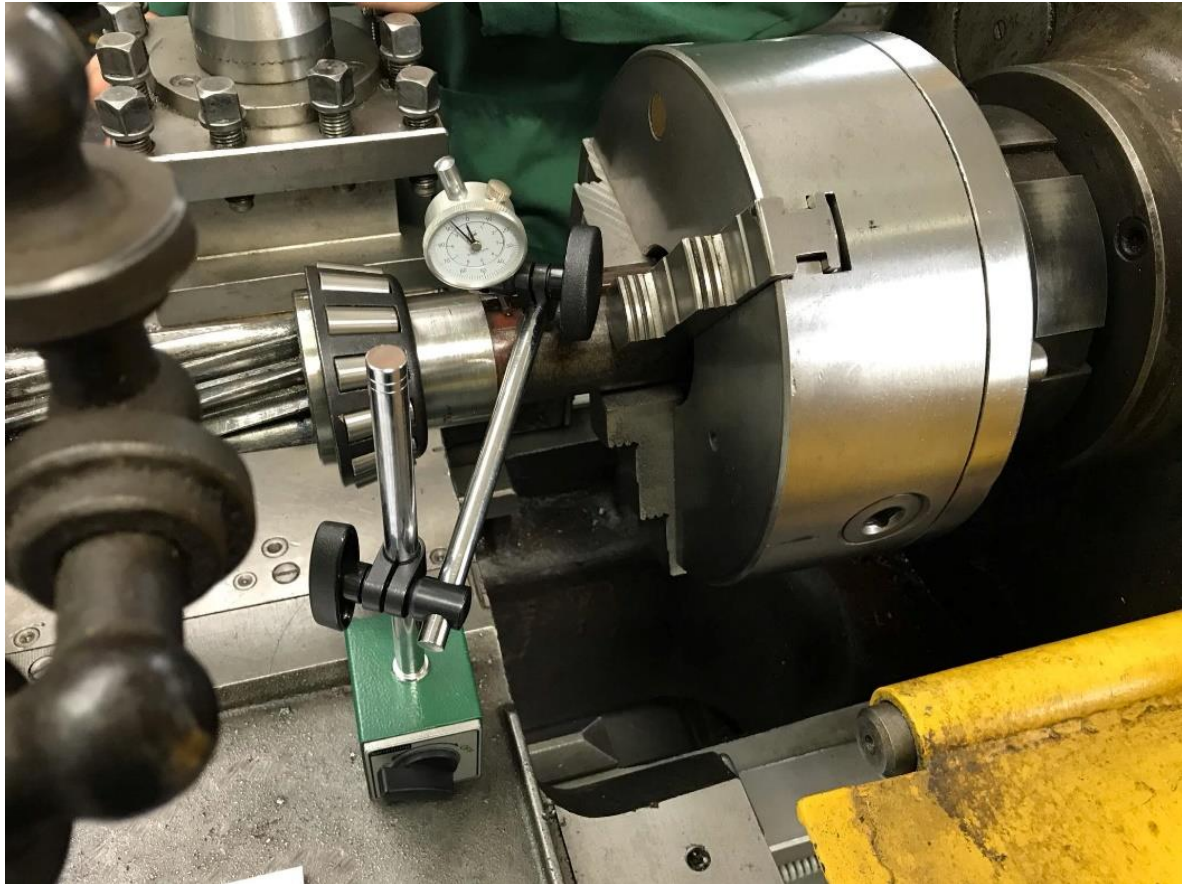
Shaft runout measurements made with the use of a workshop lathe and a dial indicator with a magnetic holder. The shaft was mounted on a lathe through a three-jaw chuck and supported by a tailstock. The measurements were read with the shaft rotating every 60 degrees in two different places. Results are within limits.

*Figure 15 Shaft runout measurements*

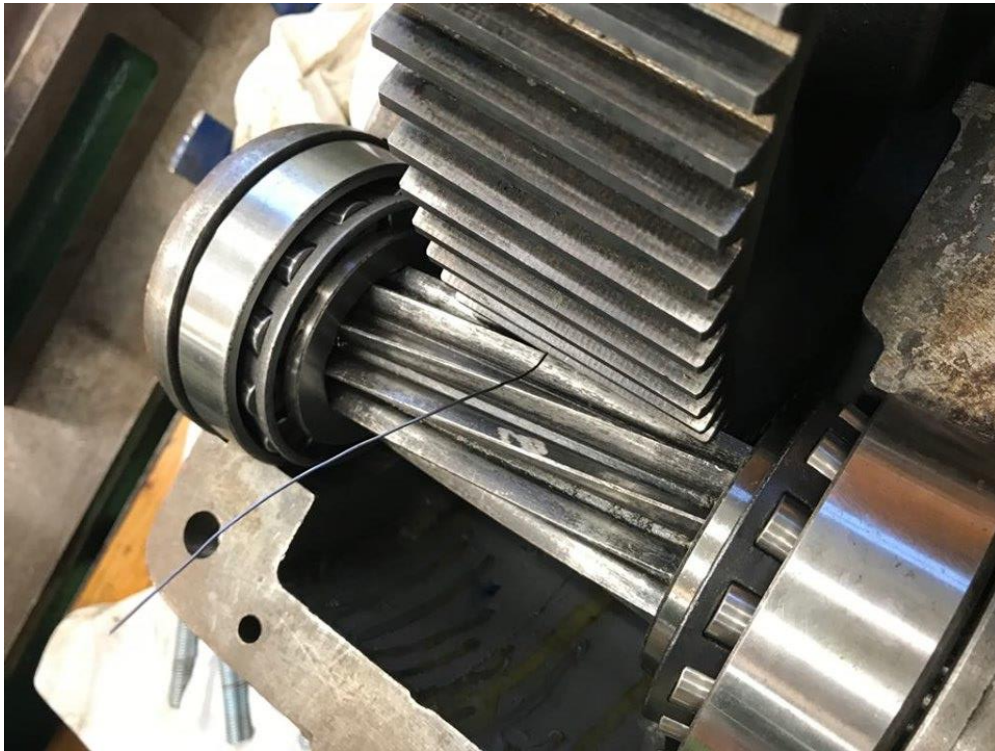
Measure the clearance between the teeth using the indirect method, through the impression of the lead wire. Measure the wire with a micrometre with an accuracy of 0.01 mm. Results are within limits.

*Figure 16 Measuring clearance between the gear's teeth*
