**Abdulaziz Aljahdali**  
**P132783**

# 1.Introduction

In December 2017, a survey taken place in the University of Wales Trinity St. David (UWTSD) has been conducted, precisely at the Lampeter campus. This survey aimed to upgrade the student accommodation and improve the sustainability condition of the building. Lampeter has been graded as Grade II of a listed building. Final year students of the Faculty of Architectural technology course at UWTSD in Swansea campus were assigned to proposed to restore the Lampeter accommodation to make it more sustainable without any modification of the original structure and the overall outside shell of the building. This report ultimate goal is to provide a solution of improving the windows of the building.

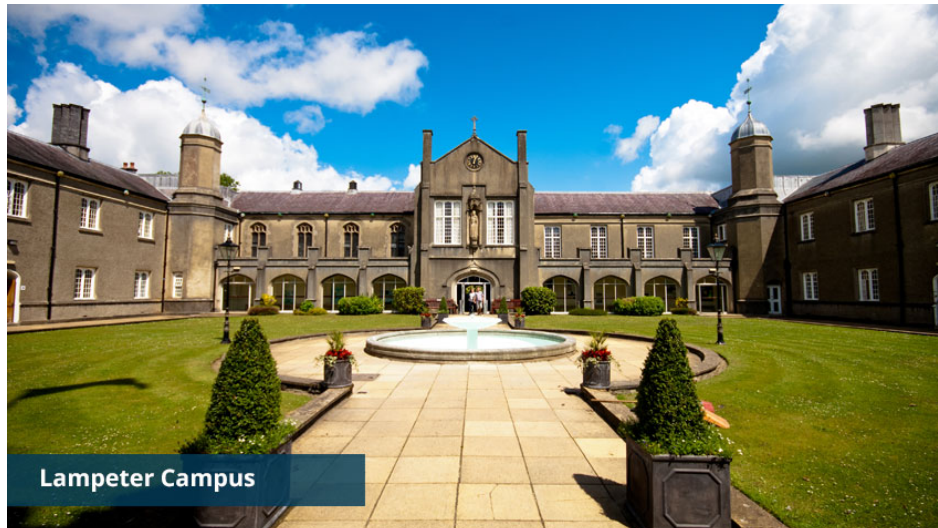
Figure 3. Lampeter Campus

These data are collected during the survey conducted on the 12<sup>th</sup> of December 2017. The survey took place in Lampeter campus UWTSD Swansea by a class of Architectural Technology students from UWTSD, Swansea. **(Figure 3)**

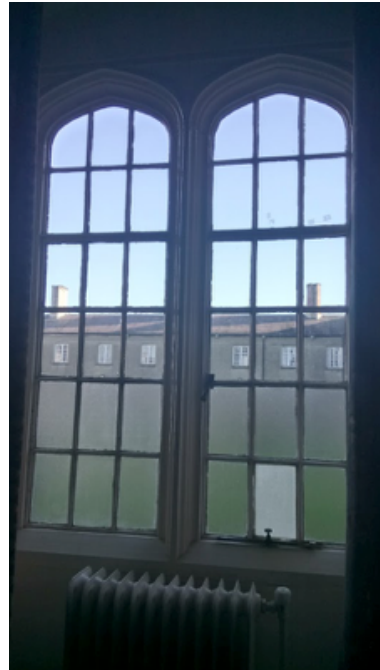
Figure 4.  
Lampeter Window

A thorough survey has been conducted to identify all the required work that needs to be done. In this report, restoration of all old windows will be the main focus. See Figure 4. Figure 4 illustrates an example of Lampeter windows to show any possible situation that might come up in the process of restoring and installing the secondary windows. It also shows the thicknesses of profiles that can be used to prevent any alteration of the original design of the building from its external view. The next step was to get access to electronic documents from the local council. The reason for this step is to identify the grade of the Lampeter building that was registered under the Local Listed Buildings.

With regards to the method and restoration process, it is vital to initiate the existing windows so that when the interior of the new windows are secure, the old materials are ready to get fixed without any risks or anything that would increase the costs. In order to begin the work, all planning works need to be prepared in advance in order adapt Lampeter building's windows efficiently and effectively. A good planning is required to avoid any risks towards the materials and the safety of the worker.

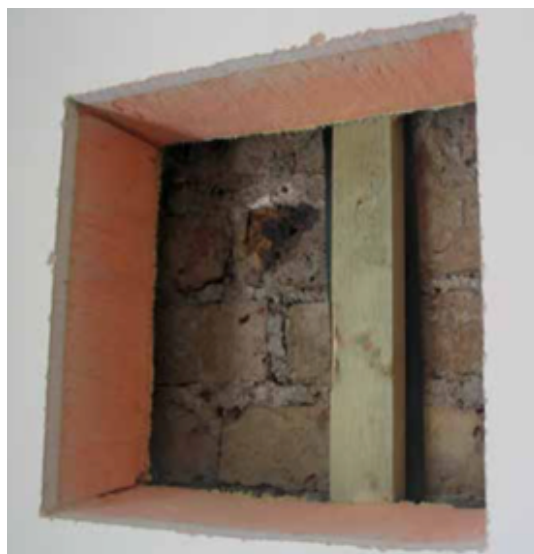
Figure 8: Internal insulation for solid wall

In order to add insulation, the two R-values need to be added together. See below calculation:

80mm Polyisocyanurate insulation

tC of 0.022

$$R\text{-value} = 0.08/0.022 = 3.63 \text{ m}^2\text{K/W}$$

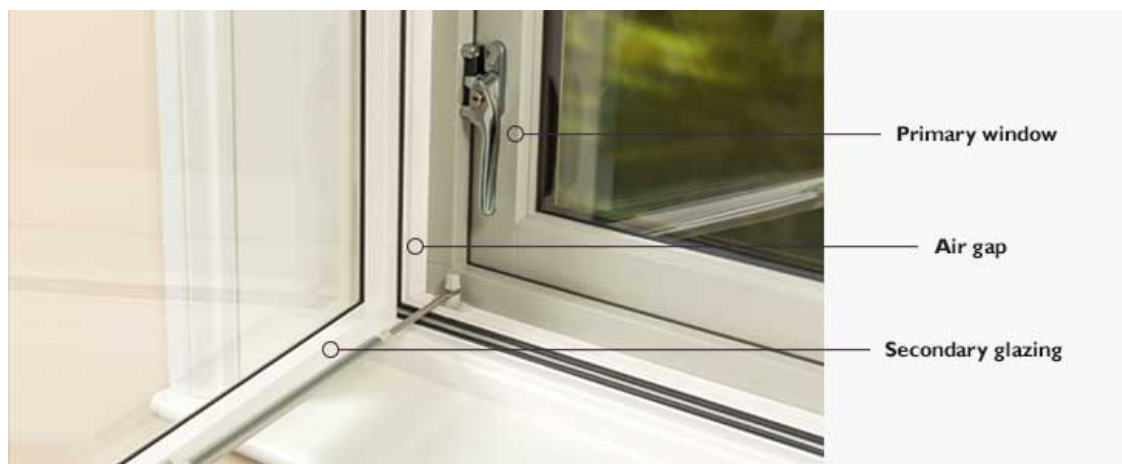
Figure 10. Frame System for Secondary Windows

Looking at the results of the survey done, the windows leak a great deal of ambient energy, therefore it needed to be treated. One of the alternatives is to use internal blinds as it helps to improve the window performance. As a matter of heat loss, heavy and coated curtains may be a good option to reduce the heat loss. Furthermore, the use of double glazing with double profile will only be effective when the existing frame supports the new features of the new windows. However, in the case of windows in the Lampeter building, it is impossible to eliminate the original windows to replace it with a new one. In this case, another option is to propose a secondary glazing and the placement of an independent UPVC frame as double glazing has the capability to provide the preferred function in a sustainable way. See Figure 10 and Figure 10.1.

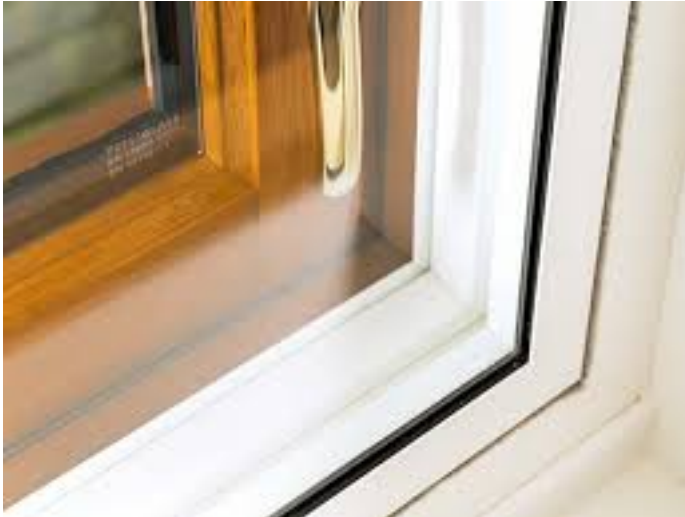
Figure 10.1. Frame System for Secondary Windows

The internal double glazed window with fixing the shoulders and window sill, offers the exact insulation values, energy losses reduction, lower the noise and dust entry, assuring the equivalent current light input across the old window. The window's design should be circumspect and projected together with outlining that it cannot be viewed from the outside of the old window to ensure that the original design or the building will not be effected. In addition, supplementary security procedure can be added in a reasonable way in existing windows. Not to forget, the new secondary window also comes with additional safety procedures.
