# **Doors and windows in Cornish buildings: an analysis**

**Connor Motley**

**Dissertation for MA Archaeological Practice,  
University of Wales Trinity St David**

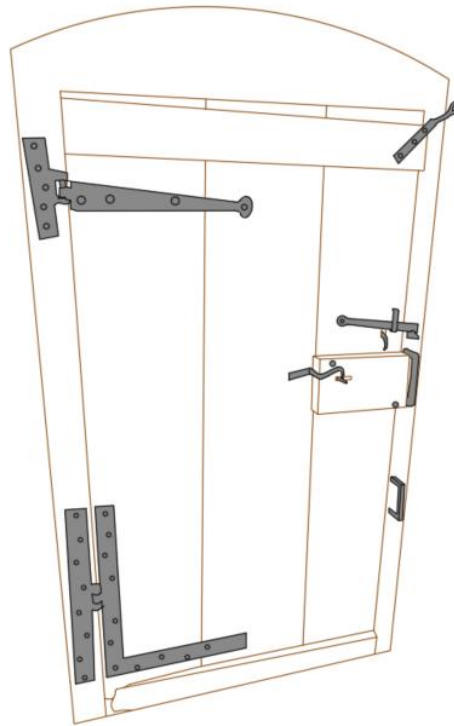
**Number:** D5

**Type:** Ledged door (rear side), four panelled door (front side, not illustrated), segmental arch, strap hinge (round finial), HL hinge, thumb latch

**Description:** The face of the door that has been illustrated is the rear internal face of the door. The unillustrated side has four panels and a thumb latch, and was originally an external door, but has since become an internal door with successive extensions of the building. It is the earliest example of a ledged door in this study. It is attached to its frame with both a HL hinge and a strap hinge.

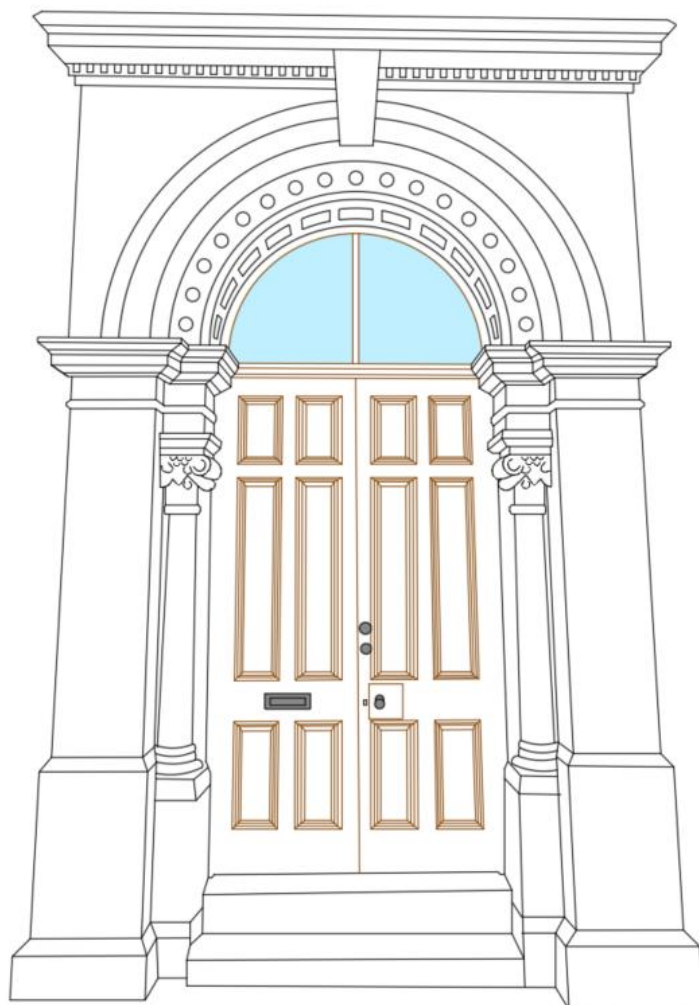
**Number:** D26

**Type:** Six panelled door (double), semi-circular arch, transom light
