# ***REPORT***

# ***FUNDAMENTALS OF CONSTRUCTION TECHNOLOGY ACBA4022***

## Case Study: Rhyd-y-car Terrace, St Fagans National Museum of History

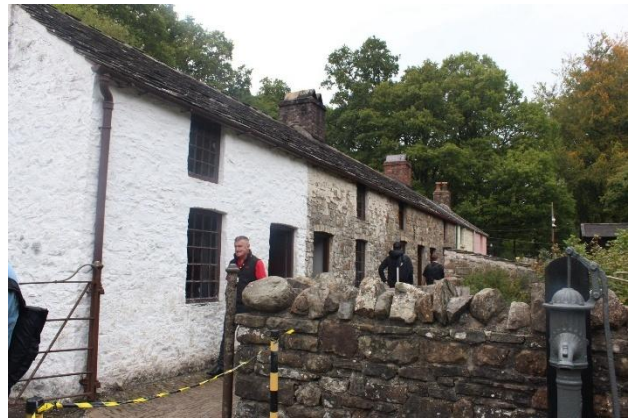
*Figure 2. Changes in Wall Coverings across the years.*

Around 1805 wall finishes consisted primarily of lime plaster applied directly to solid stone masonry. Lime plaster was well suited to traditional construction, as it allowed moisture to evaporate through the wall, reducing the risk of damp. However, finishes were often uneven and prone to cracking.

By 1925 and especially 1955, gypsum plaster was widely adopted due to its faster setting time and lower labour costs. Gypsum set more quickly than lime and required less skilled labour, making it an attractive option for builders during a period of rapid housing expansion.

While gypsum plaster produced smoother finishes, it was less breathable than lime, which in some cases contributed to moisture-related defects in solid-walled buildings. (Cadw, 2019)

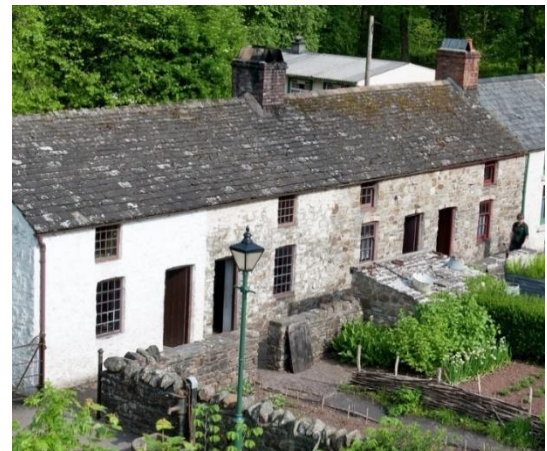
**Figure 3.** *View of Roof Coverings*

Throughout the terrace's history, locally sourced slate remained the dominant roof covering. In the earliest houses, slates were fixed directly to timber battens without underlay, leaving the roof vulnerable to wind-driven rain and draughts.

By the late nineteenth and early twentieth centuries, improvements in fixing methods and workmanship increased roof durability. The introduction of bituminous felt underlay by the mid-twentieth century significantly improved weather resistance and reduced water penetration. Ridge tiles also became mechanically fixed, enhancing resistance to wind uplift. (Historic England, 2012)

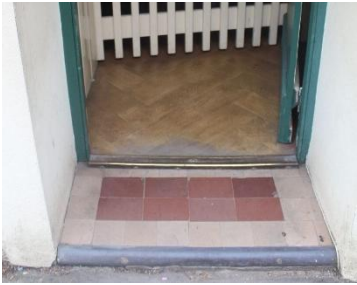
| Year | Photograph | Brief Description |
|---|---|---|
| 1955 | | Vinyl Flooring and ceramic tiles. |

In the mid-twentieth century (1955), concrete ground floors became increasingly popular. While these floors were more durable and easier to maintain they initially lacked insulation. By 1985, concrete floors typically incorporated damp-proof membranes and insulation, greatly enhancing thermal comfort and reducing energy consumption. (Chudley, Greeno and Kovac, 2020). Vinyl floorings and Carpets were also introduced on this date to cover the floors in certain areas of the home.

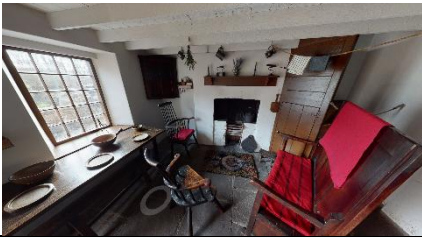
| Year | Photograph | Brief Description |
|---|---|---|
| 1805 | | Rustic oak furniture |

The Internal joinery of early houses was functional and minimal. The rustic oak furniture reflects the economic constraints of workers' housing. Doors were plain, staircases were steep and exposed, and decorative features such as skirting boards and architraves were scarce. (Curl and Wilson, 2015)

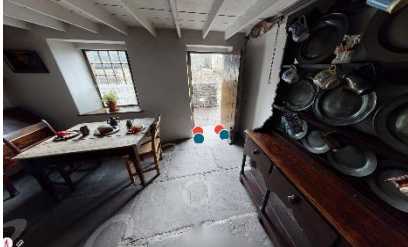
| Year | Photograph | Brief Description |
|---|---|---|
| 1855 | | Rustic oak furniture |

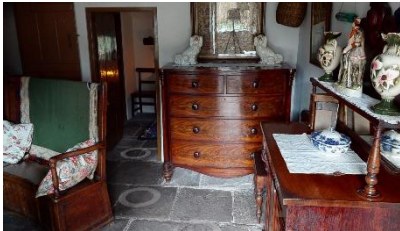
| Year | Photograph | Brief Description |
|---|---|---|
| 1895 | | It features finely crafted timber furniture and decorative joinery. |

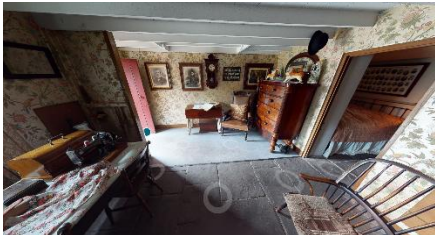
| Year | Photograph | Brief Description |
|---|---|---|
| 1925 | | Enclosed timber staircases, moulded skirtings, and framed wall panelling typical of late Victorian joinery. |

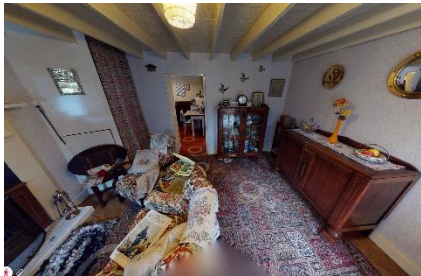
| Year | Photograph | Brief Description |
|---|---|---|
| 1955 | | Traditional timber furnishings highlight the structural and aesthetic role of joinery in rural interiors. By this year there was electricity. |

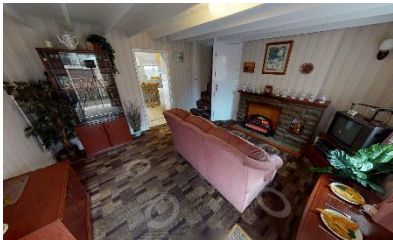
| Year | Photograph | Brief Description |
|---|---|---|
| 1985 | | Painted timber cabinets, fireplace surrounds, and skirtings reflect mid-20th century domestic joinery with modest decorative features. |
