# School of Engineering MSc Mechanical Engineering

M7X01373 - Project  
Dissertation - Final Report

Corrosion Under Insulation of Carbon Steel  
Pipework in the South Wales Coastal Region

James Milling  
1503259  
March 2021

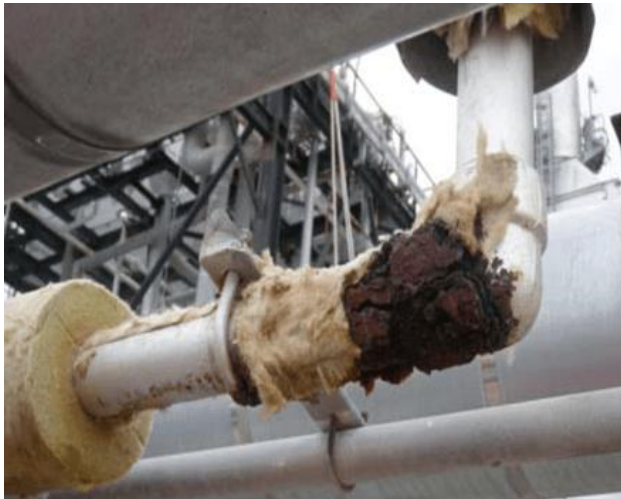
Figure 1.1 Localised CUI on pipework (BoilerRock, 2017)

Corrosion Under Insulation (CUI) occurs on steels when covered by insulation in the presences of water, it exhibits itself as a server form of localised corrosion, which if left uncorrected often results in loss of containment, unscheduled plant shutdown, and ongoing preventative maintenance costs (Winnik, 2008). The severity of corrosion is influenced by environmental and operating conditions, with the introduction of chlorides in coastal areas and cyclic operating temperatures exacerbating the problem (HSE, 2013). Water and other contaminants such as chlorides primarily enter the insulation material due to a failure in the outer environmental barrier, caused by incorrect installation and maintenance procedures, or inadequacies in design (NACE, 2010).

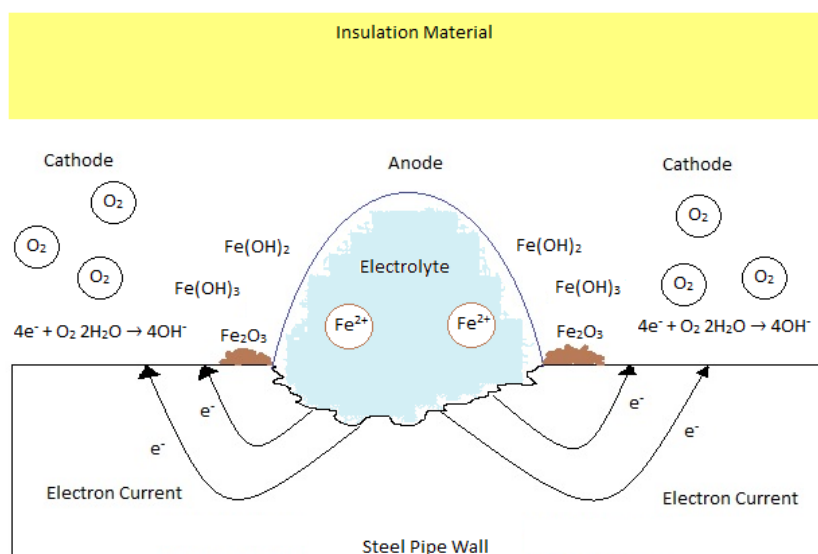
Figure 2.1 Depiction of aqueous Corrosion of Steel pipe surface

The mechanism of aqueous corrosion which takes place on a steel pipe surface is described in figure 2.1 below.

The corrosion of the pipe wall takes place at the anodic sites where in contact with the electrolyte as described by reaction (2.1).

The iron (Fe) within the steel is oxidized producing ferrous ions ( $\text{Fe}^{2+}$ ) which transfer into the electrolyte solution, and electrons which flow through the pipe wall to the cathodic sites which has a greater electrical potential. To maintain an equilibrium, and for further corrosion of the pipe wall to take place, the electrons which are produced as part of the anodic reaction are consumed as part of another reaction which occurs simultaneously at the cathode.

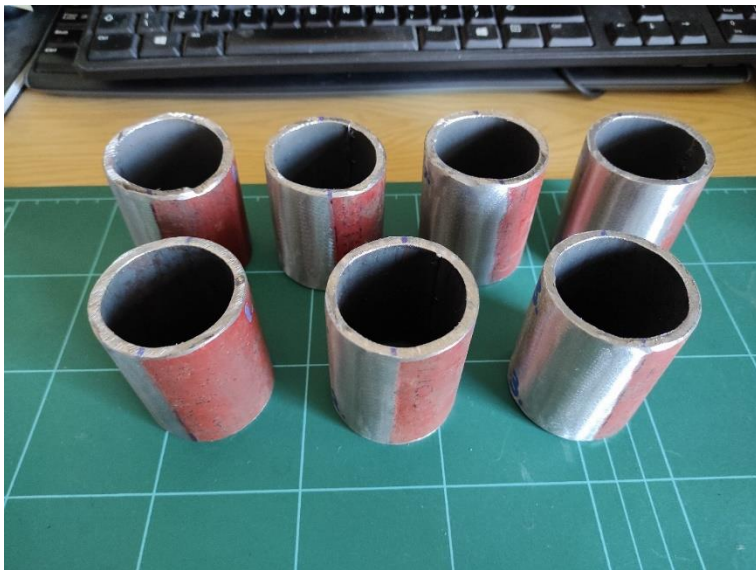
Figure 3.1 Pipe sample preparation

Each of the pipe samples are cut to a length of 60mm, half of the external protective coating as supplied is removed (180-0°) to expose the bare parent pipe material using a 120-grit abrasive flap sanding disc, ASTM G4 suggests that 120-grit abrasive will produce an acceptable finish (ASTM, 1995). The top position (0°) is marked on each end of the cut sample in addition to a sample reference using a paint marker pen.

The samples are placed in an oven at 120°C for 1 hour before the mass is recorded.

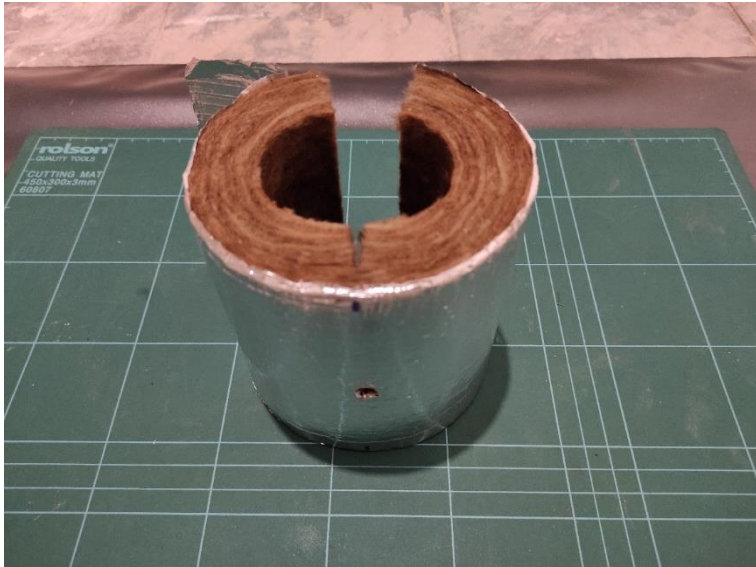
Figure 3.2 Insulation sample preparation, rock mineral fibre shown.

Each of the insulation material samples are cut to a length of 150mm. A 6mm diameter hole is formed centrally through the insulation material at the top position (0°), where the bottom position (180°) is taken as the formed longitudinal split which facilitates fitting.

The samples are placed in an oven at 120°C for 1 hour before the mass is recorded.

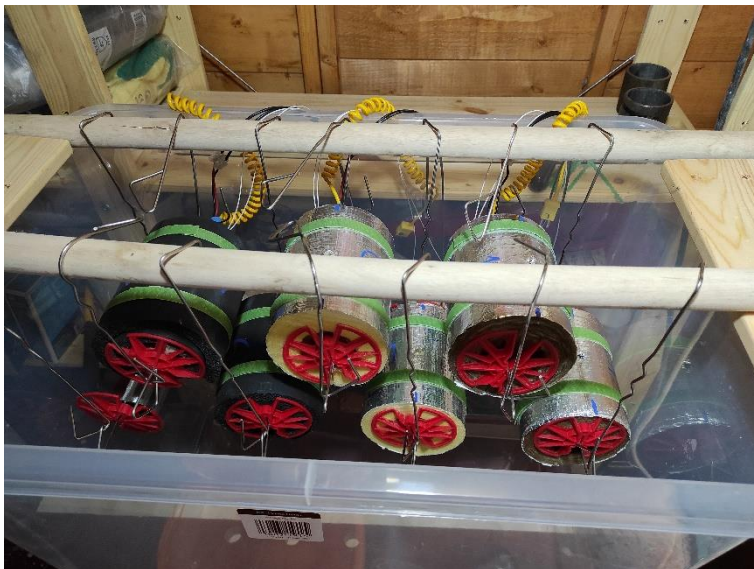
The samples are support above the environmental tank water level by stainless steel wire. The samples being arranged in two rows, the top row is heated cyclically, the bottom row is unheated and remain at ambient conditions. The pipe sample and insulation are retained in position using a plastic retaining clip. Figure 3.4 shows samples placed in the environmental tank prior to filling with water. The orientation of the uninsulated sample is just visible in the lower left of the image.

Figure 3.4 Samples arranged in environmental tank.

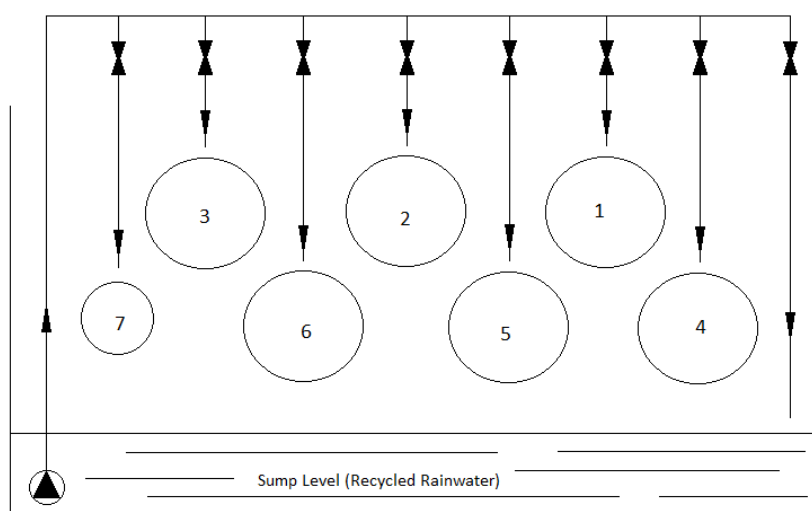
Figure 3.5 Diagram of water distribution within environmental tank

The recirculation of rainwater contained within the environmental tank aligns with studies discussed within the literature review, the working volume is manually observed on a weekly basis and maintained at 20 litres by transferring rainwater from the rainwater catch tank to allow for water loss due to evaporation.

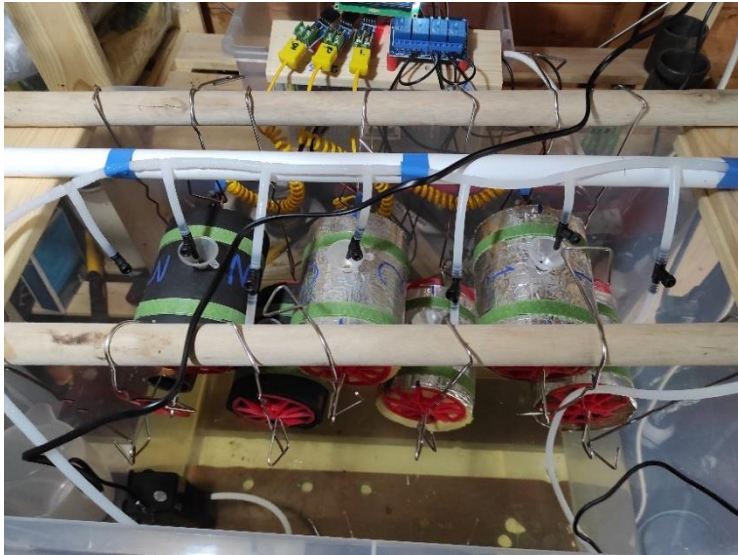
Figure 3.6 Water distribution system in place within environmental tank.

The volume of rainwater which each sample is exposed to over the period of experimentation is 14.5 litres, this being greater than would be expected to fall on the surface area of the insulation sample over a period of an average year under normal rainfall conditions at 13.2 litres over an area of  $100\text{cm}^2$ .

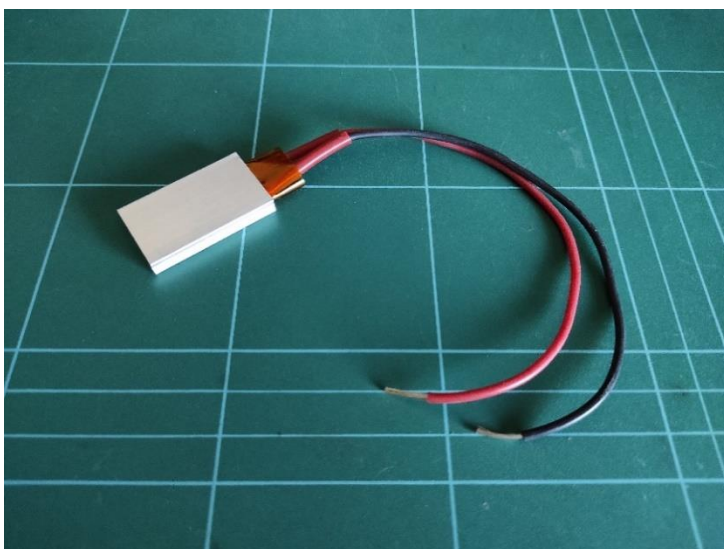
Figure 3.7 PTC Heating element

The internal volume of the pipe sample contains air as the heat transfer fluid and is heated by a 12-volt 22w PTC (Positive Temperature Coefficient) heating element rated at 220°C. A PTC heating element is specific as it is considered safer than other electrical heating methods due to the self-regulating nature of PTC. The maximum temperature cannot be exceeded as the resistance of the heating element increases with temperature to the point where it acts as an insulator (DBK, 2020).

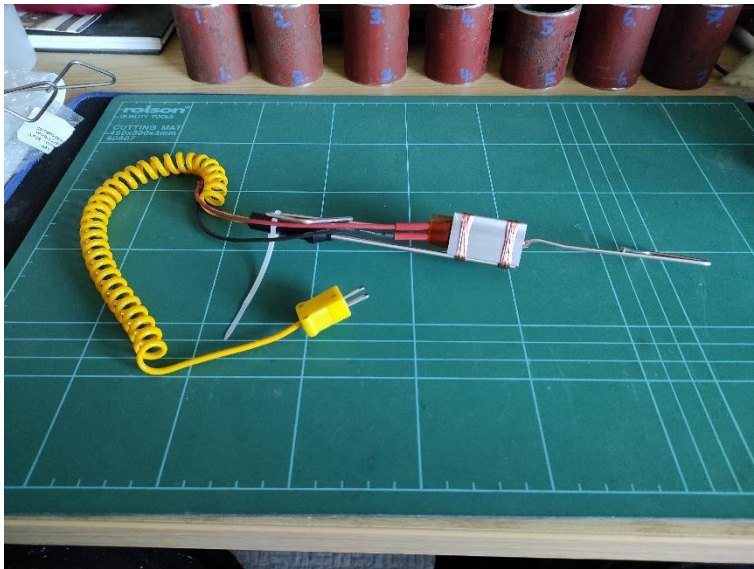
The assembled PTC heating element and thermocouple are detailed in figure 3.8, where both parts are fixed to the stainless-steel support rod. The heating unit in operation is detailed in figure 3.9, the LCD screen to the right shows Channel A on a heat cycle. The units to the lower left are the thermocouple amplifiers, lower right relay unit.

Figure 3.8 PTC element and thermocouple assembly

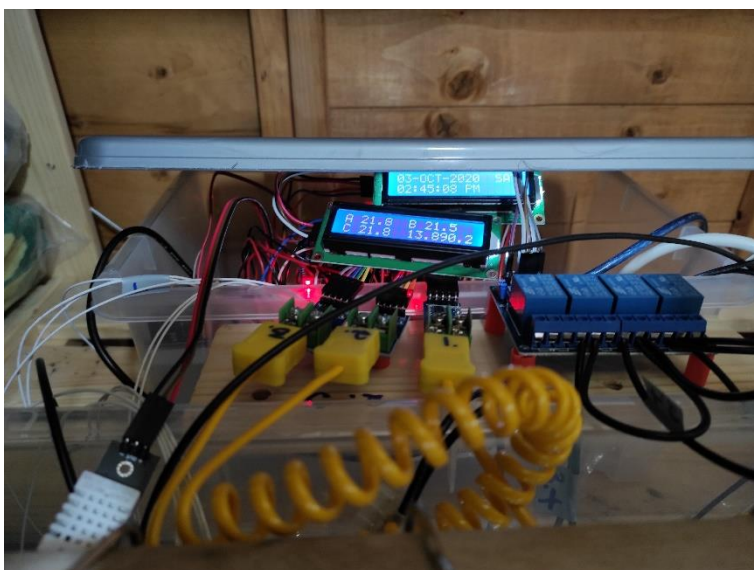
Figure 3.10 details the LCD output of the datalogger (Lower LCD), the white wires to the left are the leads associated with the thermistors, the white unit in the lower left is the ambient temperature and humidity sensor.

Figure 3.10 Datalogger in operation (Lower LCD)

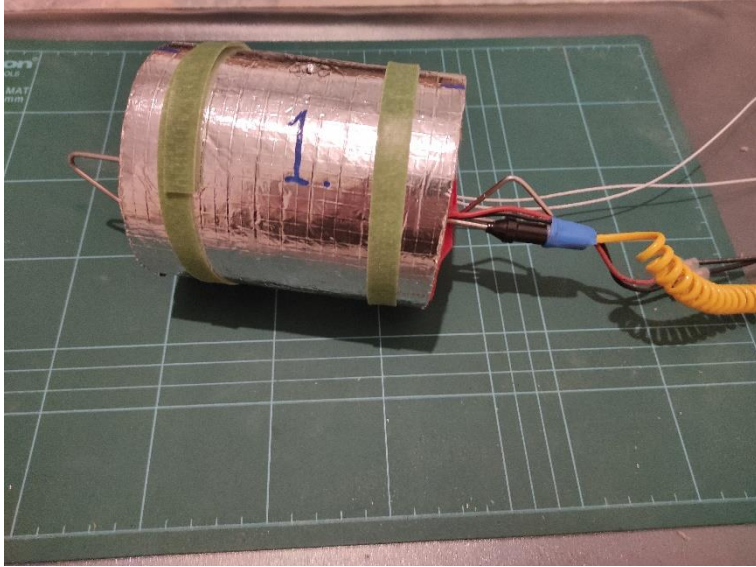
Figure 3.11 Pipe sample assembled for cyclic heating.

The assembled cyclic heating sample with PID feedback thermocouple, datalogger thermistor and PTC element leads visible are detailed in figure 3.11 below. The void space between the pipe sample and each end of insulation sample and respective clip supports is filled with thermal insulation to improve thermal efficiency during the period of experimentation.

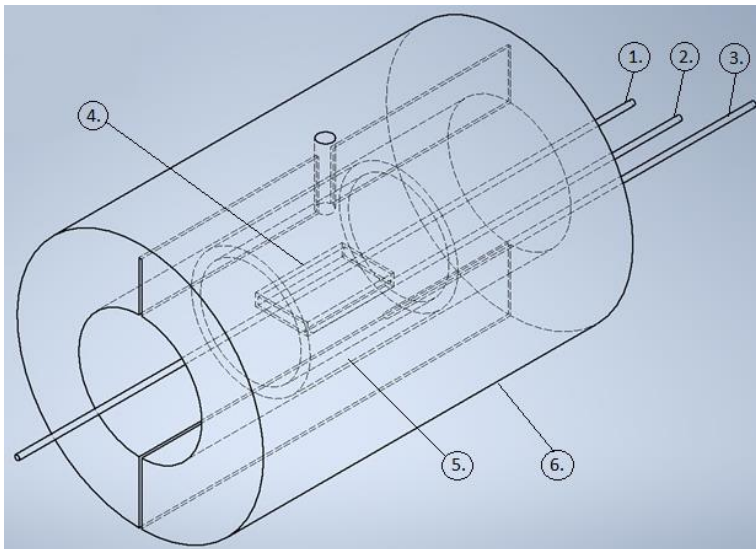
Figure 3.12 Cyclic heating sample diagram.

The sectional diagram in figure 3.12 details the position of the respective parts that make up the cyclic heating pipe samples. The respective items being: 1. Support rod, 2. PID feedback thermocouple, 3. Datalogger thermistor, 4. PTC heating element, 5. Pipe sample, 6. Insulation sample. The datalogger thermistor is located at the midpoint 90° position on the coating pipe surface to insulation interface.

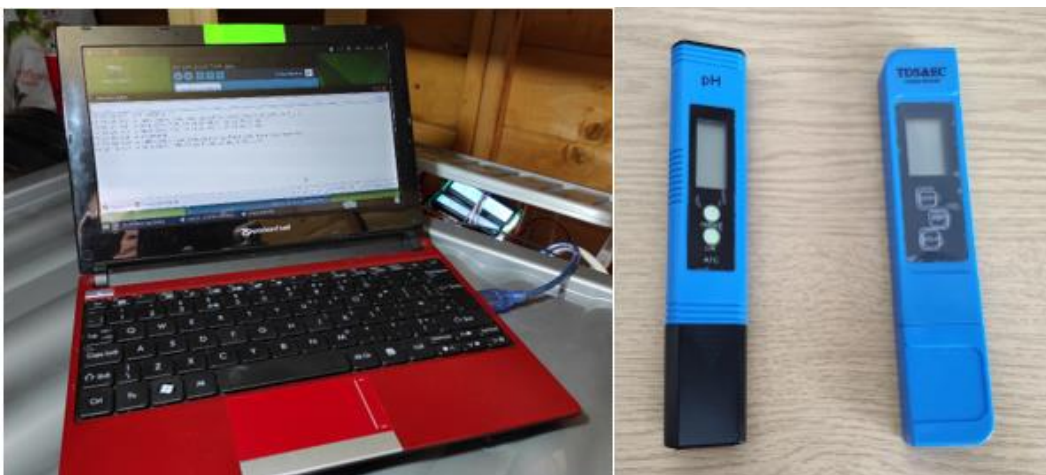
The weekly datalogger download and portable instruments used for water quality reading is described in figure 3.13.

Figure 3.13 Weekly datalogger downloads and water quality measurement instruments

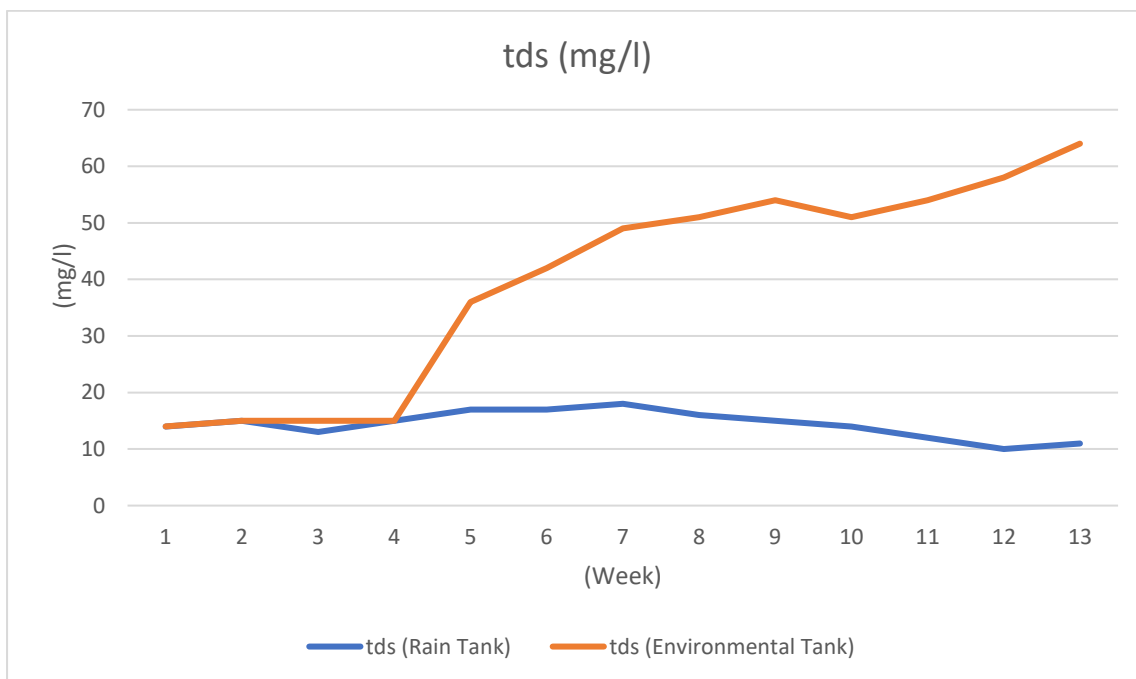
The reading taken for the total dissolved solids and conductivity within the environmental tank are seen to increase throughout the duration of the experimentation in relation to the rainwater tank and are described in a graphical format in figures 4.1 and 4.2. No change was noted in pH in any of the readings taken across both tanks within the accuracy of the instrument used.

Figure 4.1 Rainwater Tank vs Environmental Tank tds Readings

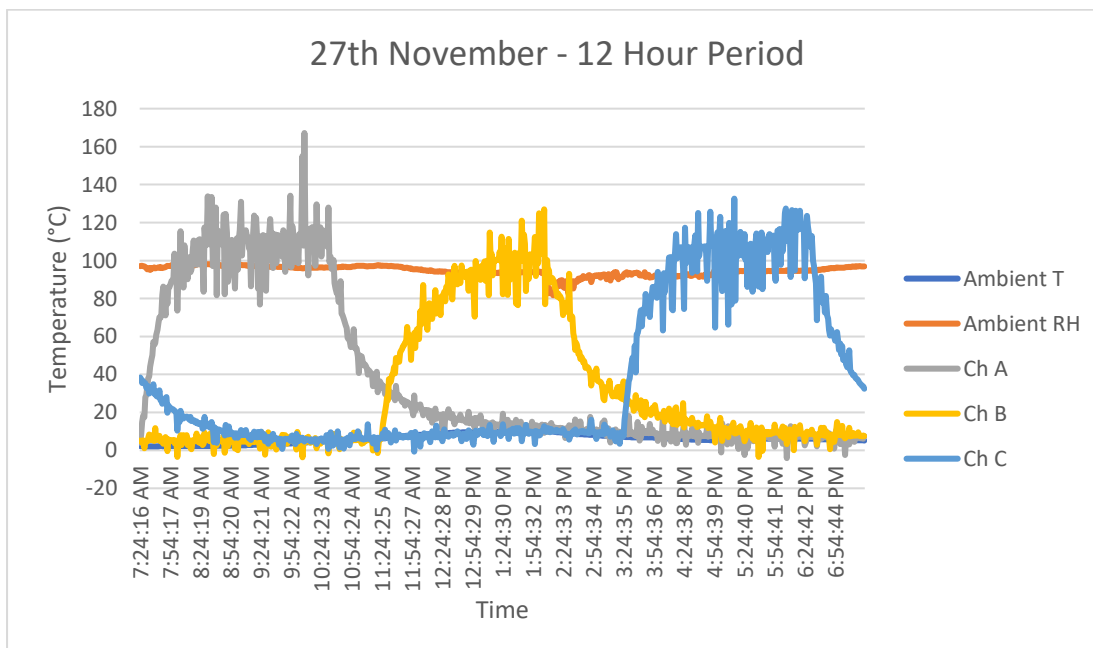
Figure 4.3 Plot of sample heating cycles over 12-hour period

The datalogger output was reviewed weekly over the 12-week experimentation period to ensure that the duration and temperature of the heating cycle for the cyclic temperature test samples remained within the desired range, the set point of the temperature controller being 140°C, the measured values from the datalogger recorded the interface temperature between the pipe surface and insulation material and can be seen to trend at temperatures below the controller set point across the three cyclic channels, A, B and C in figure 4.3 which is a random sample of a 12-hour period over which the heating cycle occurs.

The range of variation within the recorded values of temperature was anticipated due to the simplistic nature of the both the electronic components and temperature monitoring script written for the Arduino microcontroller allowing for available memory to process readings taken across 3 channels, however it clearly demonstrates the duration and profile of the temperature cycle for each of the samples subject to cyclic heating and cooling. The normalisation period at the end of the 12-week cyclic experimentation period is described in figure 4.4.

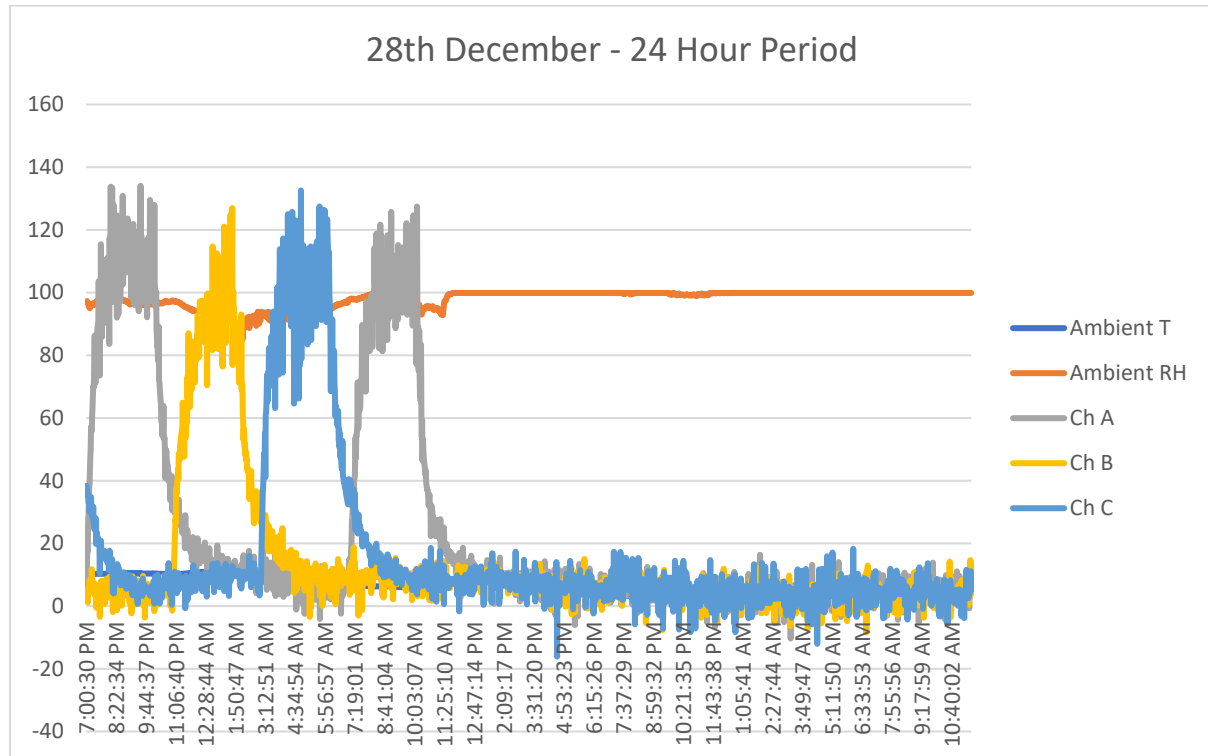
Figure 4.4 Plot of a heating cycles and normalization period at end of experimentation

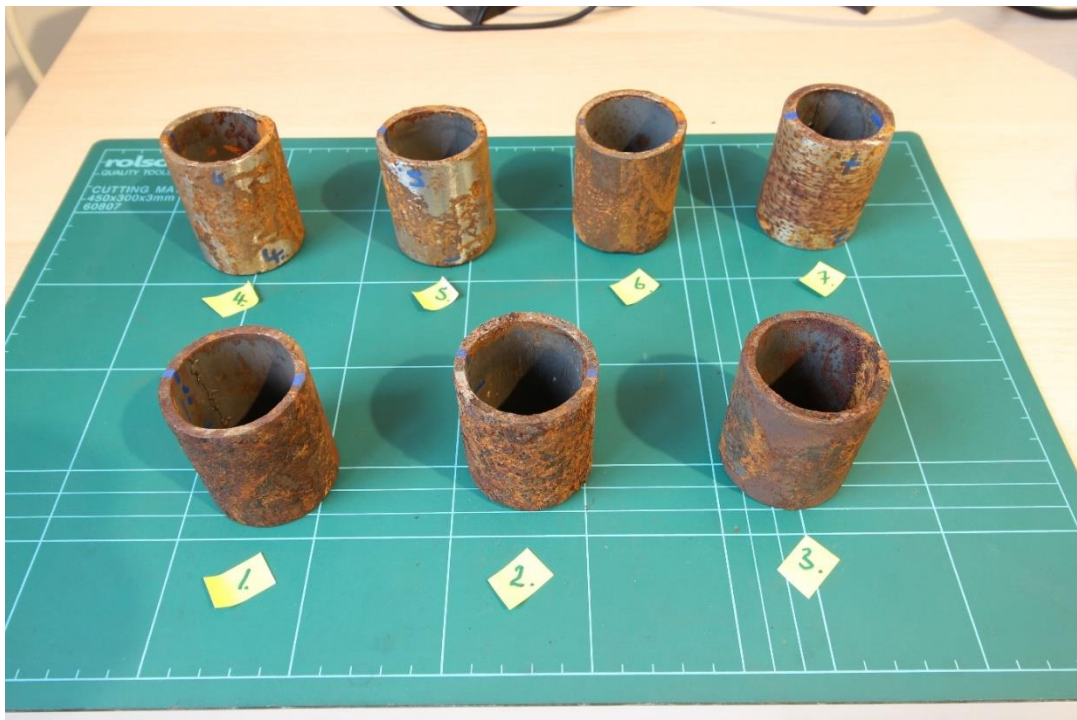
The following images depict the samples after removal from the environmental tank and drying. The lighting, camera exposure and position is consistent for all images. Figure 4.5 depicts all samples after completion of experimentation period.

Figure 4.5 Pipe Sample set at end of experimentation period

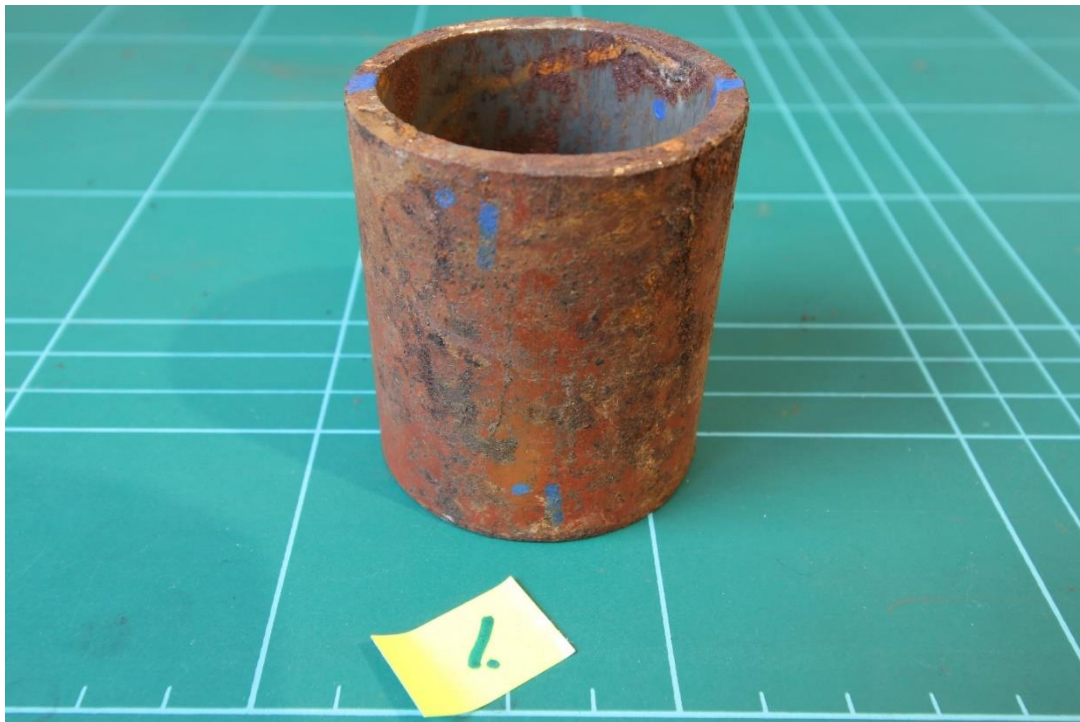
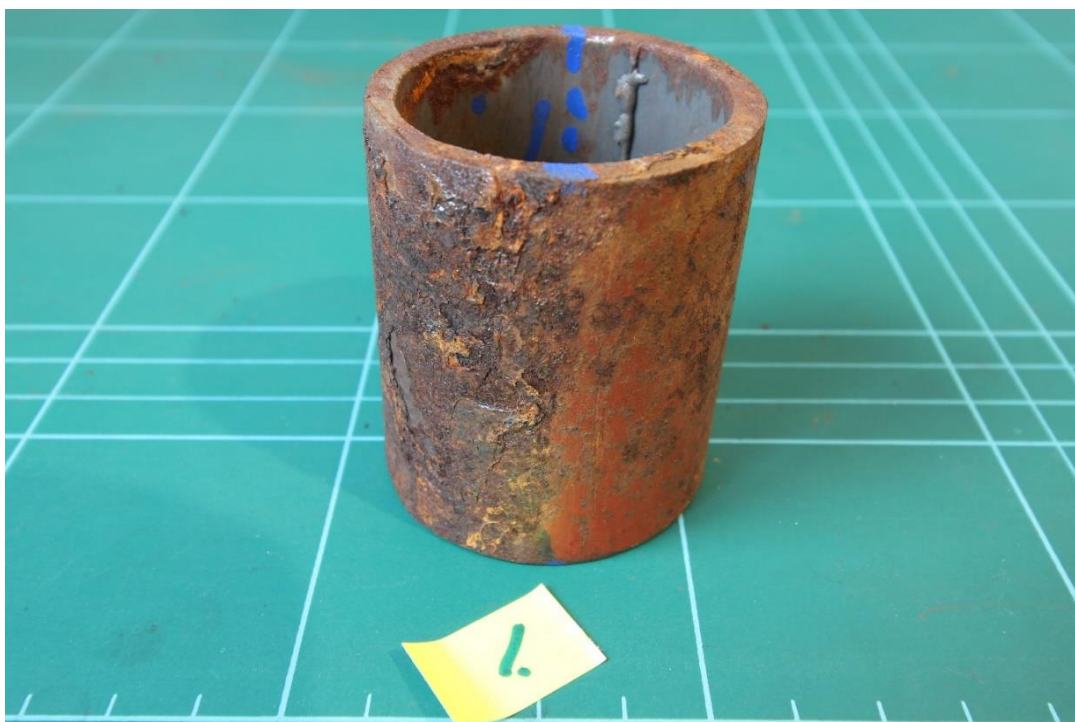
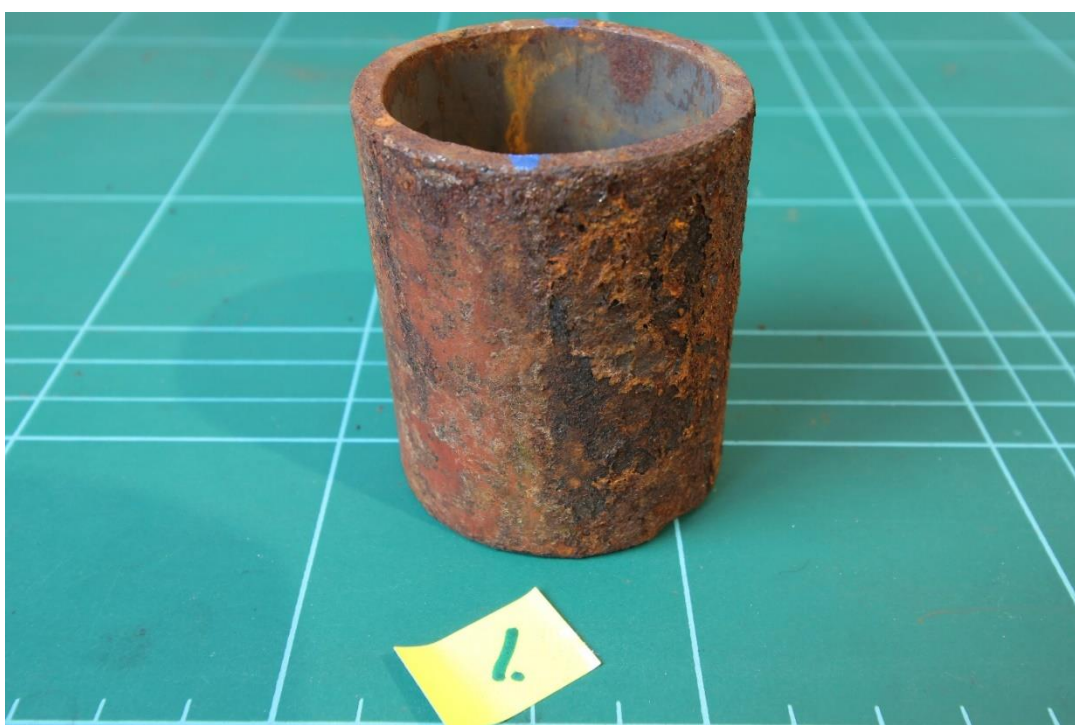
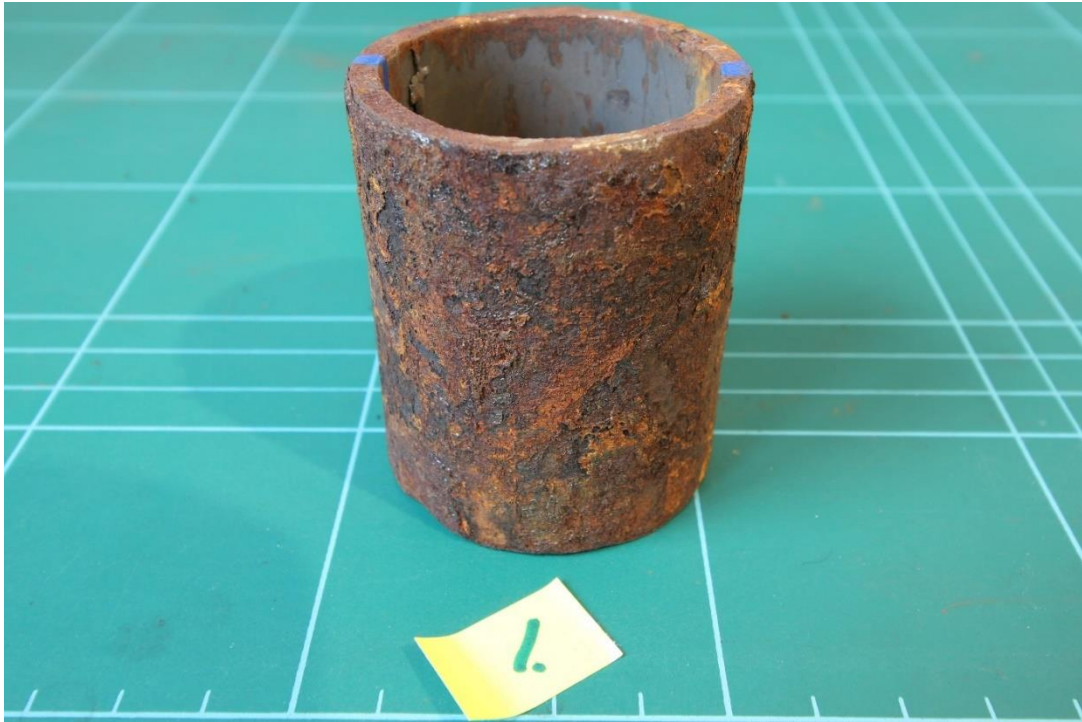
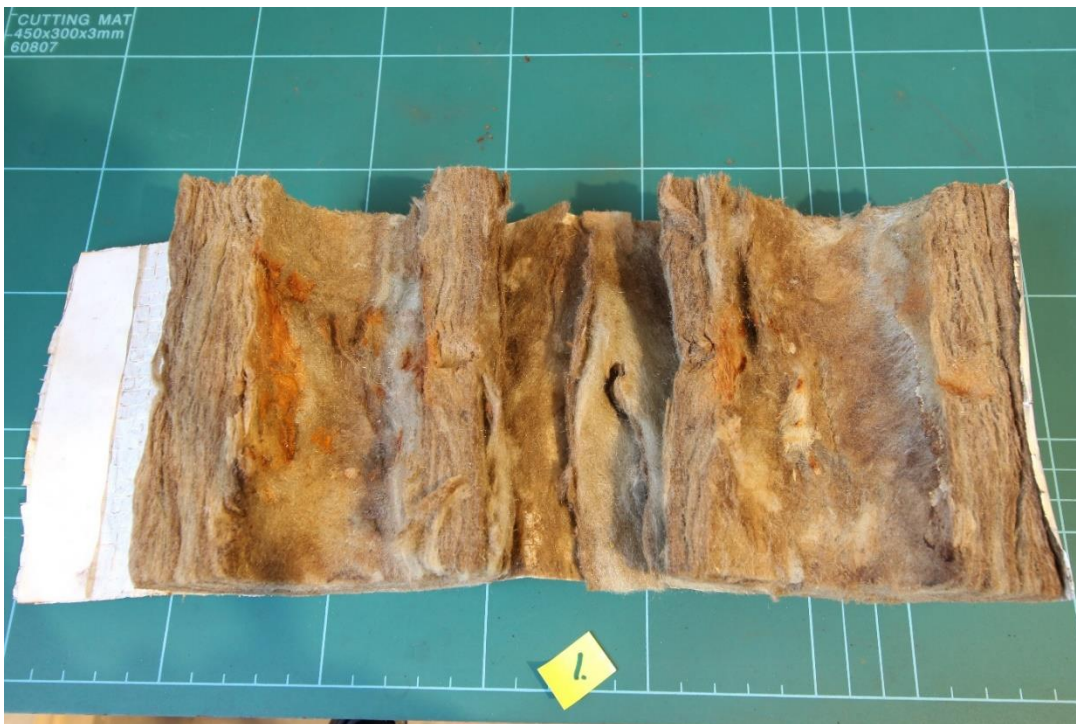
Localised areas of slight surface corrosion and deposits of attached oxide is seen on the sample pipe coating surface where breakage of the manufacturers surface coating is breached exposing the metallic surface as seen in figure 4.6, the areas where the coating is breached is consistent with the as supplied condition of the sample pipe. The preparation surface is subject to moderate uniform corrosion over all the prepared surface, with areas of attached oxide and scale still present to a moderate thickness which was not able to be removed by light mechanical cleaning, as seen in figure 4.9. A clear termination between the coating and preparation surfaces is visible in figures 4.7 and 4.8. The insulation material is found in a condition consistent with its as new application, with minor de-bonding of fibres due to attachment to surface, oxide and scale formed, and where the insulation is layered up, and handling as detailed in figure 4.10.

Figure 4.6 Pipe Sample 1 Cyclic – Rock mineral fibre insulation – Coating surface.

Figure 4.7 Pipe Sample 1 Cyclic – Rock mineral fibre insulation – Lower 180°

Figure 4.8 Pipe Sample 1 Cyclic – Rock mineral fibre insulation – Upper 0°

Figure 4.9 Pipe Sample 1 Cyclic - Rock mineral fibre insulation – Preparation surface.

Figure 4.10 Insulation Sample 1 Cyclic - Rock mineral fibre insulation – Inner surface.

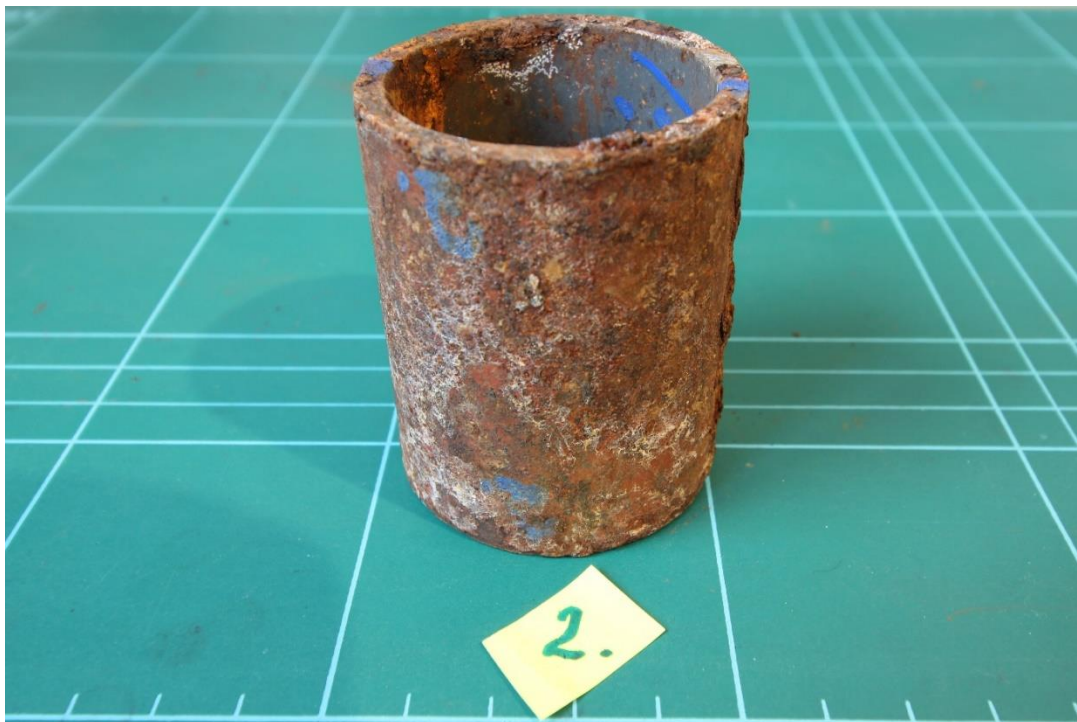
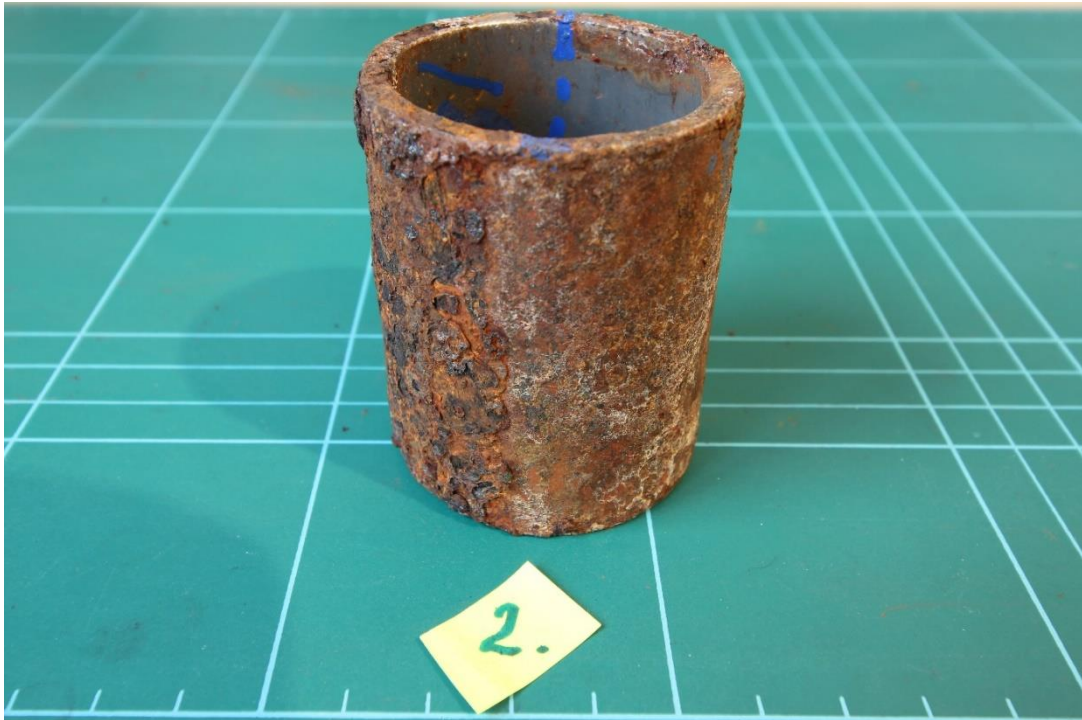
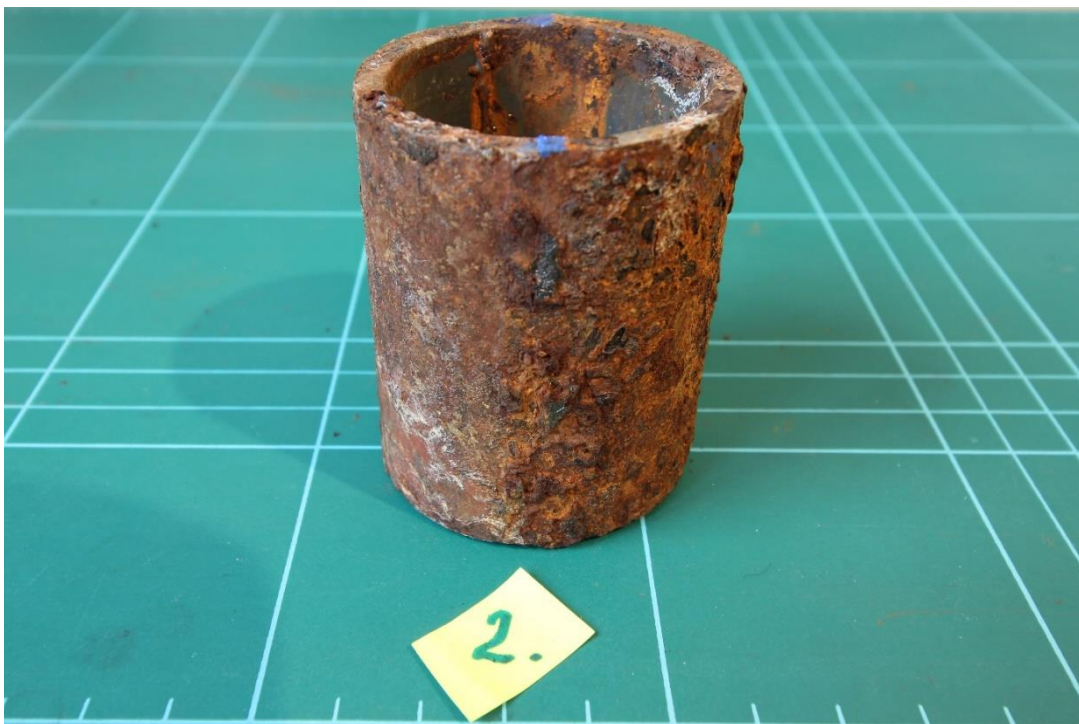
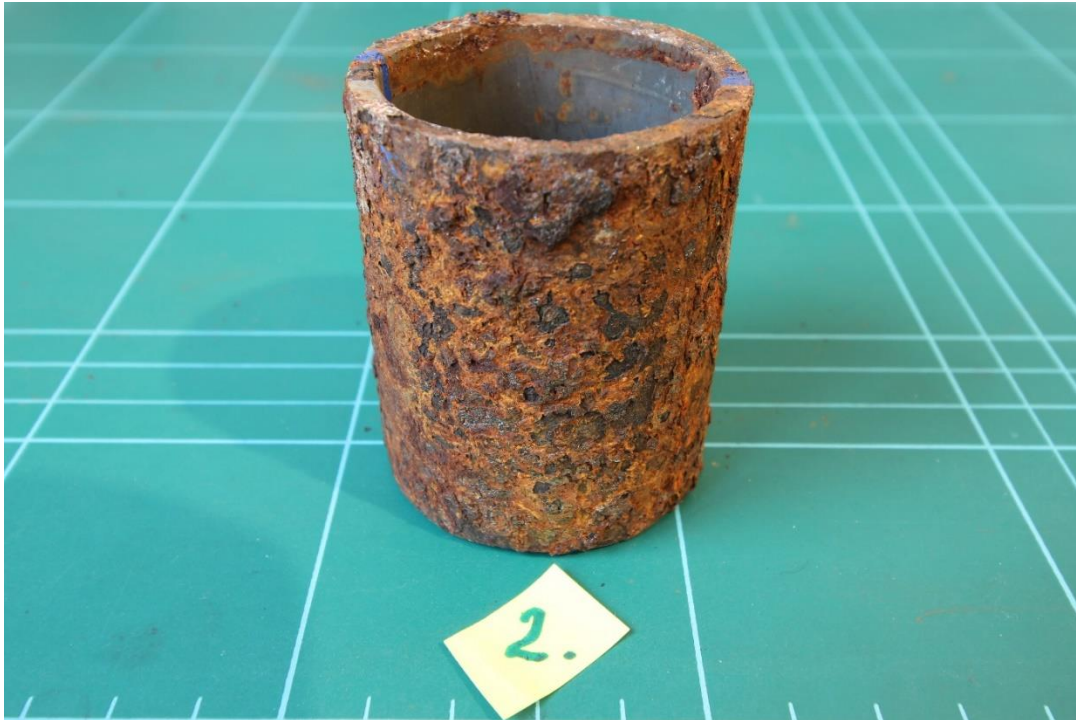
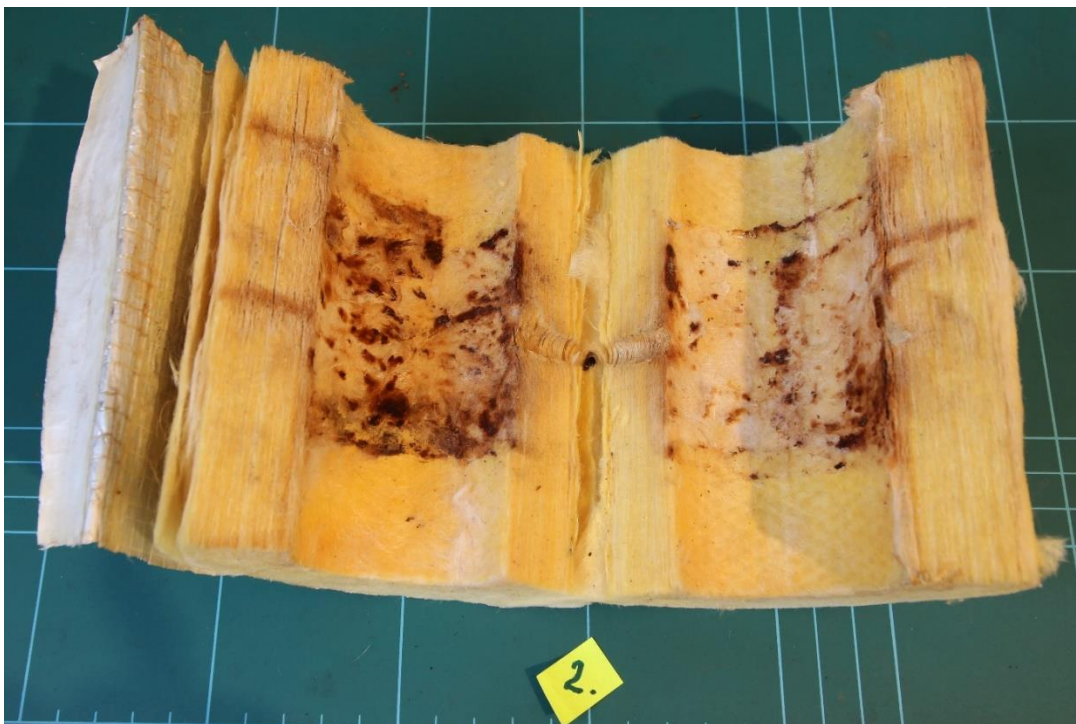
The coating face of the pipe sample has significant areas of localised corrosion and attached oxide where the manufacturers surface coating is breached, further corrosion is noted where the protective surface coating has broken down during the period of experimentation as seen in figure 4.11. The preparation surface is subject to significant uniform corrosion over all the prepared surface, with significant areas of attached oxide and scale present to a significant thickness which was not able to be removed by light mechanical cleaning as seen in figure 4.14. A termination between the coating and preparation surfaces is visible in figures 4.12 and 4.13. The insulation material is generally found in a condition consistent with its as new application, with some de-bonding of fibres due to attachment to surface and where oxide and scale formed, also where water was noted to have collected between the layup of the insulation, and on removal and handling as detailed in figure 4.15. Areas of deposited dissolved solids are noted on all surfaces and are visible as white deposits on the respective pipe sample images.

Figure 4.11 Pipe Sample 2 Cyclic – Glass wool insulation – Coating surface.

Figure 4.12 Pipe Sample 2 Cyclic – Glass wool insulation - Lower 180°

Figure 4.13 Pipe Sample 2 Cyclic – Glass wool insulation - Upper 0°

Figure 4.14 Pipe Sample 2 Cyclic – Glass wool insulation - Preparation surface.

Figure 4.15 Insulation Sample 2 Cyclic – Glass wool insulation – Inner surface.
