# School of Engineering MSc Mechanical Engineering

M7X01373 - Project  
Dissertation - Final Report

Corrosion Under Insulation of Carbon Steel  
Pipework in the South Wales Coastal Region

James Milling  
1503259  
March 2021

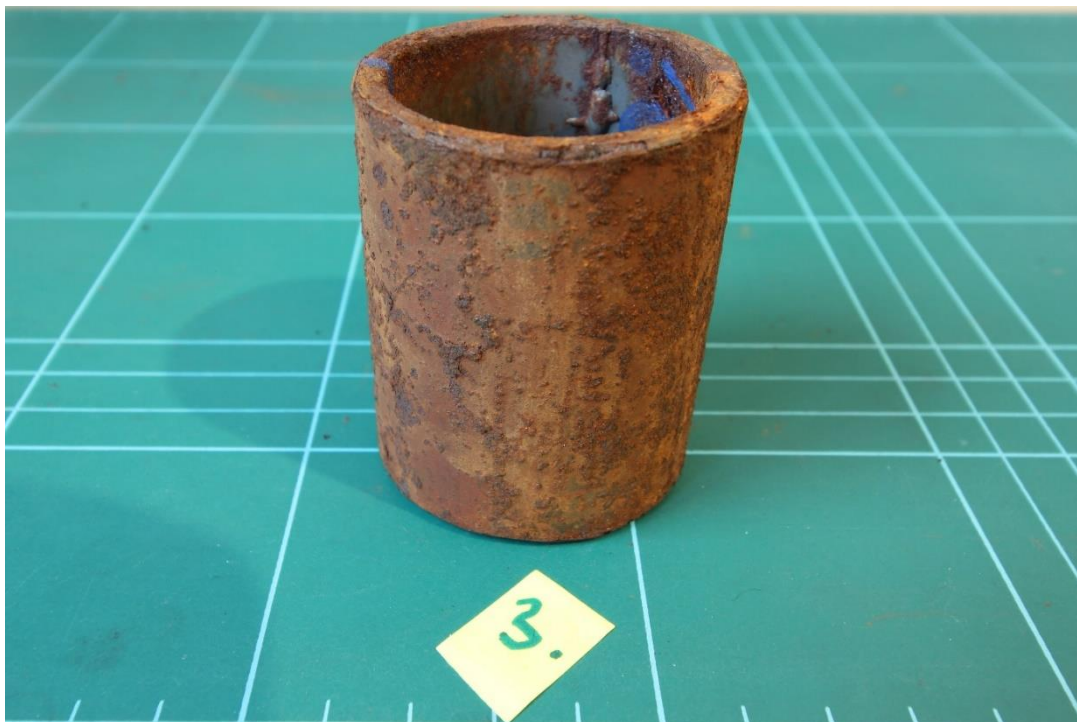
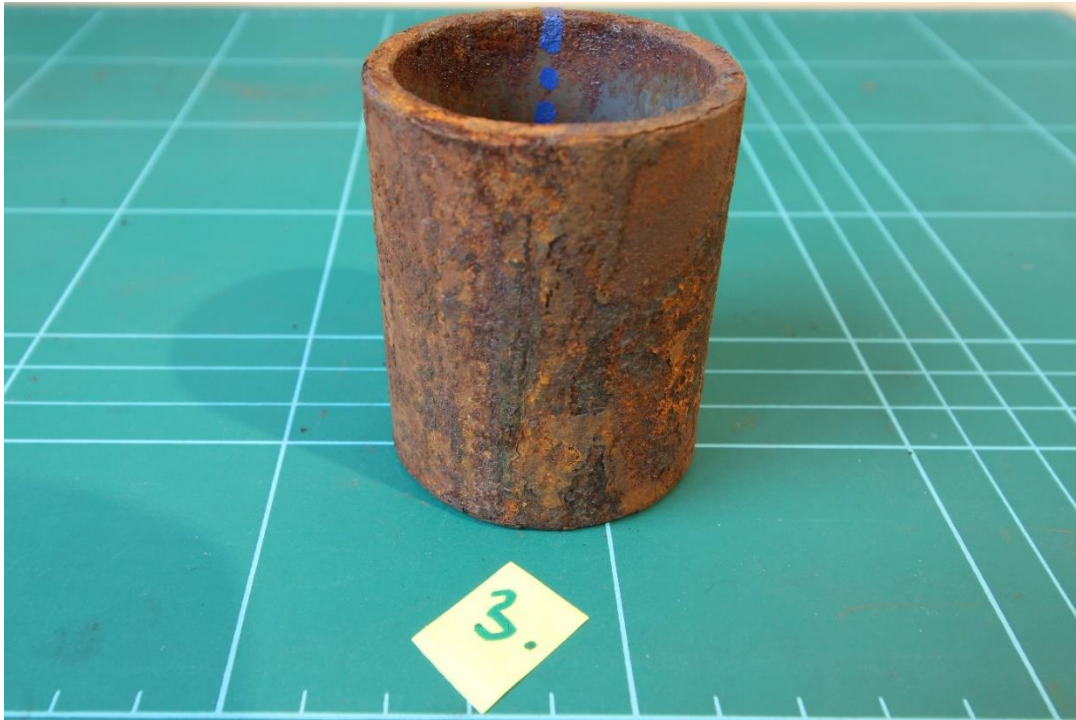
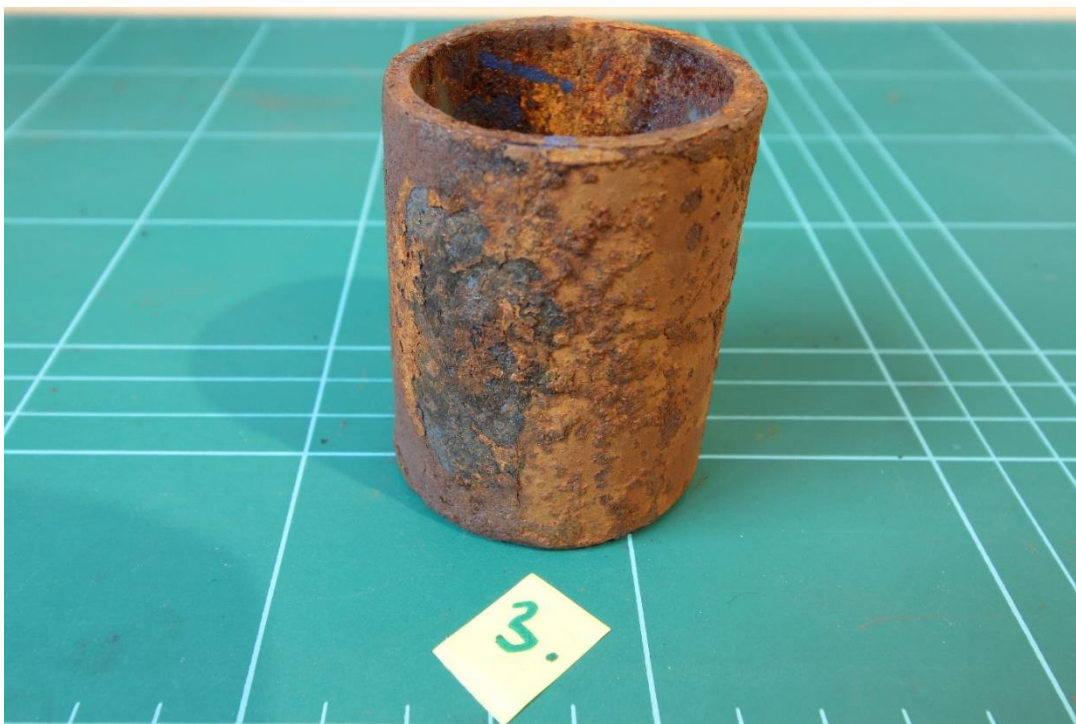
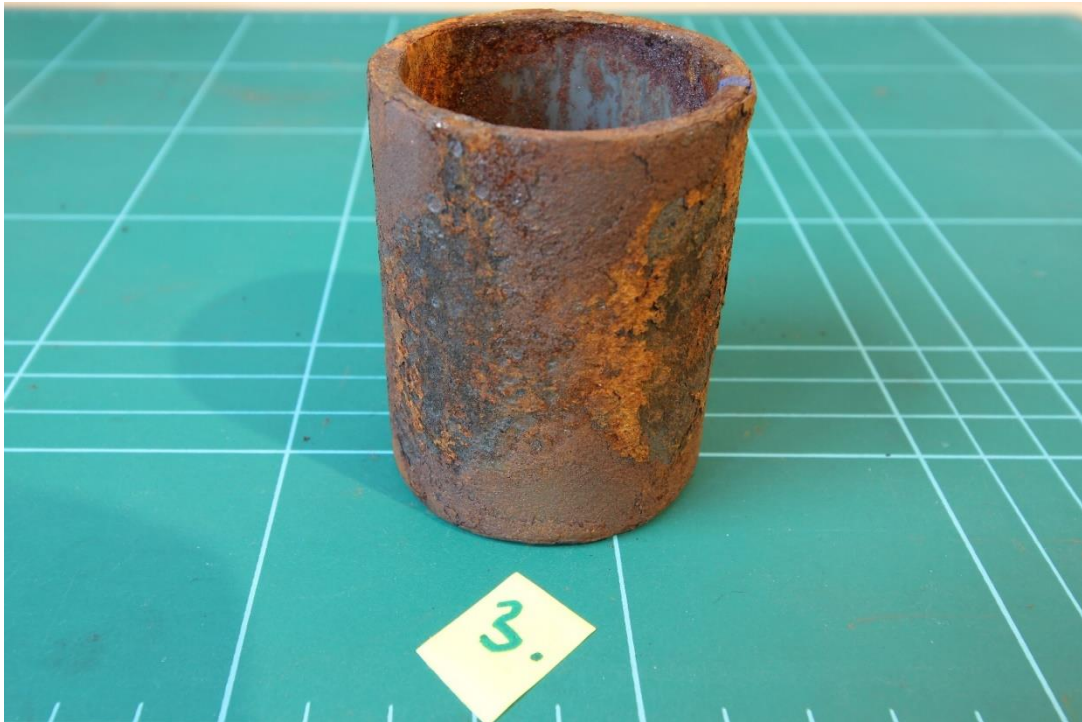
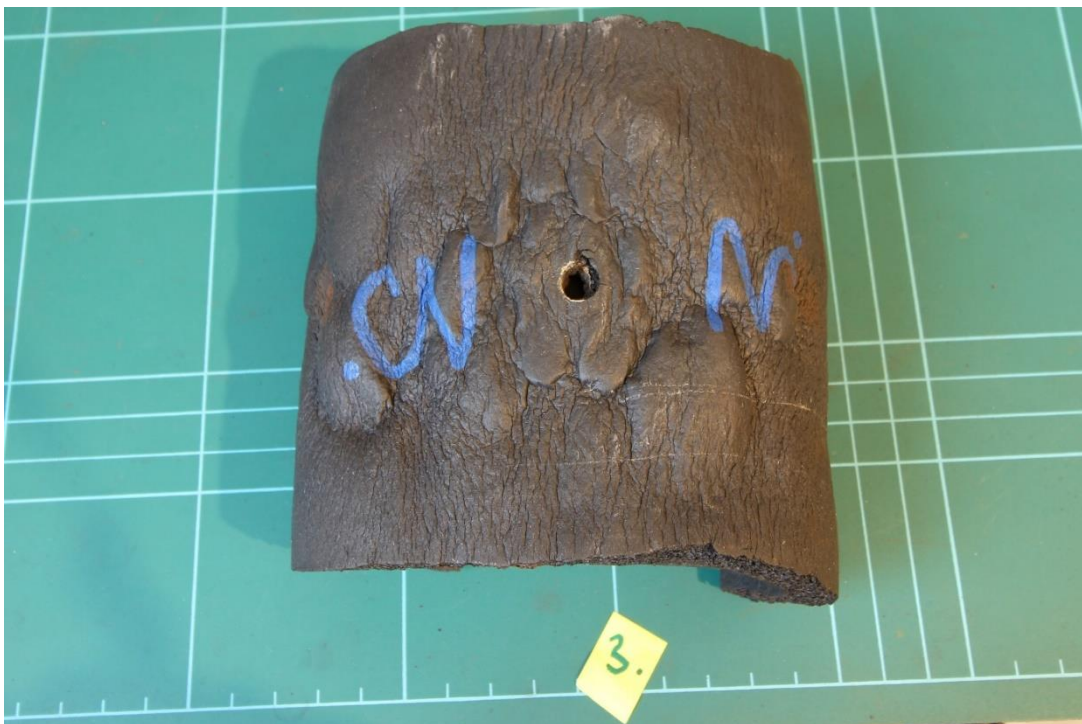
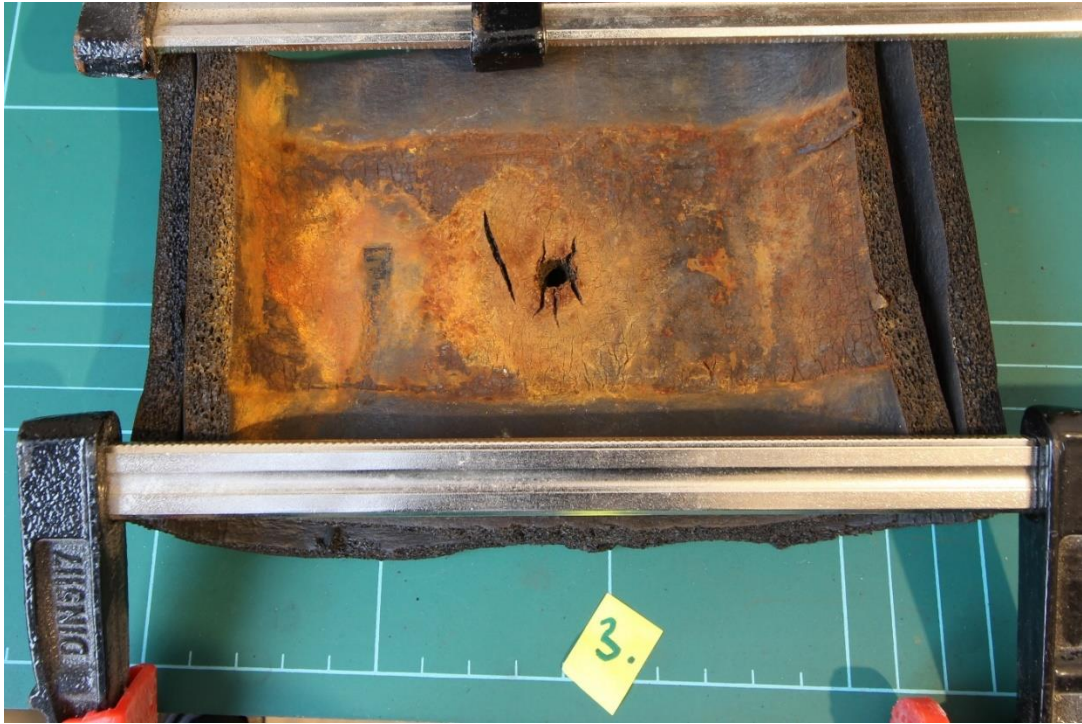
Localised areas of slight surface staining, corrosion and deposits of attached oxide is seen on the sample pipe coating surface where breakage of the manufacturers surface coating is breached as seen in figure 4.16, the areas where the coating is breached is consistent with the as supplied condition of the sample pipe, with additional corrosion noted where further parts of the protective coating have broken down during the period of experimentation. The preparation surface is subject to moderate uniform corrosion over all the prepared surface, with isolated visible large shallow pitting, with areas of attached oxide and scale still present to a minimal thickness which was generally able to be removed by light mechanical cleaning, as seen in figure 4.19. The termination between the coating and preparation surfaces is not clearly visible in figures 4.17 and 4.18. The insulation material is found to have deteriorated significantly on both the outer and inner surfaces as depicted in figures 4.20 and 4.21 respectively from the as new application condition, with significant shrinkage and contraction noted to the cellular structure.

Figure 4.16 Pipe Sample 3 Cyclic – Closed-cell elastomer foam insulation – Coating surface.

Figure 4.17 Pipe Sample 3 Cyclic – Closed-cell elastomer foam insulation - Lower 180°

Figure 4.18 Pipe Sample 3 Cyclic – Closed-cell elastomer foam insulation – Upper 0°

Figure 4.19 Pipe Sample 3 Cyclic – Closed-cell elastomer foam insulation – Preparation surface.

Figure 4.20 Insulation Sample 3 Cyclic – Closed-cell elastomer foam insulation – Outer surface.

Figure 4.21 Insulation Sample 3 Cyclic – Closed-cell elastomer foam insulation – Inner surface.

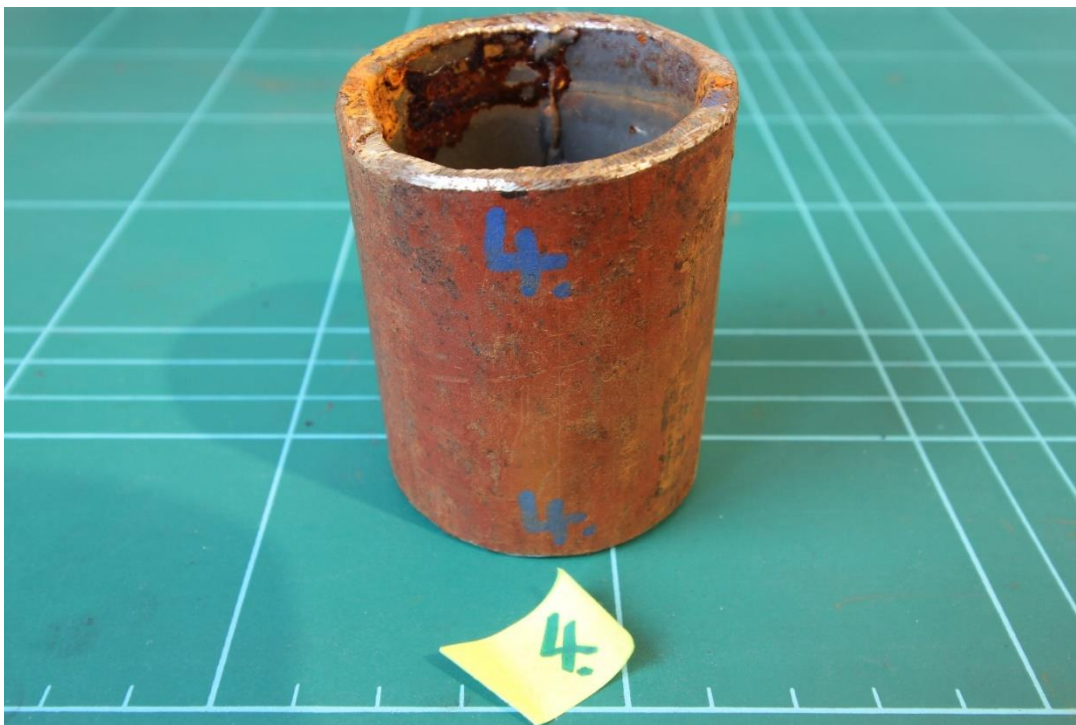
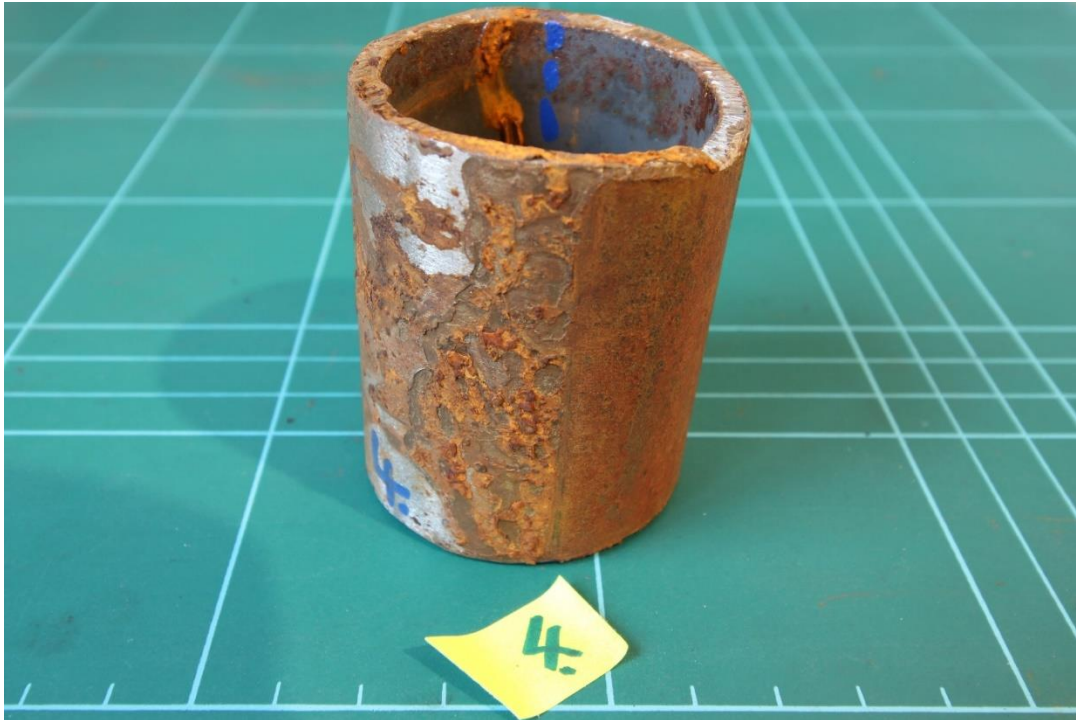
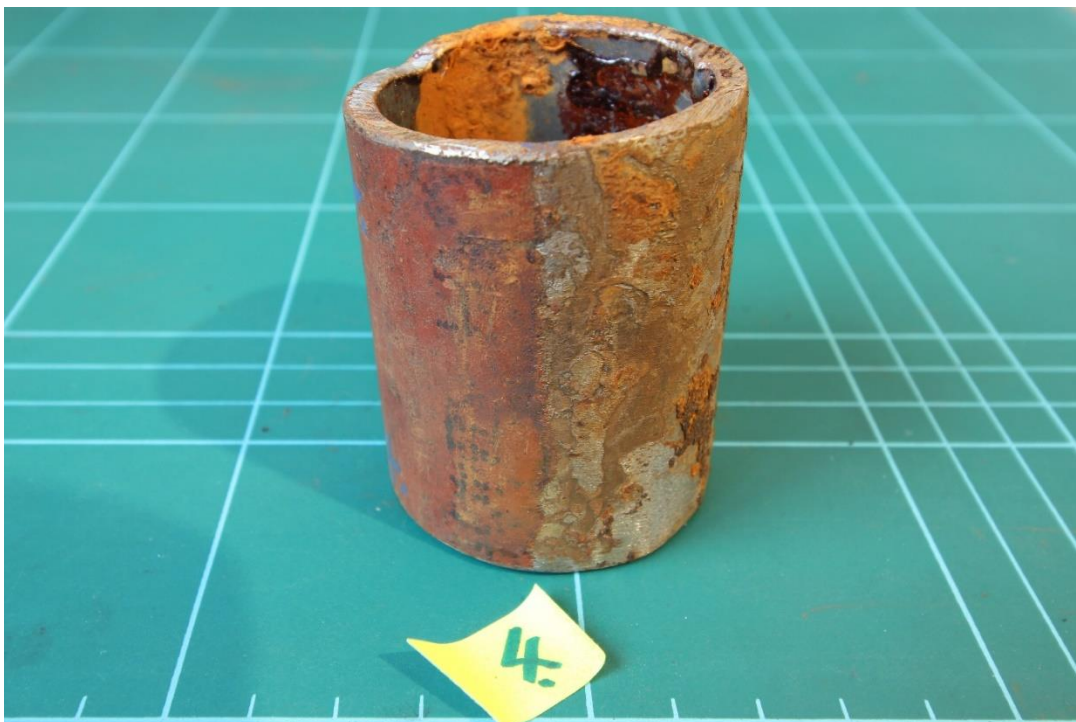
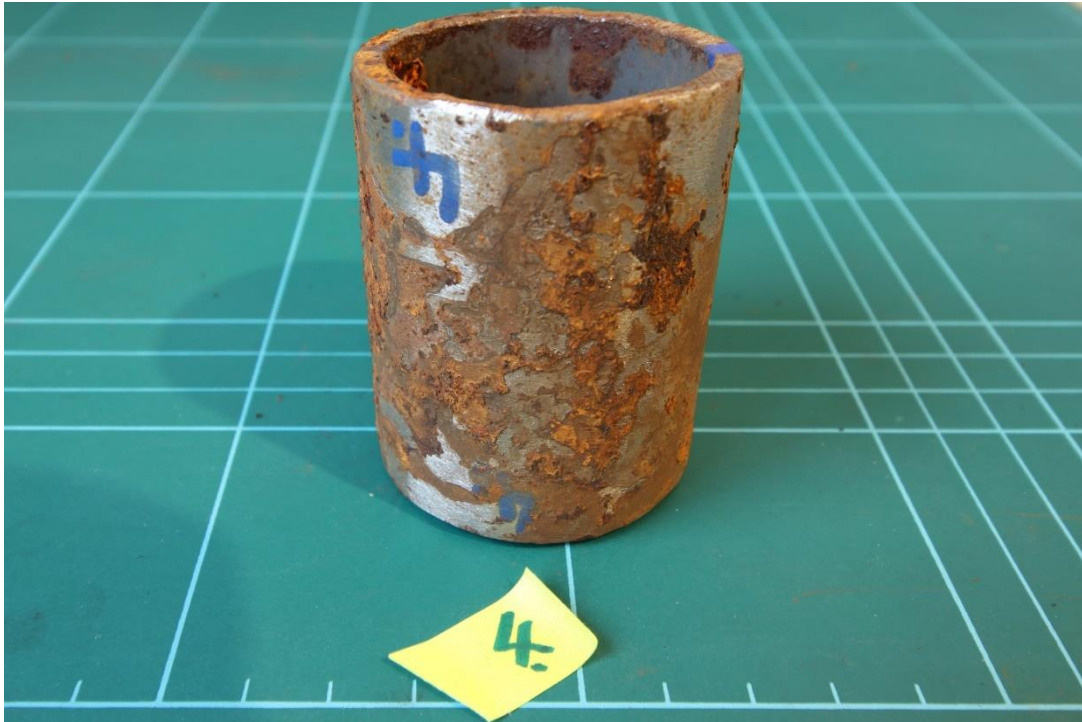
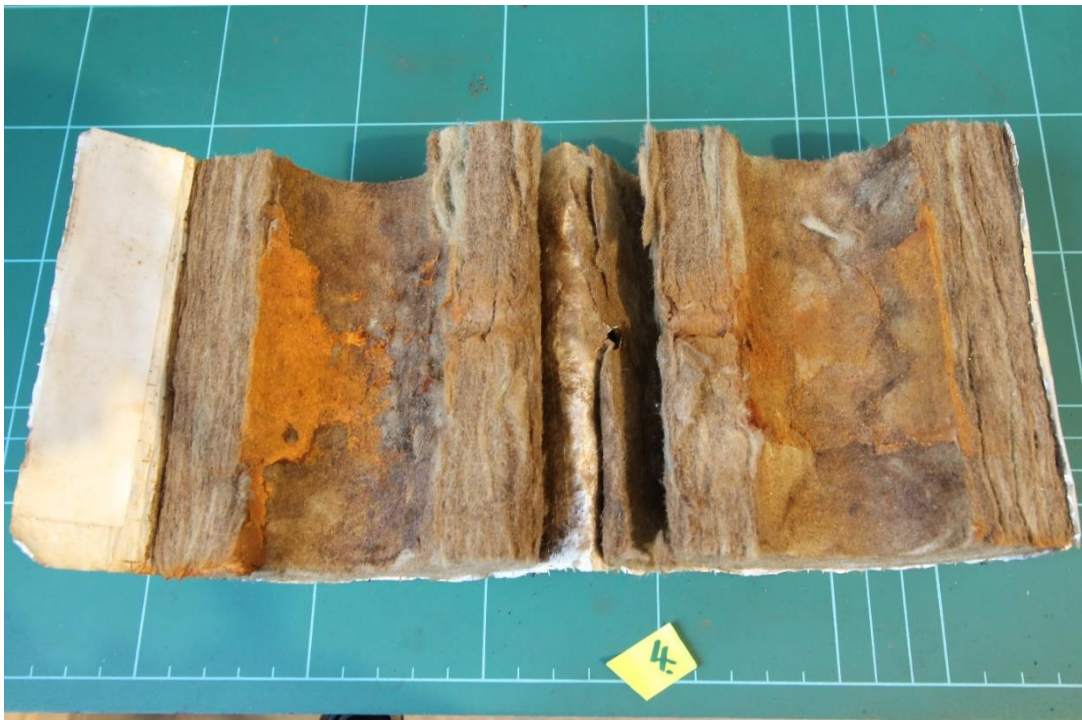
Some isolated areas of slight surface corrosion on the sample pipe surface where breakage of the manufacturers surface coating is breached exposing the metallic surface, however other parts where surface breakage of the protective coating has occurred has not been subject to visually observed corrosion, as seen in figure 4.22. The preparation surface has areas of both superficial surface corrosion, and localised uniform corrosion with slight deposits of attached oxide and scale which was not able to be removed by light mechanical cleaning, interspaced between areas where no visible surface corrosion is present as seen in figure 4.25. A clear termination between the coating and preparation surfaces is visible in figures 4.23 and 4.24. The insulation material is found in a condition consistent with its as new application, with minor de-bonding of fibres due to attachment to surface, oxide and scale formed, and handling as detailed in figure 4.26, staining of the surfaces in contact with the metallic pipe surface is also noted.

Figure 4.22 Pipe Sample 4 Ambient - Rock Mineral Fibre Insulation – Coating surface.

Figure 4.23 Pipe Sample 4 Ambient - Rock Mineral Fibre Insulation - Lower 180°

Figure 4.24 Pipe Sample 4 Ambient - Rock Mineral Fibre Insulation - Upper 0°

Figure 4.25 Pipe Sample 4 Ambient - Rock Mineral Fibre Insulation – Preparation surface.

Figure 4.26 Insulation Sample 4 - Rock Mineral Fibre Insulation – Inner surface.

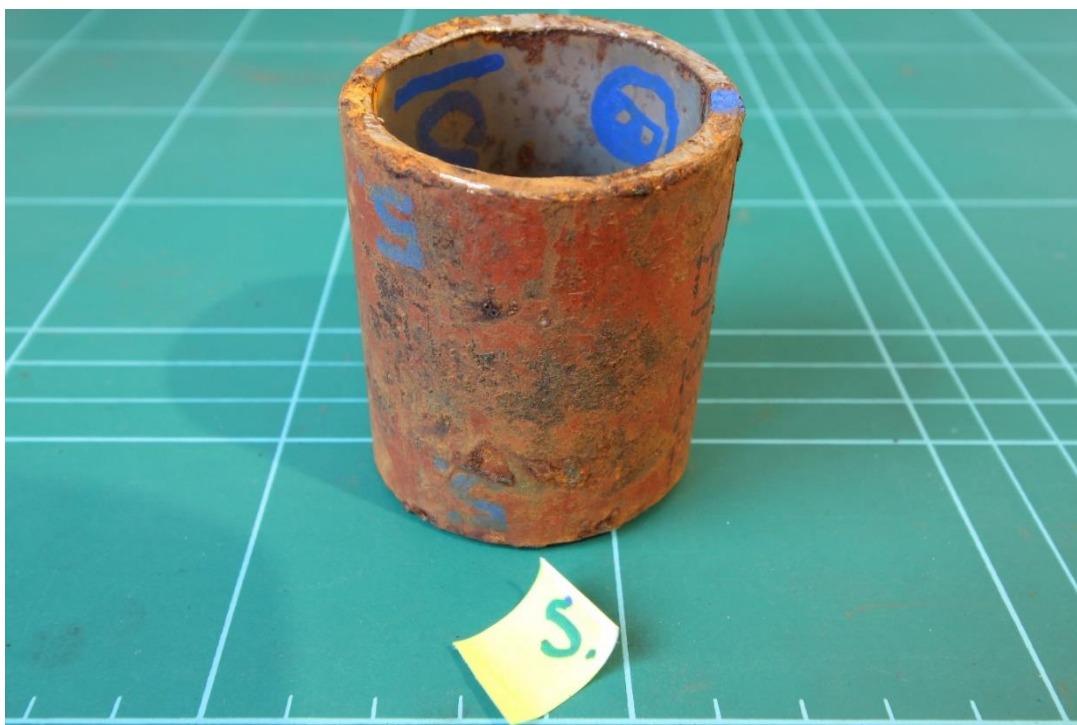
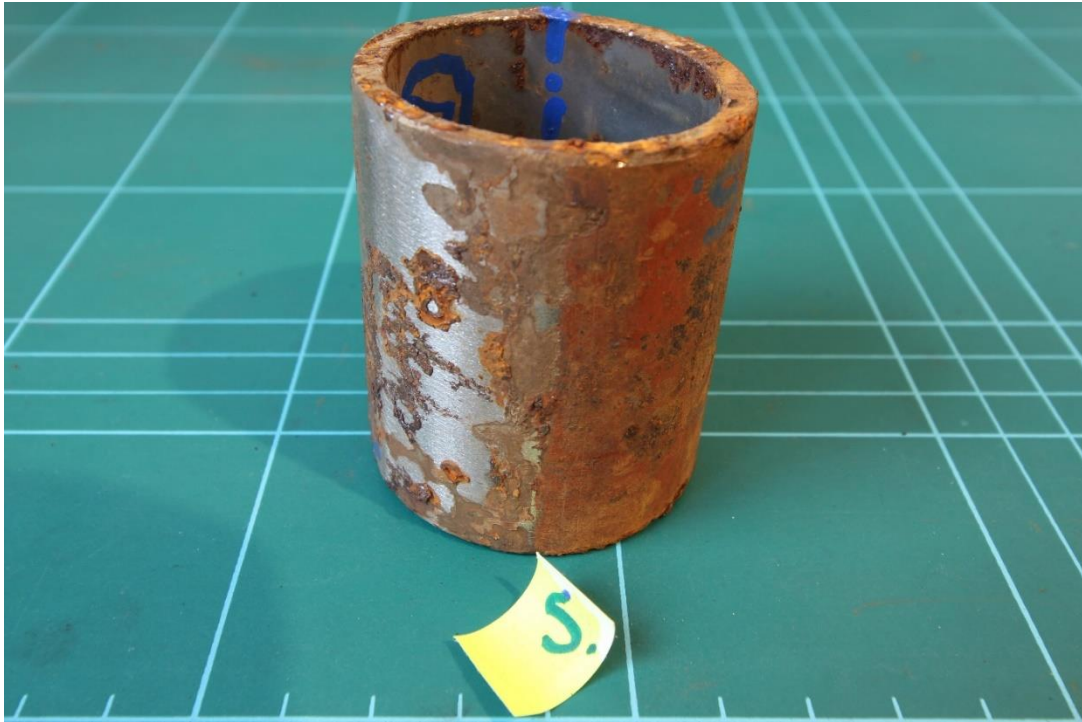
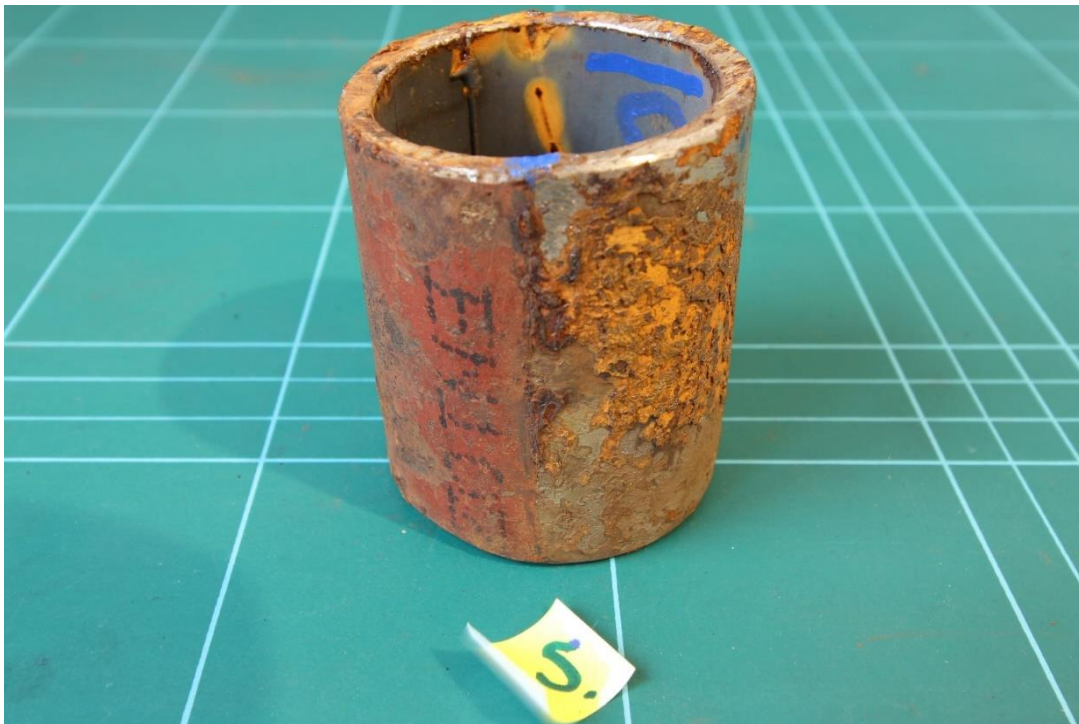
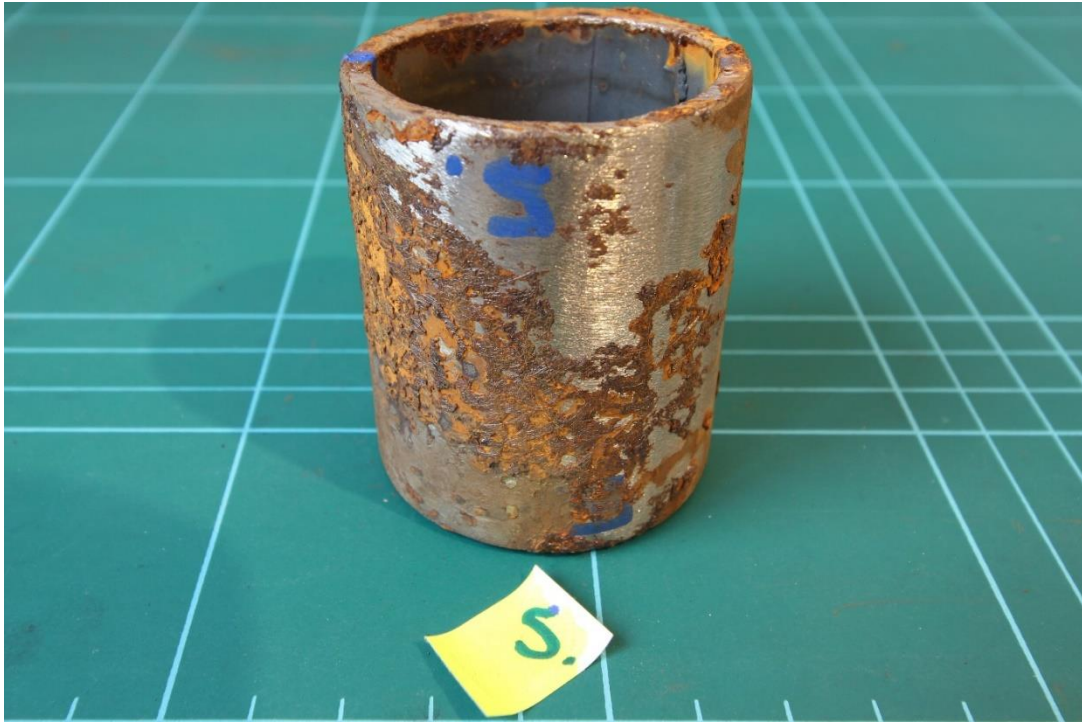
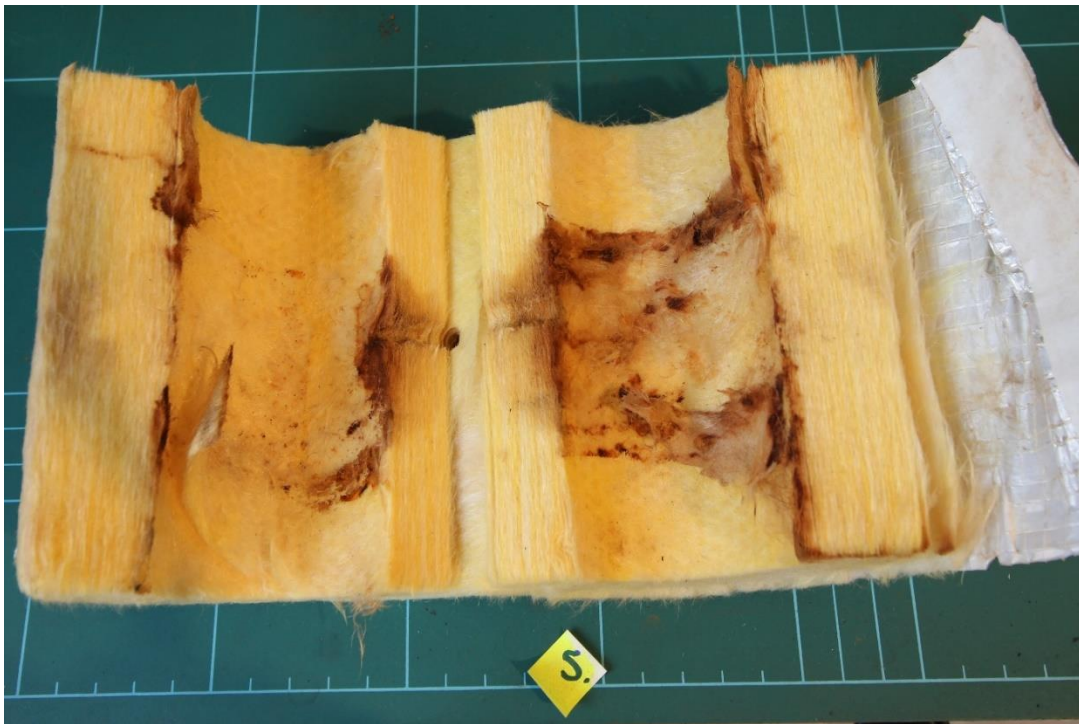
Isolated areas of slight surface corrosion on the sample pipe surface where breakage of the manufacturers surface coating is breached exposing the metallic surface, other areas where surface breakage of the protective coating has occurred has not been subject to visually observable corrosion, as seen in figure 4.27. The preparation surface has areas of localised uniform corrosion with deposits of attached oxide and scale which was not able to be removed by light mechanical cleaning where there is contact with the insulation material, as seen by the pattern of visible corrosion mirroring the insulation surface in contact with the pipe, areas interspaced between corrosion have no visible surface corrosion present as seen in figure 4.30. A clear termination between the coating and preparation surfaces is visible in figures 4.28 and 4.29. The insulation material is found in a condition consistent with its as new application, with minor de-bonding of fibres due to attachment to surface, oxide and scale formed, and handling as detailed in figure 4.31.

Figure 4.27 Pipe Sample 5 Ambient – Glass wool insulation – Coating surface.

Figure 4.28 Pipe Sample 5 Ambient – Glass wool insulation - Lower 180°

Figure 4.29 Pipe Sample 5 Ambient – Glass wool insulation - Upper 0°

Figure 4.30 Pipe Sample 5 Ambient – Glass wool insulation – Preparation surface.

Figure 4.31 Insulation Sample 5 Ambient - Glass wool insulation – Inner surface.

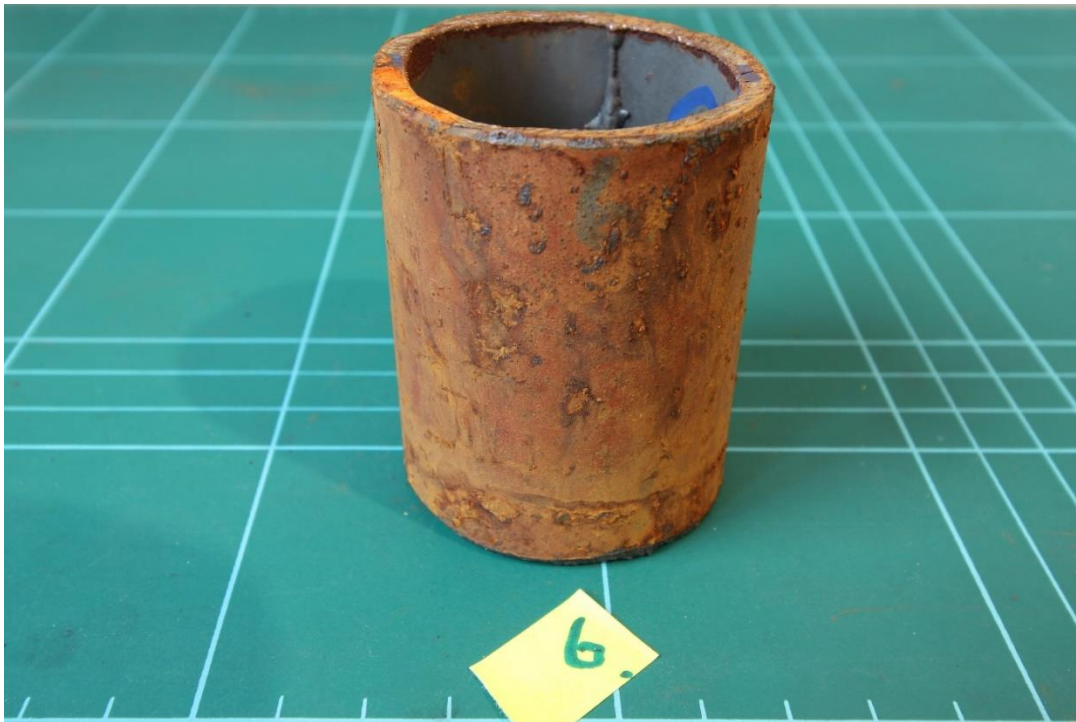
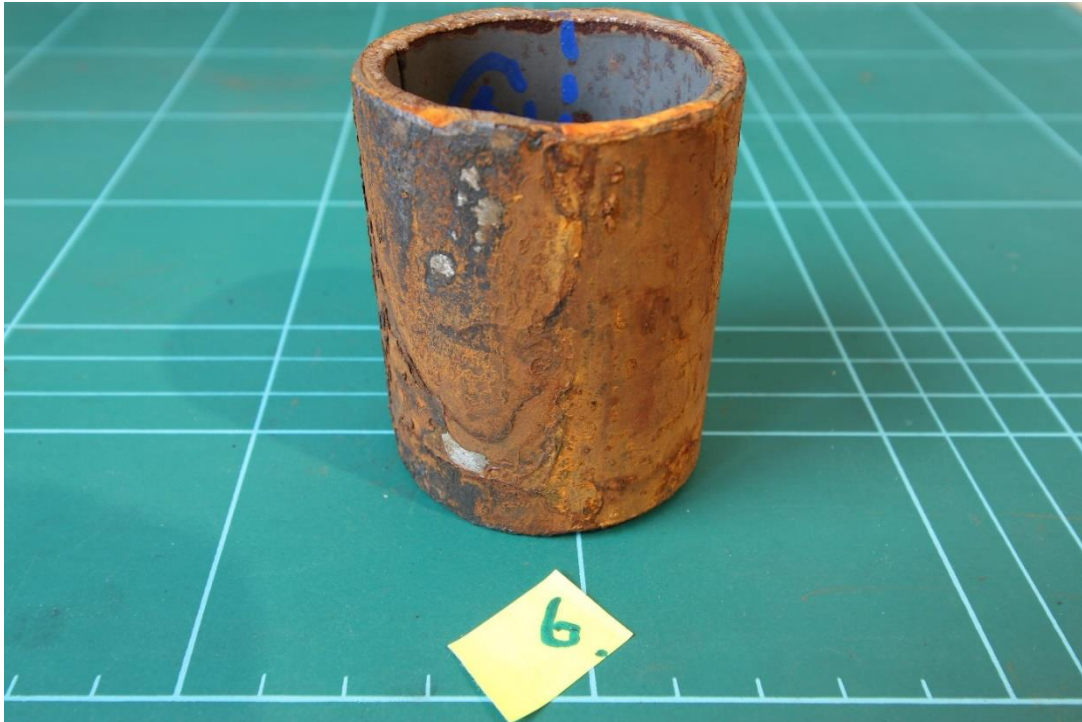
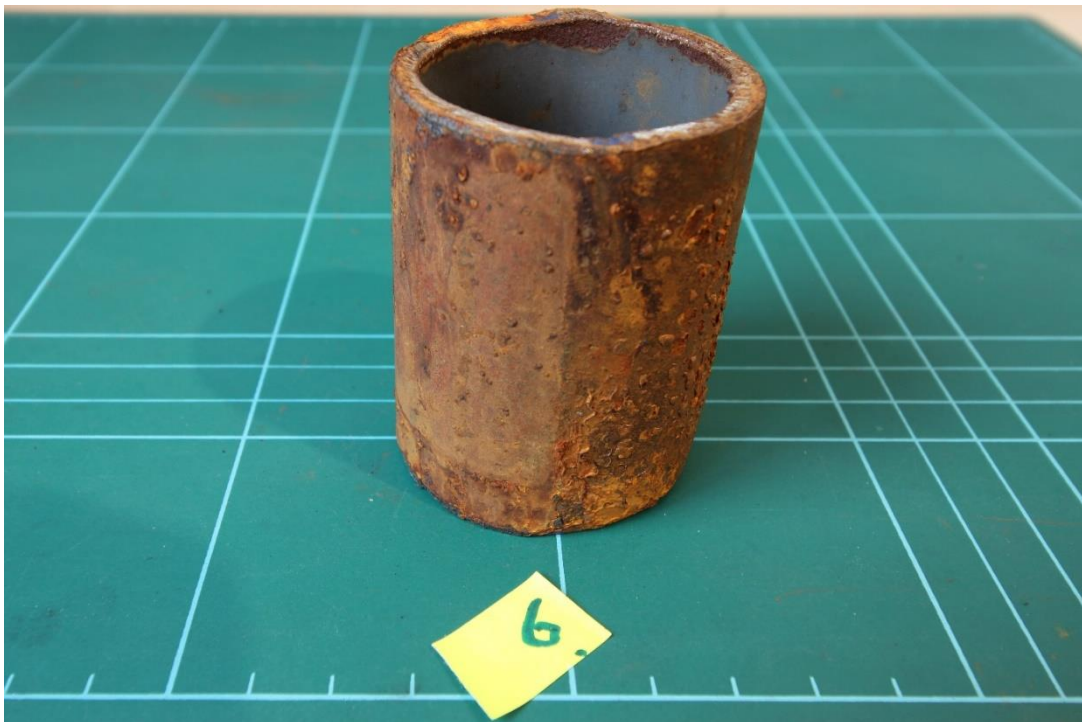
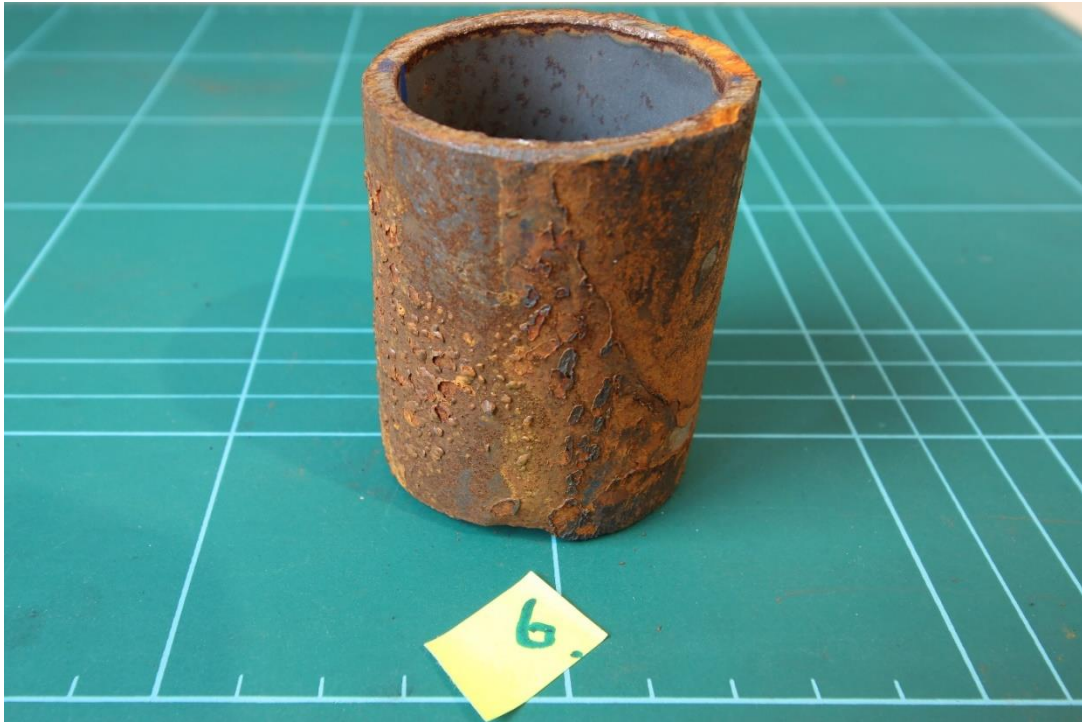
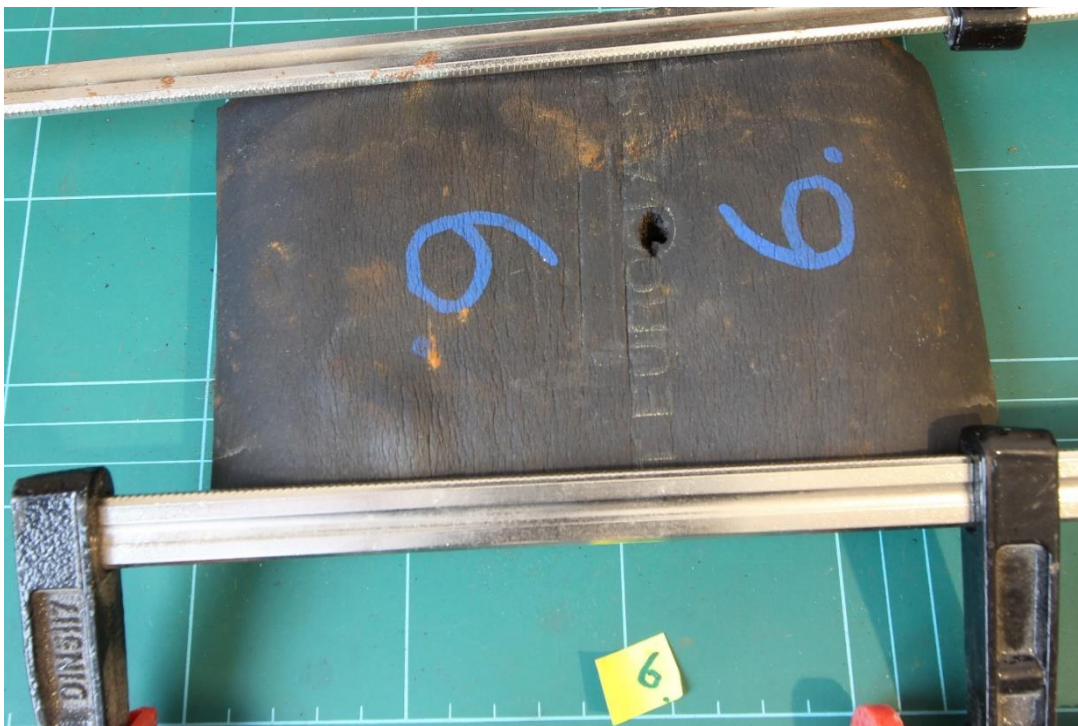
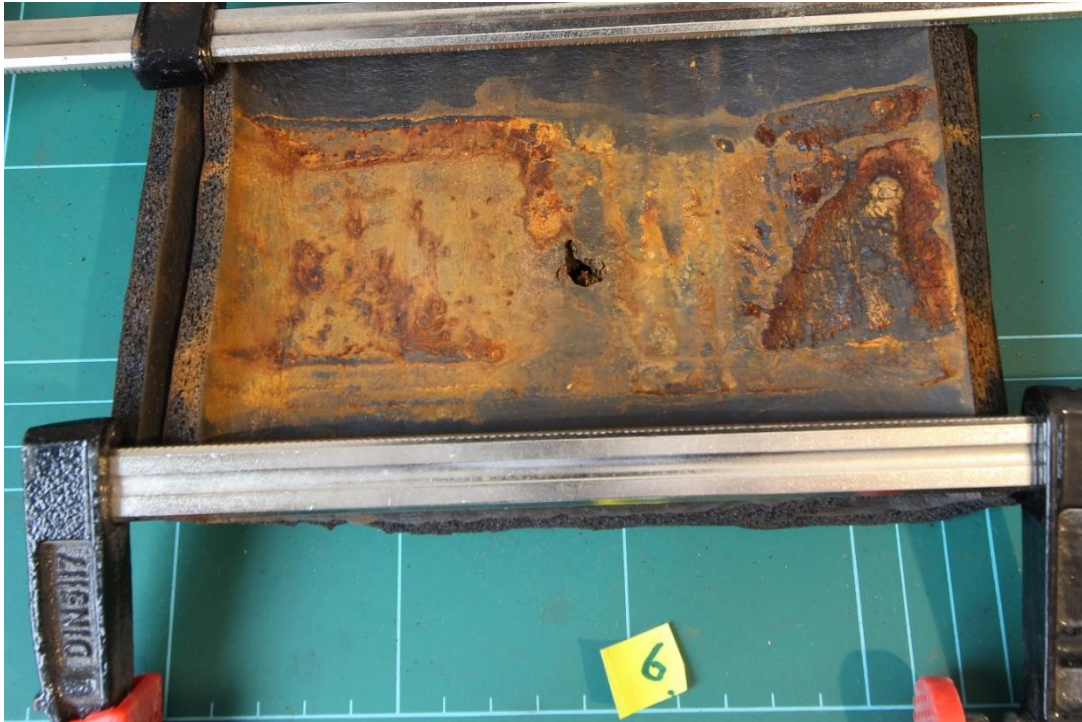
Localised areas of slight surface staining, corrosion and deposits of attached oxide is seen on the sample pipe coating surface where breakage of the manufacturers surface coating is breached as seen in figure 4.32, with isolated areas of additional corrosion noted where further parts of the protective coating have broken down during the period of experimentation. The preparation surface is subject to moderate uniform corrosion over the prepared surface where in contact with the insulation material, with isolated visible large shallow pitting, areas of attached oxide and scale still present to a minimal thickness which was generally able to be removed by light mechanical cleaning, as seen in figure 4.35. Other parts not in contact with the insulation material are affected by isolated areas of superficial surface corrosion. The termination between the coating and preparation surfaces is visible in figures 4.33 and 4.34. The insulation material is found to have deteriorated slightly on the inner surfaces as depicted in figures 4.37 where the pipe has been in close contact. Externally the insulation is found in a condition consistent with its as new application as detailed in figure 4.36.

Figure 4.32 Pipe Sample 6 Ambient - Closed-cell elastomer foam insulation – Coating surface.

Figure 4.33 Pipe Sample 6 Ambient - Closed-cell elastomer foam insulation – Lower 180°

Figure 4.34 Pipe Sample 6 Ambient - Closed-cell elastomer foam insulation - Upper 0°

Figure 4.35 Pipe Sample 6 Ambient - Closed-cell elastomer foam insulation – Preparation surface.

Figure 4.36 Insulation Sample 6 Ambient – Closed-cell elastomer foam insulation – Outer surface.

Figure 4.37 Insulation Sample 6 Ambient – Closed-cell elastomer foam insulation – Inner surface.

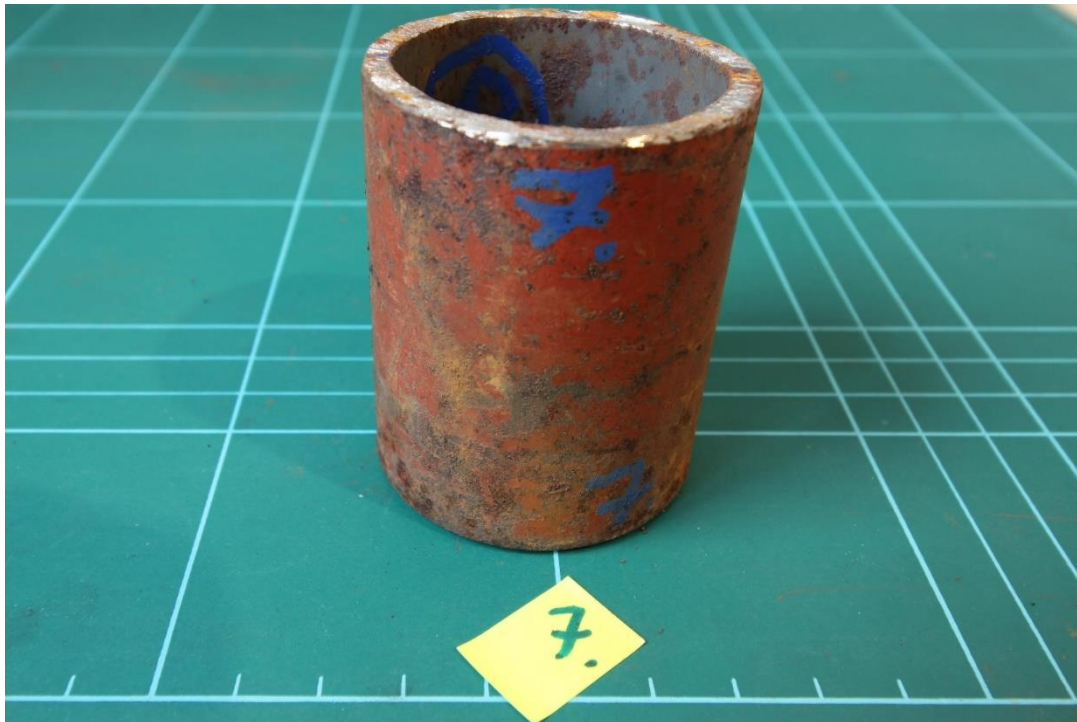
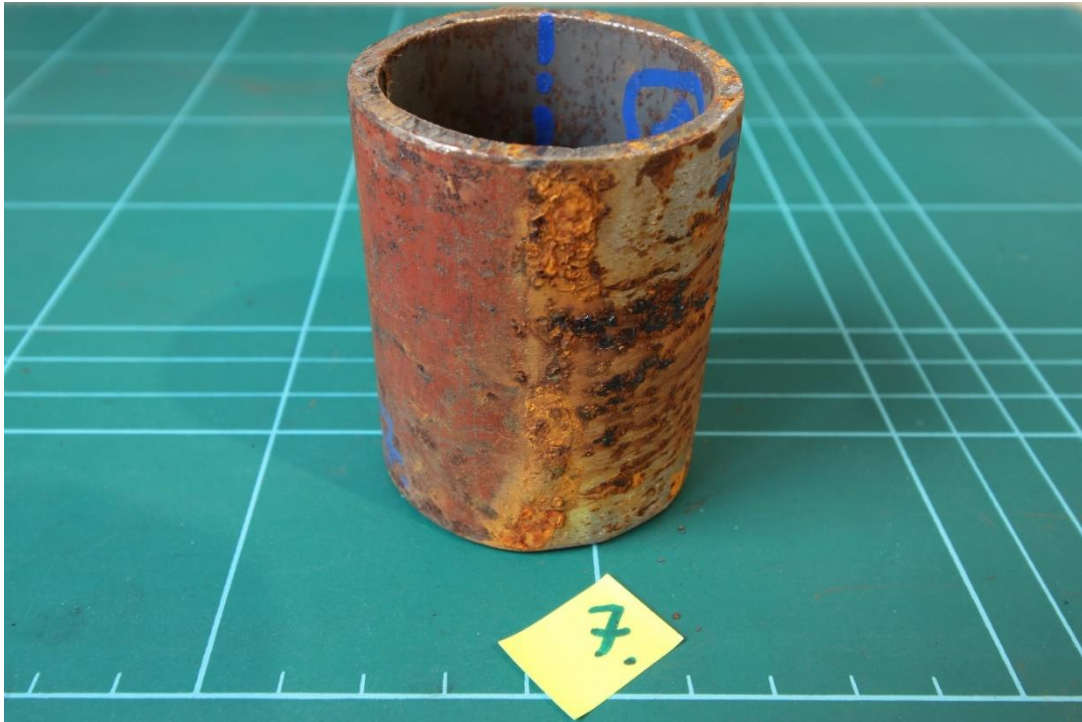
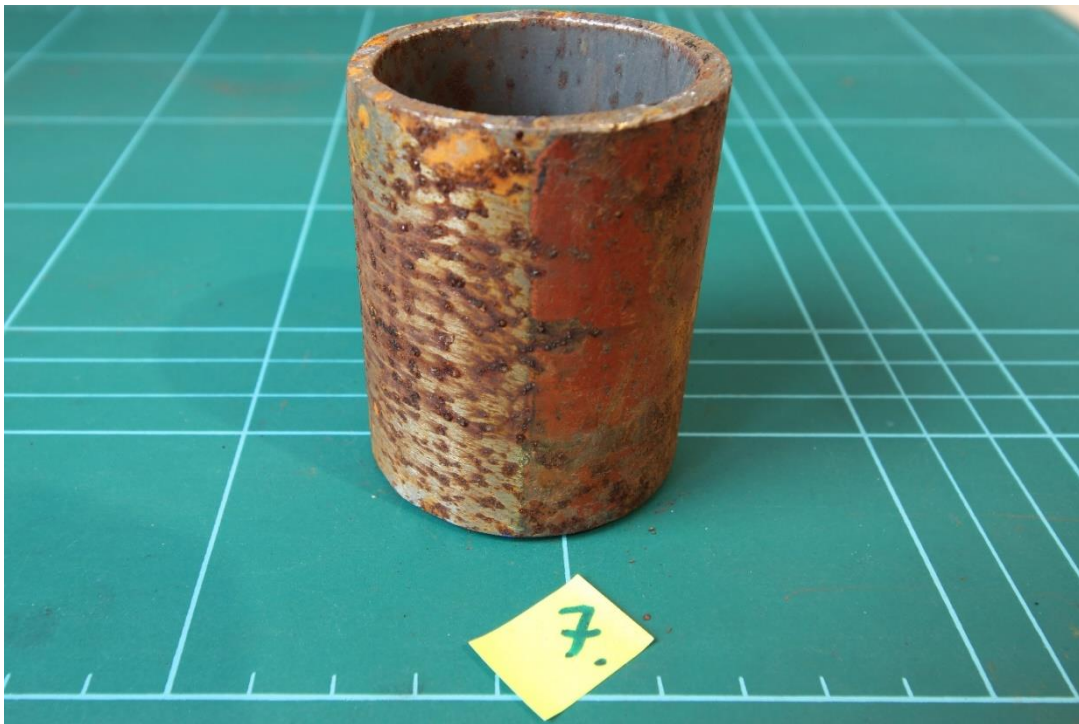
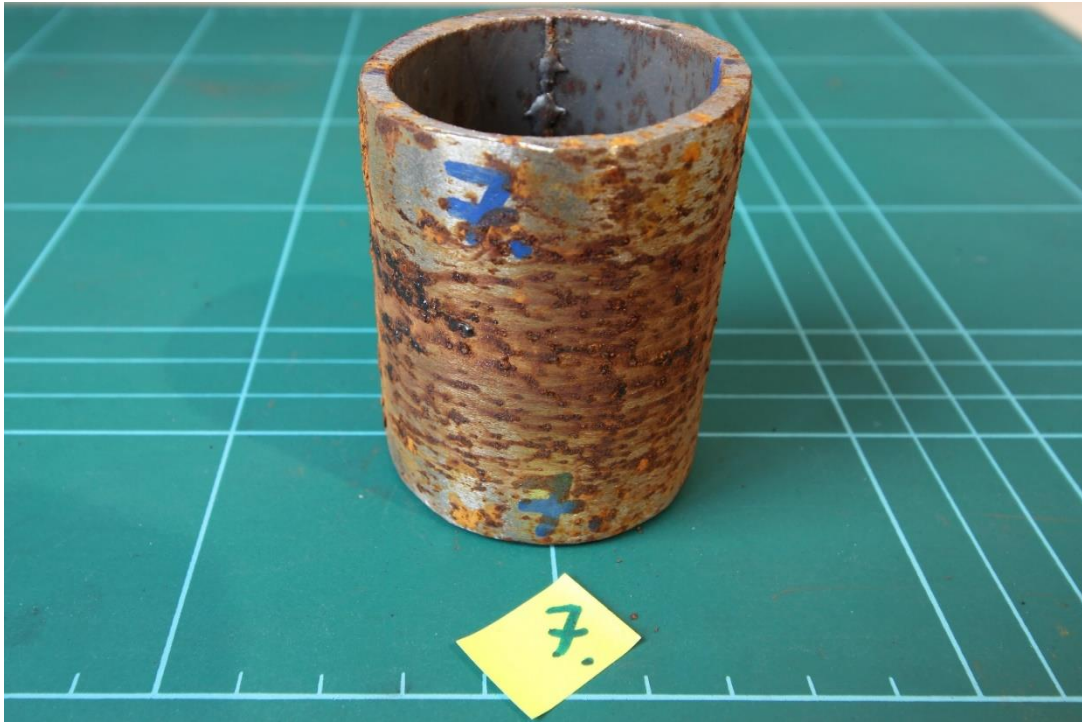
Sample 7 was not covered with thermal insulation; the sample being exposed to ambient conditions within the environmental tank and subject to the same volume of recirculated rainwater as the insulated pipe samples. Some isolated areas of slight surface corrosion are noted on the sample pipe surface where breakage of the manufacturers surface coating is breached exposing the metallic surface, however other parts where surface breakage of the protective coating has occurred has not been subject to visually observed corrosion, as seen in figure 4.38. The preparation surface has areas of both superficial surface corrosion, and localised pitting corrosion with slight deposits of attached oxide and scale which was not able to be removed by light mechanical cleaning, the axial extremities of the pipe sample where no visible surface corrosion is present is generally in areas where recirculated rainwater was not in contact with the pipe surface as seen in figure 4.41. A clear termination between the coating and preparation surfaces is visible in figures 4.40, whilst a clear termination is also noted in figure 4.39 further localised general surface corrosion, oxide and scaling is found where the surface water applied forms into droplets before returning to the environmental test tank sump.

Figure 4.38 Pipe Sample 7 Ambient – Uninsulated – Coating surface.

Figure 4.39 Pipe Sample 7 Ambient – Uninsulated - Lower 180°

Figure 4.40 Pipe Sample 7 Ambient – Uninsulated - Upper 0°

Figure 4.41 Pipe Sample 7 Ambient – Uninsulated – Preparation surface.

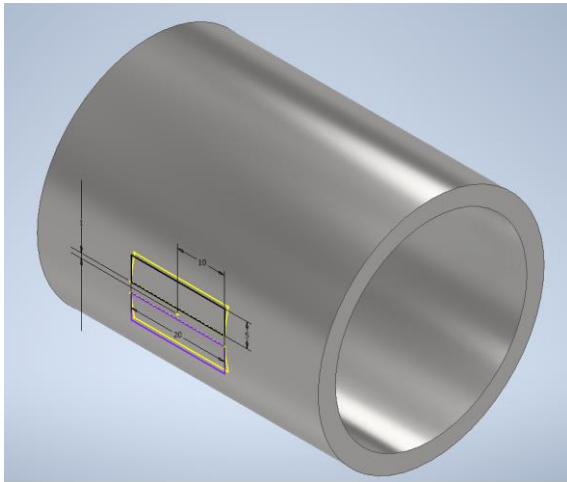
Figure 4.42 Position of metallographic test coupons within pipe sample

Each of the samples is sectioned for metallographic examination by removing a test coupon from the preparation surface at the midpoint of the 270° position as detailed in figure 4.42.

A further set of test coupons extracted from the preparation surface as described in figure 4.42 of section 4.5 is prepared for energy dispersive x-ray spectroscopy (EDX) analysis.
