# School of Engineering MSc Mechanical Engineering

M7X01373 - Project  
Dissertation - Final Report

Corrosion Under Insulation of Carbon Steel  
Pipework in the South Wales Coastal Region

James Milling  
1503259  
March 2021

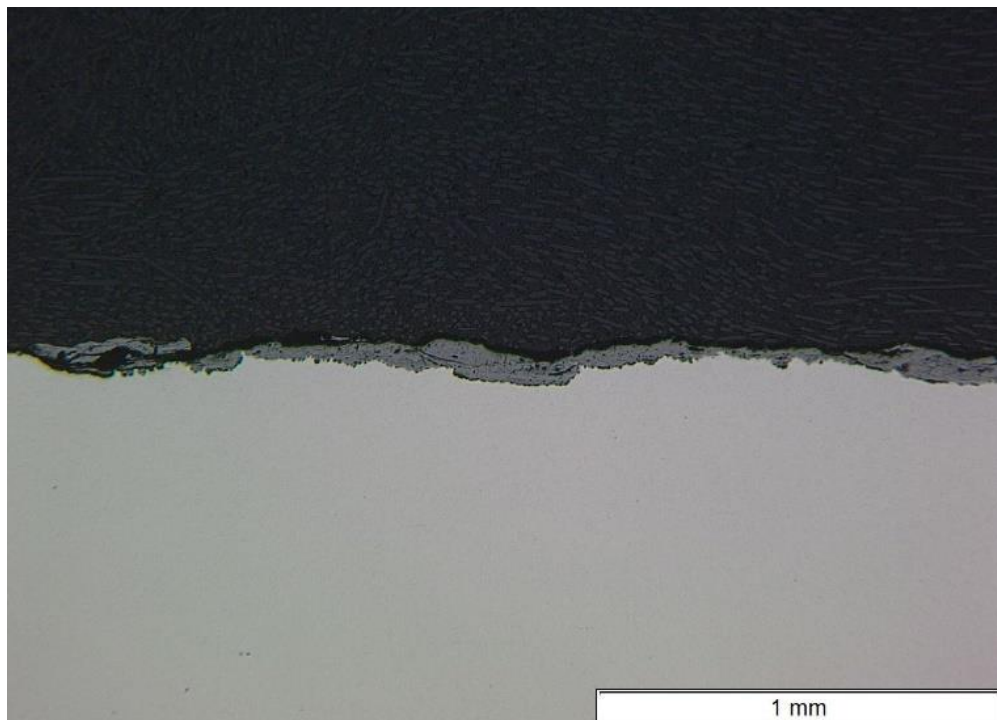
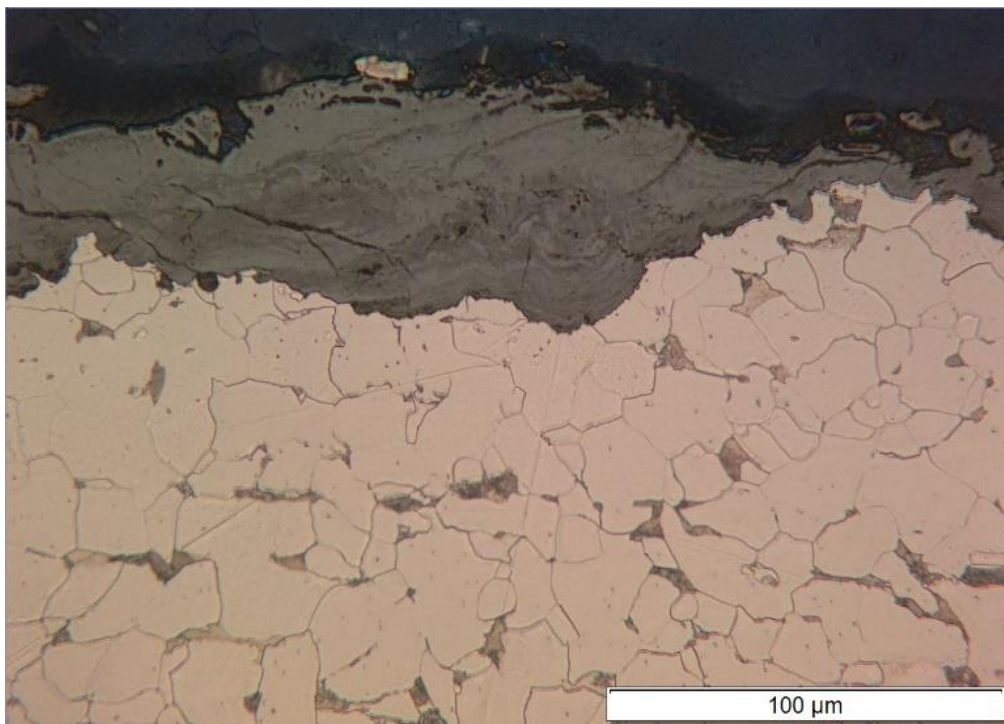
The preparation surface is subject to regular aggressive pitting corrosion, which occurs consistently over the sample as described in the 50x image detailed in figure 4.44, the products of corrosion forming a continuous oxide layer up to 50-70 microns in places, the oxide layer is found with multiply fractures which propagating to the exposed steel surface as seen in figures 4.44 and 4.45. No intergranular or transgranular corrosion is seen to originate from the corrosion pits into the grain boundaries of the exposed steel as detailed in figure 4.46.

Figure 4.44 Pipe Sample 1 Cyclic – Rock mineral fibre insulation – 50x magnification.

Figure 4.46 Pipe Sample 1 Cyclic – Rock mineral fibre insulation – 500x magnification.

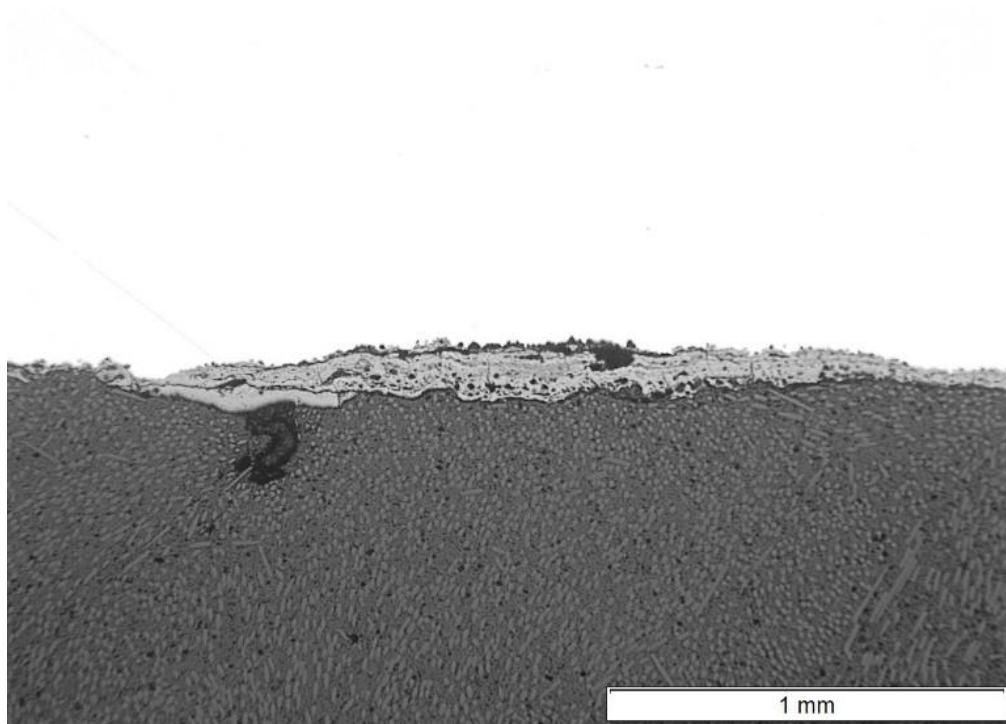
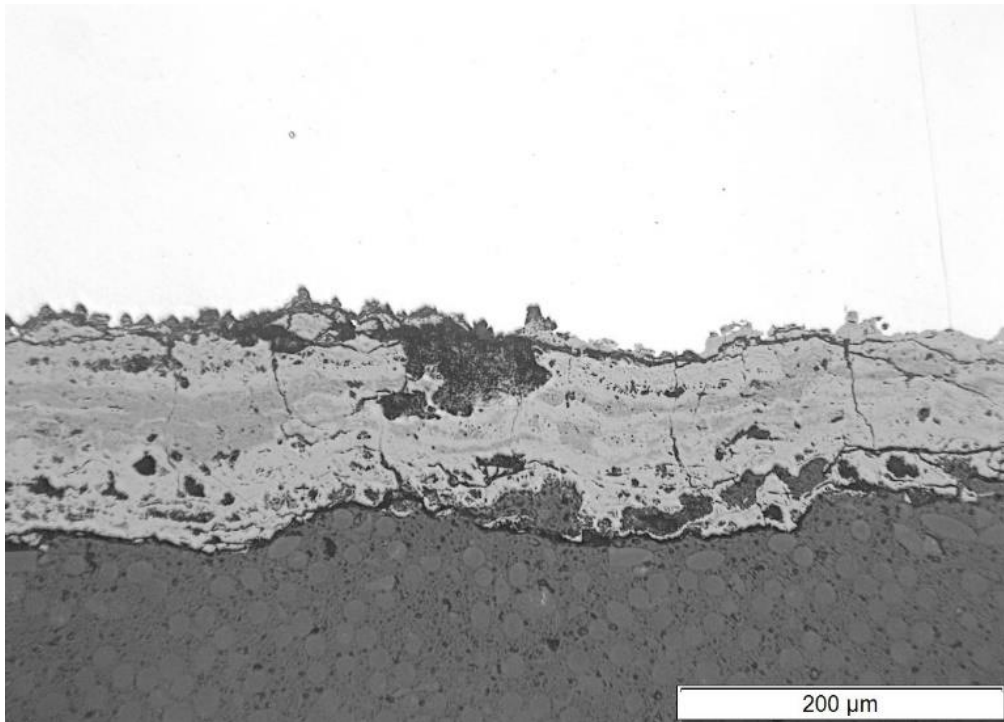
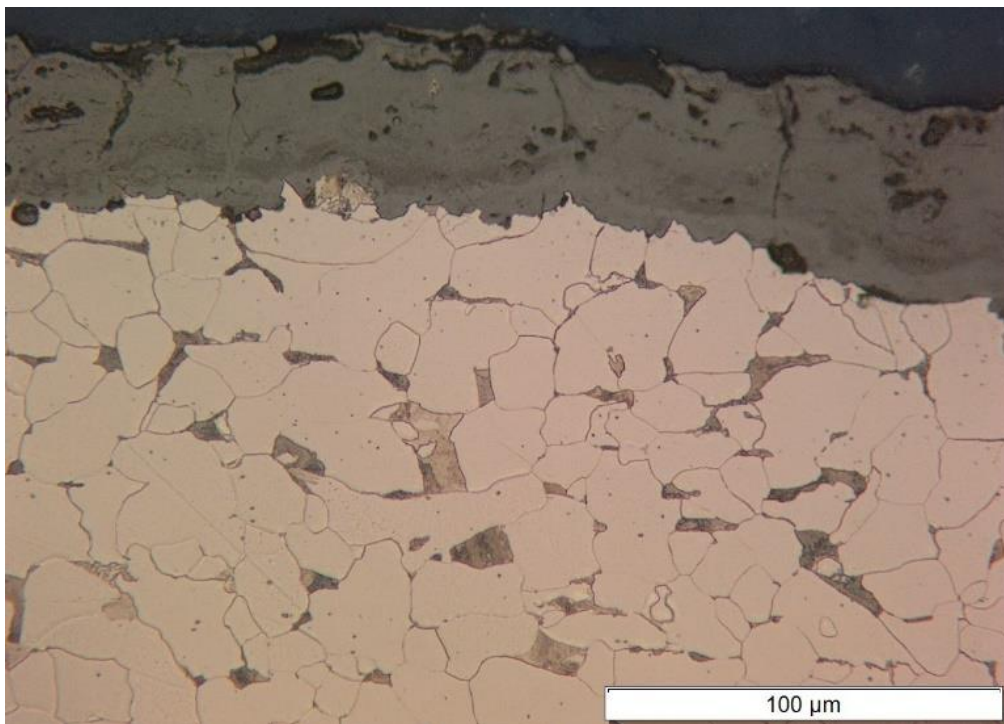
The preparation surface is subject to regular aggressive pitting corrosion, which occurs consistently over the sample as described in the 50x image detailed in figure 4.47, the products of corrosion forming a continuous oxide layer up to 80-120 microns in places, the oxide layer is found with multiply fractures which propagating to the exposed steel surface as seen in figures 4.48 and 4.49. No intergranular or transgranular corrosion is seen to originate from the corrosion pits into the grain boundaries of the exposed steel as detailed in figure 4.49.

Figure 4.47 Pipe Sample 2 Cyclic – Glass wool insulation – 50x magnification.

Figure 4.48 Pipe Sample 2 Cyclic – Glass wool insulation – 200x magnification.

Figure 4.49 Pipe Sample 2 Cyclic – Glass wool insulation – 500x magnification.

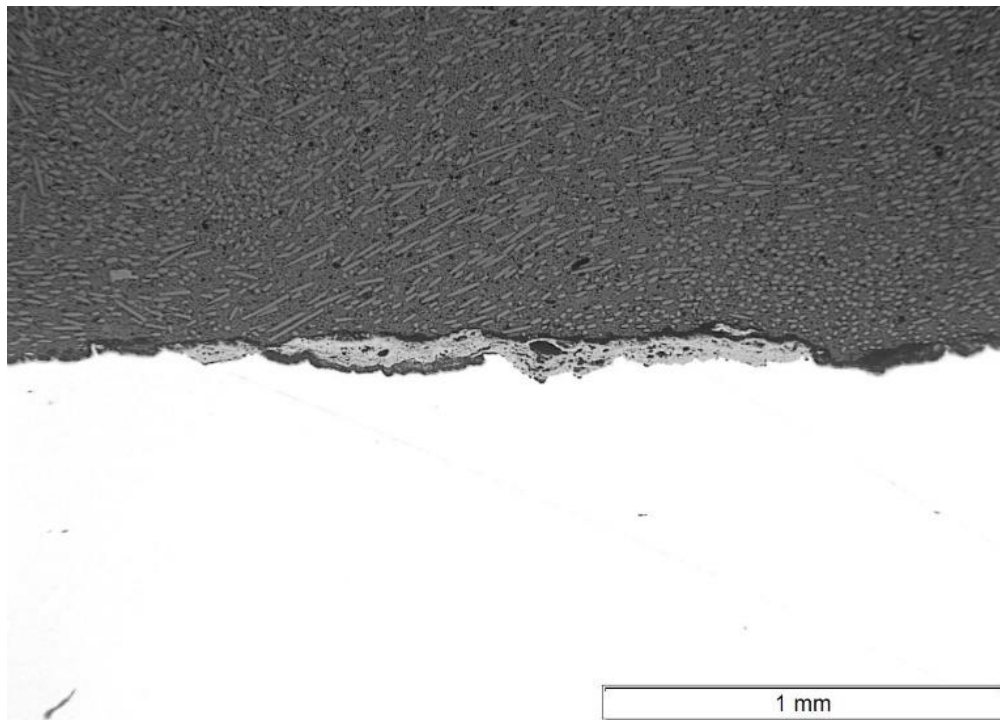
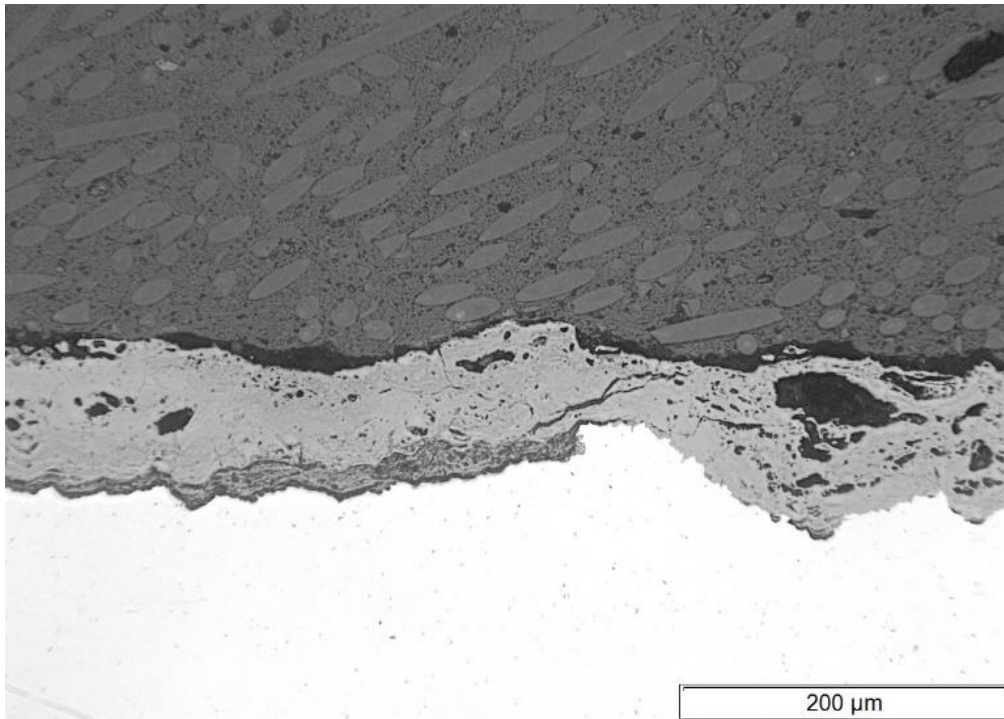
The preparation surface is subject to regular pitting corrosion, which occurs consistently over the sample as described in the 50x image detailed in figure 4.50, the products of corrosion forming a continuous oxide layer up to 40-60 microns in places, the oxide layer is found with multiple fractures which propagating to the exposed steel surface as seen in figures 4.51 and 4.52. No intergranular or transgranular corrosion is seen to originate from the corrosion pits into the grain boundaries of the exposed steel as detailed in figure 4.52.

Figure 4.50 Pipe Sample 3 Cyclic – Closed-cell elastomer foam insulation – 50x magnification.

Figure 4.51 Pipe Sample 3 Cyclic – Closed-cell elastomer foam insulation – 200x magnification.

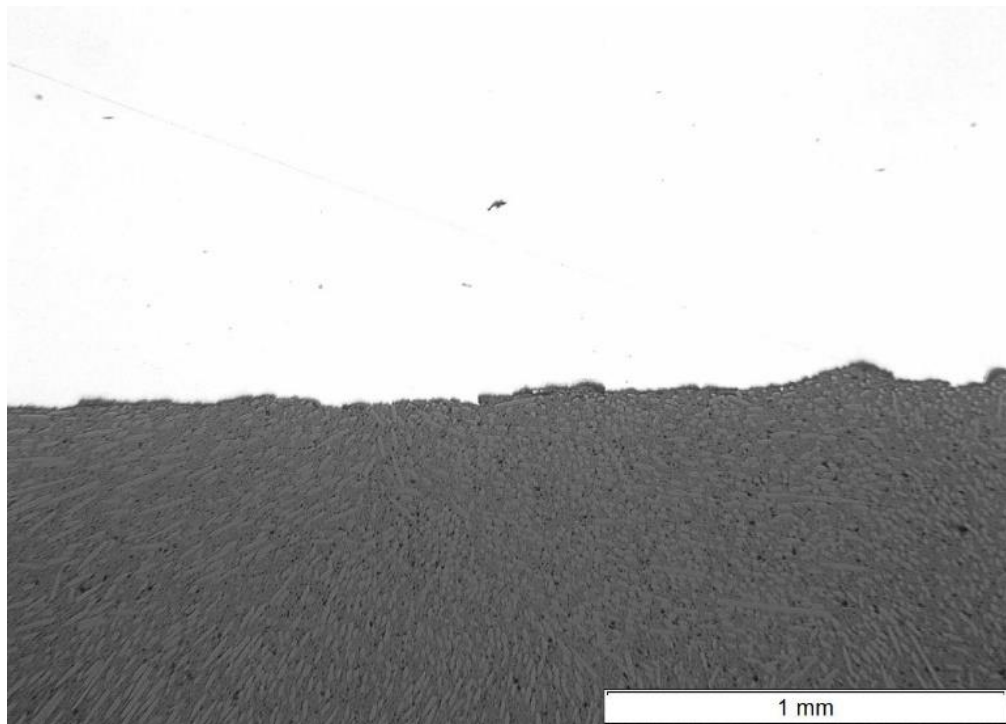
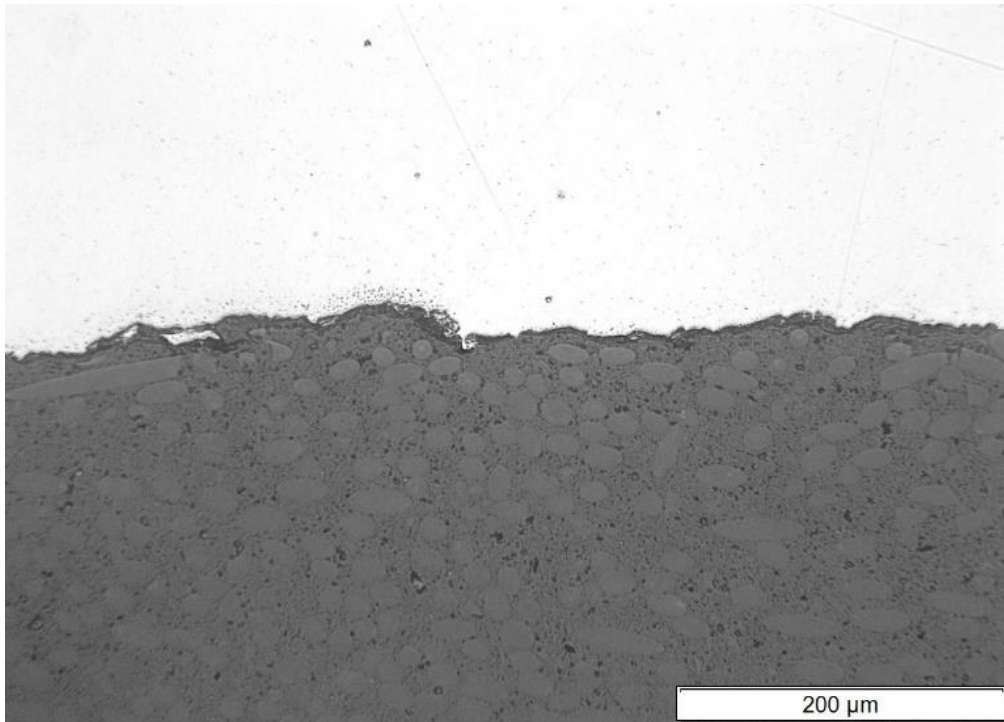
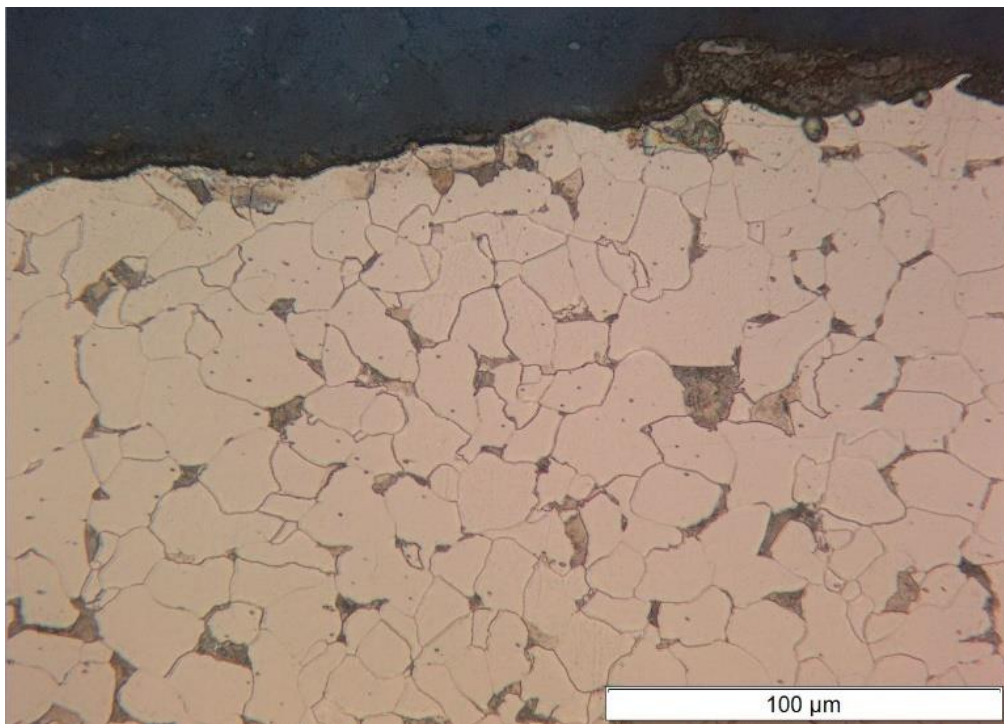
The preparation surface is subject to regular minor pitting corrosion, which occurs consistently over the sample as described in the 50x image detailed in figure 4.53, the products of corrosion forming a continuous oxide layer up to 10-20 microns in places, the oxide layer is found generally intact with no fractures propagating to the exposed steel surface as seen in figures 4.54 and 4.55. No intergranular or transgranular corrosion is seen to originate from the corrosion pits into the grain boundaries of the exposed steel as detailed in figure 4.55.

Figure 4.53 Pipe Sample 4 Ambient - Rock Mineral Fibre Insulation – 50x magnification.

Figure 4.54 Pipe Sample 4 Ambient - Rock Mineral Fibre Insulation – 200x magnification.

Figure 4.55 Pipe Sample 4 Ambient - Rock Mineral Fibre Insulation – 500x magnification.

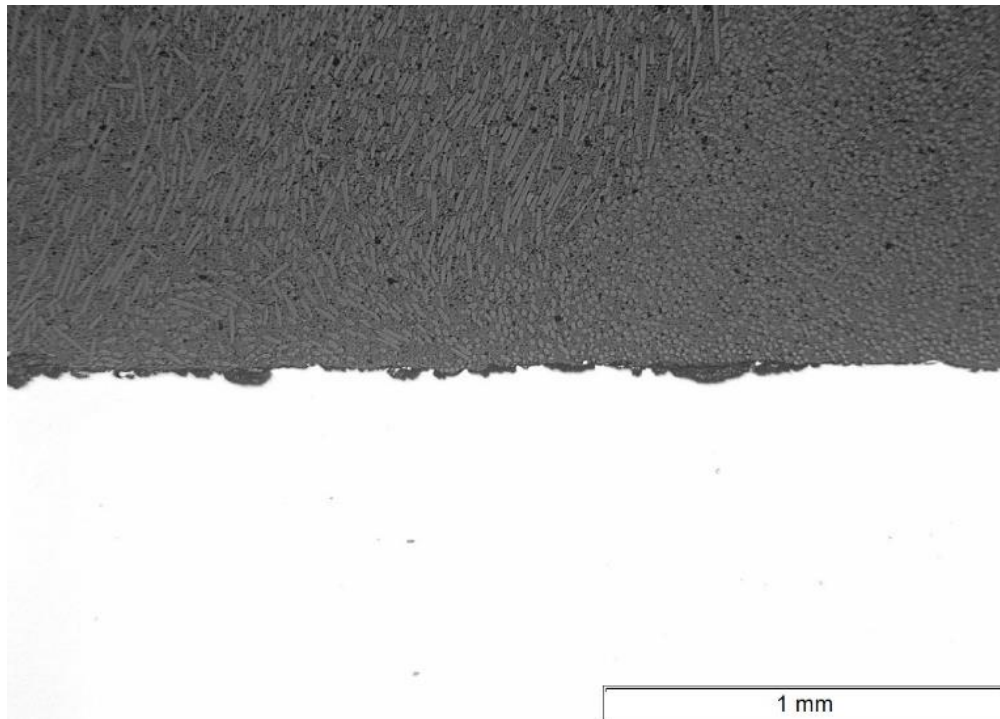
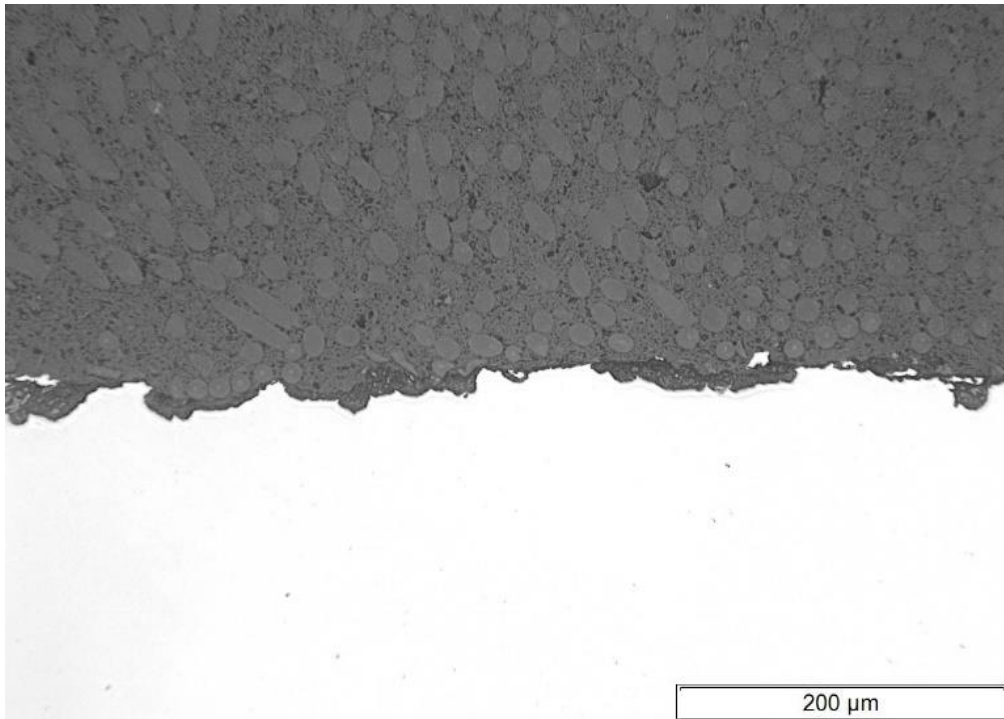
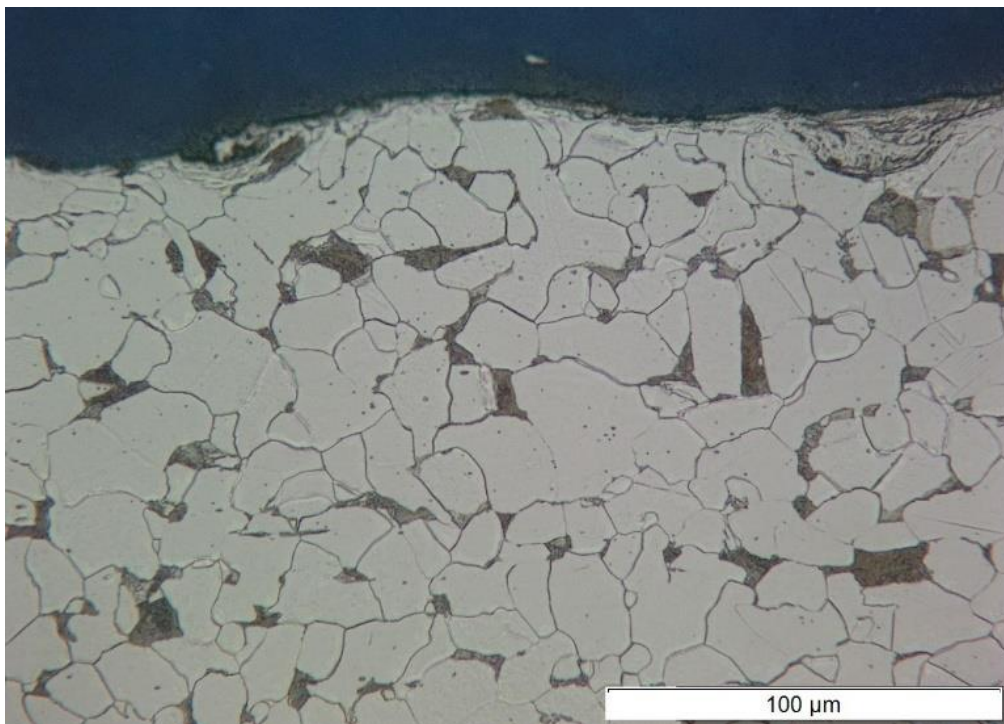
The preparation surface is subject to regular moderate pitting corrosion, with isolated areas of aggressive pitting corrosion, both occurring consistently over the sample as described in the 50x image detailed in figure 4.56, the products of corrosion forming a continuous oxide layer up to 5-10 microns, increasing to 20-40 microns in places, the oxide layer is found generally intact with no fractures propagating to the exposed steel surface as seen in figures 4.57 and 4.58. No intergranular or transgranular corrosion is seen to originate from the corrosion pits into the grain boundaries of the exposed steel as detailed in figure 4.55.

Figure 4.56 Pipe Sample 5 Ambient – Glass wool insulation – 50x magnification.

Figure 4.57 Pipe Sample 5 Ambient – Glass wool insulation – 200x magnification.

Figure 4.58 Pipe Sample 5 Ambient – Glass wool insulation – 500x magnification.

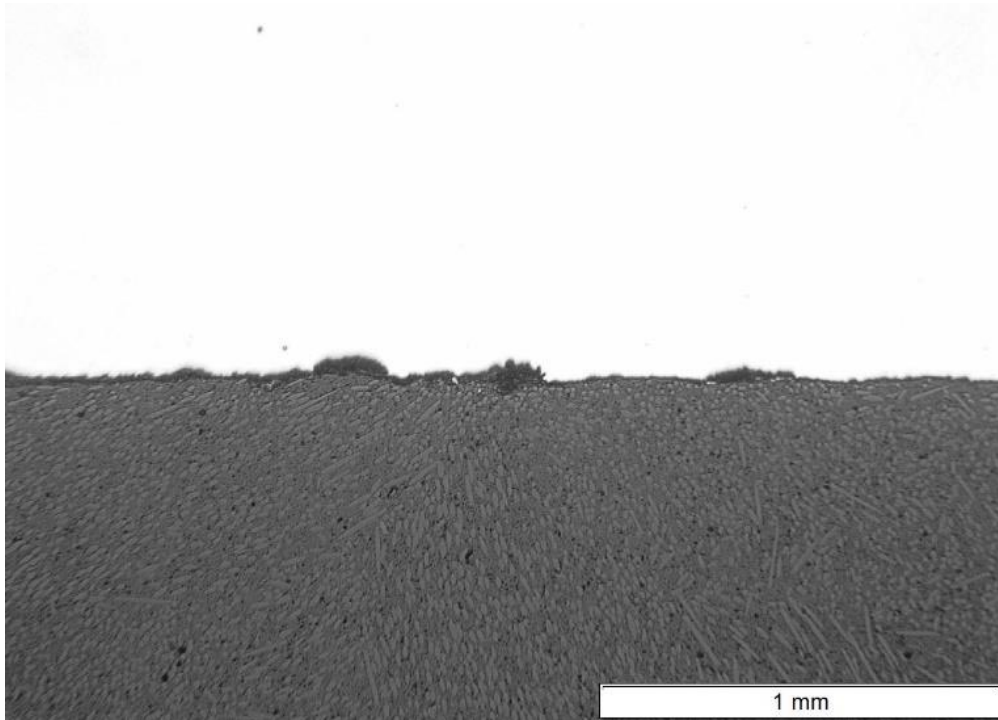
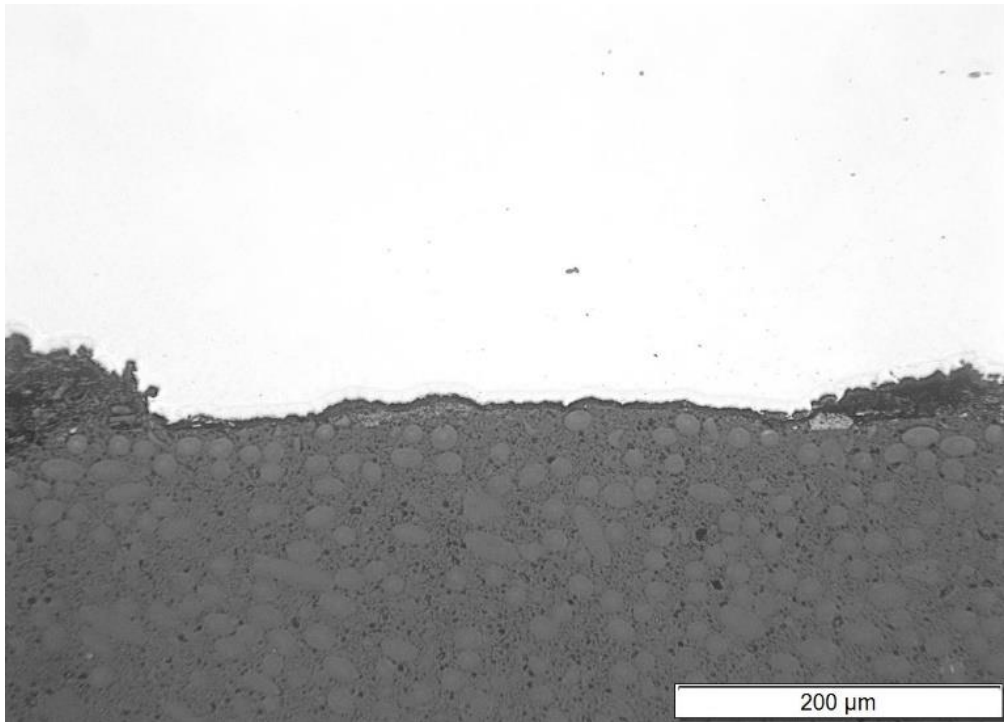
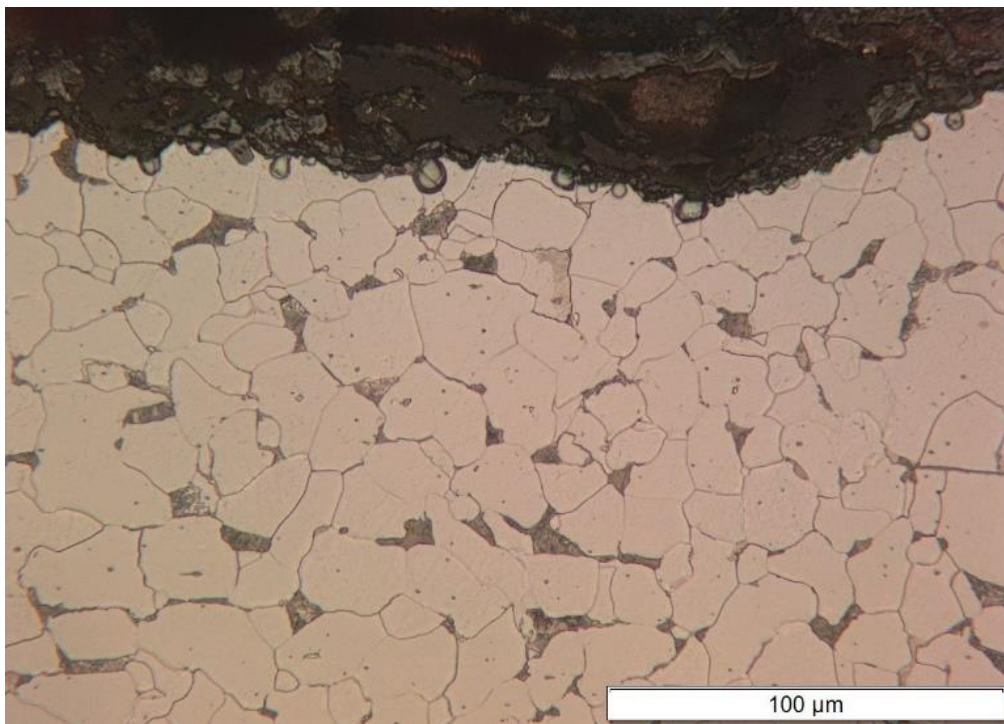
The preparation surface is subject to regular minor pitting corrosion, with isolated areas of aggressive pitting corrosion, both occurring consistently over the sample as described in the 50x image detailed in figure 4.59, the products of corrosion forming a continuous oxide layer up to 5-10 microns, increasing to 20-40 microns in places, the oxide layer is found generally intact with no fractures propagating to the exposed steel surface as seen in figures 4.60 and 4.61. No intergranular or transgranular corrosion is seen to originate from the corrosion pits into the grain boundaries of the exposed steel as detailed in figure 4.61.

Figure 4.59 Pipe Sample 6 Ambient - Closed-cell elastomer foam insulation – 50x magnification.

Figure 4.60 Pipe Sample 6 Ambient - Closed-cell elastomer foam insulation – 200x magnification.

Figure 4.61 Pipe Sample 6 Ambient - Closed-cell elastomer foam insulation – 500x magnification.

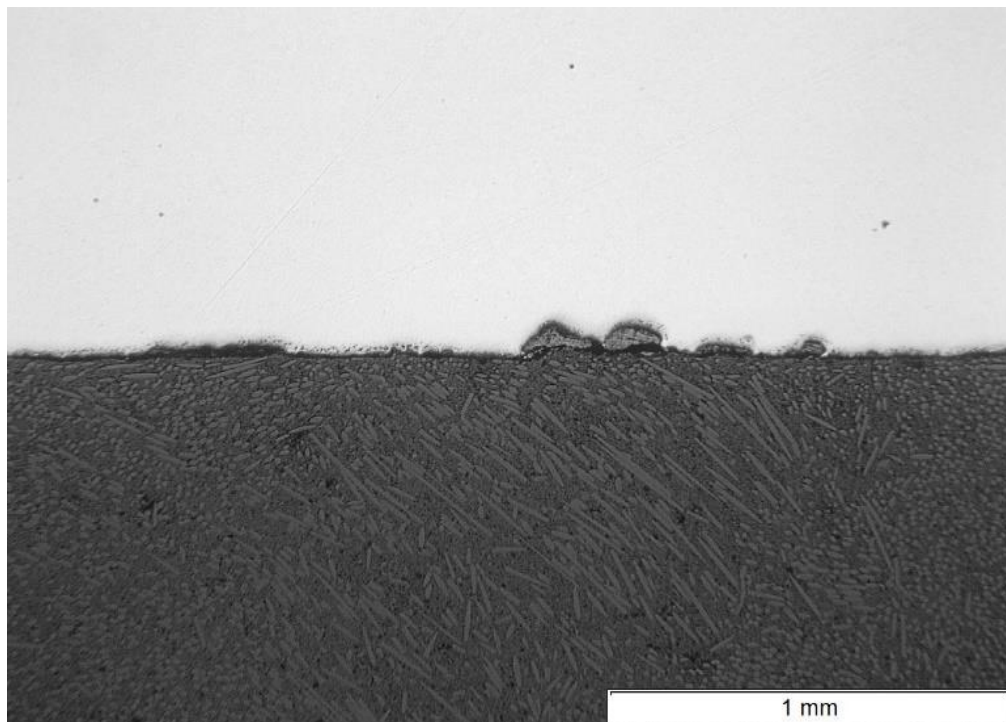
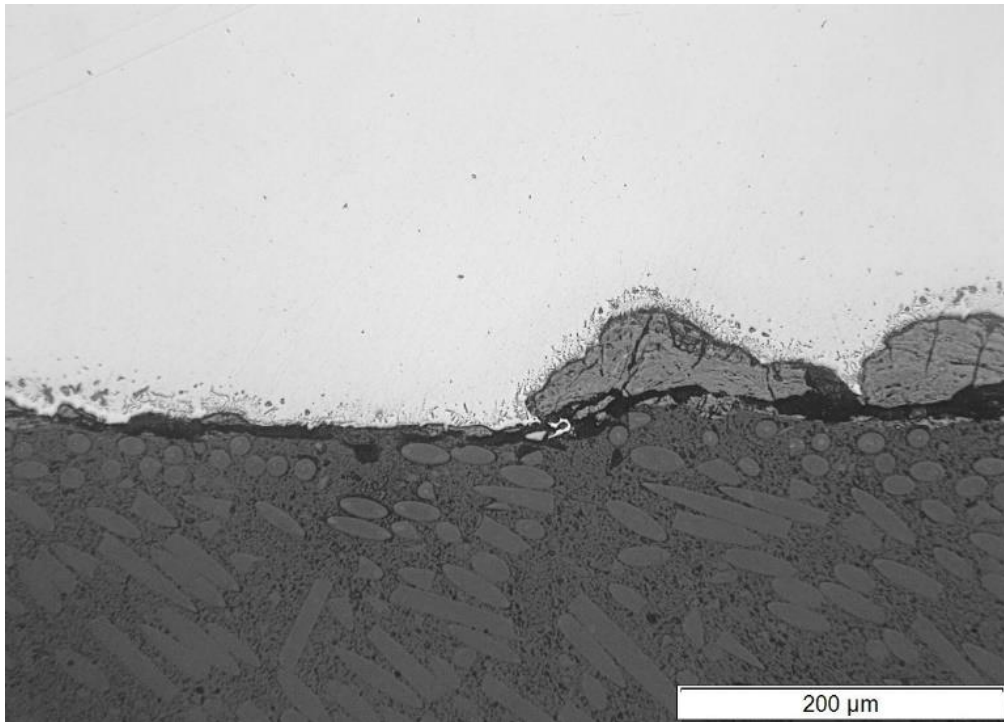
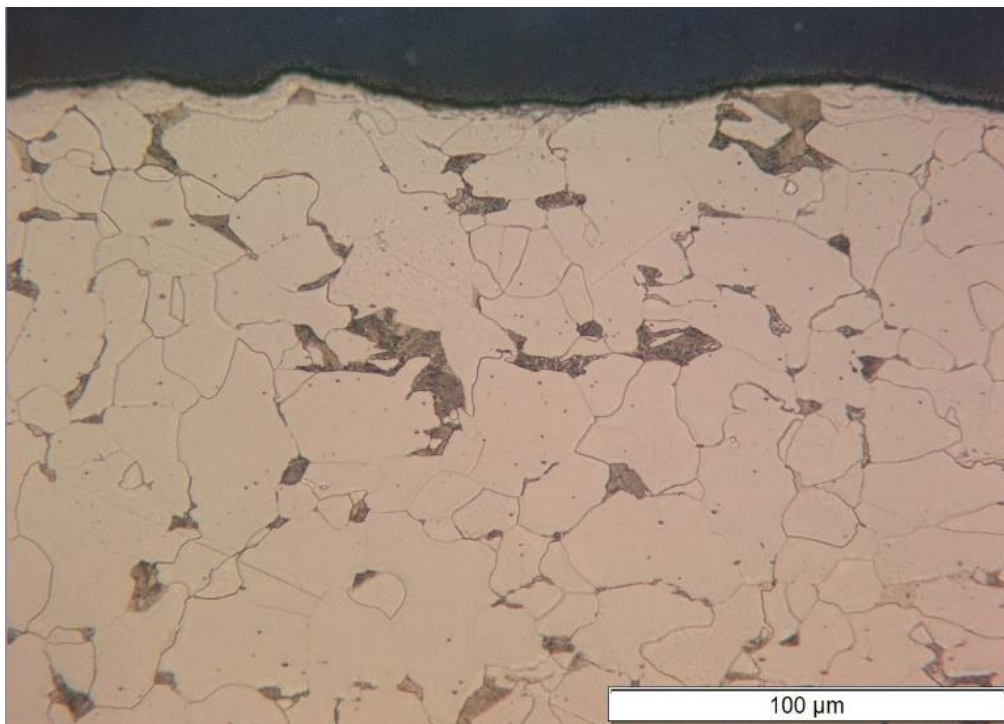
Figure 4.62 Pipe Sample 7 Ambient – Uninsulated – 50x magnification.

Figure 4.63 Pipe Sample 7 Ambient – Uninsulated – 200x magnification.

Figure 4.64 Pipe Sample 7 Ambient – Uninsulated – 5000x magnification.

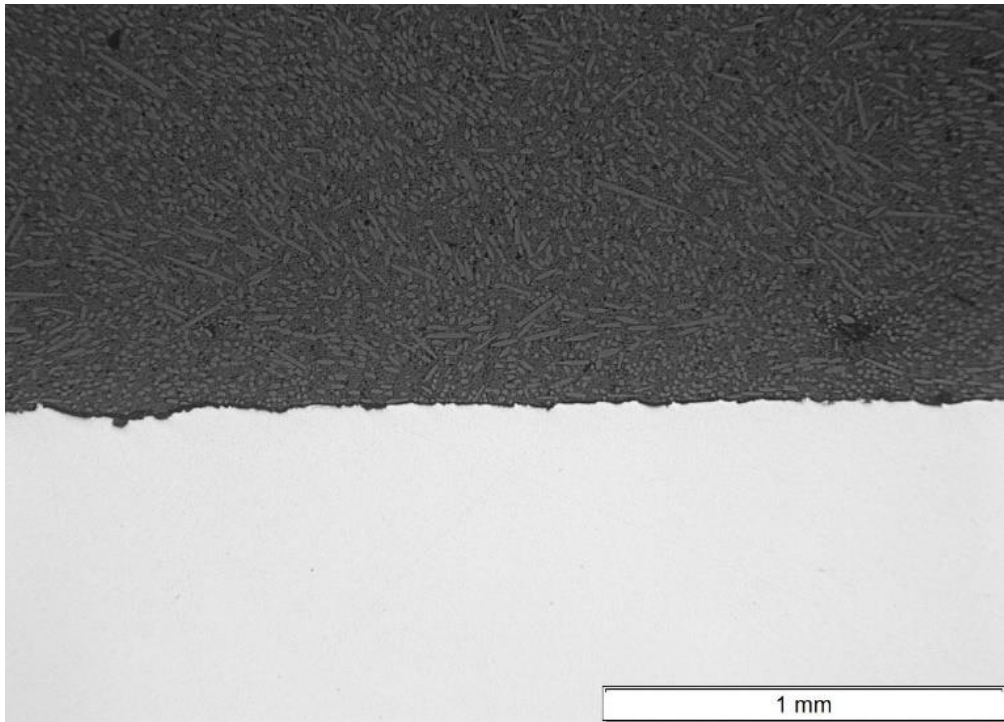
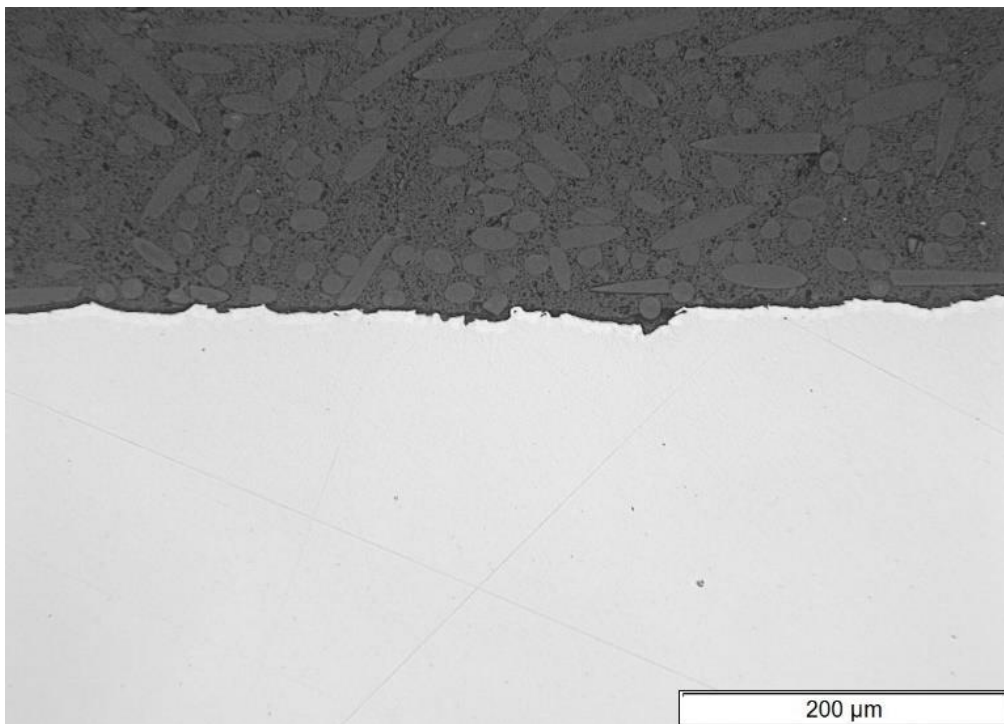
Figures 4.65 and 4.66 detail the inner surface of the pipe wall, mill scale present for manufacture is seen uniformly up to 5 microns.

Figure 4.65 Pipe Sample 7 Ambient – Uninsulated – Inner wall 50x magnification.

Figure 4.66 Pipe Sample 7 Ambient – Uninsulated – Inner wall 200x magnification.

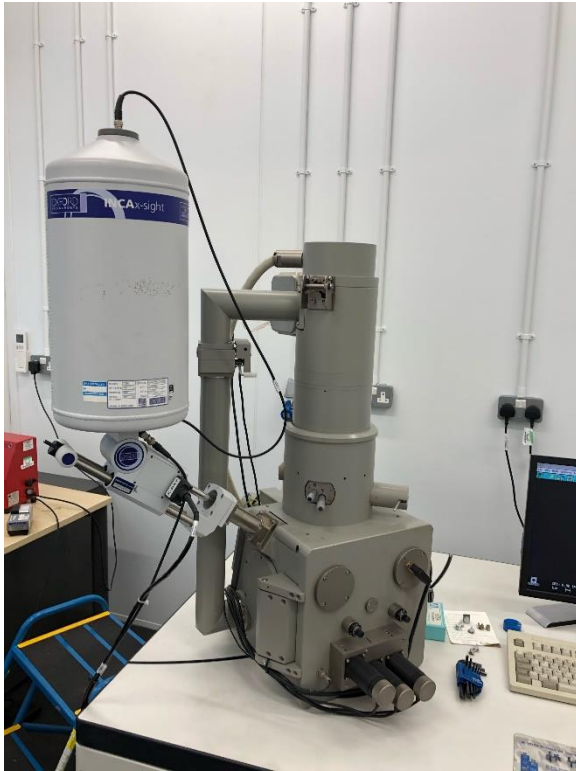
Figure 4.67 SEM and EDX sample chamber

The EDX analysis is undertaken using a scanning electron microscope (SEM) with an EDX function. As the samples have already been examined using conventional optical microscopy the higher magnification available with SEM was not considered necessary as part of this study, and only the EDX function is utilised. Figure 4.67 describes the SEM and EDX sample chamber.

EDX allows the elemental composition analysis of a materials surface to be undertaken and provides a spectrum of the elements present within the sample area. Whilst the technique can be used to determine the presence of elements, the results are relative to all elements present on the sample.

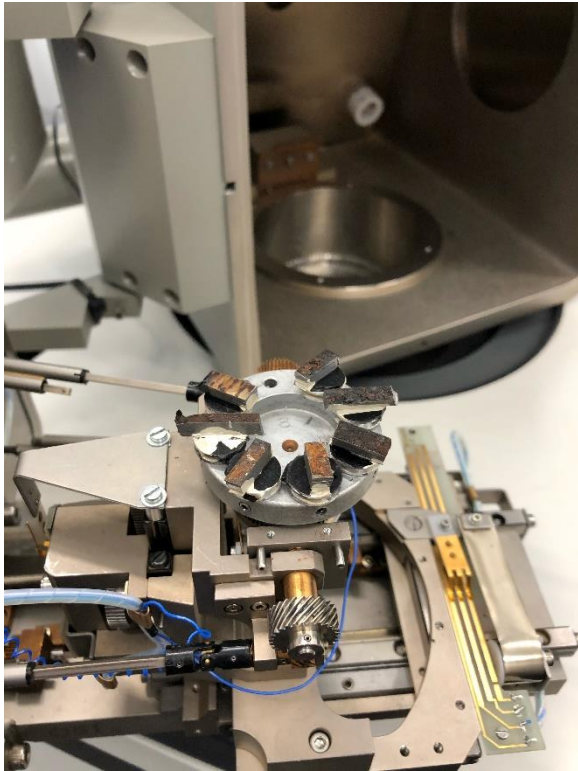
Figure 4.68 Sample preparation for EDX
