## Engineering Materials

### Materials and Manufacturing

The performance demands of the Dakar Rally place exceptional mechanical and environmental stresses on every component of a racing vehicle, particularly those within the drivetrain. During the fourth and fifth stages of the event, both team vehicles suffered complete drive shaft fractures, resulting in immediate loss of mobility and early retirement from the competition. The failures occurred despite the shafts being manufactured and assembled using the same design, processes, and specifications as previous successful iterations. This unexpected failure has led to a detailed engineering investigation to determine the underlying cause of the fractures and to identify measures that will prevent recurrence in future events.

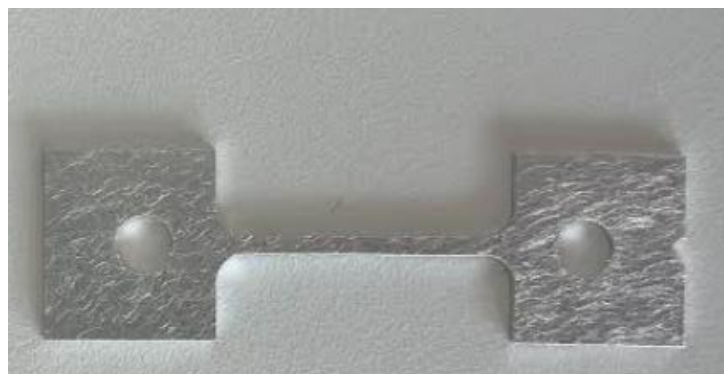
Figure 2 Aluminium Specimen

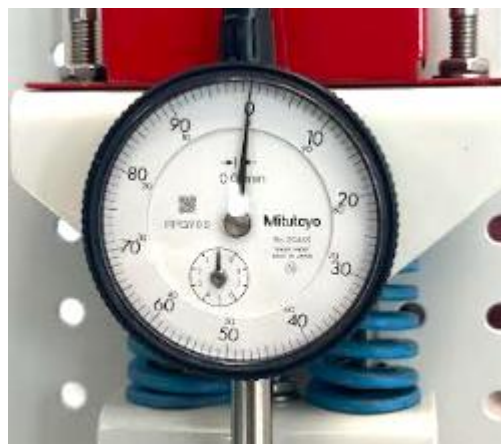
*Figure 4 Dial Gauge Zeroed*

To begin the aluminium specimen was placed in the chucks, which were then tightened using an Allen key. The dial indicator was then set to zero, this was done by adjusting load nut until the specimen had just begun to move, at that point the dial indicators outer case was turned until it was pointing at zero.

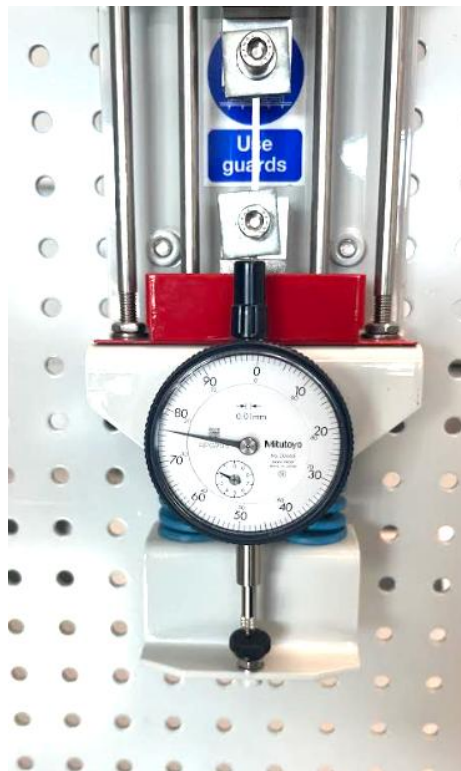
*Figure 6 Reading on Dial Indicator During Experiment*

The top nut was then turned by two markers, an equivalent value of 0.2mm, at which point the reading of the dial indicator was taken and recorded. This was repeated until the specimen broke.

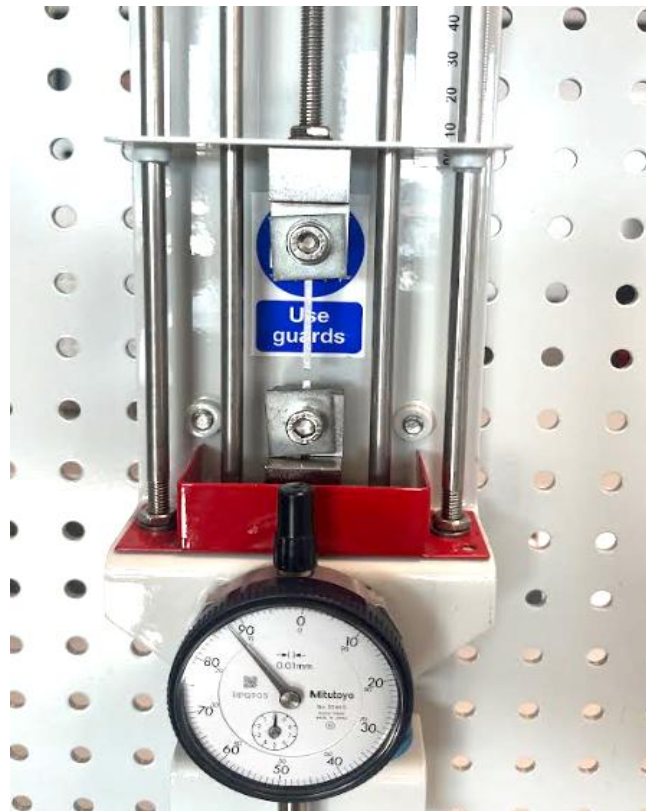
*Figure 7 Specimen Broken in Chucks*

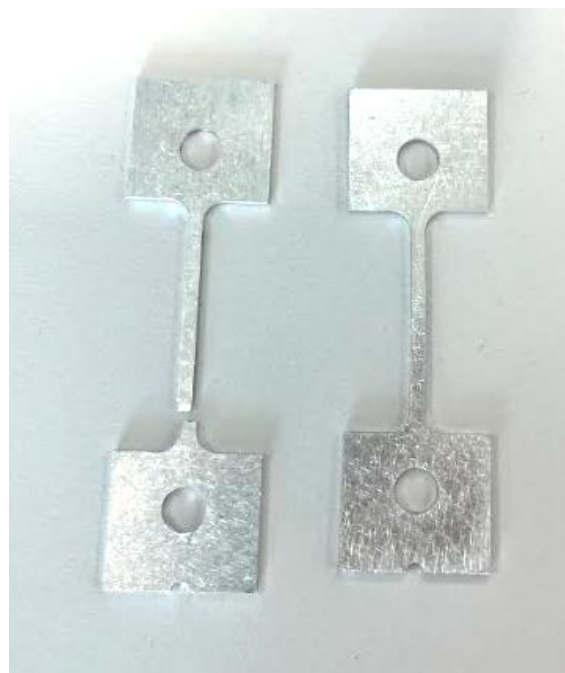
*Figure 8 Comparison of Broken and New Specimen*
