# Analysis of Debris Effect on Heat Exchangers

*School of Engineering*  
BEng (Hons) Mechanical Engineering

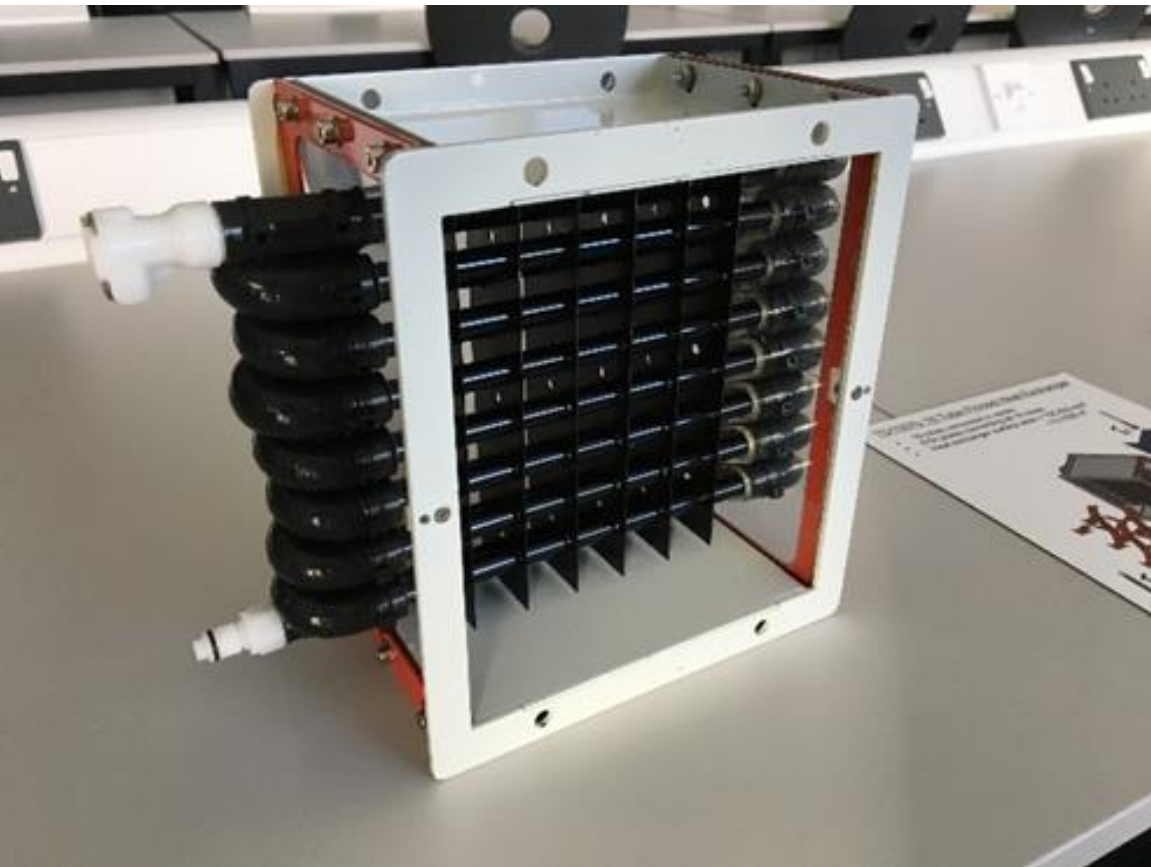
Pictured below is the 16 tube heat exchanger, a different design to the 32 tube used in the investigation.
