## **The wreck of the Dutch East Indiaman *Amsterdam* near Hastings, 1749**

### **An interim report**

**Peter Marsden**

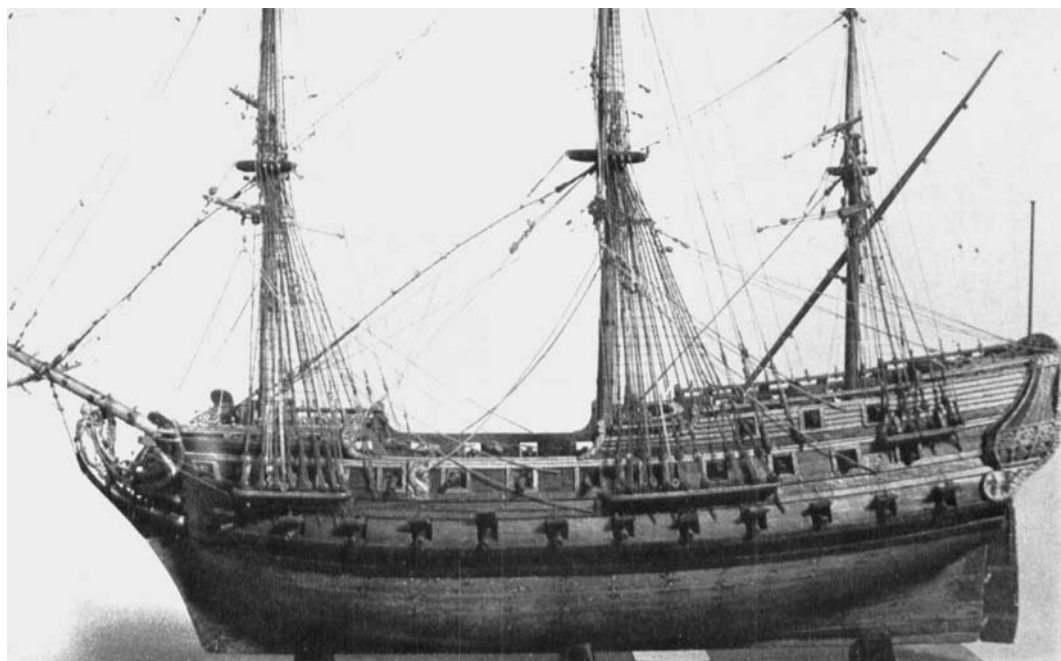
Figure 4. Early 18th century model of a Dutch East Indiaman, similar to the *Amsterdam*; now in the National Maritime Museum.

form, although there were variations in details (Fig. 4). No contemporary illustrations of the *Amsterdam* are known to exist.

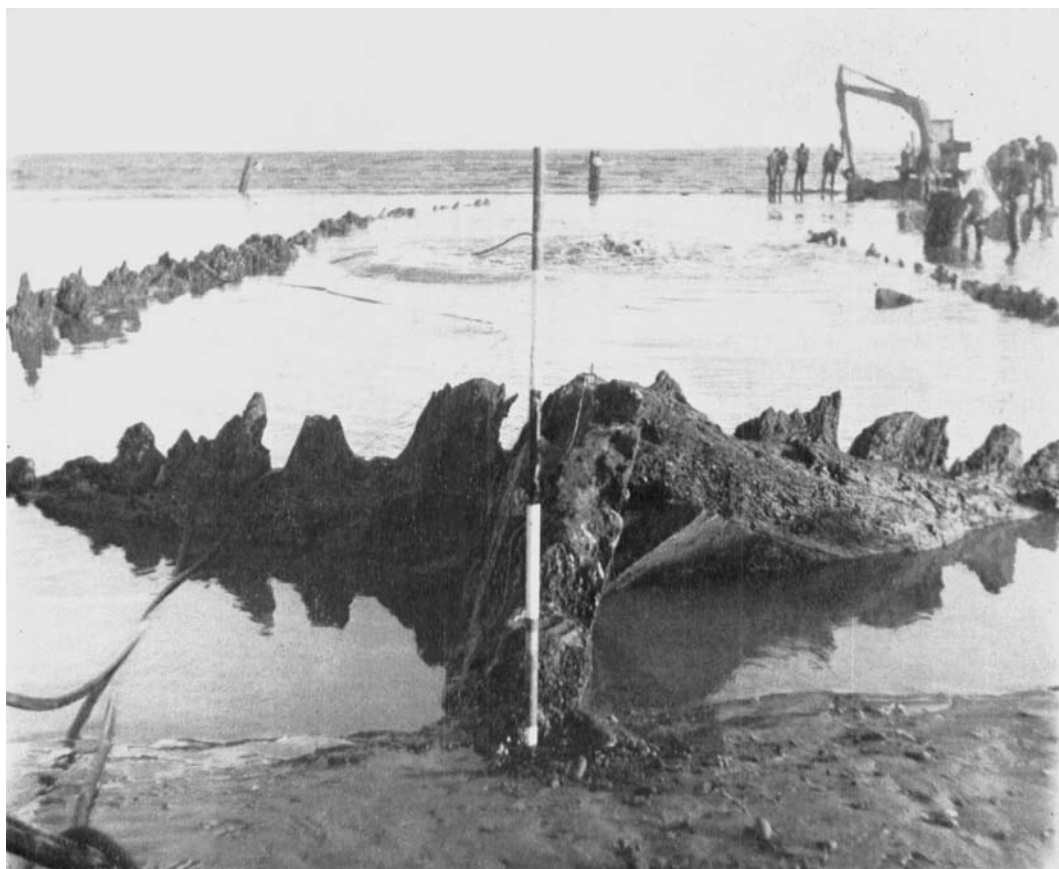
Figure 6. View of the bow showing the lean to the port side.

The ship is lying with her bow facing northwards towards the shore, and she has partly heeled over so that her port side is more deeply buried than her starboard side. This accounts for the unequal shapes of the two sides of the ship on the plan. The starboard side survives up to the level of the upper deck beams and knees which are shown on the plan, but the port side survives up to the lower parts of some of the upper deck gun-ports. As a result the port side deck beams and knees are buried in the sand, except at the forward end where the deck level rises above the beach.

Judging by the angle of the stem the ship has heeled about 18° from the vertical to the port side (Fig. 6). Also it seems that there may have been some hogging or twisting at the bow, or that one or both of the sides of the ship have been distorted by the pressure of sand. The bow has not sunk as deeply as the stern, indicating that a layer of rock harder than the clay and sand surrounding the ship, may have stopped the subsidence of the bow to a greater depth. On the other hand the stern, with its additional and larger decks above the upper deck, was much heavier than the bow and so was more likely to sink deeper.

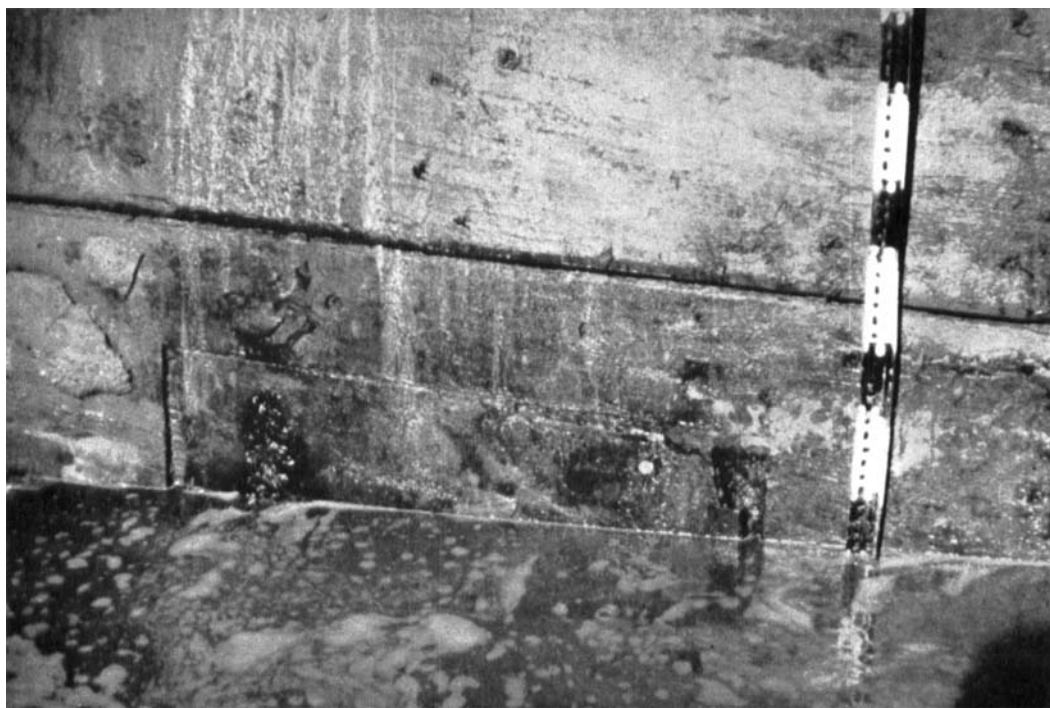
Figure 7. Upper part of a closed gun port of the lower deck on the port side. Scale in 0.1 m divisions.

copies of contemporary drawings of similar vessels kindly supplied by the Director of the *Nederlandsch Historisch Scheepvaart Museum*, in Amsterdam. This excavation was about 2 m deep and exposed the smooth carvel-built side of the vessel. There was no sheathing and no projecting wales between the upper and lower deck gun ports. Two lower deck gun ports were exposed, and both were found to be closed by their port lids (Fig. 7). The top of the lower deck gun ports lies 1.4 m below the bottom of the upper deck gun ports, and the ports measure about 0.65 m square. Holes found in the top of the port lid and in the planking above must be part of the arrangement by which the lid was hinged and raised.

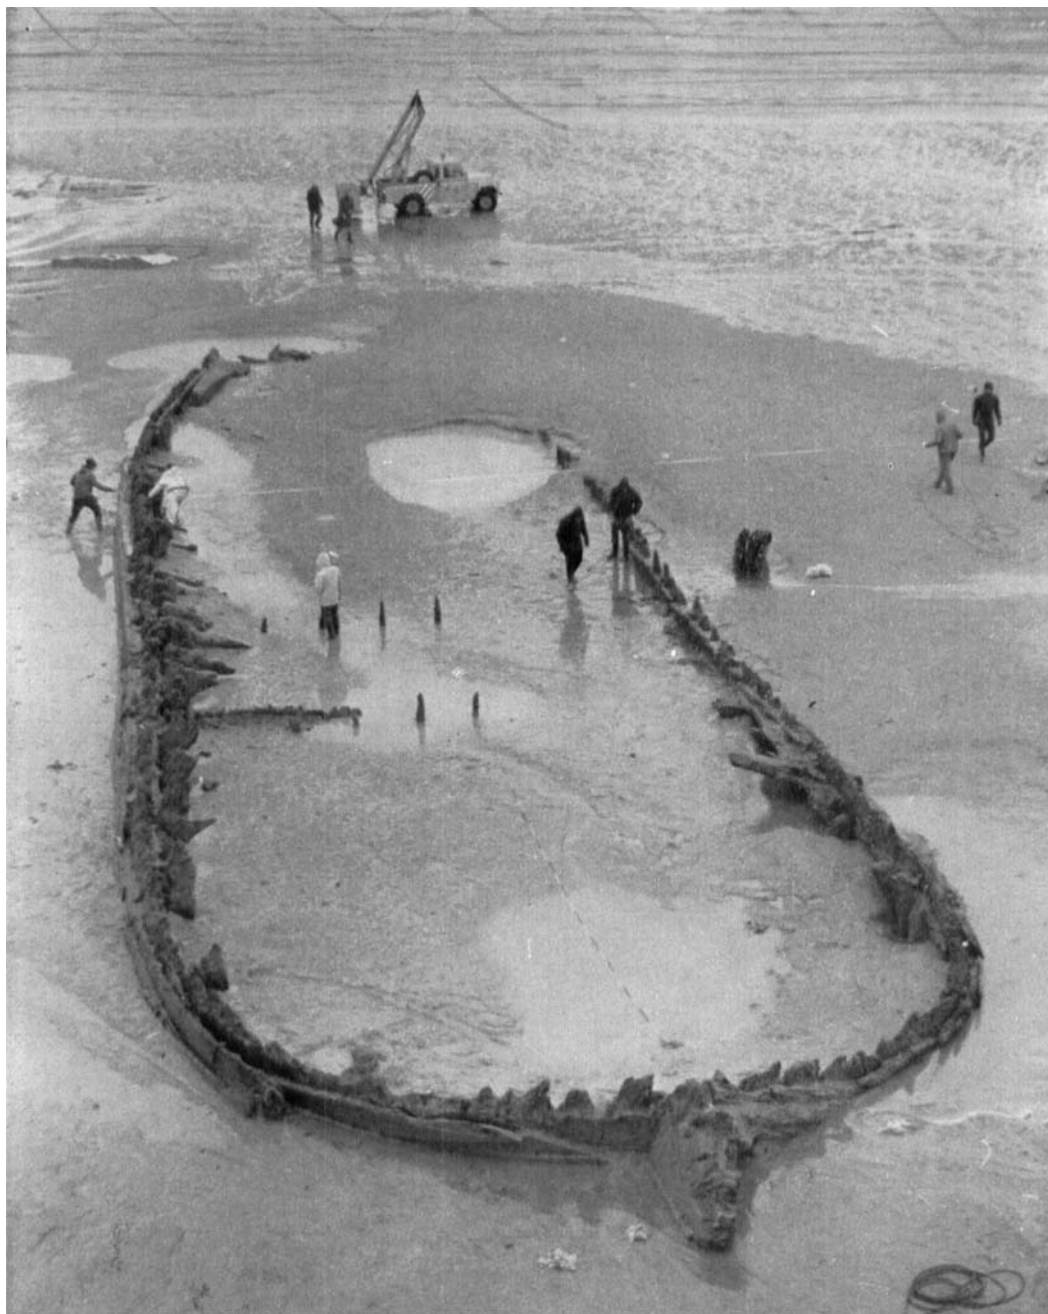
Figure 8 View of *Amsterdam* looking aft, showing the transverse partitions, and just outside the ship the end of the mast.
