# Coastal Regeneration at Llanelli, South Wales, UK: Lessons not Learned

PHILLIPS, M.R., POWELL, V.A. AND DUCK, R.W., 2009. Coastal regeneration at Llanelli, South Wales, UK: lessons not learned. *Journal of Coastal Research*, SI 56 (Proceedings of the 10th International Coastal Symposium), 1276 – 1280. Lisbon, Portugal, ISSN 0749-0258.

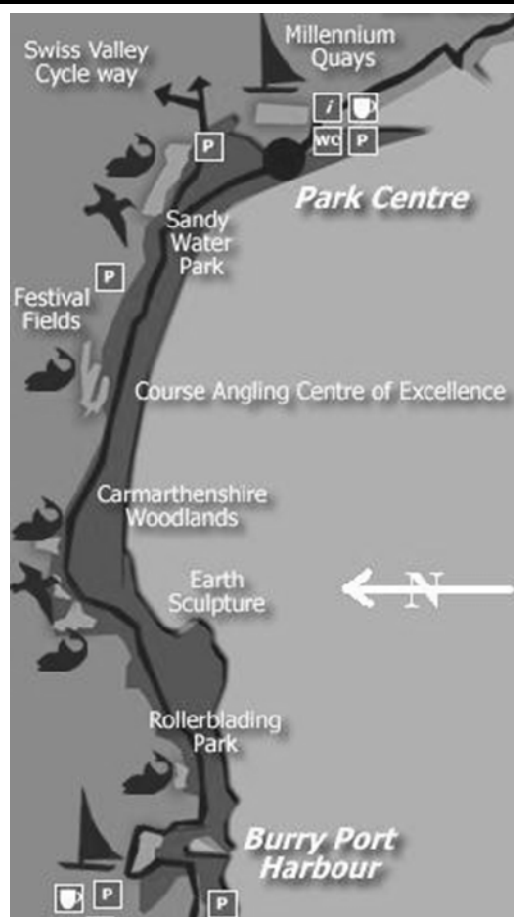
Figure 3. Millennium Coastal Park

The MCP (Figure 3) gives views over the Burry Inlet and Gower Peninsula (Figure 2). Pulverised Fuel Ash (PFA) was used for ground remediation, landscaping, engineering fill for bridges

and lime cement for roads (UKQAA, 2003). The Earth Sculpture, 'Walking with the Sea', was formed from PFA and highlights environmental benefits of reuse rather than disposal. It incorporated newly constructed beaches on its western and eastern flanks and the sculpture was designed to be seen from land, sea and air. Silt from Burry Port Harbour and sewage sludge facilitated rapid natural re-vegetation (UKQAA, 2003). It is located on the coastal path between Burry Port and Llanelli (Figure 3) and this coastal section previously had no hard defences.

The Earth Sculpture (Figure 3) experiences westward river currents and eastward sea currents. The design meant it protrudes from surrounding land into the sea, making it vulnerable to attack. Since its construction the structure has eroded but is not yet irreversibly compromised. The newly constructed beach to the east shows evidence of erosion with PFA appearing as black streaks on the sand. On completion there had been gentle gradients from the hinterland onto the beach but these are now steep and the beach has increased in width. On the western flank, there are sections that have >2m drop onto the beach. In that March 2007 storm, sections near the Earth Sculpture retreated by 10m (CCCESCTFG, 2007a; CCCESCTFG, 2007b). Concrete fence posts erected to prevent people falling over an ever increasing cliff edge, now lie at intervals along the beach, some 2m from the sculpture base. There is evidence that the naturalness of this site is starting to be compromised by rock revetments constructed to protect the coastline. However, if this section was allowed to retreat then more of the coastal path would be lost.

The Earth Sculpture needs both structural and aesthetic protection. Despite treatment, the land may still contain contaminants and current erosion rates are exposing PFA layers used as landscaping material. From a large-scale perspective, if the land had not been modified to form the MCP then no contaminants would have been treated. However, the Earth Sculpture shoreline has been extended into the sea and coastal processes do not support its location. Direct and refracted wave attacks combined with strong estuary currents are eroding the sculpture from both west and east. Protection and/or sediment recharge needs detailed consideration, including sediment size/material and allowable retreat rates. Current management has discreetly placed small gabion cages and igneous rock but should consider future retention of shape and naturalness.

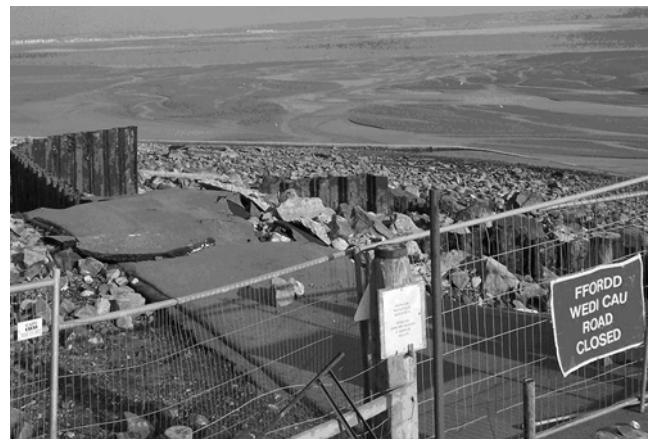
Figure 4. Coastal path failure

2007a) to the detriment of the adjacent coastline. The coastline immediately east is significantly affected by this loss. Figure 4 shows the impacts on the coastal path following a severe storm in March 2007. Prior to its construction, the beach was several metres seaward of the path, which illustrates the volatile and unpredictable nature of this coastline. It has subsequently been protected by rock armour to reduce further storm impact.

Infrastructure at Burry Port is defended with rock armour and coastal structures. Harbour defences result in sediment loss from the system and continuation of current practices will result in further adjacent beach depletion. Therefore it is suggested that dredged material from the harbour channel is used to recharge beaches to the east. This will be compatible with the size of material already on the beach, a sustainability requirement identified by CIPRIANNI *et al.* (1999) and MICALLEF *et al.* (2001). Furthermore, the originally planned flushing lock gates should be installed to reduce dredging costs and sediment losses. The low-lying coastal path is too close to the sea and original design problems are accentuated during storms. Its location should have been higher and further from the coastline and if it is not moved, further failure, as shown in Figure 4, is inevitable. In the short term, maintenance and observation regimes are needed to protect the path (CCCESCTFG, 2007a).

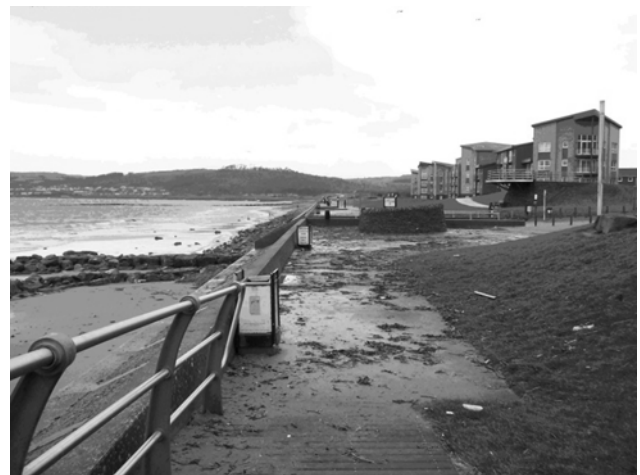
Figure 5. Promenade post March 2008 storm

Llanelli's redevelopment removed industrial ruins and provided a flat complex behind the beach for residential and commercial development, the nearest located within 8m of the seawall (Figure 5). However, severe storms are endangering these homes (SWEP, 2007), including when Millennium Quays (Figures 3 and 5) lost part of its roofs, forcing evacuation of new residents (LLANELLI STAR, 2005b). The necessity for a roof design change half way through construction highlights poor design considerations for this shore-side development. The MCP was hit by severe high tides and storms in both March 2006 and March 2007, which led to considerable seawall and promenade damage (Figure 5; CCCESCTFG, 2007a).

Siltation of the Loughor Estuary (Figure 2) after the collapse of training walls further up river caused movement of the nearshore channel and since 1970, has caused considerable damage to Llanelli beach. Any future management plans would need an assessment of the nearshore channel's movement. The March 2008 storm event detached sections of the main dune formation and distributed them along the beach. The dunes were not greatly impacted by this loss which protected part of the seawall. Currently Llanelli beach has many hard engineering structures that are incapable of total storm protection. In 2001, these defences protected up to £5M of assets from erosion and flooding, but risk increases as new housing is built. Defences in place before the MCP development now protect further infrastructure (Figure 5). Additional armour and sediment have been used to protect the seawall base from undercutting, which is not uncommon (SIMM, 1996). It is traditional for Anglo-Welsh coastlines to manage through hard-engineering holding-the-line practices (TURNER *et al.*, 2007), but tourists and ecologists prefer a more natural soft-engineered approach (ERGIN *et al.*, 2006; TUDOR AND WILLIAMS, 2006). It would no longer be practical to remove Llanelli's seawall especially due to the height difference between the promenade and foreshore. The majority of the seawall is >3m above the foreshore and near the railway line, reaches a maximum height of 3.92m. This height variance suggests the foreshore needs to be higher. By covering the base of the seawall with igneous rocks, wave impacts are reduced but for effective protection, greater volumes are needed.
