# **Ultrasonic Attenuation Coefficient Determination and Probability of Sizing Analysis**

Student number: 2322213  
Student name: Jingrong Wang  
Date: 15.12.2024

# 1. Part 1: Ultrasonic Attenuation Coefficient Determination

## **2. Part 2: Through Wall Sizing Accuracy Analysis**

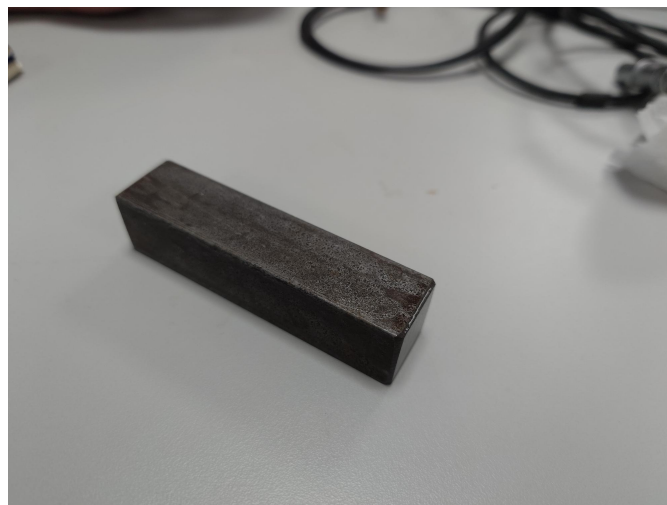
Figure 1 Mild steel (Sean D, 2024)

1. Mild steel rectangular block

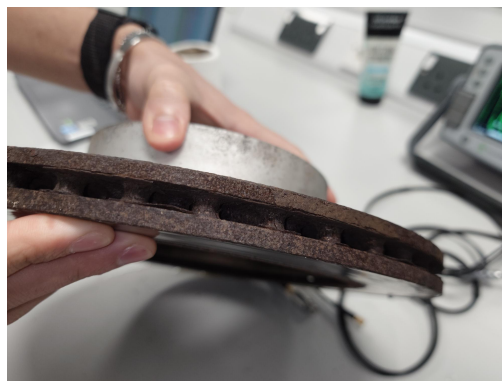
Figure 2 Brake disc (Sean D, 2024)

2. Brake disc

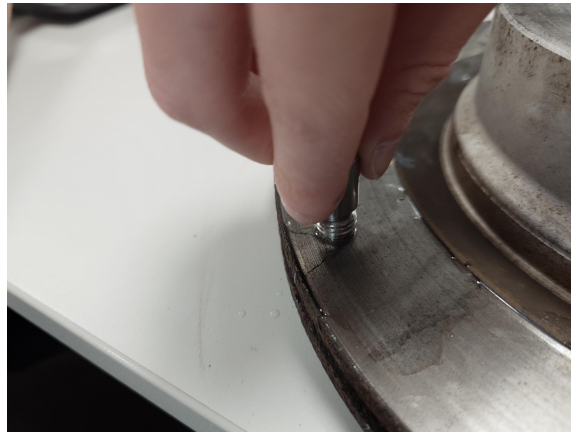
Figure 4 Ultrasonic probe (Sean D, 2024)

### 4. Zero-degree, 5 MHz ultrasonic probe
