# Is Basalt Fibre Reinforced Polymer (BFRP) a viable replacement for steel in reinforced concrete applications?

An Experimental evaluation of the mechanical behaviour of BFRP and steel reinforced concrete beams using three-point bending tests

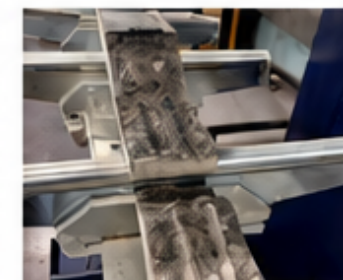
### Evidence of bond deterioration

Clean separation and limited concrete adherence around the BFRP bar indicated partial debonding, contributing to the sudden loss of load capacity
