## **‘The Monk’s Boat’—a Roman-period relic from Lough Lene, Co. Westmeath, Eire**

**P. O hEailidhe**

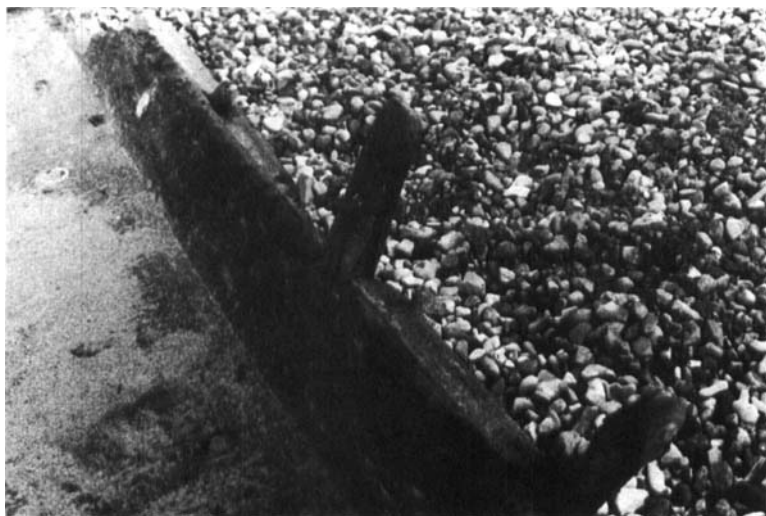
Figure 3. Bottom and chine of the boat showing tenons *in situ*. (Photograph: National Museum of Ireland.)

and, at their centres, are 65 mm wide and 20 mm thick, tapering towards each end. This taper can be seen along both edges and on the outboard face, the other face being quite flat from end to end. This is apparently dictated by the slight sheer of the side strake. Eight of these tenons remain *in situ* and a number of others were found detached nearby. When the tenons were in position and the joints closed two pegs or dowels were driven through each tenon, one above and one below the seam. These pegs are 15 mm thick at one end and 10 mm at the other, and are 70 mm long, passing right through the thickness of the strake. Some of those which remain *in situ* were driven from the inside and others from the outside of the boat. In all the scarfs of this boat there are traces of a white substance which was used as an adhesive or luting, a sample of which has been scraped off for identification (see below).

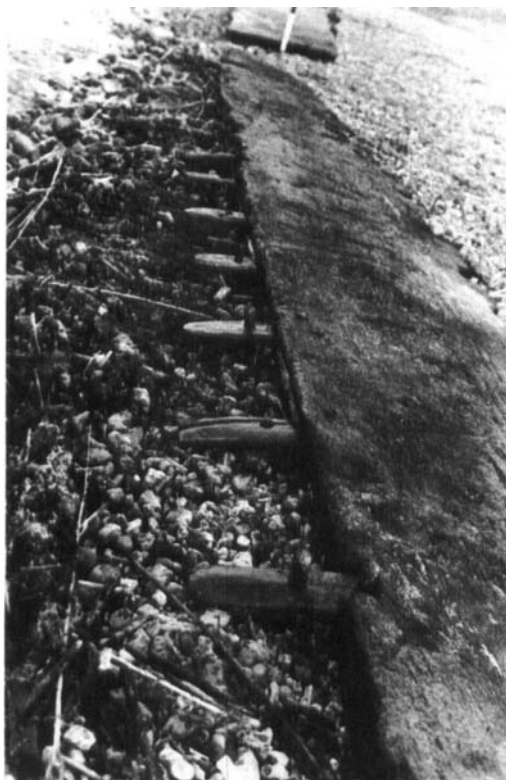
Figure 4. Detached strake with pegged tenons protruding from it. (Photograph: National Museum of Ireland.)

The sides were secured to the bottom by a series of keys or tenons fitting into corresponding mortises in both members. These mortises are 65 mm long, 20 mm wide and 130 mm deep, and are irregularly spaced along the line of the V-shaped groove in each member. There are traces of 23 along one side of the boat, 17 along the other, and 18 along the lower edge of the surviving strake. The shortest distance between two mortises is 110 mm and the longest is 360 mm, the overall average being 276 mm. This irregular spacing enabled the detached side strake to be correctly fitted into its original position on the boat (Fig. 4).

The existing side-strake is 6.5 m long and was found lying beside the bottom portion. The greatest width is 600 mm at the centre, tapering to 300 mm at one end and 130 mm at the other (Fig. 4). It is 70 mm thick along the edge which was scarfed to the bottom where there are remains of 18 mortises in which seven tenons remain *in situ*. (Two of these were loose and have been removed for safety.) In addition to the pegs which secure each tenon there are four similar pegs spaced between the mortises.
