# THE EVOLUTION OF A LOCAL PHYSICAL LANDSCAPE

Rebecca Macfarlane

BSc Environmental Conservation

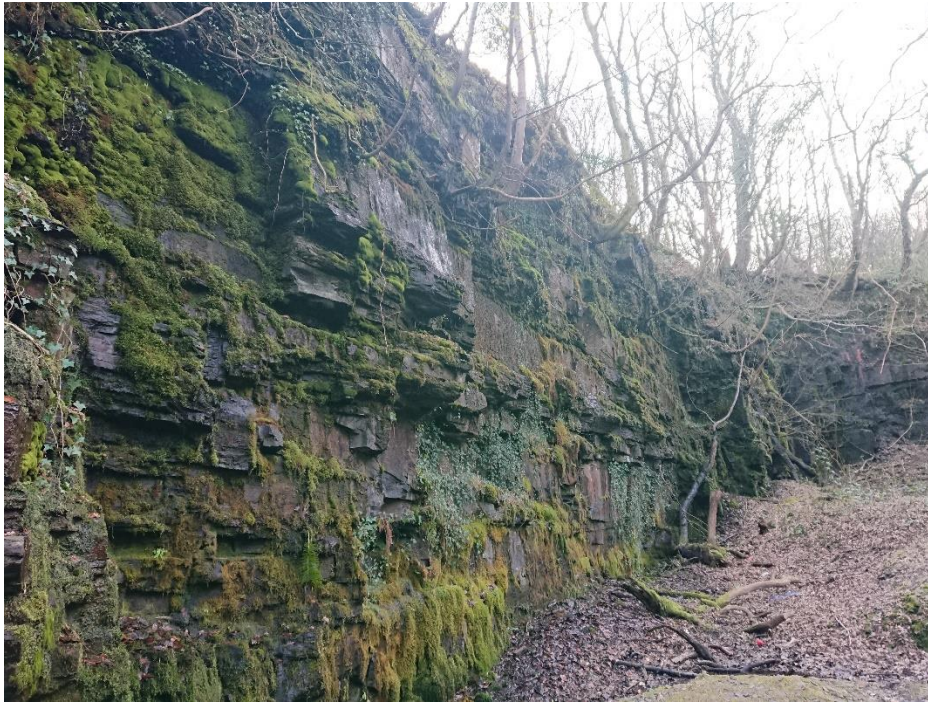
The geological formations from the fault lines can be traced partially down through Swansea valley and the location site itself even though the rock type itself changes; the gritstone and limestone found higher up towards Cribarth is not found at the location site. As can be seen in Figures 2 and 3, the rock type has change and is now pennant sandstone, showing that a fault line will continue regardless of the rock type and finding no resistance or deviation in route.

*Figure 3: Quarry site off bridleway at location site, image author's own 2021*

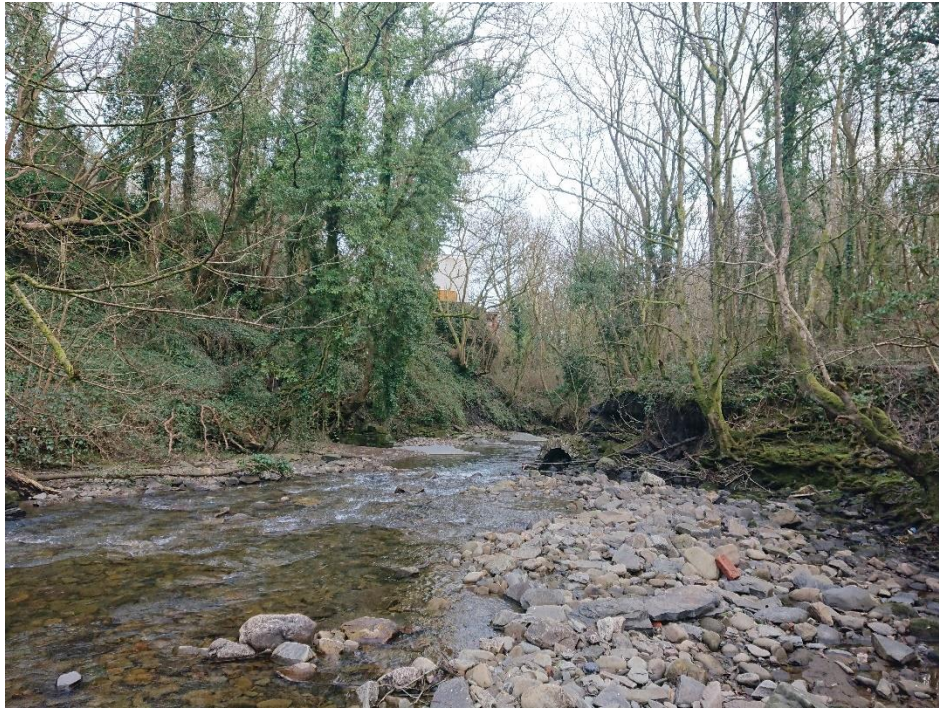
The glaciofluvial ice contact deposits shown on the map in Figure 4 provide further information for evidence found of the glaciation at the location site. The riverbed is littered with different rock types which is typical of glacial flow (as can be seen in Figure 8).

*Figure 8: Glacial deposit at location site, image author's own 2021*

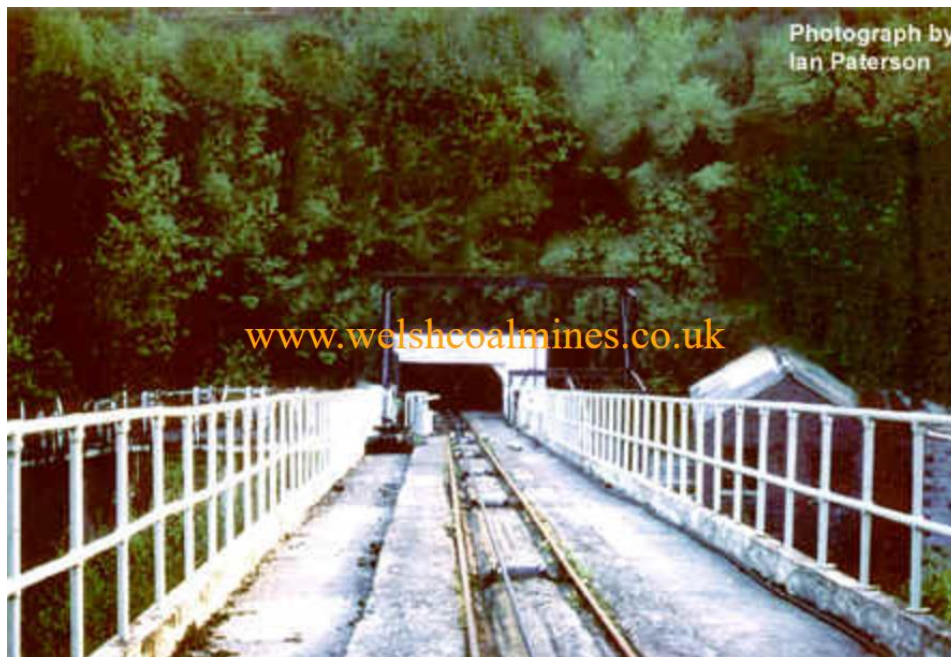
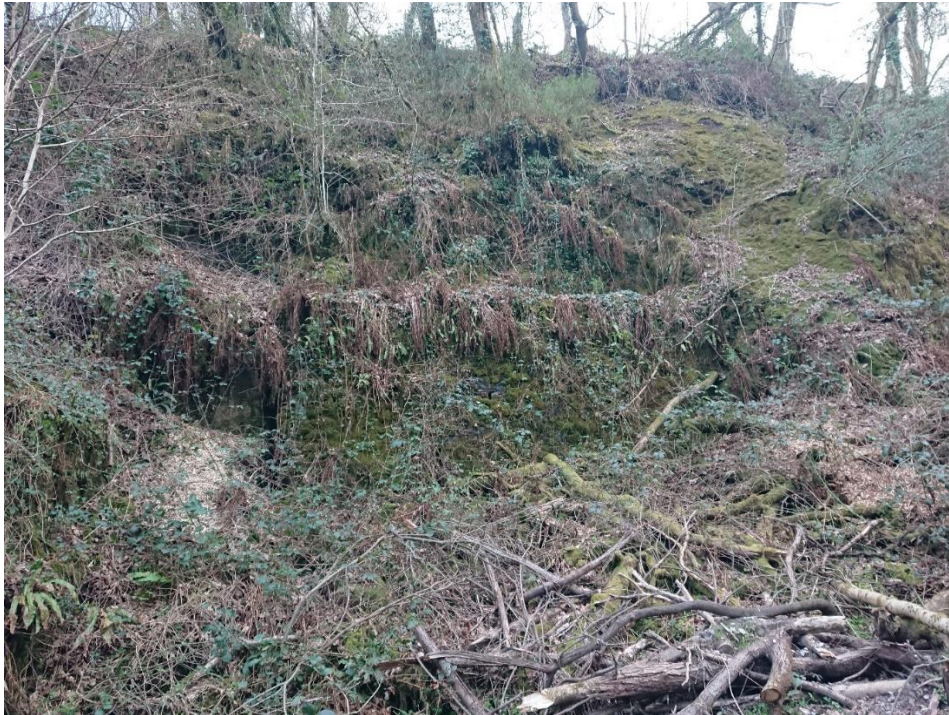
Openly operating from 1863 until 1961 and then used for air venting until 1978, the Clydach Merthyr Colliery, or 'Nixon's Mine' (see entrance in Figures 9 and 10), was known for high-quality coal with low ash content (Swansea University Archives, nd) and before its official closure by the National Coal Board, it was estimated to produce an annual output of 115,000 tons. It was also notable for two other reasons- as it was virtually gas free, carbide lamps were commonly used, and also had an underground blacksmith shop and boilers to raise steam for the haulage engines (Paterson, nd).

The mines were renowned for having a strong sandstone roof and needing little in the way of support; however, from carving into the rock, the mining process has resulted in the landscape now being unstable in places. Evidence of mining activity is littered across the location site with remnants of buildings, blocked entrances, machinery, and most notably changes to the soil profile and water quality here heavy metals are now present.

Figure 9: Nixon's Mine entrance, Paterson 1970

Figure 10: Nixon's Mine entrance, image author's own 2021

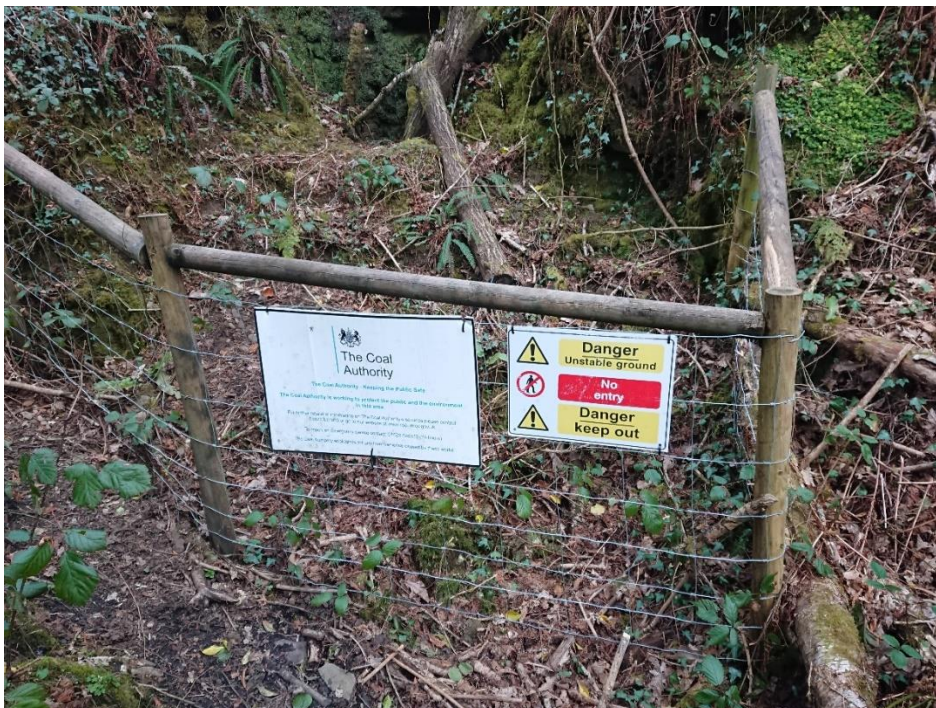
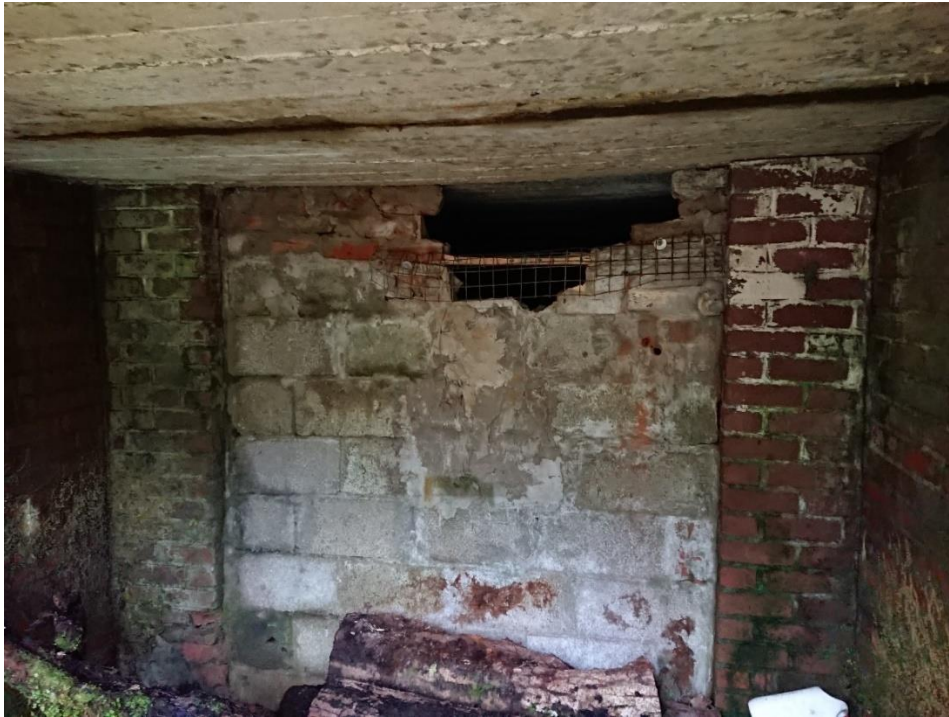
Upon closure and the site being taken over by the RSPB, all historical mine remains are now being maintained by the Coal Authority (GOV UK, 2021). As can be seen in Figures 11 and 12, this can range from fencing off areas and leaving signs to warn the public of unstable ground to blocking off more obvious entrances entirely. Where some of these have also fallen into disrepair or have been damaged by the public, common pipistrelle bats (*Pipistrellus pipistrellus*) have started now started to roost in the tunnels (such as Figure 12).

Figure 11: Sealed mine entrance, image author's own 2021

*Figure 12: Sealed mine entrance, image author's own 2021*

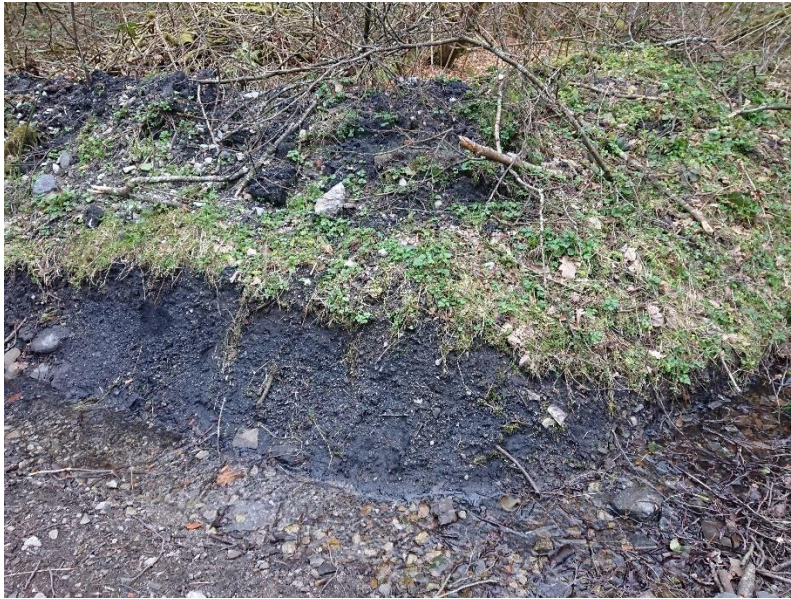
Taking the natural and anthropogenic influences into consideration, the soil profile of the location has experienced significant negative change in a relatively short period of time. Areas will have remained dry and well-draining to maintain the established beech woodland in the upper regions, however further down towards the river (as can be seen in Figures 14 and 15) will be contaminated with heavy metals from the coal mining (Guo-li, et al., 2008). Areas that have been cleared of beech and planted with alternative species to encourage phytoremediation are still struggling and seeing little in the way of positive results.

*Figure 14: Section of riverbank at location site, image author's own 2021*

perspective, continuing with soft engineering techniques such as regular planting and coppicing to protect the riverbank along the location site would reduce the risk of erosion and flooding. Further downstream into the village this is obviously harder with the structures in place, however effective land management would allow for some relief; the land adjacent is used by the village youth rugby team. By removing concrete walls built to protect the fields from flooding, this space could be used as a new flood plain and the rugby team be relocated, however it is understandable that there would be a reluctance for a plan such as this to be acted on given the cultural importance of the sport and old training grounds.

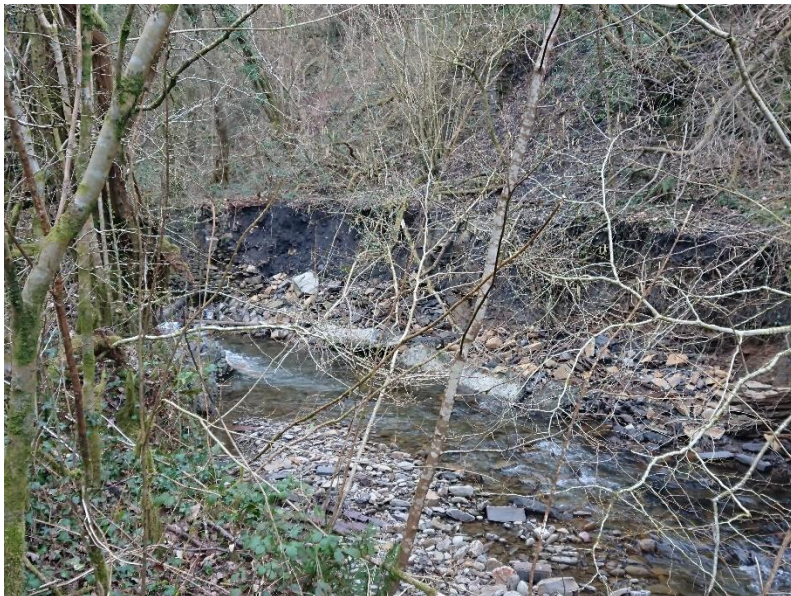
*Figure 15: Collapsing riverbank at location site, image author's own 2021*

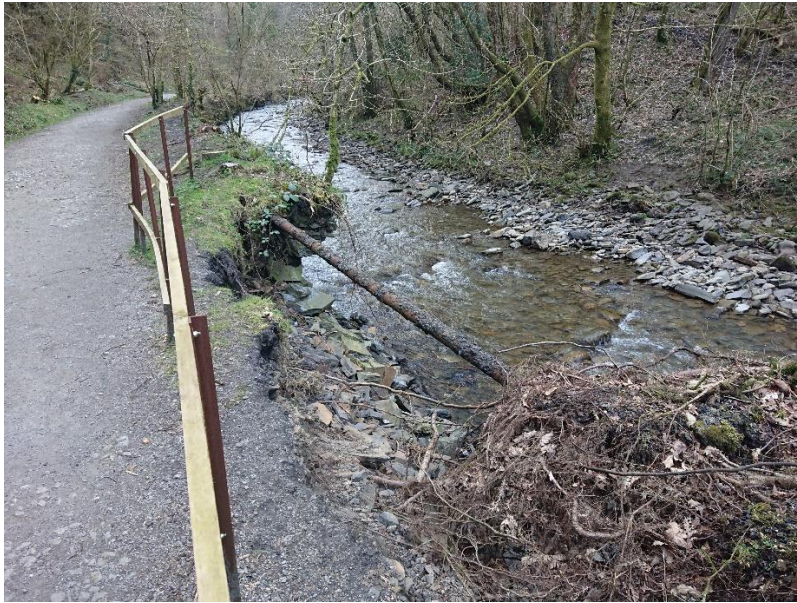
Important indicators for environmental change, the evidence of a variety of fossils in the area is important for conservation of the area. Notably these would not have to be removed, but slope stabilisation to protect the riverbank after the extensive coal mining is required. Trees that have been planted in in the years since the site closure also need frequent coppicing to ensure they do not grow beyond the ground's capacity; with the soil profile changed from the mining, the ground around the riverbank is still quite loose and unable to support larger trees, meaning large sections have collapsed under their weight in recent years. Frequent coppicing will protect the riverbank, the shale and fossils in the river itself, encourage new shoot and decomposer growth (encouraging soil remediation), provide habitats for burrowing animals, which will in turn encourage more predatory birds back into the area. As can be seen in Figure 16, without regular maintenance, the riverbank can easily collapse and so work is still required to stabilise the area to make it both a sustainable habitat and a viable recreation space. Arguably there may eventually come a time where the needs of one will outweigh the other, but assessments on biodiversity and prolonged conservation efforts would need to be considered for an effective decision to be made in that instance.

Figure 16: Further collapsing riverbank at location site, image author's own 2021
