Fracture and Fatigue failures of products and components in service

University of Wales Trinity Saint David  
L6 Material Science ACDA 6016

Ordnance, Munitions and Explosives Degree Apprenticeship  
Academic Year: 2025 - 2026

## 4 Case Study – Bulk Carrier Intermediate Propeller Shaft Failure Analysis

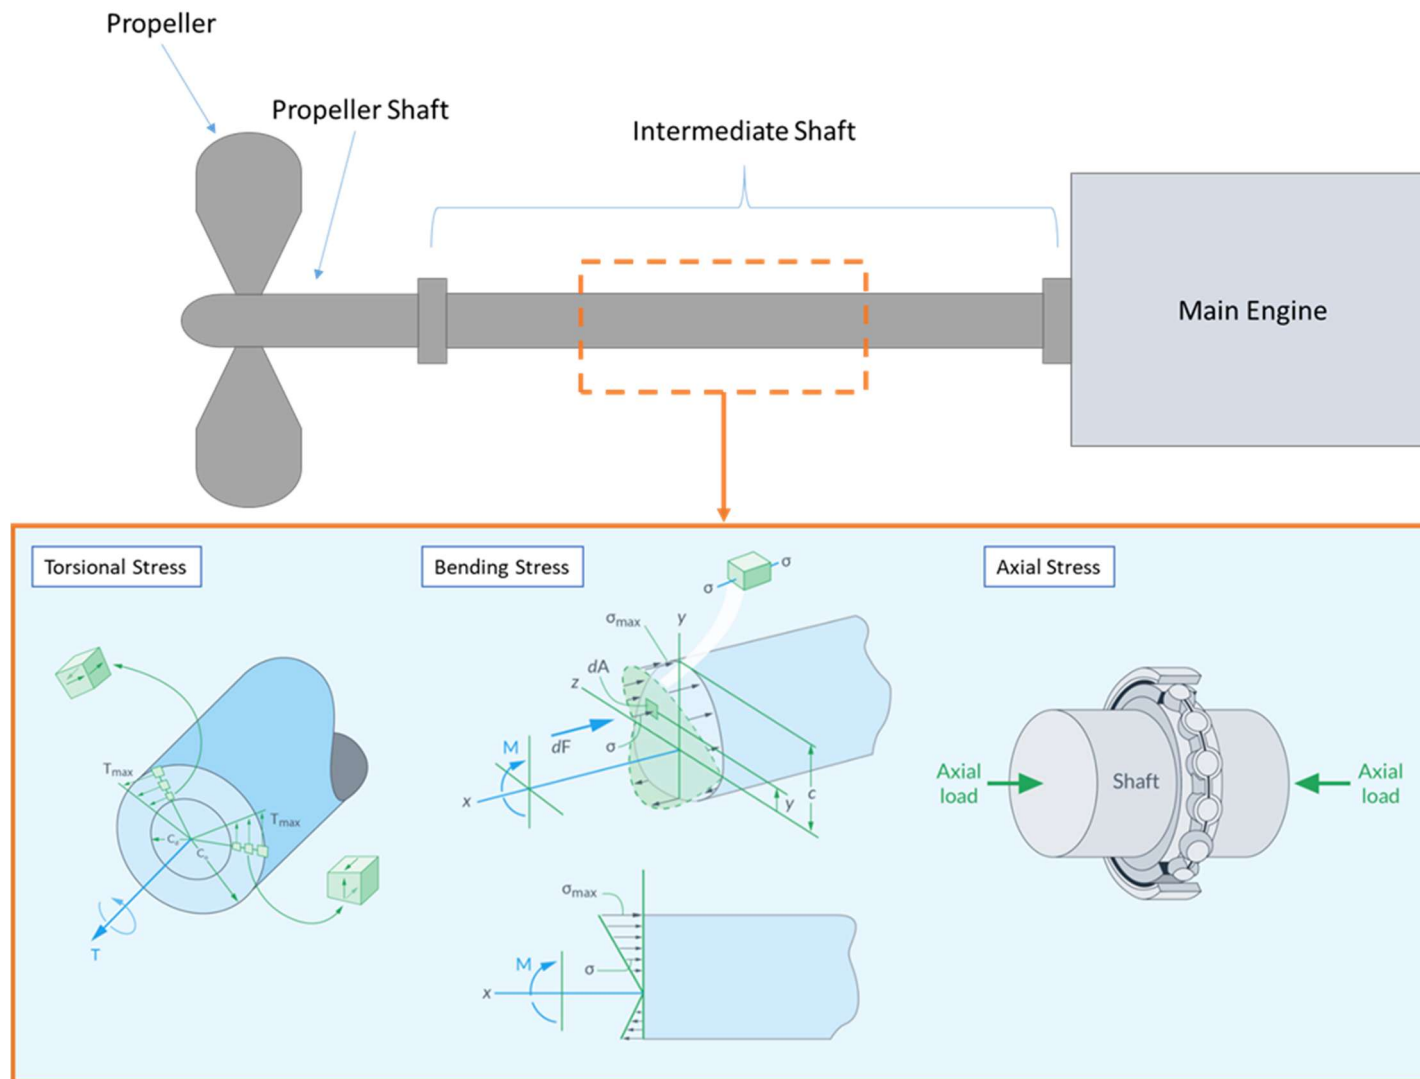
fluctuating loads comprising of bending and torque of various degrees of stress concentration [2]. Figure 2-1 [3] illustrates the stresses a rotating propulsion shaft undergoes during navigation, where total stress ( $\sigma_{total}$ ) can be expressed as [4]:

**Figure 2-1 - Combined Loading Conditions Acting on a Ship's Intermediate Shaft During Propulsion**

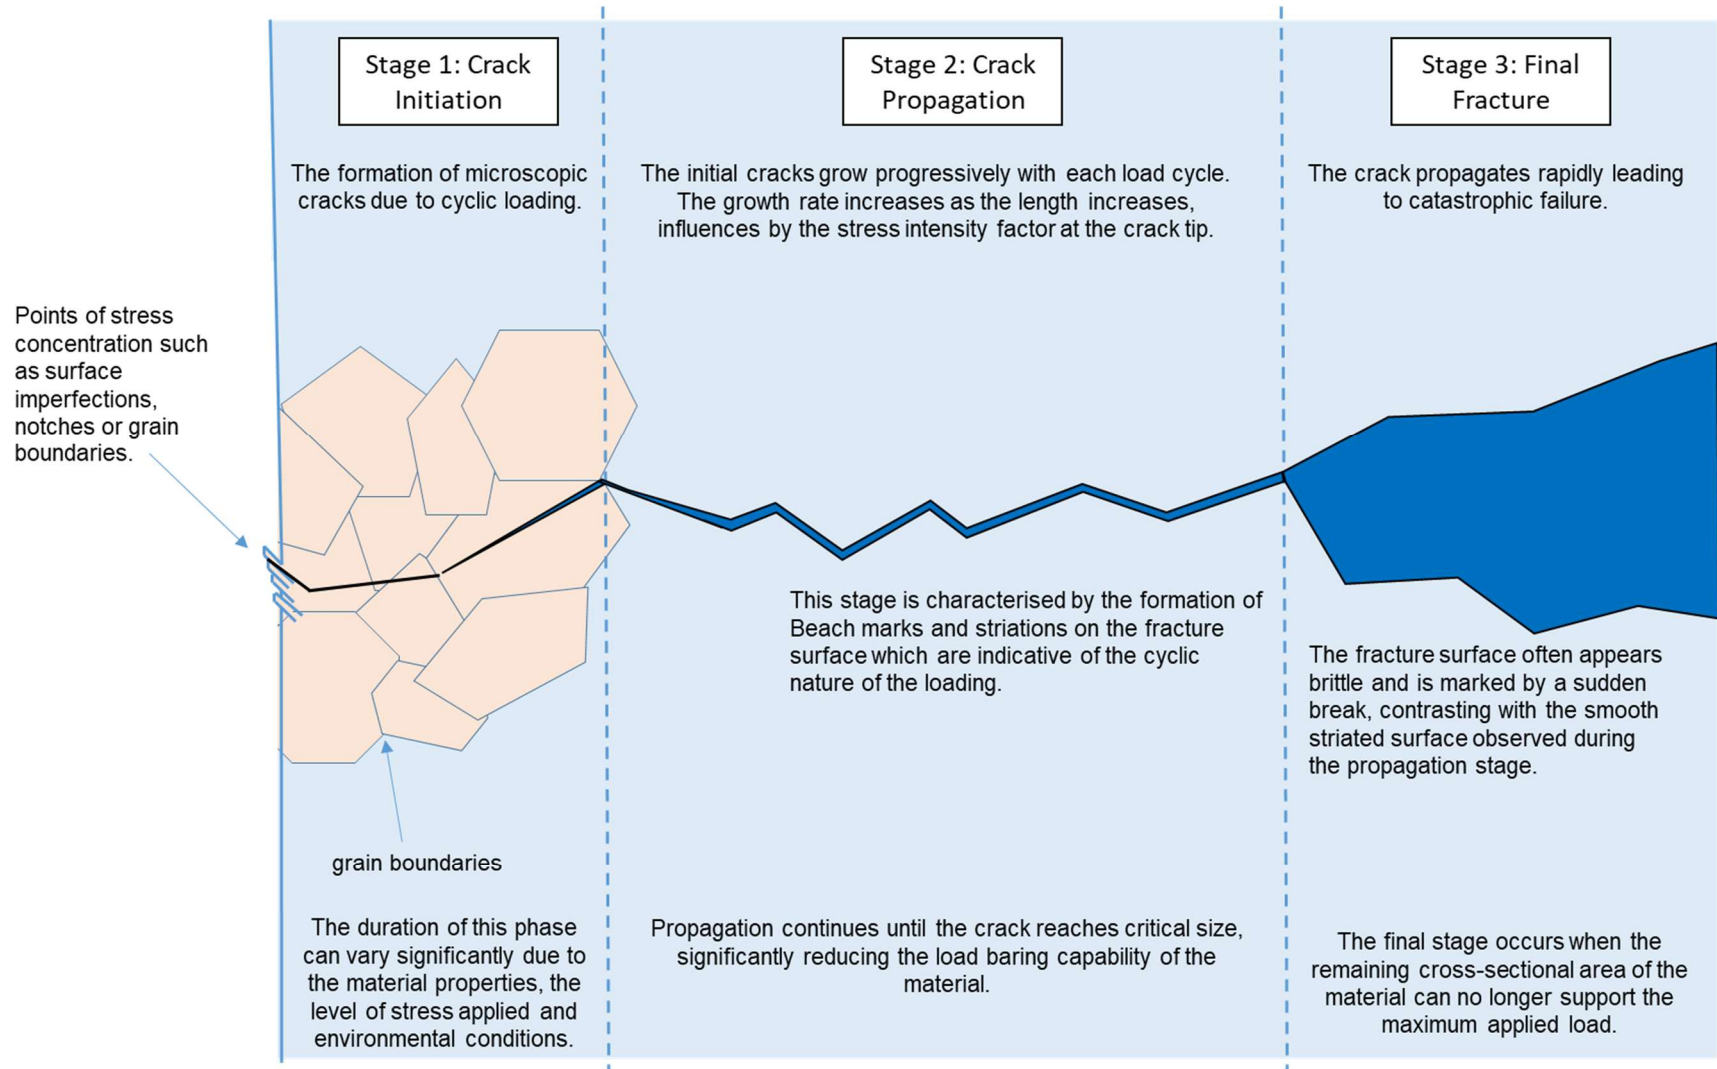
Fatigue occurs when materials are subjected to dynamic and fluctuating stresses [6] over a period of time. Due to repeated stress cycling, it is possible for failure to occur at a stress level considerably lower than the tensile or yield strength of a material. The three stages of fatigue presented in Figure 2-2 are:

**Figure 2-2 - Three Stages of Fatigue**

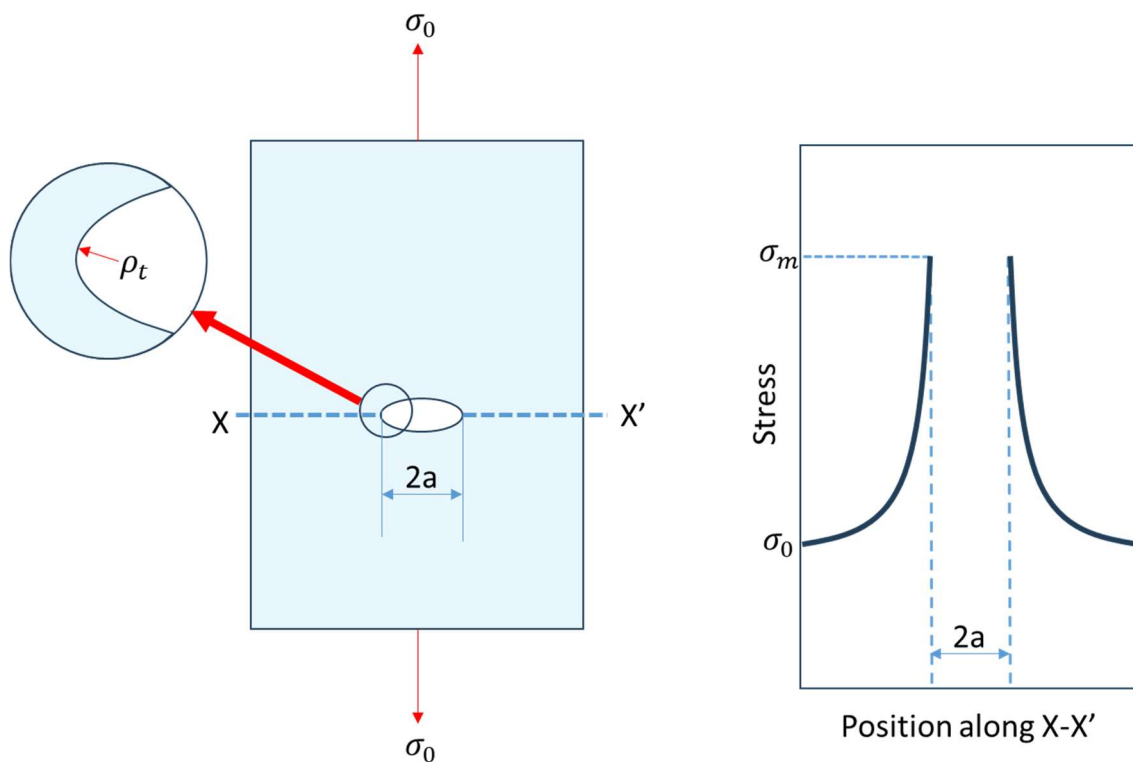
Microscopic defects, often called stress raisers, play a key role in fatigue failure as they create localised regions of elevated stress [6]. This phenomenon is demonstrated in Figure 2-3 which shows that the magnitude of localised stress decreases with distance from the crack tip. If it is assumed that the crack is similar to an elliptical hole and the load is applied perpendicular to the crack, the maximum stress  $\sigma_m$ , at the crack tip can be approximated by [5, 6]:

**Figure 2-3 - Schematic Stress Profile Along the Line X-X' Showcasing Increased Stress at Crack Tips, Recreated From [6]**

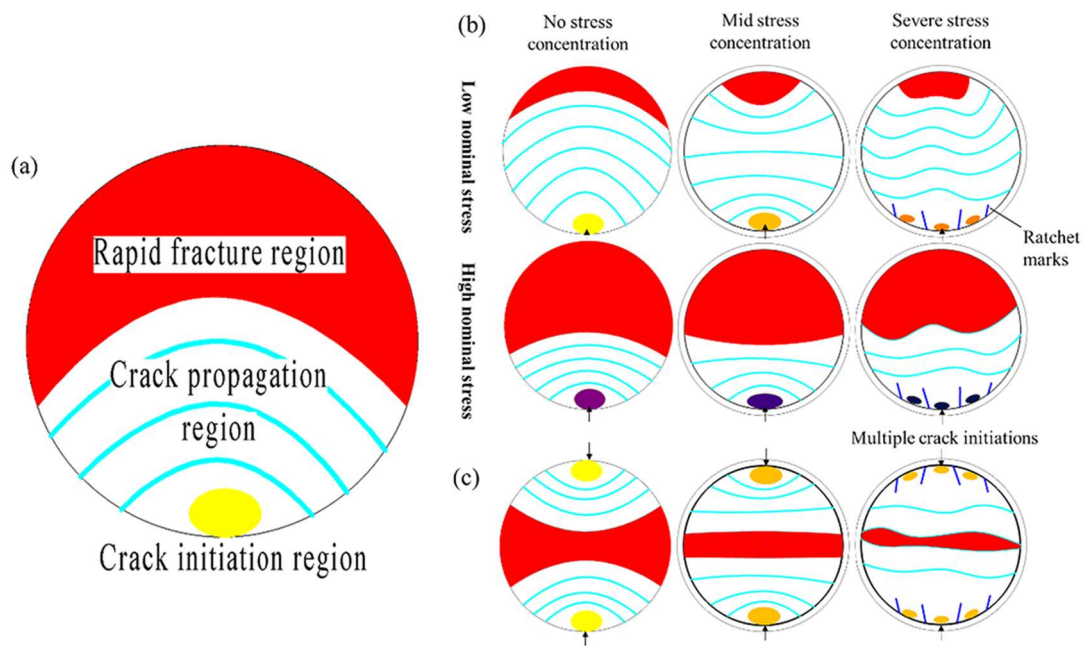
The relative positions and structure of these regions are closely related to the cyclic loading acting on the shaft [2] as illustrated in Figure 2-4. The presence of beach marks is a key identifier of high-cycle fatigue and can highlight crack initiation points. This area is typically smooth and flat, contrasting with the rough, brittle texture of the rapid fracture region [2] as shown in Figure 2-5. Ratchet marks also indicate multiple initiation points and areas of high stress concentration [7].

**Figure 2-4 - Macroscopic Characteristics of Fatigue Failure Highlighting (a) The Three Regions Under (b) Unidirectional Bending and (c) Reverse Bending Fatigue [2]**

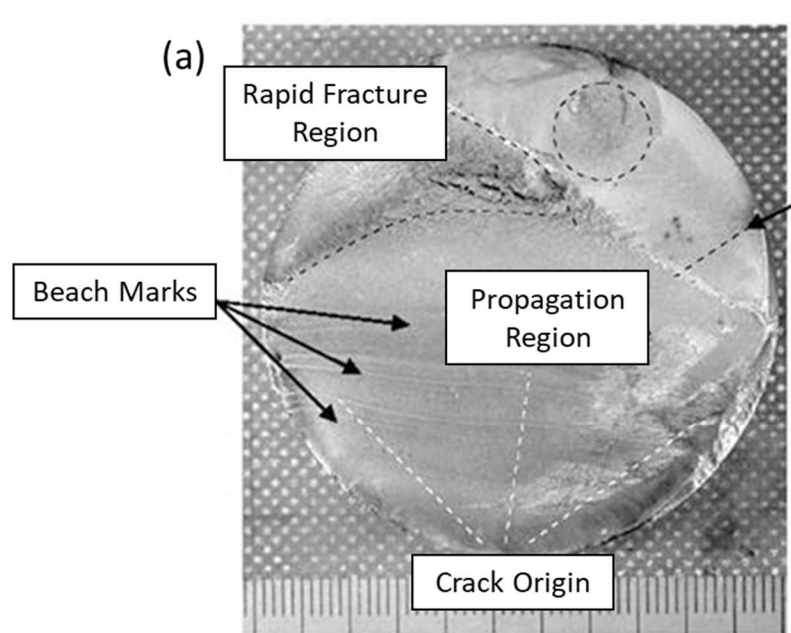
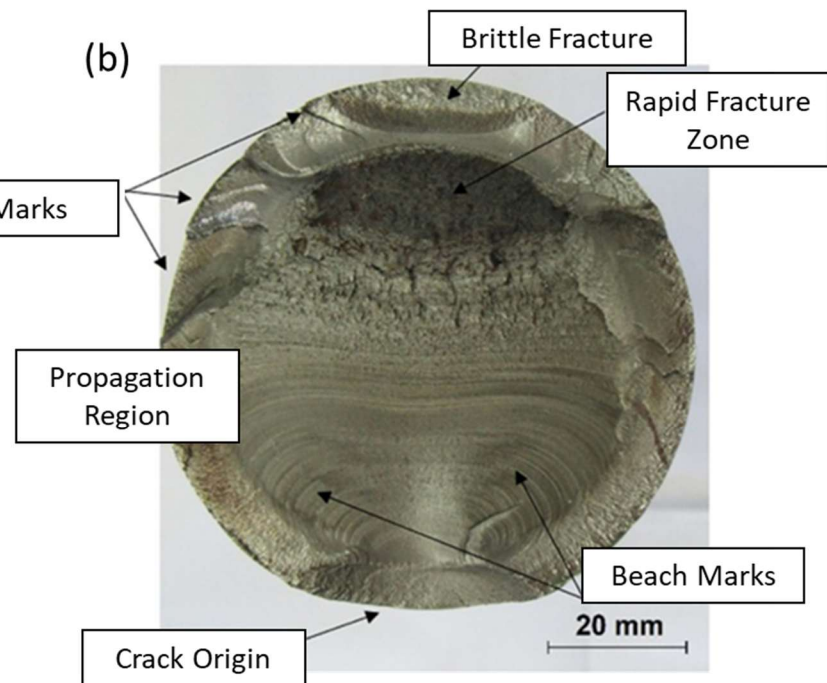
Shaft: Marine Propeller Shaft  
Failure: Rotating Bending Fatigue

Shaft: Rear Differential Shaft  
Failure: High-cycle  
Unidirectional Fatigue

Figure 2-5 - Macroscopic Features of Fatigue Failure of (a) Marine Propeller Shaft [4] and (b) a Rear Differential Shaft [8]

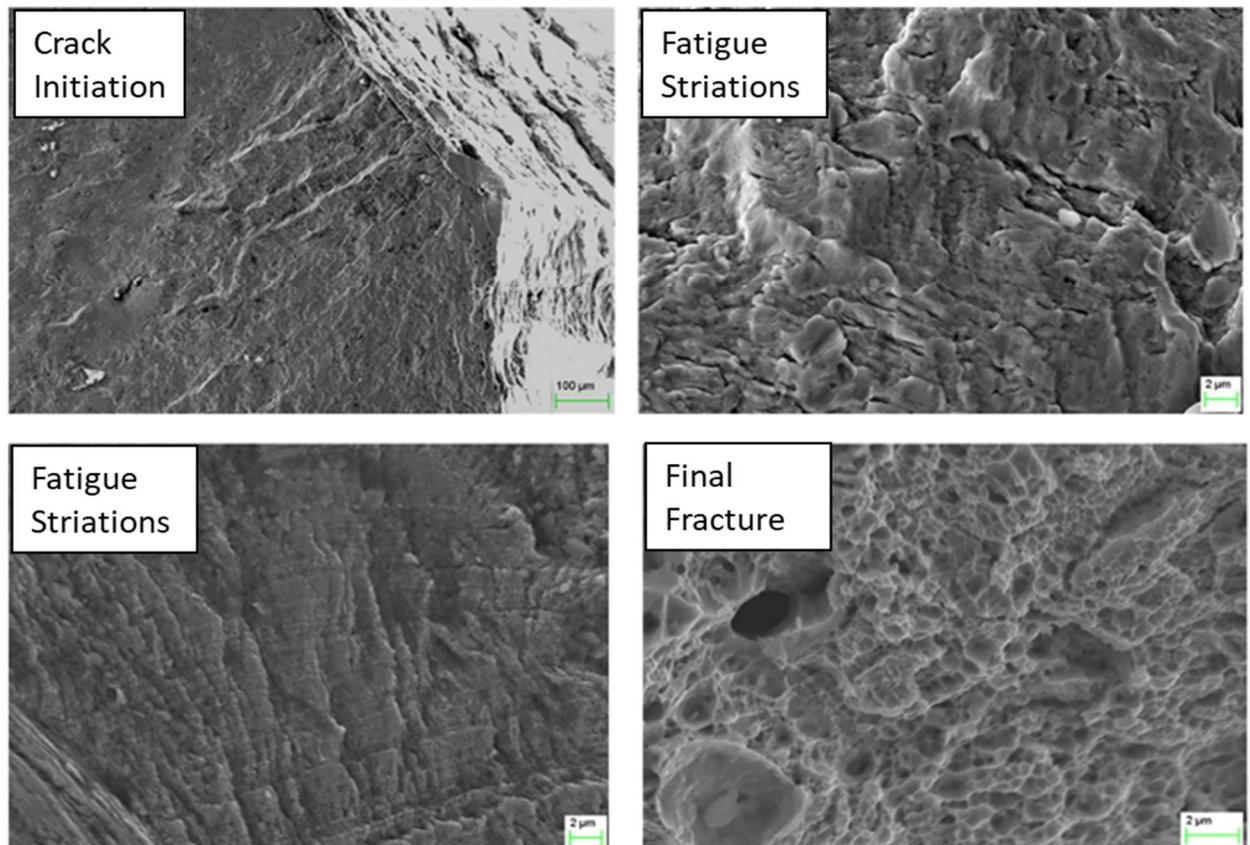
Additional features such as radial ridges and grinding marks can be identified at the crack initiation sites, while dimple-like features can be observed at the final fracture region [2]. These are highlighted in Figure 2-6.

**Figure 2-6 - Microscopic Characteristics of Fatigue Failure [2]**

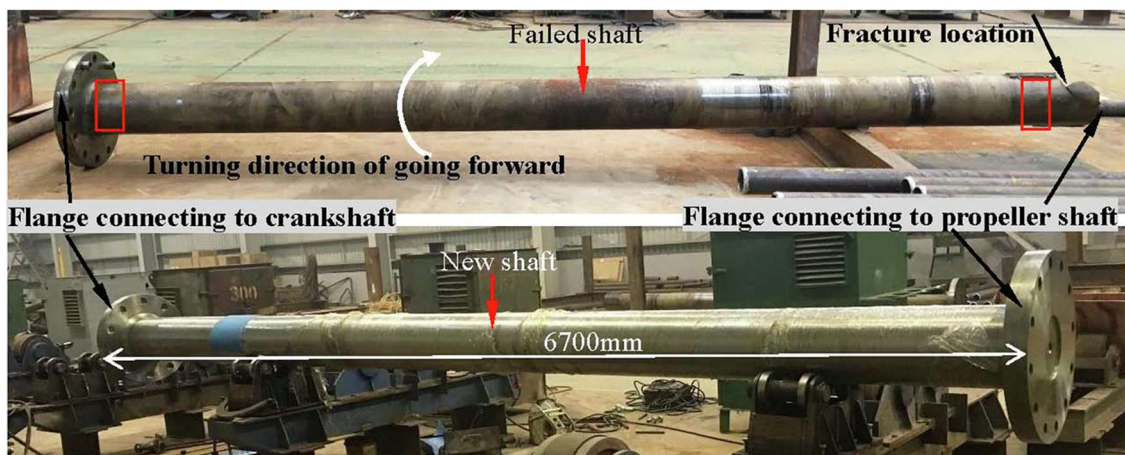
In February 2019, a failure occurred on a bulk carrier while performing berthing manoeuvres at half speed. When attempting to engage “dead slow” for final positioning, the crew reported a total loss of rudder effect and suction. Subsequent inspection found that the intermediate shaft fractured at the fillet root of the flange [4]. Figure 4-1, shows the failed shaft compared to a new shaft.

**Figure 4-1 - Failed Bulk Carrier Shaft Highlighting Fracture Location, Compared to New Shaft [4]**

Tensile testing was conducted using an Instron-5500R tensile tester and standard round specimens of 50mm in length and 10mm in diameter, taken from the marked location in Figure 4-1. From the results in Table 4-2, it can be seen the UTS and yield strength were lower than technical specification requirements, while the elongation and reduction areas were within tolerance. The UTS and yield strength close to the point of fracture were 20% and 16% lower than the required values, however, the samples from the crankshaft flange were 8% and 7% lower, coinciding with the difference in material composition of the shaft. During evaluation of the results, it was noted that the average UTS near the crack origins (416 MPa) was 12% lower than the lower limit of the UTS based on the design criteria (520 MPa).

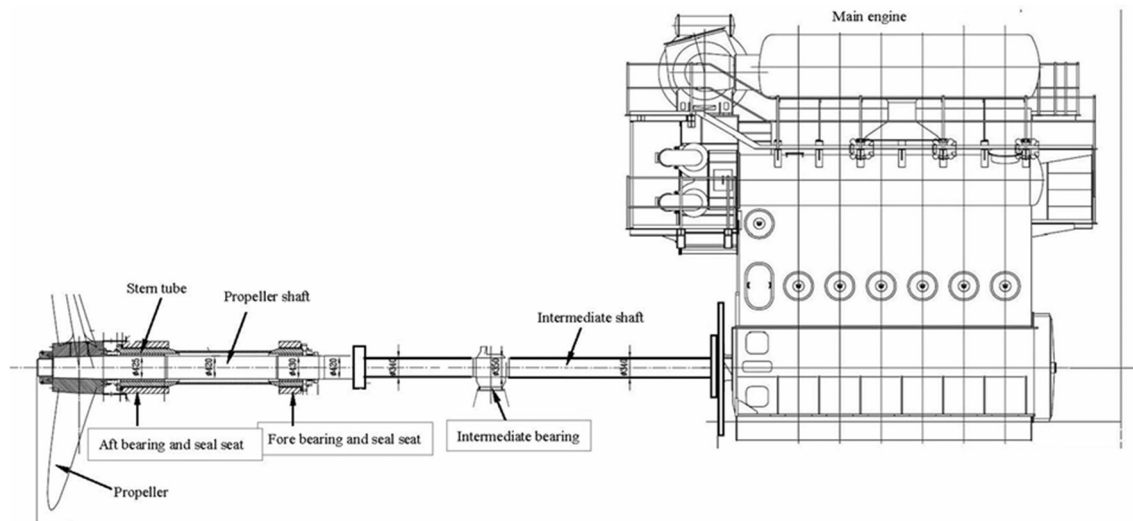
The intermediate shaft connected the crankshaft to the propeller shaft as demonstrated in

Figure 4-2. This measured 6700mm in length and 340mm in diameter with two flanges 83mm thick and 810mm in diameter. The shaft was manufactured in 2007 and had been in service for 43,000 hours before fracturing.

**Figure 4-2 - Schematic of typical propulsion system for a Bulk Carrier [4]**

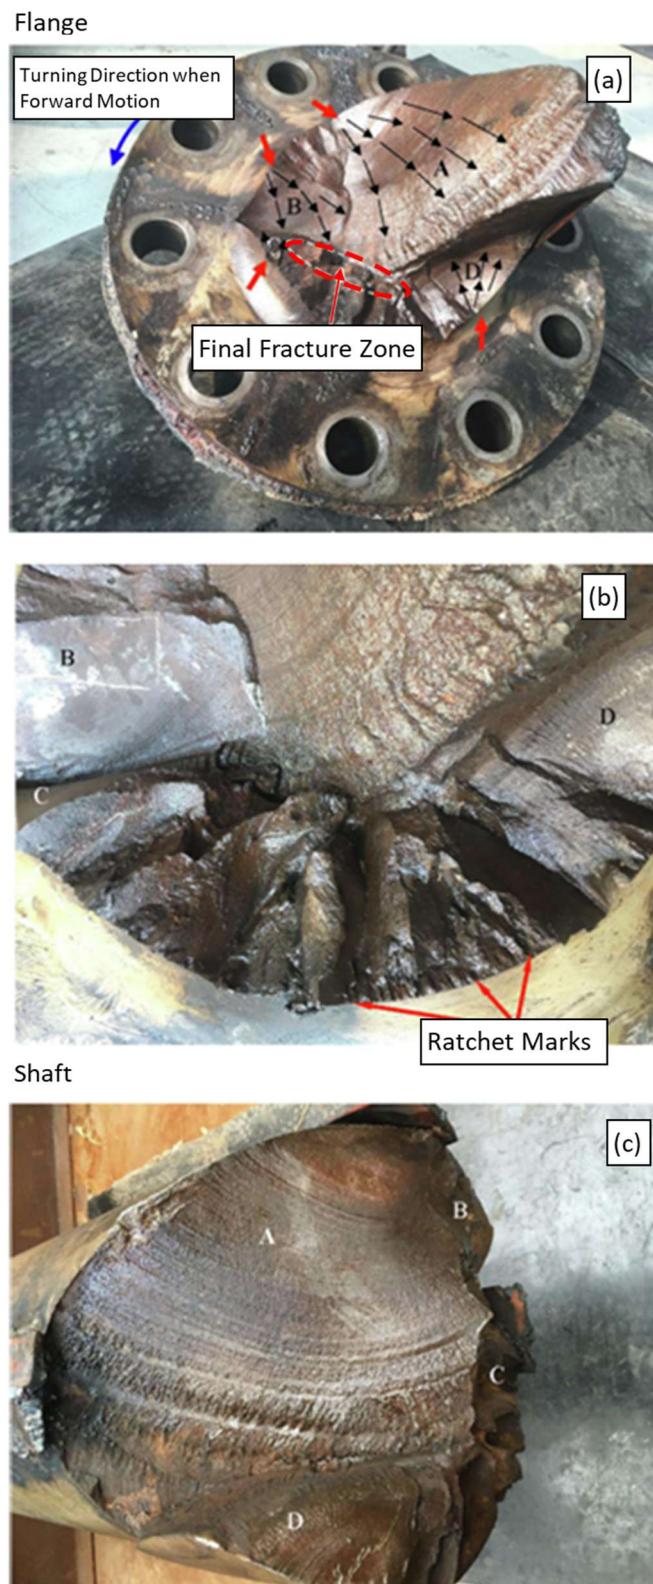
From initial macroscopic analysis of the recovered flange and shaft, four main crack propagation zones, labelled A, B, C and D on Figure 4-3, with a singular final fracture zone indicated in (a), were identified. Ratchet marks indicate multiple crack initiation points along with high stress concentration and torsional loading on the shaft. The final fracture zone accounts for 8% of the total fracture surface, indicating the shaft was under minimal static load at the time of failure.

Figure 4-3 - Recovered Components of Failed Intermediate Shaft [4]

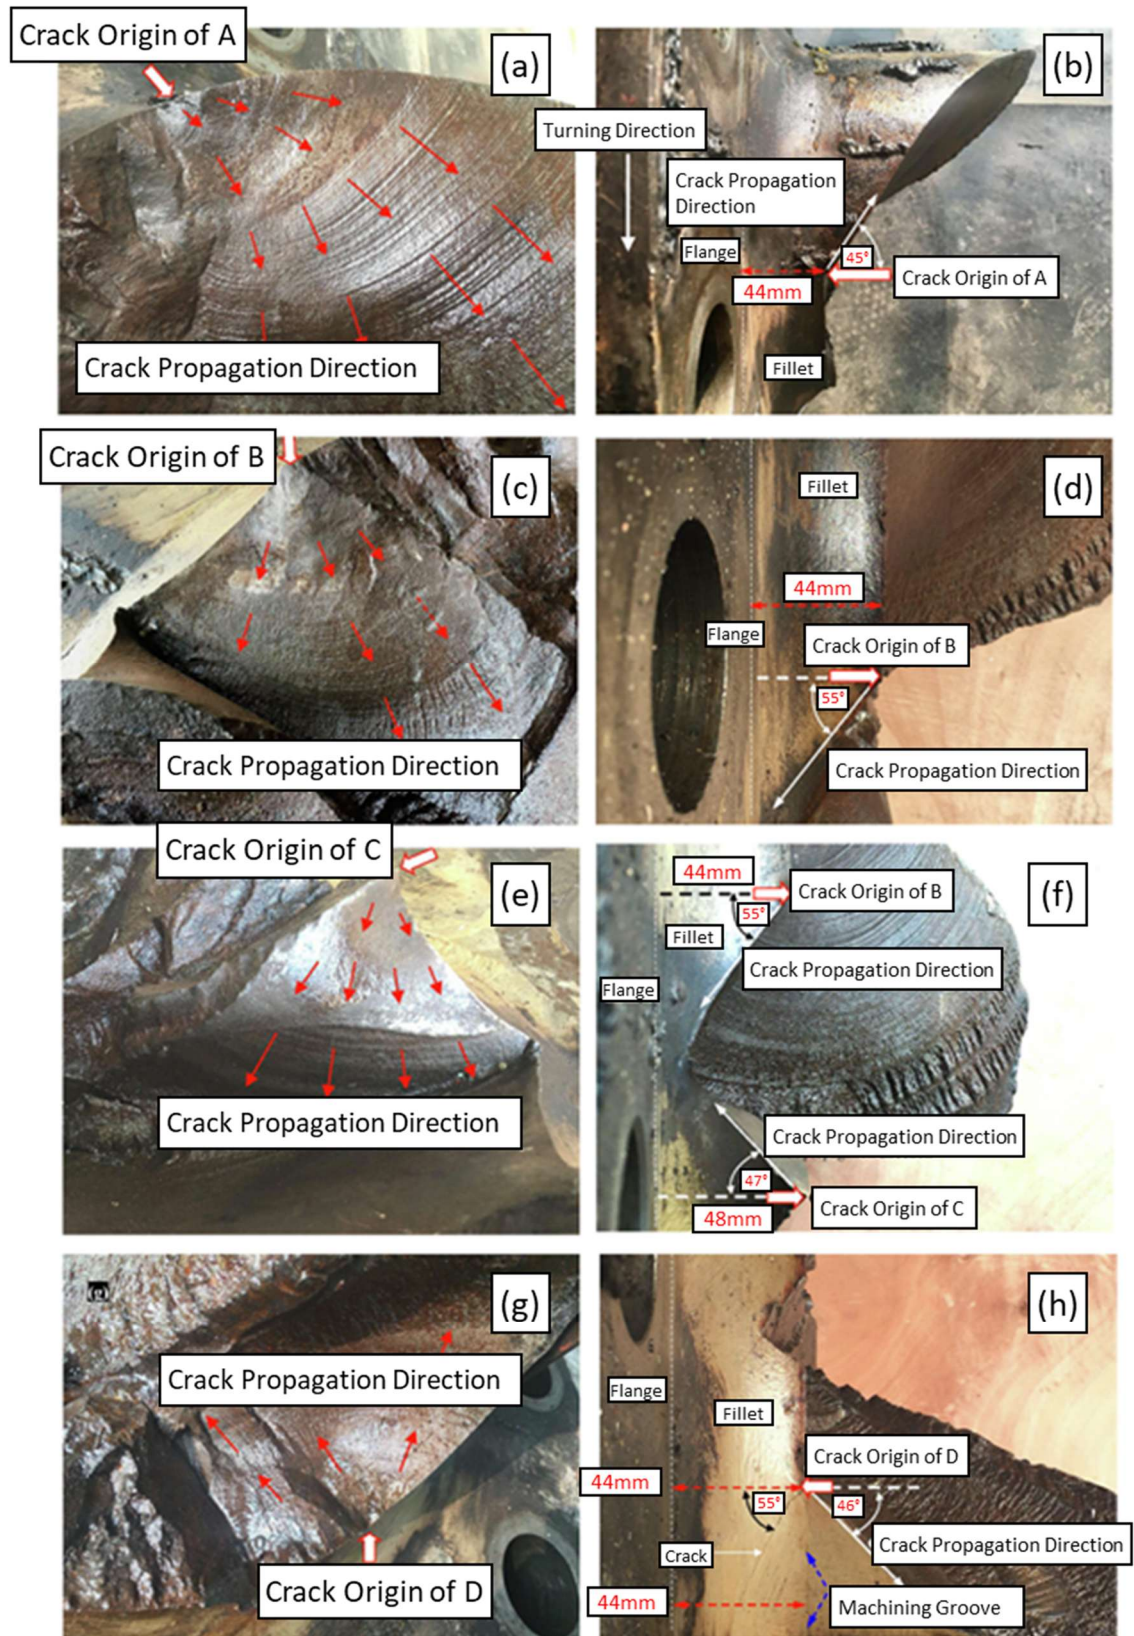
Beach marks, highlighted in Figure 4-4, distinctly suggest fatigue failure leading to the final fracture. Following beach marks, crack initiation points can be identified, along with the direction of crack propagation indicated by the red arrows in Figure 4-4(a)(c)(e) and (f). The crack origins were initiated from the fillet root of the flange and propagated outward [4]. It can be shown that cracks propagated towards the central zone at an angle of 45-55° of the shaft axis. The fracture angles of the cracks are negative and positive to the shaft axis, suggesting the shaft experienced stresses in both directions during its service. The 55° angle at crack B indicates the dominant failure was due to torsional and bending tension.

Figure 4-4(h) highlights a groove 44mm from the flange plane. This coincides with crack origin locations, which suggest that there is a weakness in the groove that led to the shaft failure. Further analysis was undertaken on samples of the flange fillet regions. Stereomicroscope observation identified machining marks on the fillet roots, SEM revealed these marks were notably deep with short cracks at the bottom as highlighted in Figure 4-5. These notches could act as areas of significant stress concentrations providing effective initiation areas for fatigue.

Figure 4-4 - Stereomicroscopic Observation of Fracture Morphology [4]

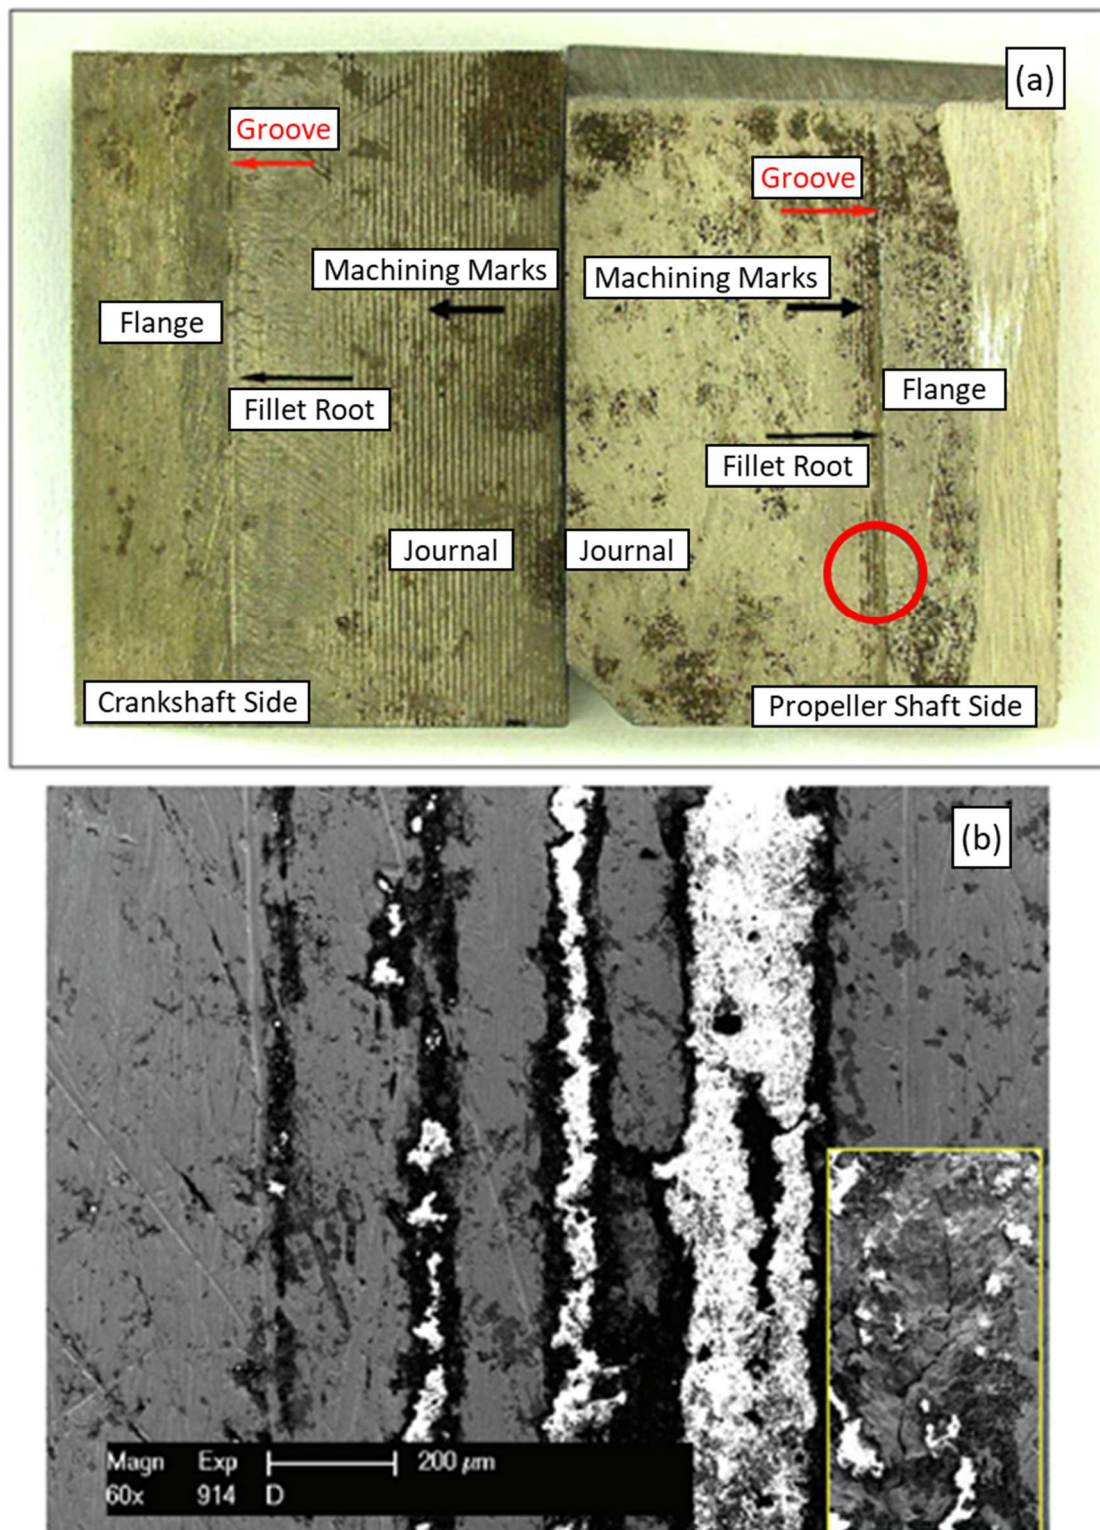
Figure 4-5 - (a) Stereomicroscopy and (b) SEM Observations, on Circled Location on (a), of Machining Marks on Intermediate Shaft [4]

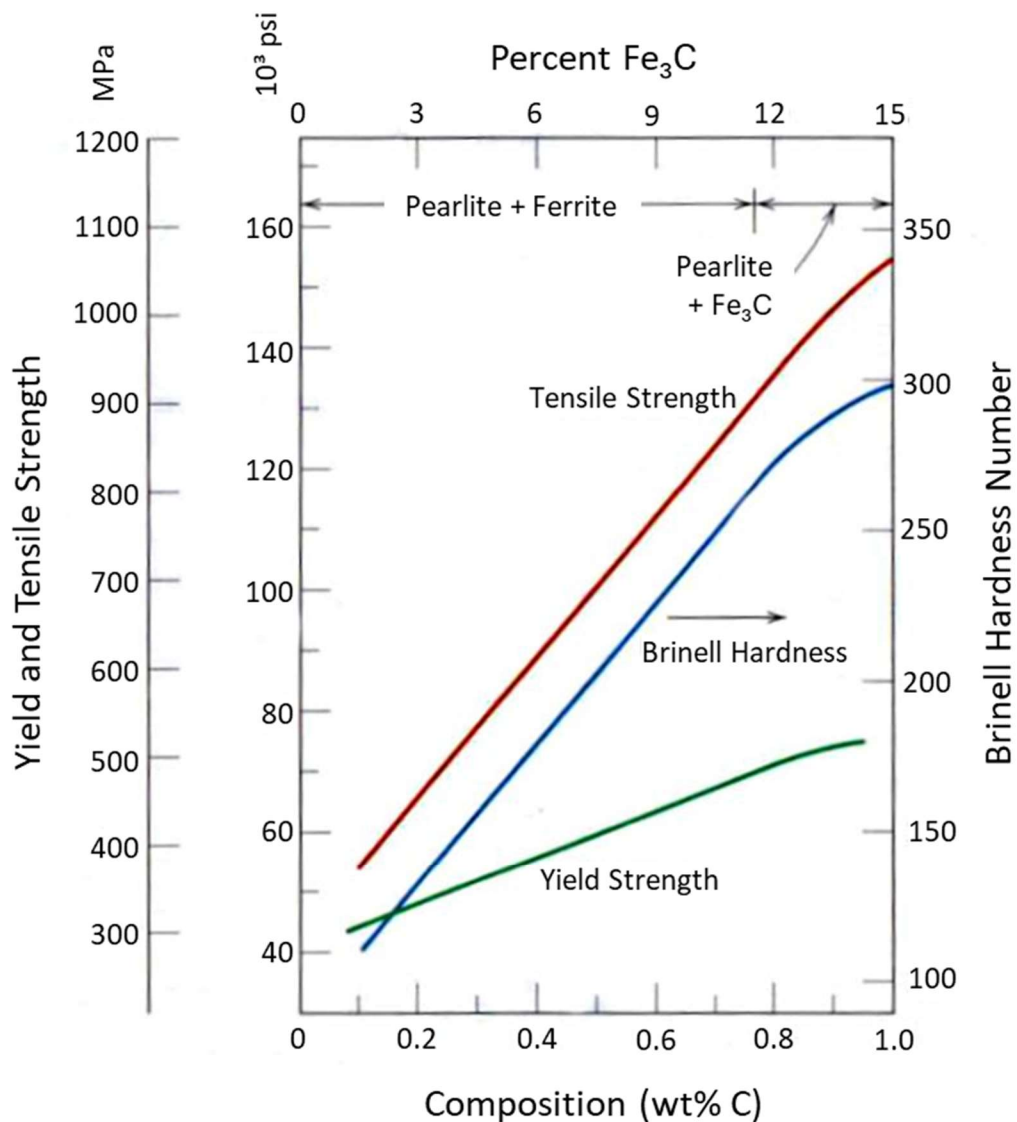
by approximately 20-30% [16, 17]. This is consistent with the measured 20% reduction in the failed shaft. Lower UTS values are characteristic of low carbon steel as demonstrated in Figure 5-1. Ferrite-rich microstructures accelerate fatigue crack propagation because the soft ferrite deforms easily and has fewer microstructural barriers than pearlite [18]. Ultimately, the use of low carbon steel resulted in inadequate tensile performance and reduced resistance to fatigue crack growth, contributing to the shaft's failure.

**Figure 5-1 – Yield Strength, Tensile Strength and Brinell Hardness versus Carbon wt% for Plain Carbon Steels [6]**

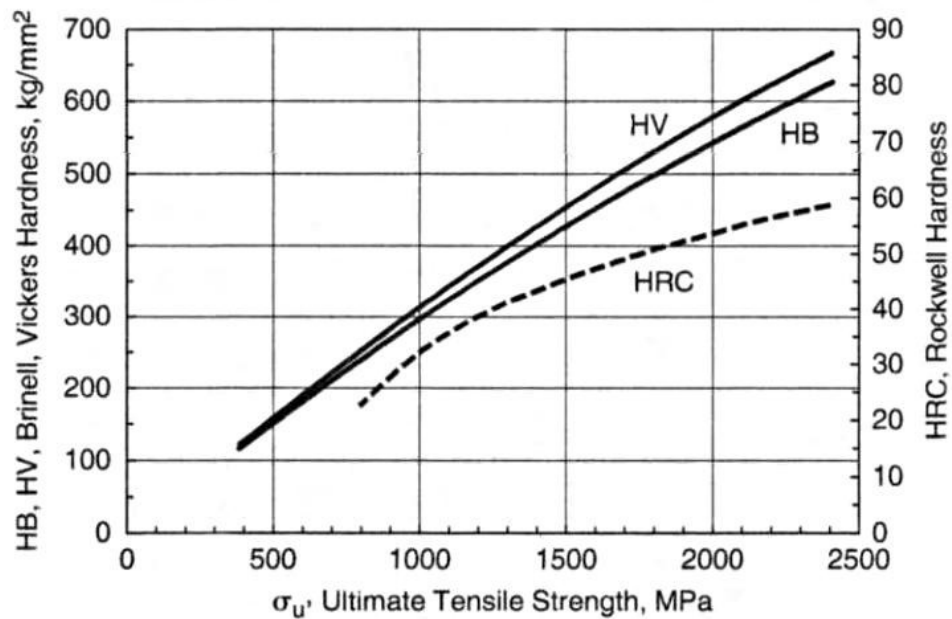
Mechanical testing conducted on the intermediate shaft showed the material had significantly reduced strength relative to the design specification. The measured average hardness of HB114, which was 24% lower than the specified requirement, indicates a substantially softer microstructure with reduced resistance to localised plastic deformation. Brinell hardness correlates strongly with yield strength as presented in Figure 5-2. A hardness deficit of this magnitude implies that the material's pearlite and ferrite levels were significantly lower than intended, allowing larger cyclic plastic zones to form at stress concentrations. The reduced hardness therefore facilitated earlier, and more extensive, plastic deformation at the crack origins. This lowered the threshold for microcrack initiation and accelerated the transition to stable crack propagation, making the material more susceptible to fatigue crack initiation under operational loading.

**Figure 5-2 – Approximate Values of Brinell (HB), Vickers (HV) and Rockwell C (HRC) Hardness, as a Function of Ultimate Tensile Strength for Carbon and Alloy Steels [5]**
