**School of Engineering**

**BEng Mechanical and Manufacturing Engineering**

**Development of a handle for an automotive battery  
due to supply issues**

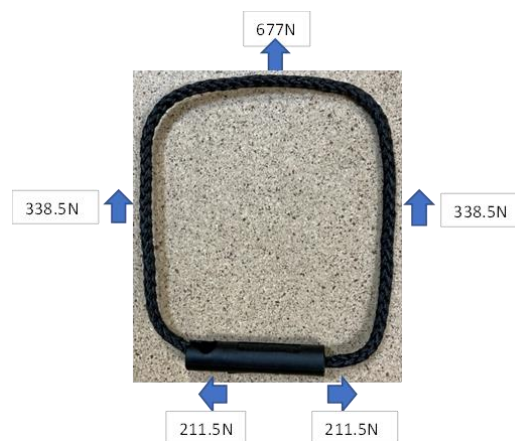
*Figure 17 Force Calculations for Sudden Load Test*

Figure 17 shows the forces acting in each direction of the handle assembly.

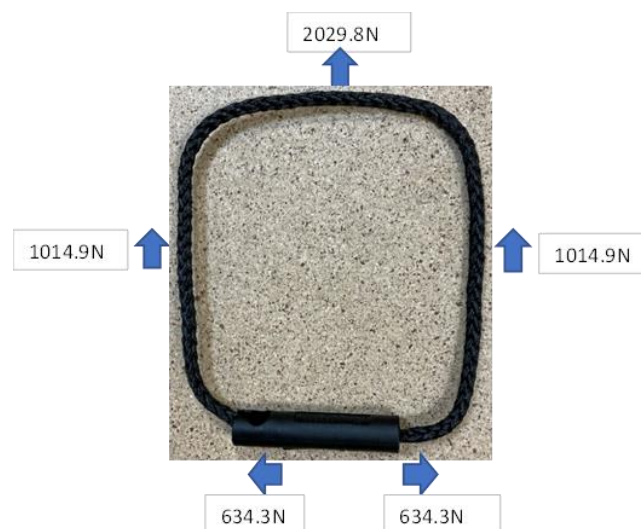
*Figure 18 Force Calculations for Continuous Load Test Following EnerSys' requirement*

Convert to Newtons x 9.806 = 2029.8N

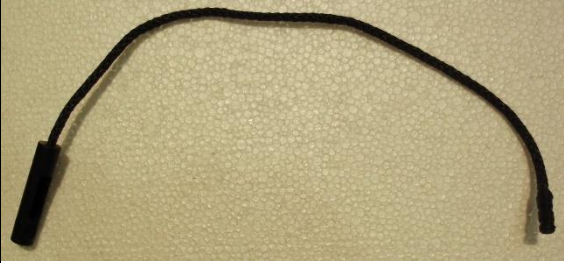
| | Photographs of Procedure | |
|---|---|---|
| 1 | | Select a Rope Sample as shown. |

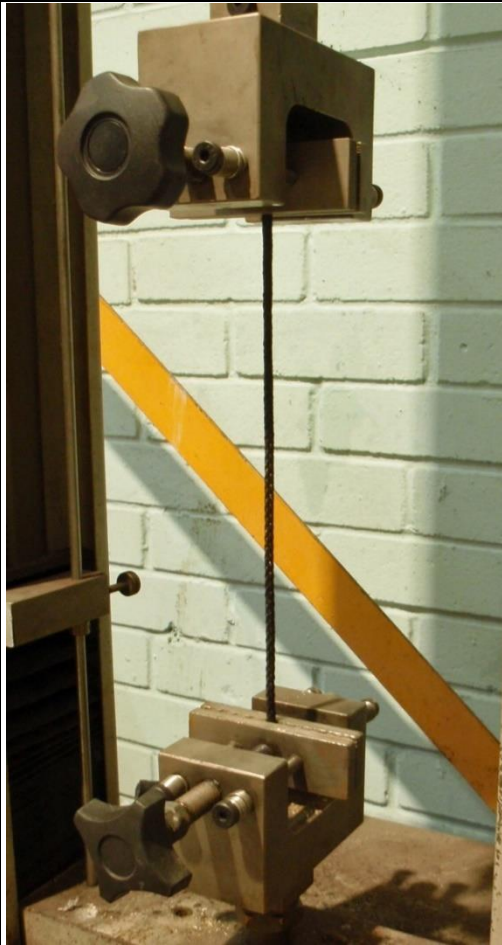
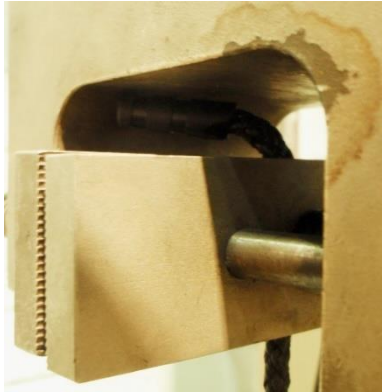
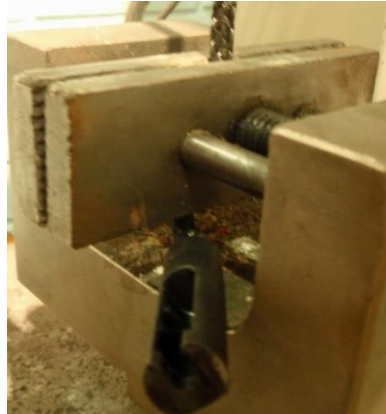
| | Photographs of Procedure | |
|---|---|---|
| 2 | | <p>Place the sample into a Tensile Testing Machine as shown.</p> <p>Position the End Mouldings as shown above and below the clamping jaws to avoid slippage during application of Tensile load.</p> <p>Subject the sample to a Load of 1500N using a rate of 50mm per minute. Ensure the rope is not clamped onto, as this will affect the results.</p> |

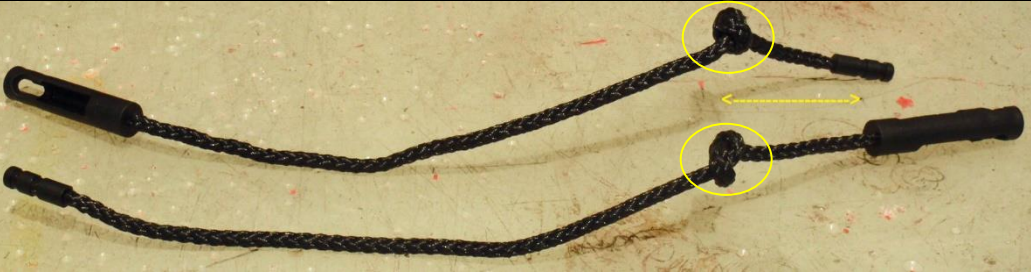
| | Photographs of Procedure | |
|---|---|---|
| 1 | | <p>Select 2 Rope Handles and tie 2 knots in the highlighted positions, 1 to 2 inches from each end moulding as shown.</p> |

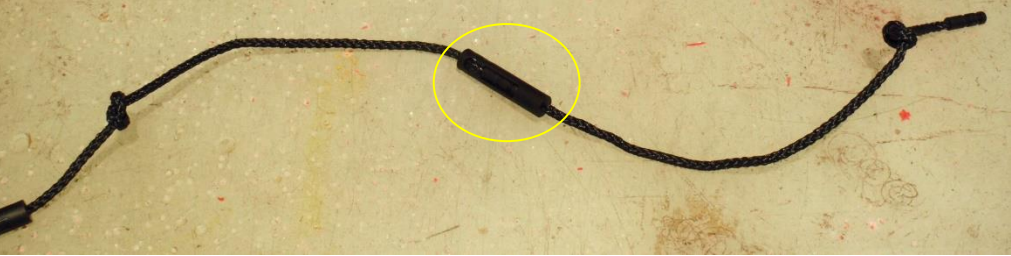
| | Photographs of Procedure | |
|---|---|---|
| 2 | | <p>Join both Handle samples at Locking mechanism.</p> |

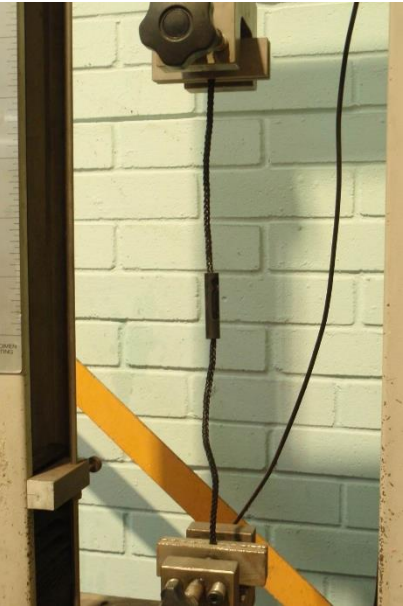
| | Photographs of Procedure | |
|---|---|---|
| 3 | <p style="text-align: center;"><b>Cyclic Load Test</b></p> <p style="text-align: center;">Number of Cycles = 5</p> <p style="text-align: center;">Load Rate = 50mm per minute</p> <p style="text-align: center;">Loads = 0N to 800N</p> | <p>Place the Sample into a Tensile Testing Machine as shown. Position the 2 knots above and below the clamping jaws to avoid slippage during application of Tensile load. Subject the sample to the cyclic load test shown.</p> |

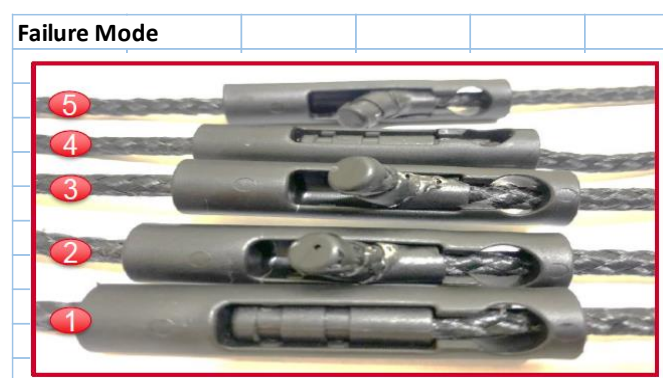
*Figure 24 Images Supplier took of failure modes of samples that have undergone the locking mechanism test*

Figure 24 shows some examples of failure modes the supplier has taken images of (load results were obtained and compared in section 7.2).

It is noted that all sample failures occurred at the locking mechanism.

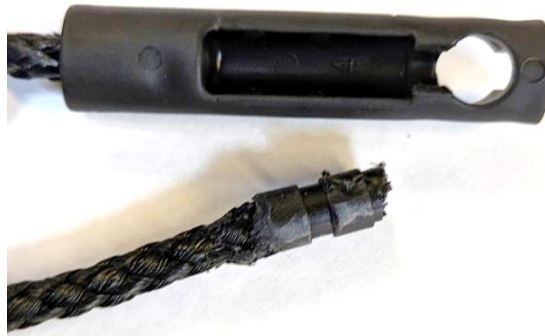
*Figure 34 Sample 1 - Failure Mode 1 - Newport Physical Testing*

Sample 1 – Failure mode 1 – End moulding displaced from locking mechanism

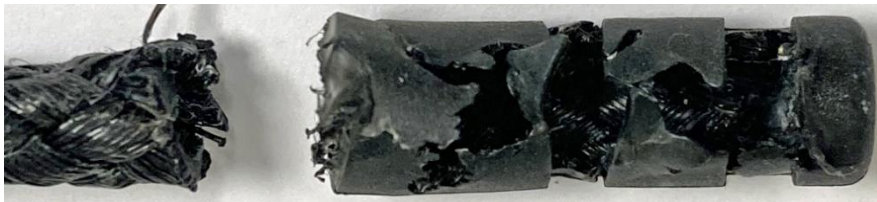
*Figure 35 Sample 6 - Failure Mode 2 - Newport Physical Testing*

Sample 6 – Failure mode 2 – Rope displaced from end moulding

Sample six's unique failure mode can be attributed to some edges not being fully formed. There were many exposed strands across the entire end moulding, leading to a weak connection between the rope and plastic, ultimately leading to the rope becoming dislodged (see Figure 36 for sample 6 image before testing).

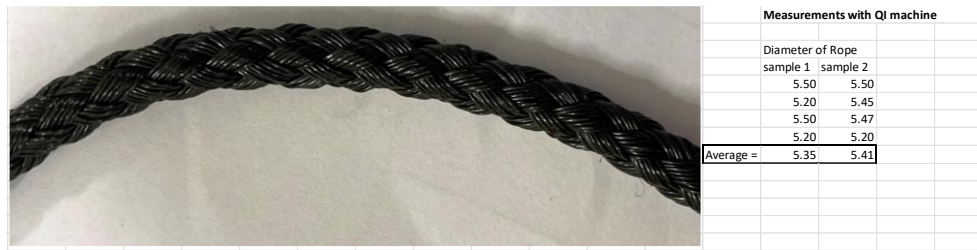
Figure 39 Measurements of Rope Diameter (old rope)

The new ropes that have been supplied have a diameter that is, on average, 0.6mm larger than the originally supplied rope (see Figures 39 & 40). It can be determined that this leads to an overmoulding issue where there is a larger amount of exposed strand around the end moulding of the plastic moulding, as a larger rope diameter leads to less plastic surrounding the rope (refer to section 12.0). Note that the thicknesses were taken around the whole diameter of the rope using a quick image machine.

The thickness results from Figures 42 & 43 show an average of 0.1mm difference in diameter at the grooves where the currently supplied rope (new rope) is 0.1mm larger. This means that there is approximately a 0.5mm decrease in the thickness of the plastic at these points as the new rope is, on average, 0.6mm larger (refer to figures 39 & 40), meaning it will take a reduced amount of stress at these areas before failure occurs.

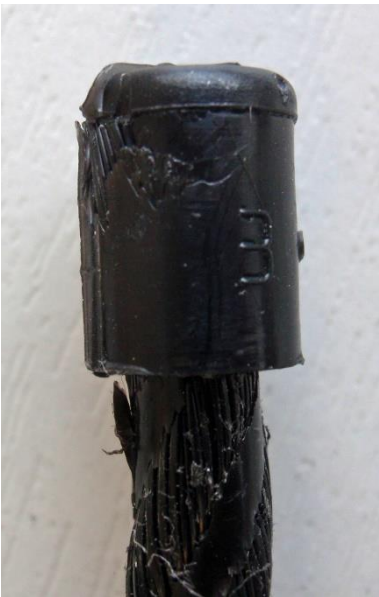
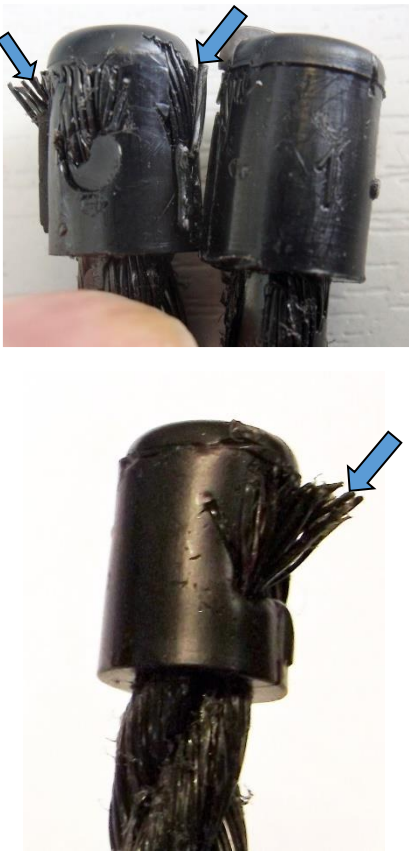
Table 4 Example of use of exposed strand criteria for a rope used on another product type (Historical Criteria) (EnerSys, 2016)

| <b>FAULT – LOOSE / EXPOSED STRANDS AT END CAP MOULDING</b> | | |
| | <p>Percentage of Loose Strands must not exceed 40%</p> | <p><b>Loose Strands cause a problem on assembly.</b></p> |

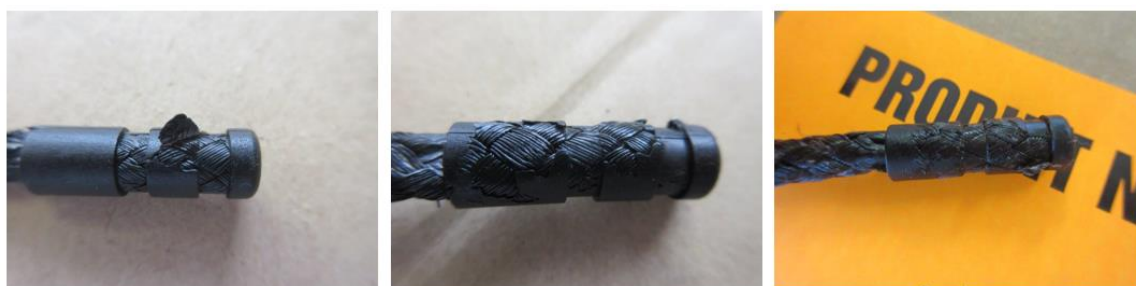
Figure 50 Example of 'Bad Samples' picked out after supplier screening during EnerSys screening

Testing carried out from 26 Oct to 04 Nov are post the new screening process, and as is noted, %NC is below 1%. The main issue is that “bad” rejections remain even after the supplier has 100% screened the samples. If the samples marginally failed due to the percentage of exposed strands, this would not be a large issue; however, samples like those shown in Figure 50 are being observed.

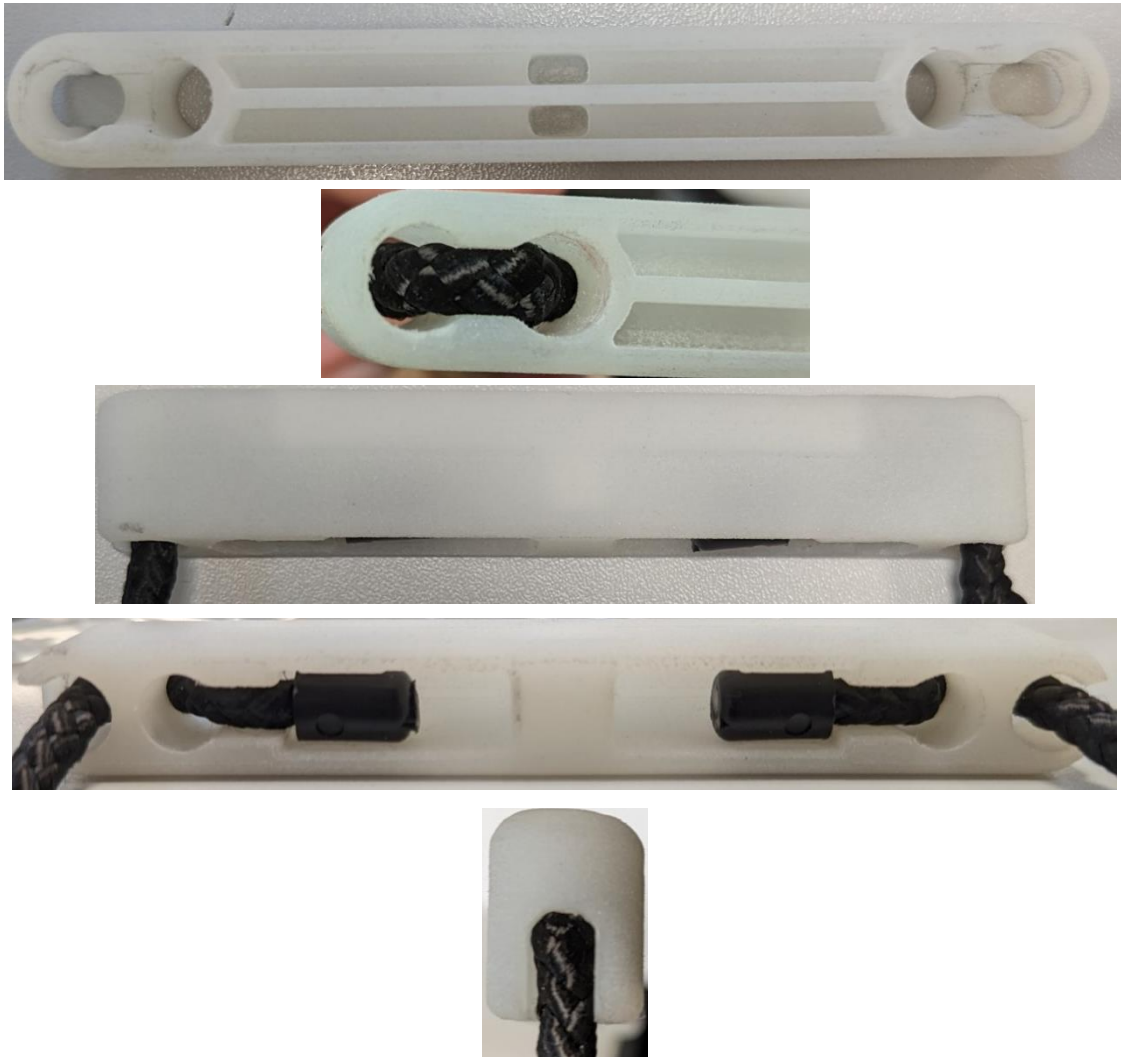
*Figure 56 General View of Handle Prototype Design*

Figure 56 shows general views of a rope assembled into the prototype sample.

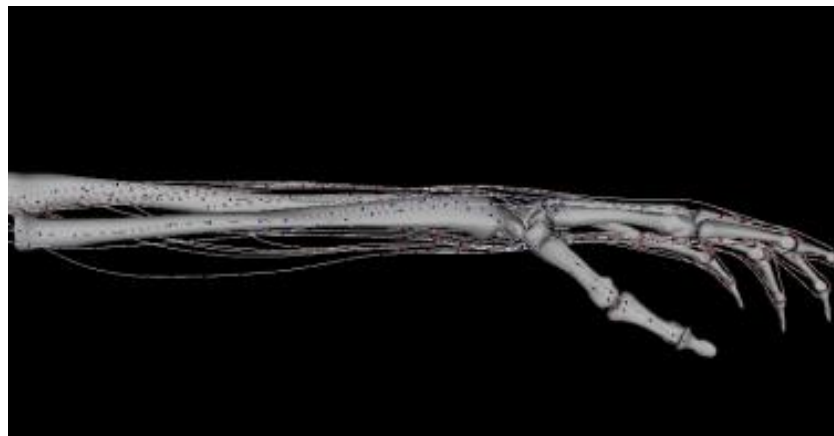
*Figure 66 Model of Hand produced by the University of California (Yan, 2012)*

An example of this method being successfully used was during a study conducted by researchers at the University of California, Los Angeles (UCLA), where they developed a finite element model of the human hand and wrist to simulate the forces and deformations experienced during a lifting task. In their model, they included spring elements to represent the stiffness of the hand and wrist, allowing for more realistic deformations and better accuracy in the results (Yan, 2012).

Figure 66 is an image of the model created in the referenced document.

The rope could also be implemented into the model, with force being applied to the rope itself, better representing the loads that would be observed during physical testing.

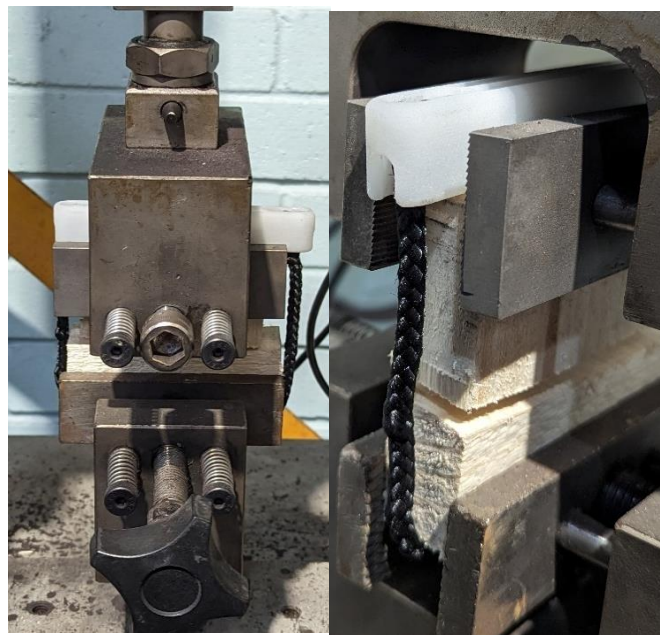
*Figure 67 Prototype Handle Physical Test Set-up*

The grips then pull apart the pieces of wood until a failure occurs.
