## The Newport Medieval Ship, Wales, United Kingdom

The Newport Ship is the most substantial late medieval vessel excavated and recovered in Britain in recent years. It was abandoned after extensive salvage, possibly following attempts at repairs to the hull. More than 23 m of the clinker-built ship were recovered, along with significant artefact and environmental assemblages. Finds point to strong Iberian connections during the active life of the ship, which arrived in Newport in the Severn Estuary, after the spring of AD 1468. The dismantling and recovery of the ship has enabled detailed recording using innovative 3D digital techniques and approaches to hypothetical reconstruction. Publication includes a digital archive hosted by the Archaeological Data Service, a substantial report and this article.

**Key words:** ship construction, scantlings, 3D modelling, laser sintering, pumps.

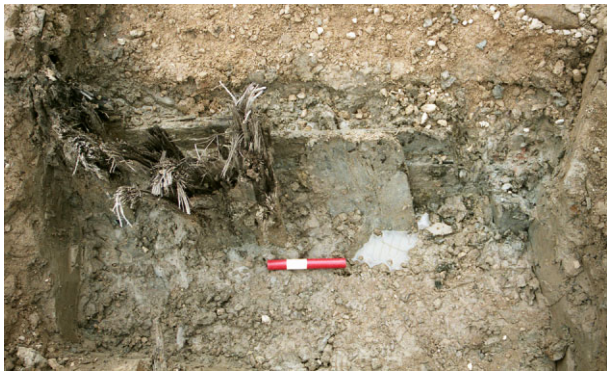
Figure 3. First recognition of the Newport Ship. Machine damaged tops of framing timbers and outer hull planks with nail and rove fastenings on the port side. (Nigel Nayling)

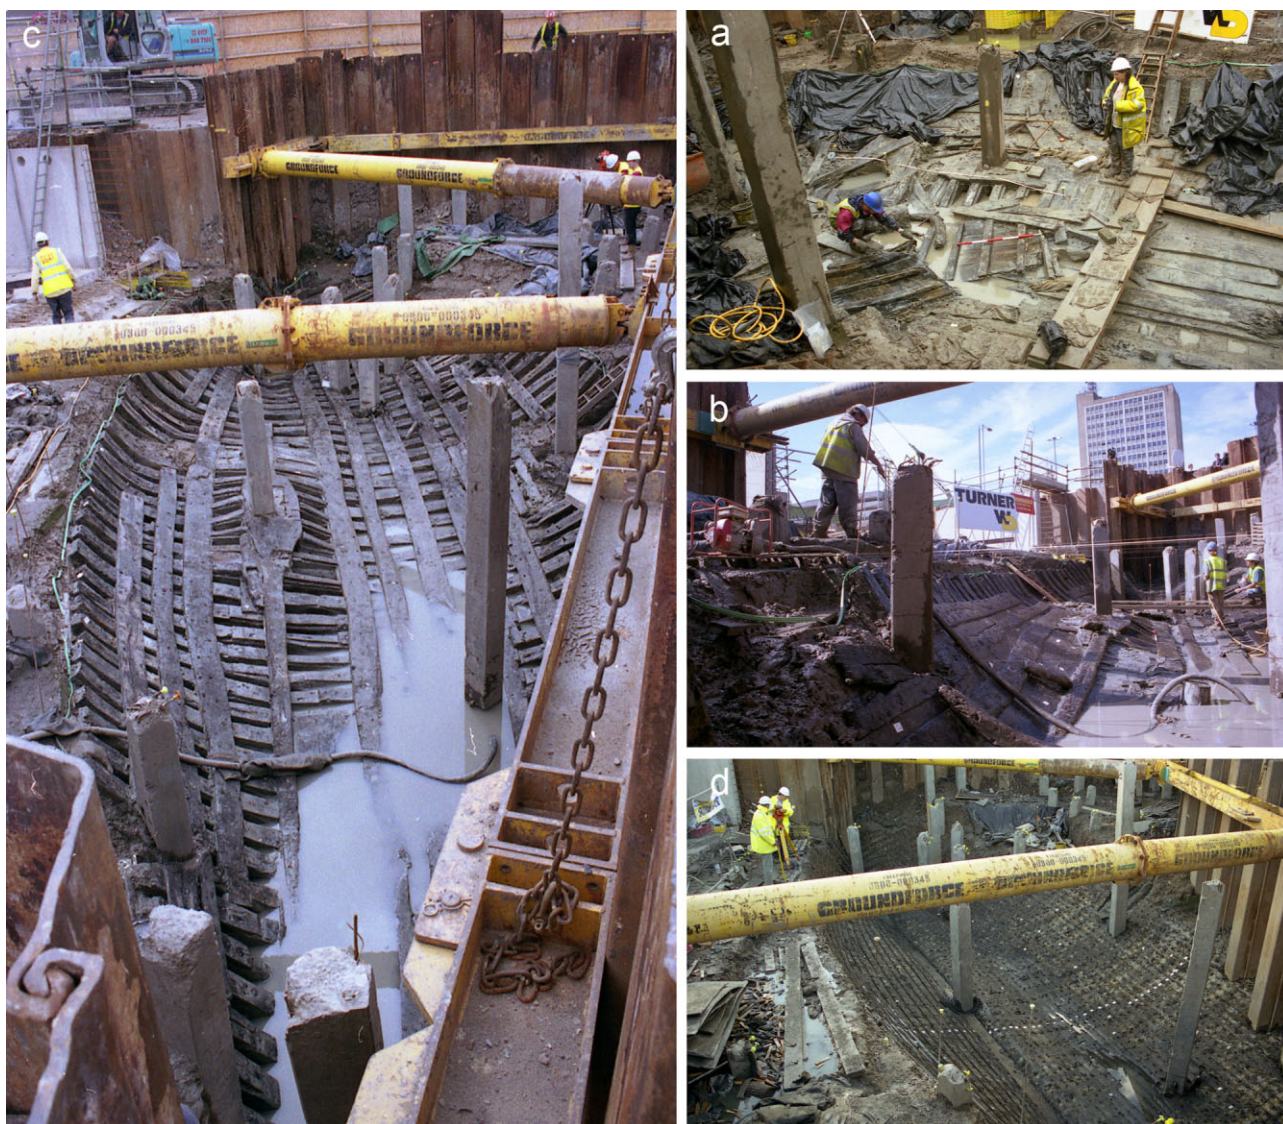
Figure 4. *a)* Loose timbers and hatch covers lying within the ship. View towards the port side. The keelson with mast-step, braces and pump hole is partially exposed; *b)* View towards the bow following removal of loose timbers. Stringers and ceiling tagged and running cross-section lines in place; *c)* Photogrammetric recording of the hull after removal of ceiling planks and inter-frame sedimentation. View towards the bow; *d)* Photogrammetric recording of the hull planks after removal of the majority of framing timbers. View towards the bow. (All Nigel Nayling)

frames proved by far the most time-consuming aspect of the ship's recovery. In contrast, following photogrammetric recording of the inboard face of the hull planks (Fig. 4d), these were rapidly recovered. Iron nails and roves fastening the strakes together were easily broken. Occasional wooden spikes at the land needed to be cut with a handsaw, and the remains of treenails sometimes had to be forcefully removed at scarfs between hull planks on the same strake. The planks were in surprisingly good condition and could be handled with only minimal padding to protect the surface during carrying, usually by two people. Once lifted, planks were placed on large custom-built pallets which could be craned on to waiting lorries. The keel, apparently originally a single piece of beech more than 20 m long, had been damaged by a number of the modern concrete piles, and was lifted in six sections with the garboard strakes still attached as support. Towards the bow, an oak stem found scarfed to the forward end of the keel had been cut and heavily damaged by the insertion of the sheet-pile cofferdam. The recovery of these disturbed timbers completed excavation of the ship itself in November 2002, some 16 weeks after its discovery.

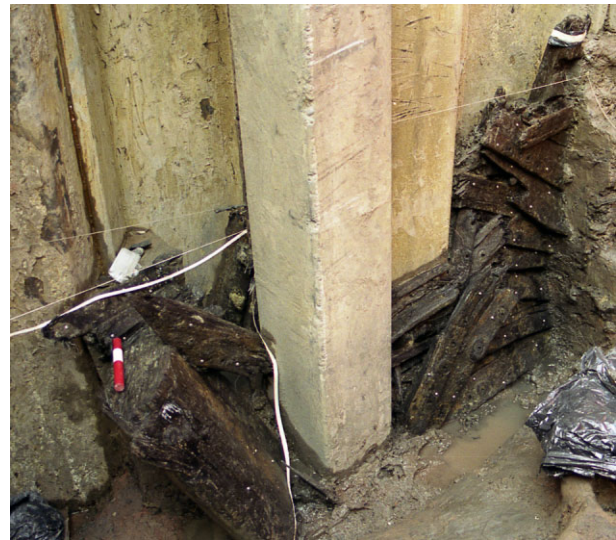
*Figure 5.* Excavation of the bow. View of outboard face of stem and associated forward hull badly disturbed by sheet and concrete piles. (Nigel Nayling)

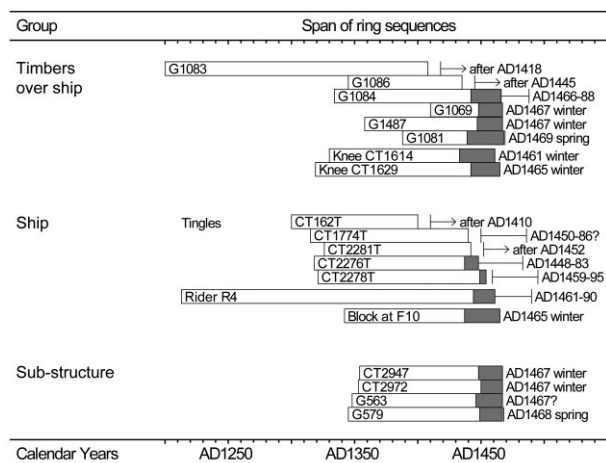
Figure 6. Bar diagram showing timbers absolutely dated against British chronologies giving felling dates or date ranges. (Nigel Nayling)

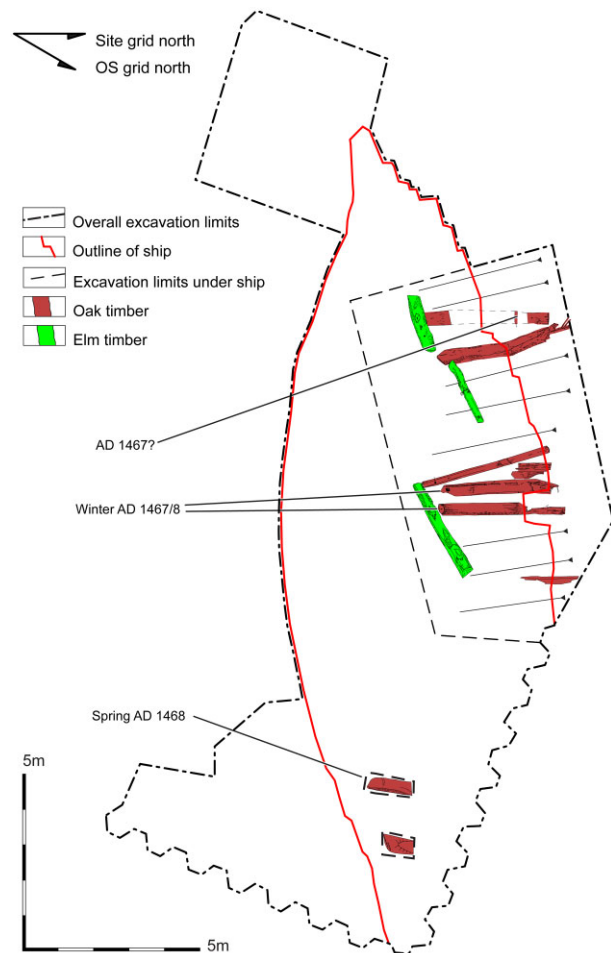
Figure 7. Plan of structures below the ship. Timbers are colour coded by species and tree-ring dates indicated. (Nigel Nayling)

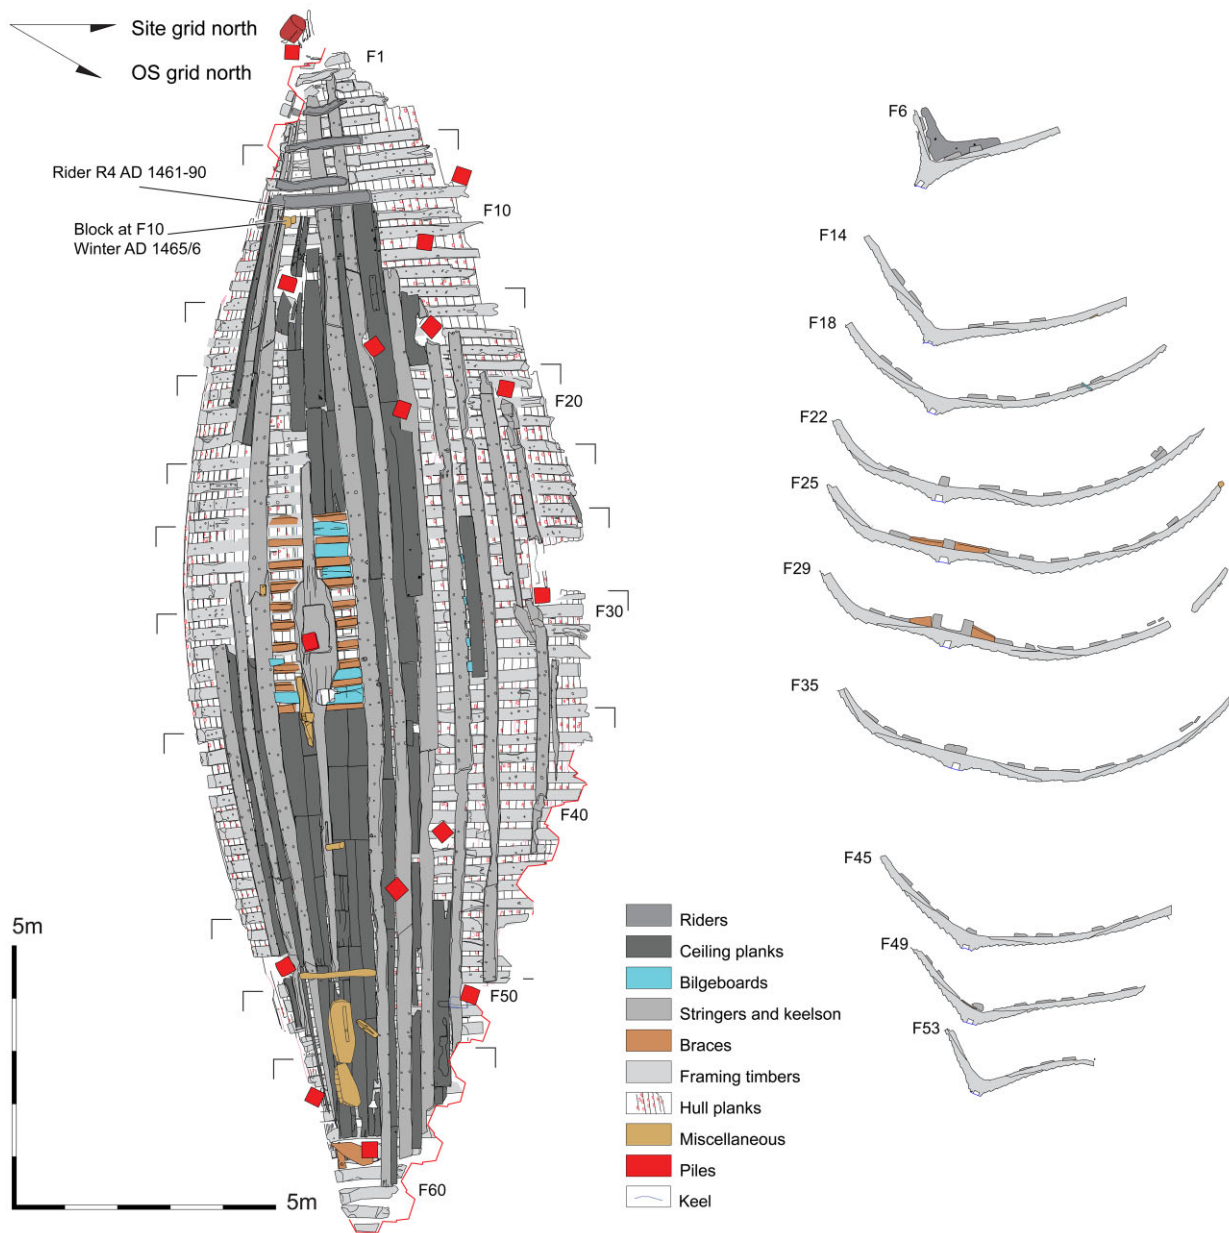
Figure 8. a) Plan of the ship based on photogrammetric recording supplemented by hand drawings. Timber types are colour coded and position of cross-section drawings indicated; b) Sections through the ship *in situ* based on photogrammetric recording supplemented by hand drawings. View towards bow. (Both Nigel Nayling)

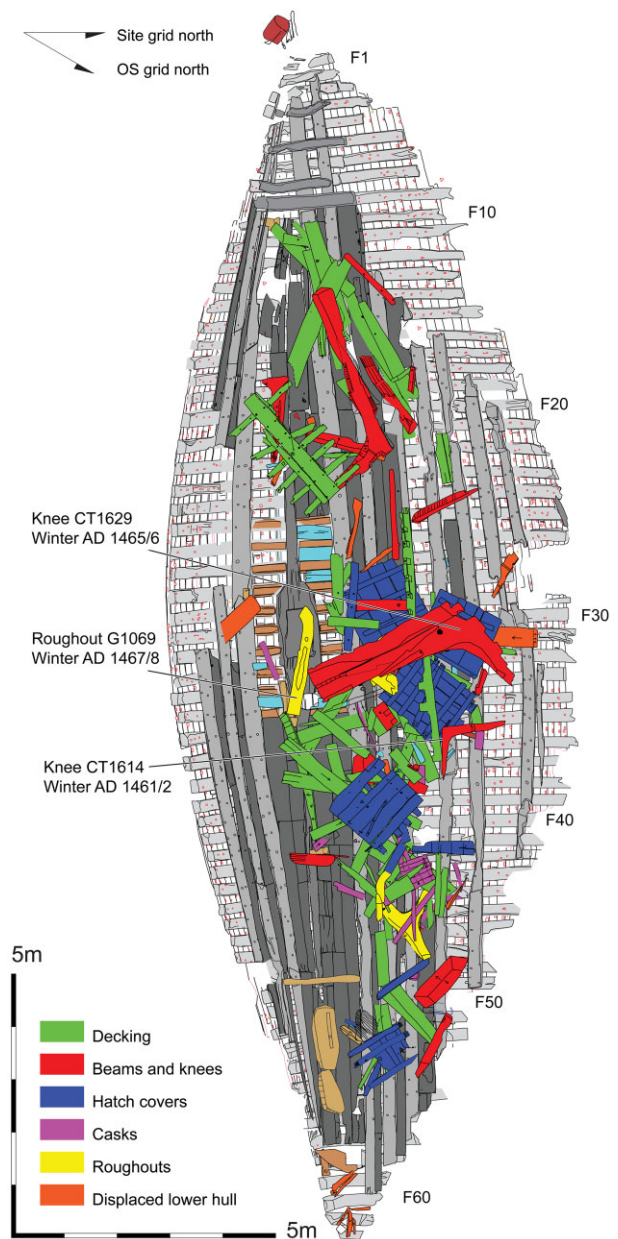
Figure 9. Timbers lying within the ship, colour coded by major categories. (Nigel Nayling)

The disarticulated timbers lying within the ship (Fig. 9) generally comprised tangentially sawn planks (mostly oak but also some elm and conifer) with iron spike-nail fasteners. While some of these may be displaced ceiling planks, the majority are interpreted as

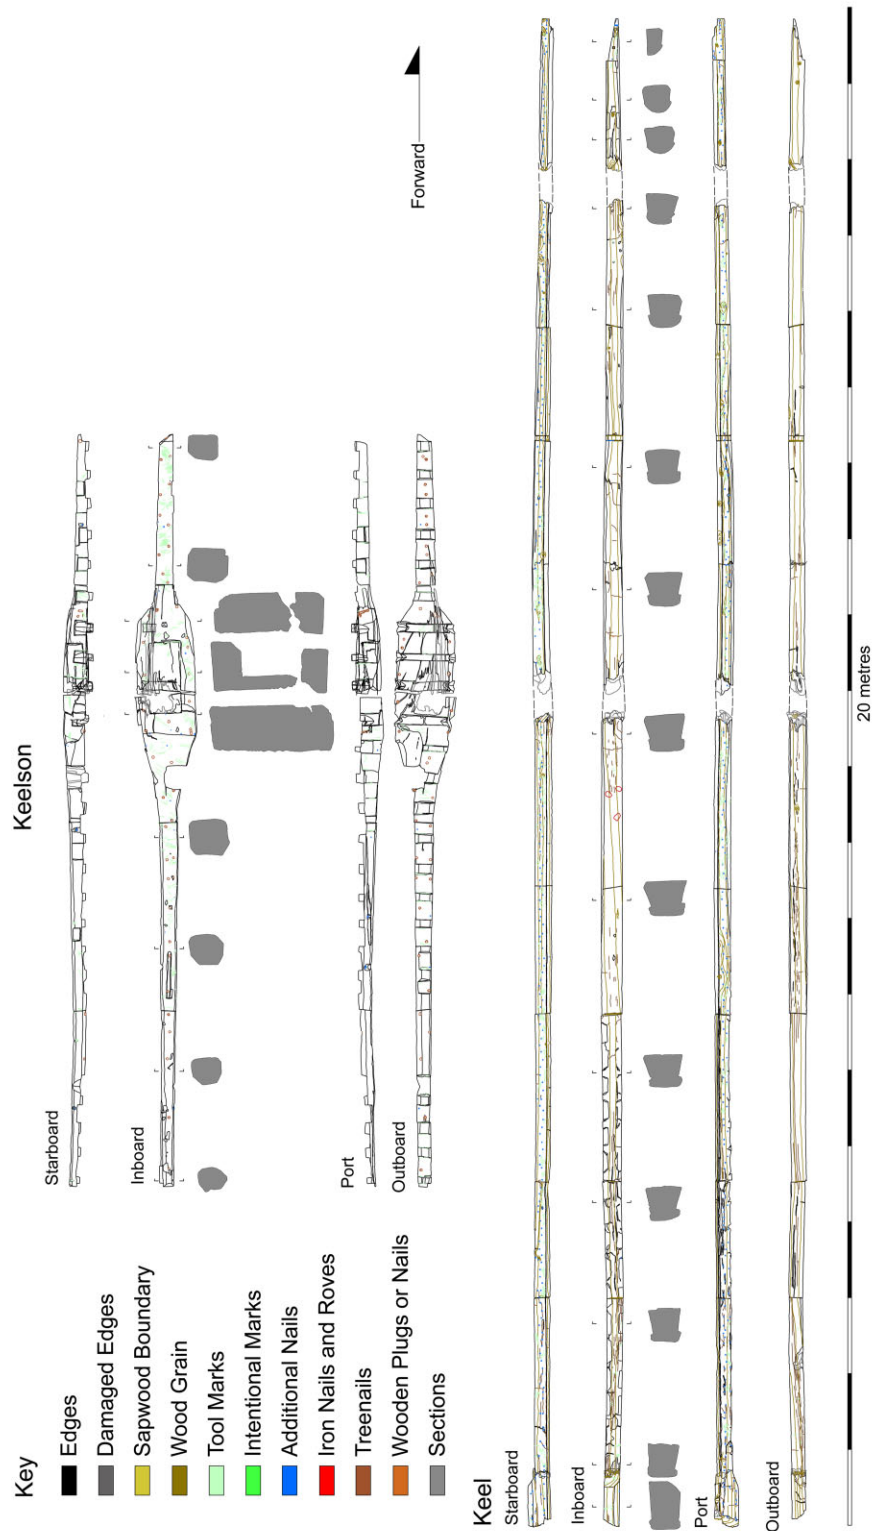
Figure 10. Keel and keelson based on 3D record. Sections shown at double scale. Colour coding of lines shown in key used throughout for timber drawings. (Toby Jones)

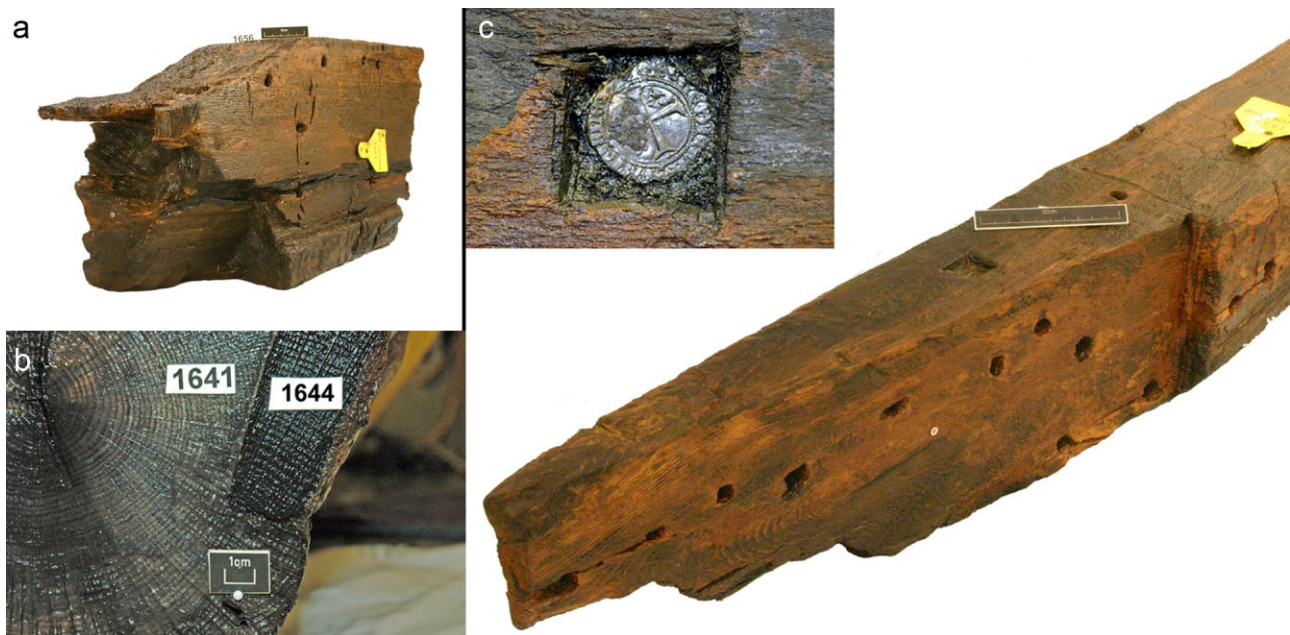
Figure 11. *a*) Aft swelling in keel (Stuart Churchley, Newport Museums and Heritage Service); *b*) Cross section through keel and adjoining starboard garboard showing rebate. (Newport Museums and Heritage Service); *c*) Keel forward scarf with rebate for coin on inboard face. Coin shown *in situ* in inset, diameter 22 mm. (Newport Museums and Heritage Service)

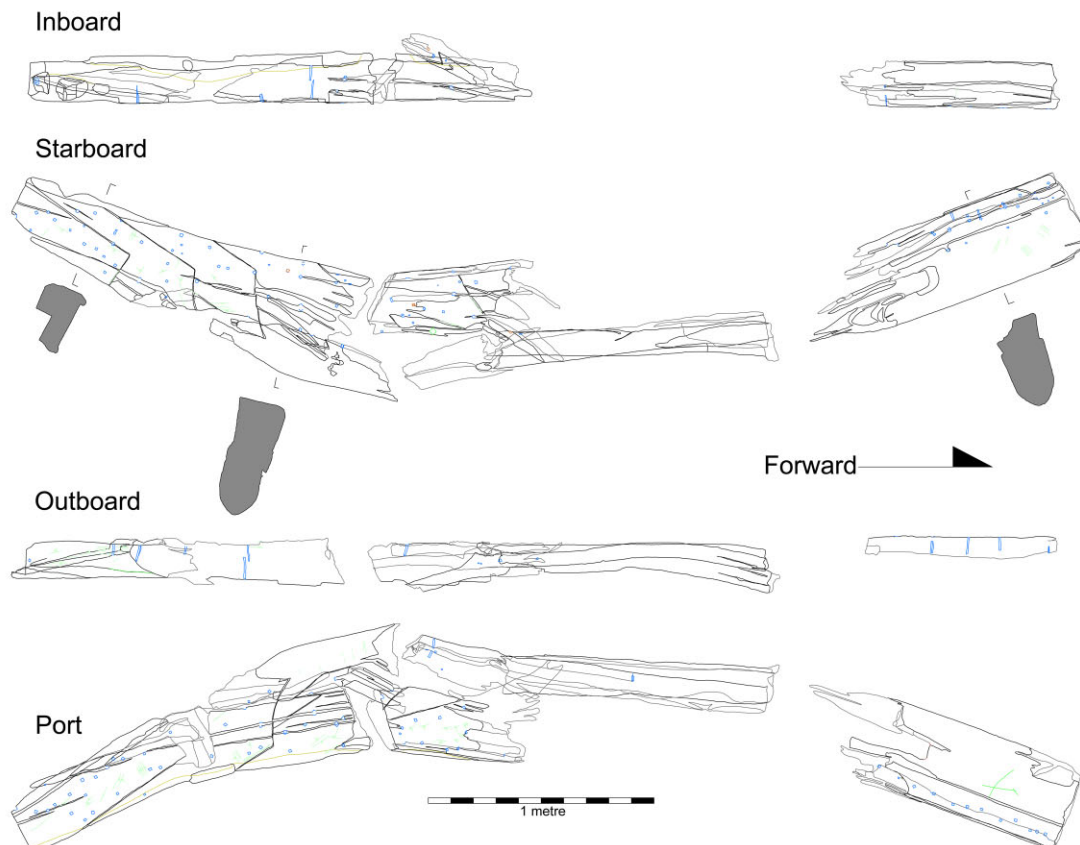
Figure 12. The stem was heavily damaged by sheet and concrete piles. This drawing shows the recorded fragments in their approximate original positions. (Toby Jones)

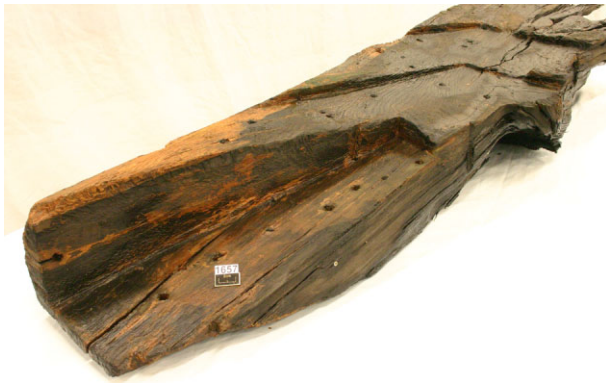
*Figure 13.* Starboard side of the stem showing scarf to keel and rebates for hull planks. (Stuart Churchley, Newport Museums and Heritage Service)

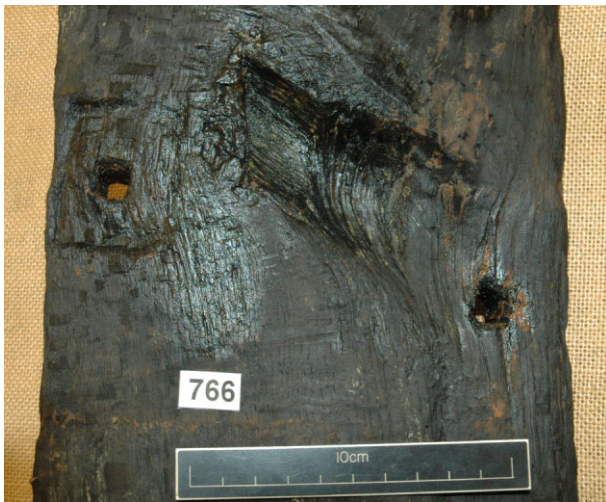
*Figure 14.* Trimmed sidebranch encapsulated by later tree growth on P10.7—evidence for forest management. (Newport Museums and Heritage Service)

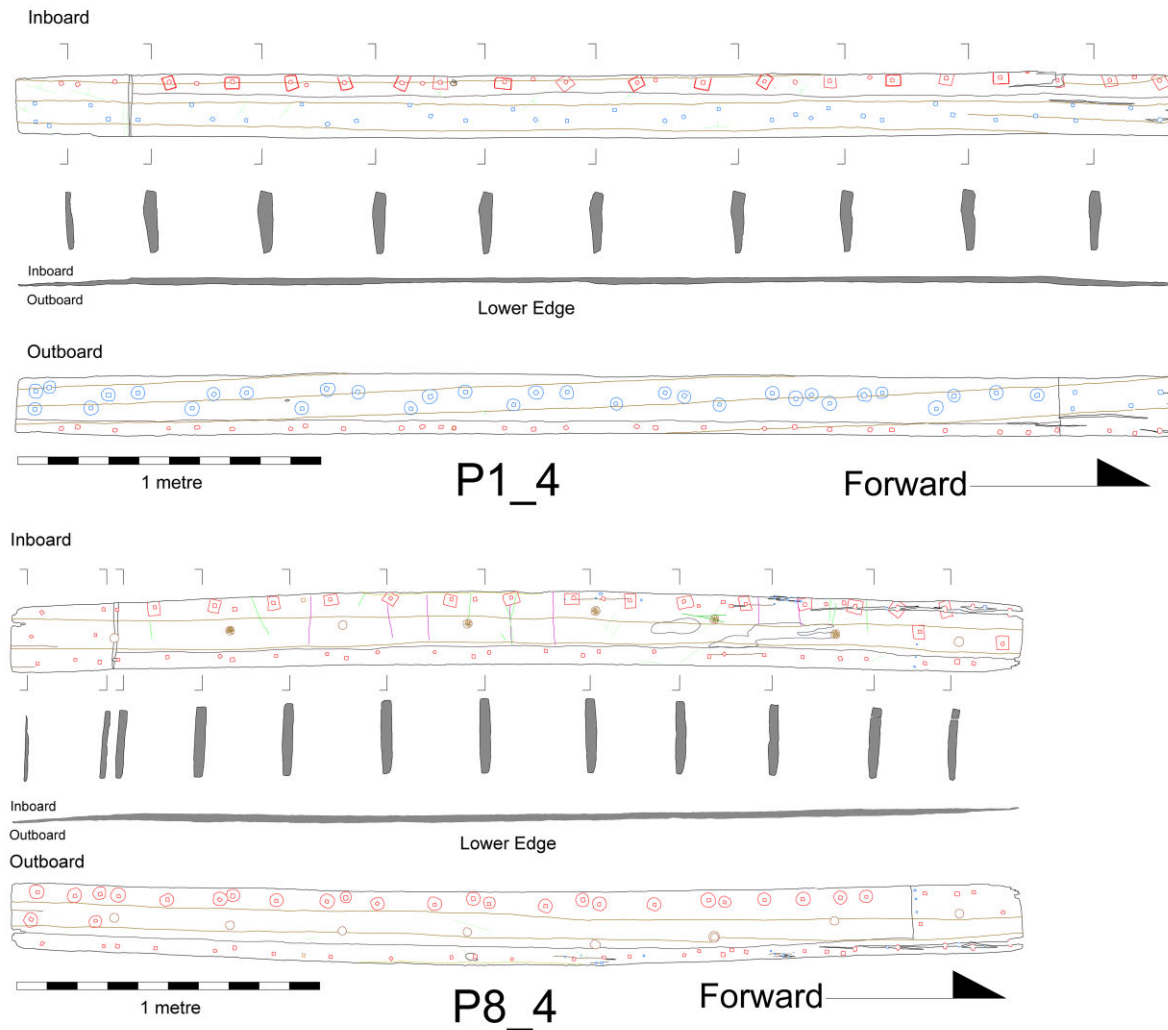
Figure 15. Typical garboard plank (P1.4) with spike-nail fasteners passing through into the keel and clenches along the upper land; Typical hull plank (P8.4) with nailheads on lower outboard face and roves on upper inboard face. (Toby Jones)

The intact planks range in length from 1.28–4.51 m, with a mean length of 2.69 m (longer and shorter planks are a distinct possibility, as many were damaged during salvage and post-depositional damage) (Fig. 15). The plank widths, measured at the midpoint of the length, range between 170 mm and 256 mm, with a mean width of 212 mm. The planks range between 11 mm and 33 mm thick, with a mean thickness of 24 mm along the upper edge and 19 mm along the lower edge. Plank widths taper fairly evenly towards the ends of the vessel, with the visible width (measured on the inboard face) ranging from an average of 176 mm at F30 to an average of 147 mm at F1 and F60.

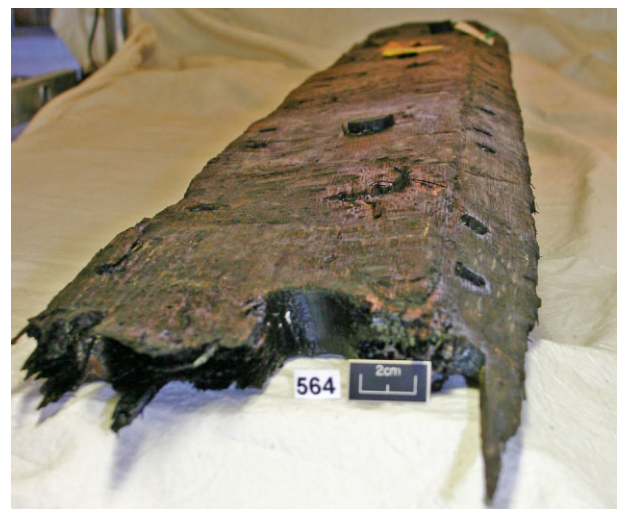
Figure 16. Angled inboard land on hull plank P2.4. (Newport Museums and Heritage Service)

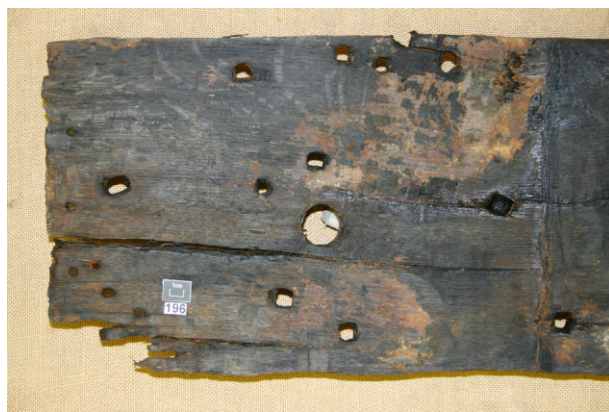
Figure 17. Inboard face of aft scarf on hull plank P11.5. (Newport Museums and Heritage Service)

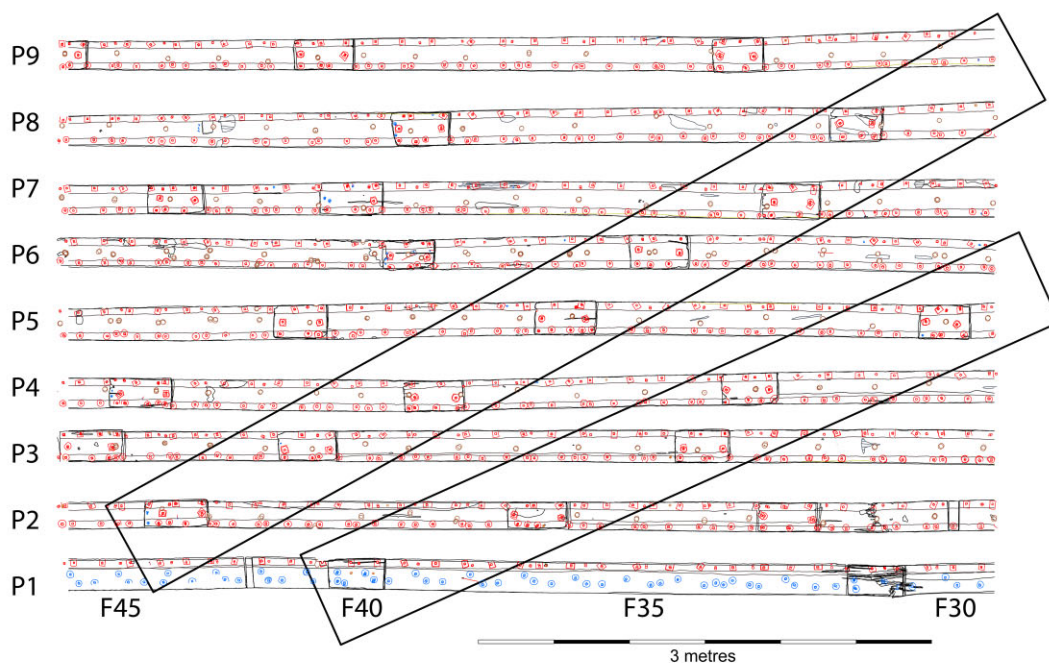
Figure 18. Scarf pattern between P1 and P10 and between F30 and F45. (Toby Jones)

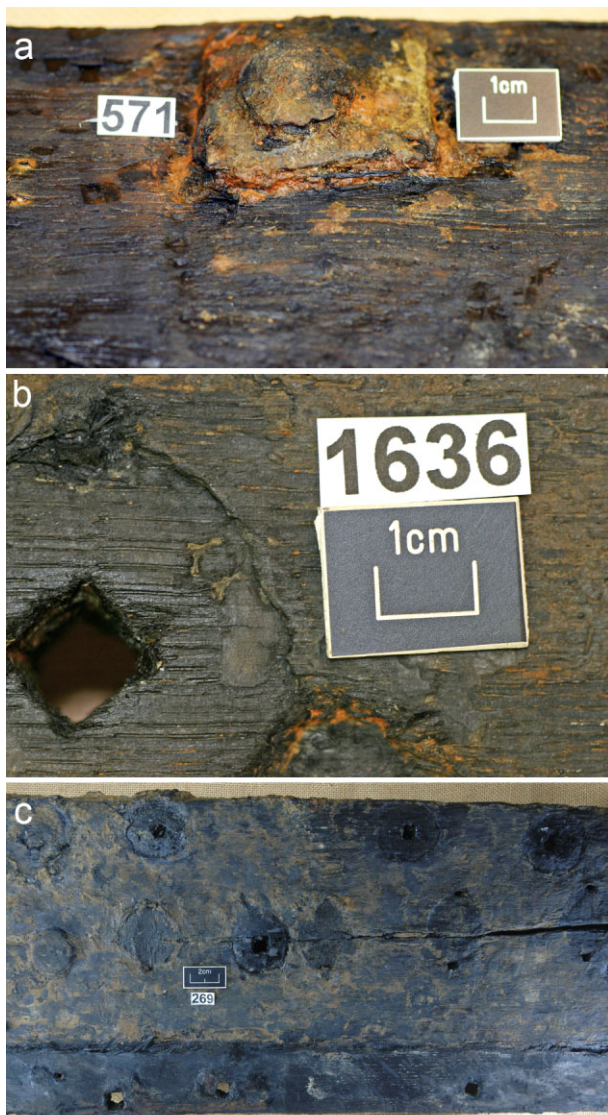
Figure 19. a) Rove on the inboard face of hull plank S2.5; b) Nail-head impression on outboard face of garboard hull plank S1.1. A star-shaped impression is interpreted as a nail-maker's mark; c) Outboard face of hull plank S17.4 during cleaning. Impressions of four sintels used to repair a crack. (All Newport Museums and Heritage Service)

Fastenings clearly visible on the inboard face of the outer hull consisted of oak treenails, concreted roves along the inboard upper edge of the strakes and at the scarfs between planks, iron spike-nails also visible along the upper edge of each strake located at the frame stations, and oak spike-nails presumably reflecting repair of failing iron fastenings. The planks are fastened to each other with round-headed square-shanked wrought-iron nails driven from the outboard through pre-drilled holes and peened over wrought-iron roves (Fig. 19a). Two extra nails and roves were used to

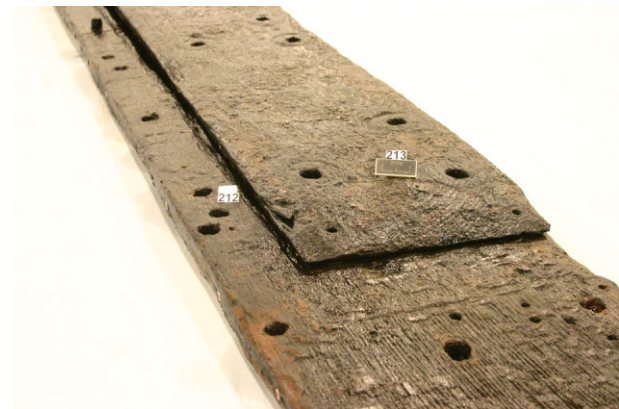
Figure 20. Tingle (repair patch) on outboard face of hull plank P11.6. (Newport Museums and Heritage Service)

Oak tingles or repair planks covering areas of cracking or damage were primarily found attached to the outboard faces of the hull planking (Fig. 20). Tingles were recorded in the lower bow area as well as amidships. The tingles could be classified by the presence or absence of rebates on the inboard face. Tingles with such rebates were designed to accommodate the proud-standing extant fastener heads, while tingles without rebates were applied to areas where the original

fastener heads had been purposely removed or rotted/corroded away. Tree-ring analysis of some of these timbers led to the cross-matching of five unrebated tingles which were dated against a range of British (and one Irish) chronologies. Assuming these represent a single repair phase, the parent trees for these timbers were felled AD 1459–1483.

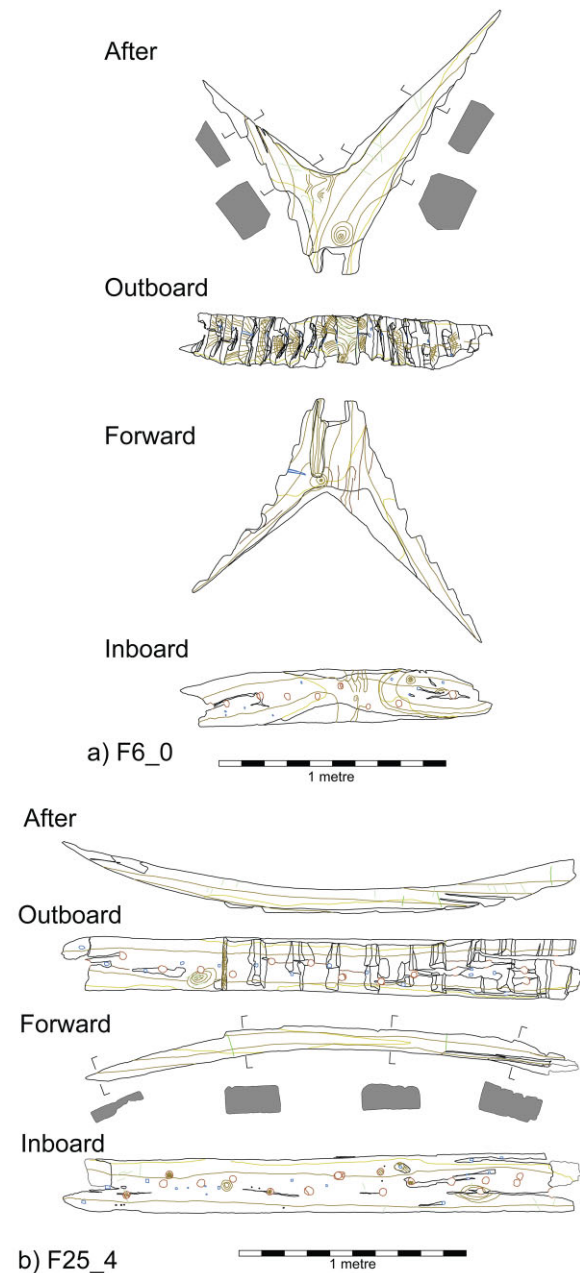
Figure 21. a) Typical V-shaped floor-timber from the bow; b) Typical side timber—second futtock starboard side. (Both Toby Jones)

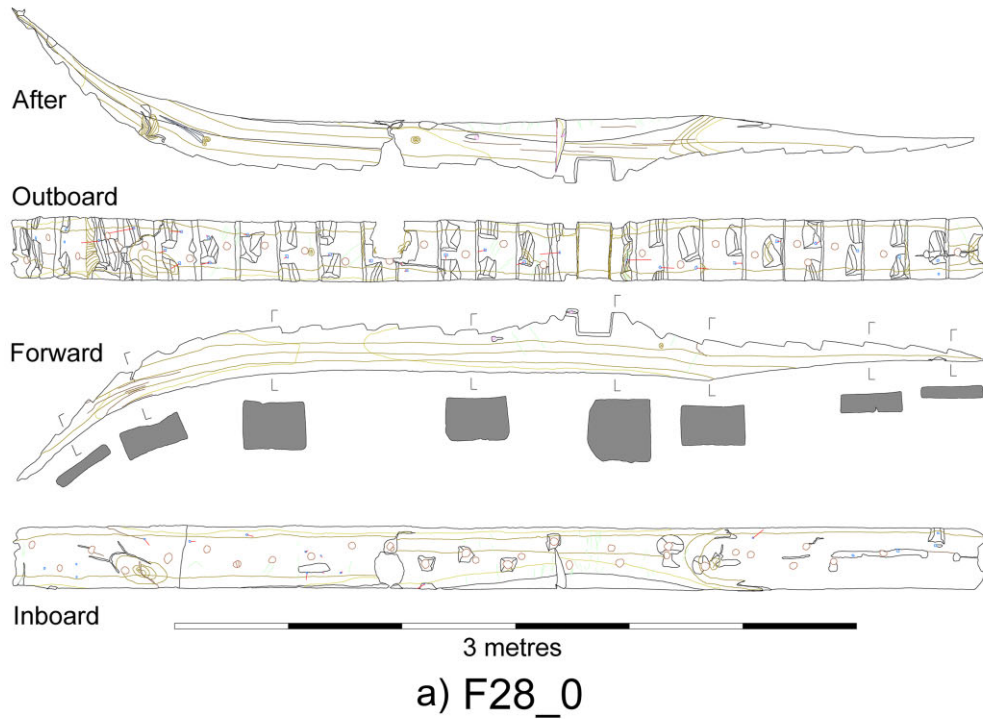
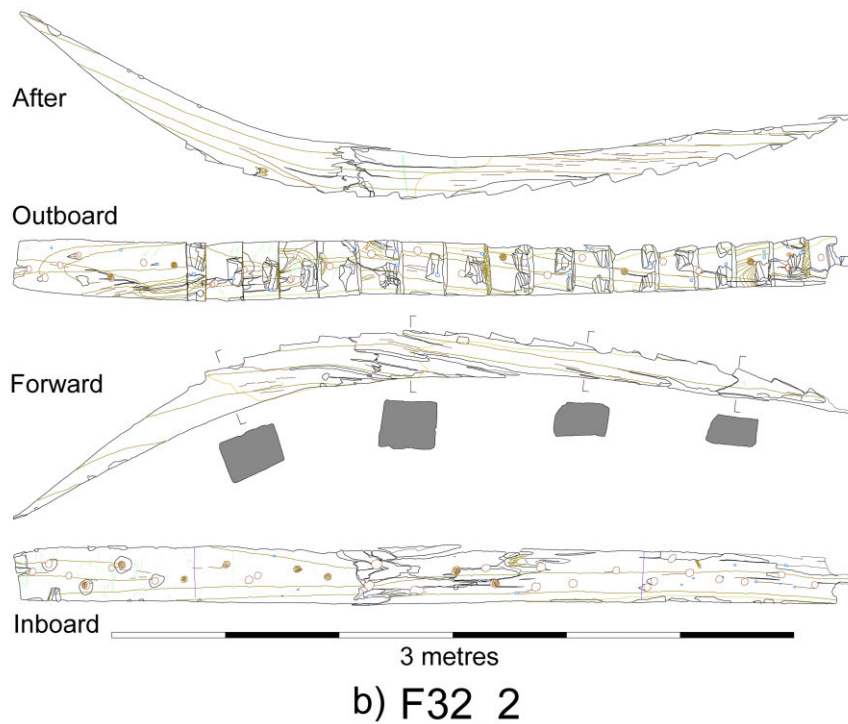
Figure 22. a) Typical floor-timber—assymetric floor from near to midships; b) Typical side timber—first futtock starboard side. (Both Toby Jones)

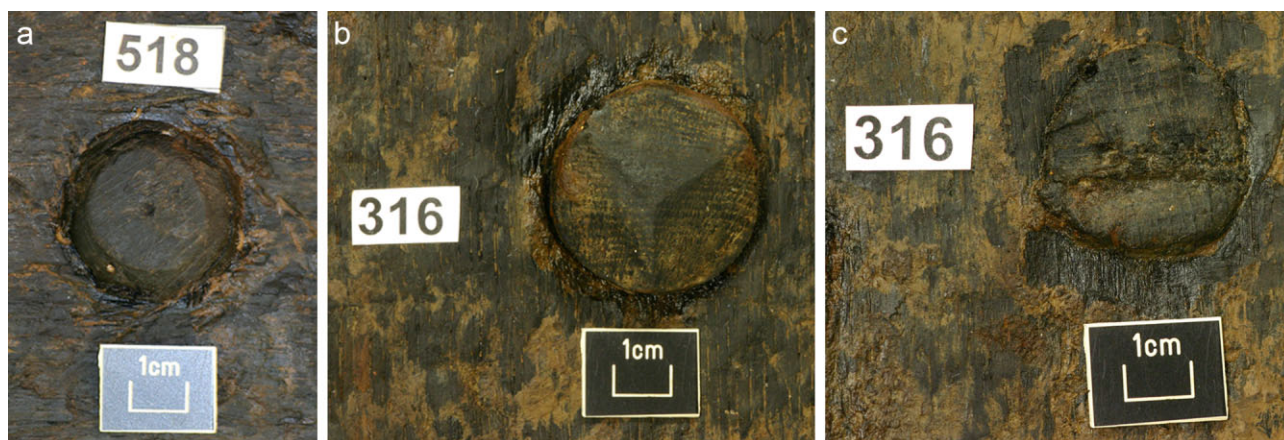
Figure 23. Treenail heads a) fastening framing timber to hull plank S13.7 with well-defined dimple; b) fastening framing timber to hull plank S19.5 with faceted head; c) fastening framing timber to hull plank S19.5 with wedged head. (All Newport Museums and Heritage Service)

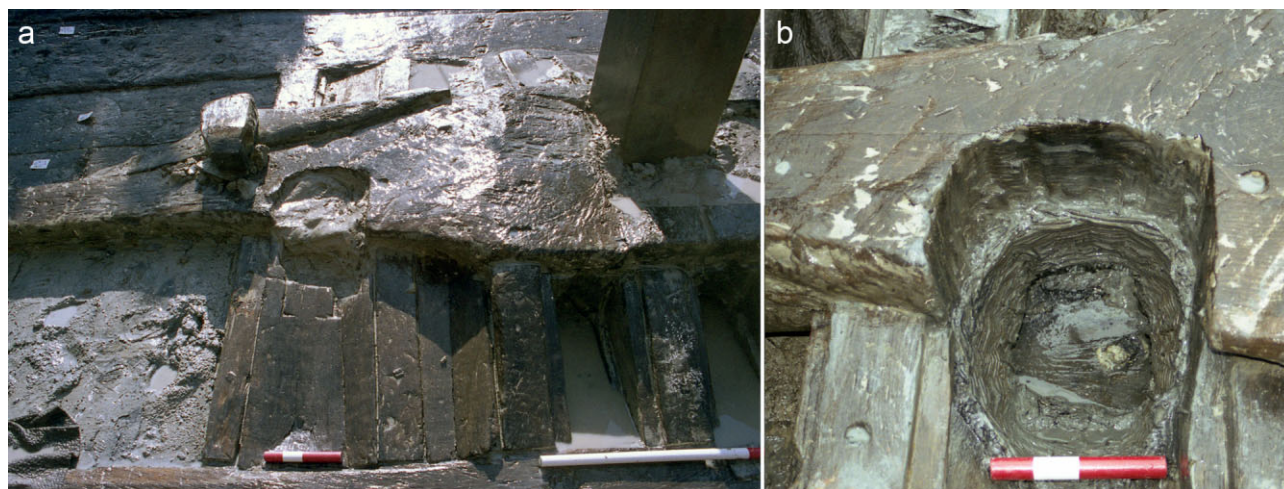
Figure 24. a) Keelson and surrounding timbers during excavation viewed from the starboard side. The mast-step and starboard pump hole have not been excavated. A stanchion found in a mortise in the timber adjacent to the keelson on the port side has been lifted; b) Starboard pump hole with strum box *in situ*. (Both Nigel Nayling)

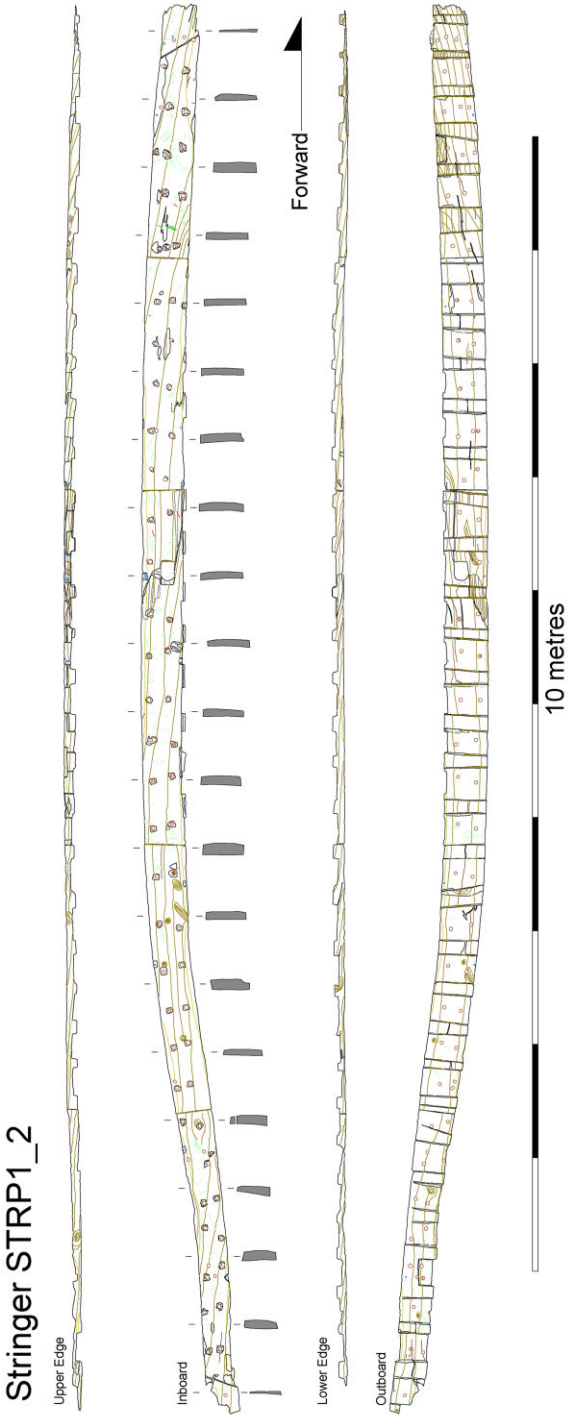
Figure 25. Stringer STRP1\_2, with rebates for the mast-step braces visible along the lower edge. (Toby Jones)

There are 25 distinct stringer timbers, recovered as 124 components (Fig. 25). The longest stringer measures 12.9 m and spans 35 floors. The stringers were

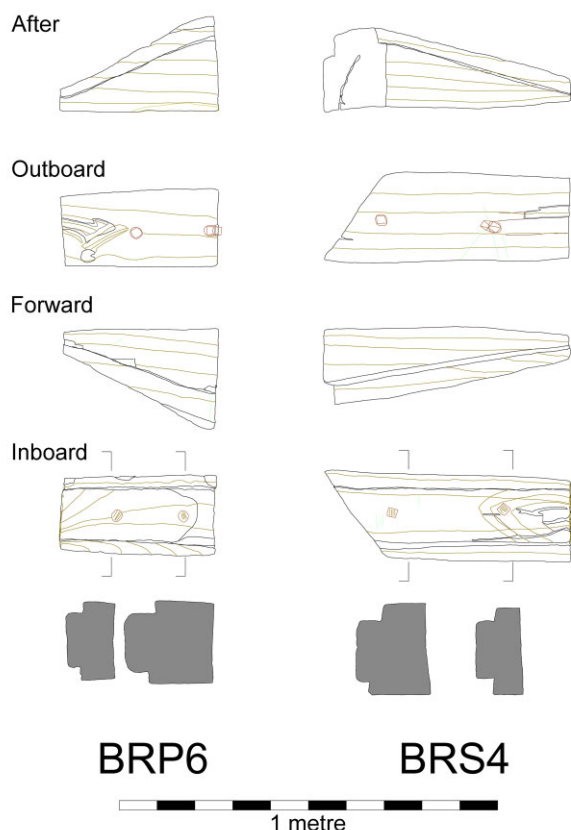
Figure 26. Typical mast-step brace. The braces were fastened to the underlying floor-timbers with square-sectioned treenails. (Toby Jones)

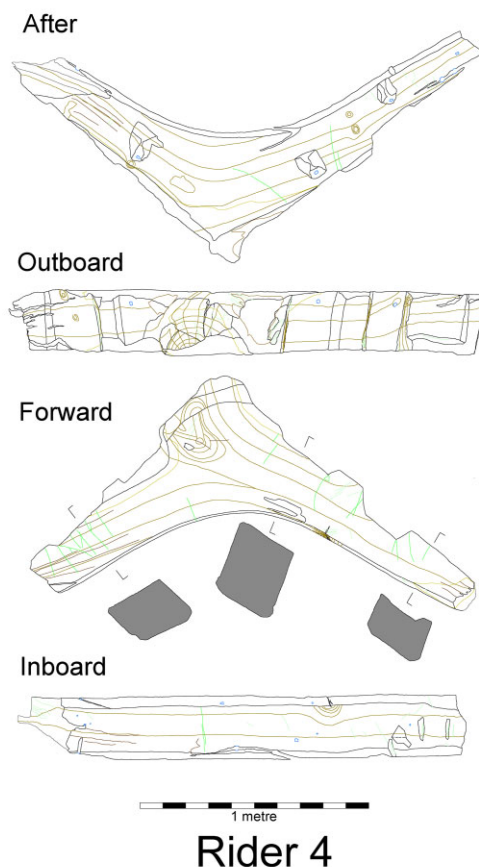
Figure 27. The largest of four riders found in the bow of the vessel. The riders were rebated on their outboard faces to fit over the stringers. (Toby Jones)

The four riders (all found in the bow area) were made from compass-grown oak timbers and rebated to sit on top of the stringers (Fig. 27). They range in length from 1.04–2.01 m, in width from 100–261 mm and in height from 306–636 mm.

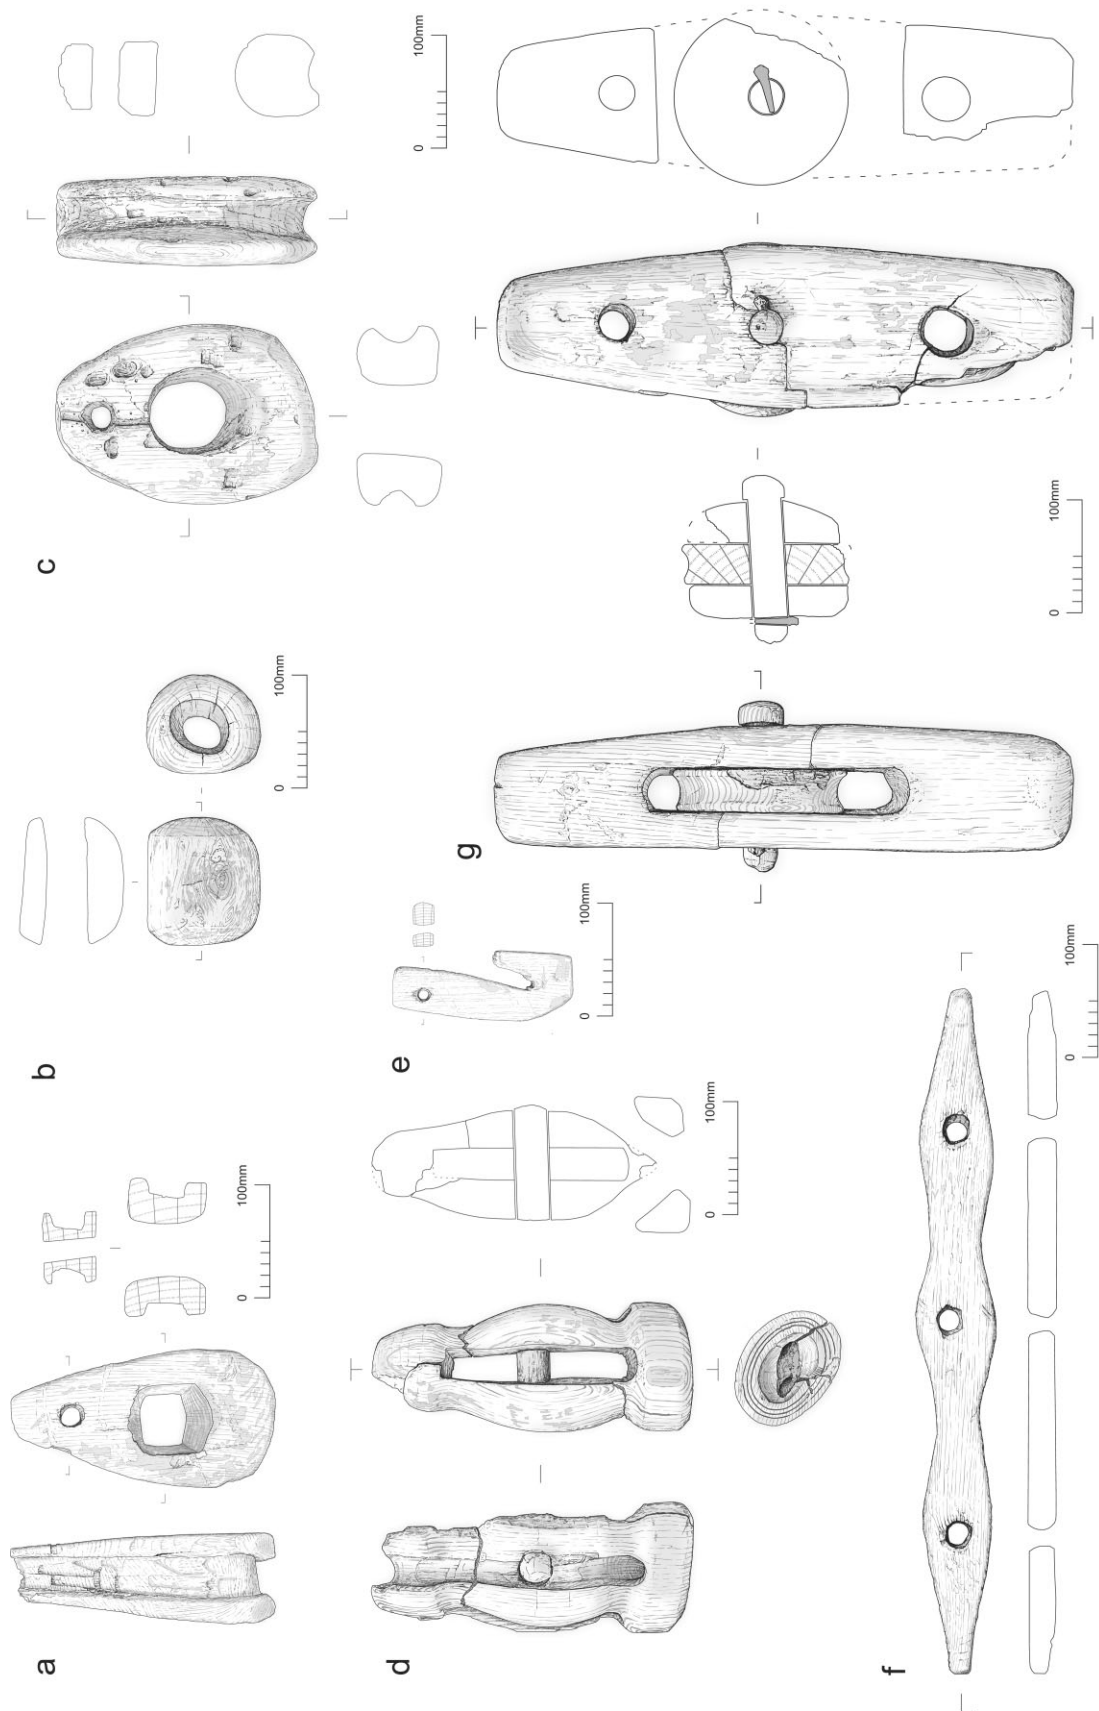
Figure 28. a) Heart block; b) Parrel truck or bead; c) Heart block; d) Dutch lift block; e) Lifting hook; f) Parrel rib; g) Clew garnet block. (All Anne Leaver)

Recovered rigging elements (Fig. 28) include two parrel ribs, two parrel trucks or beads, two heart blocks, a clew garnet block, and a Dutch lift/pendant

block as well as several loose sheaves, pins, a rigging bitt or spill toggle, bullseye, and a lifting hook. The rigging assemblage is small in terms of quantity and size, and it seems likely that many of the larger rigging elements, and cordage, would have been salvaged for reuse (McCarthy, 2013).
