## The Newport Medieval Ship, Wales, United Kingdom

The Newport Ship is the most substantial late medieval vessel excavated and recovered in Britain in recent years. It was abandoned after extensive salvage, possibly following attempts at repairs to the hull. More than 23 m of the clinker-built ship were recovered, along with significant artefact and environmental assemblages. Finds point to strong Iberian connections during the active life of the ship, which arrived in Newport in the Severn Estuary, after the spring of AD 1468. The dismantling and recovery of the ship has enabled detailed recording using innovative 3D digital techniques and approaches to hypothetical reconstruction. Publication includes a digital archive hosted by the Archaeological Data Service, a substantial report and this article.

**Key words:** ship construction, scantlings, 3D modelling, laser sintering, pumps.

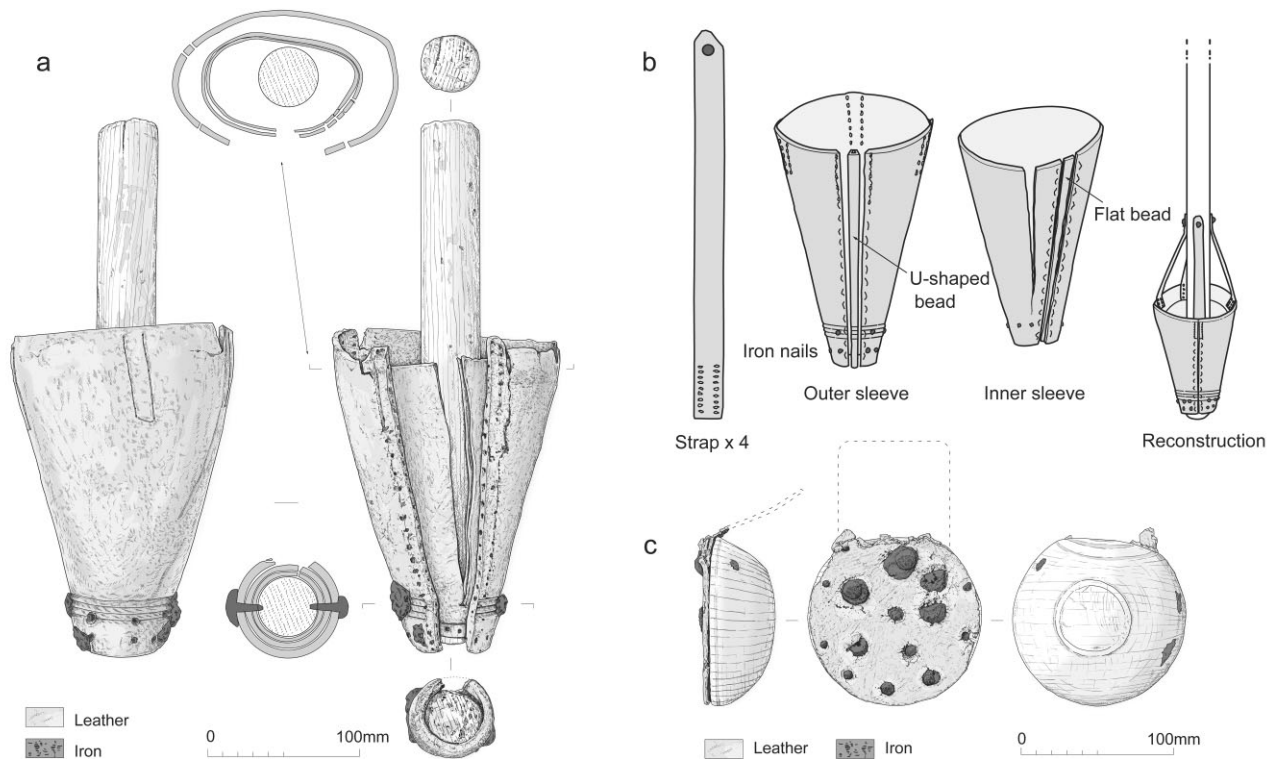
**Figure 29.** *a)* Composite pump spear or burr from a common pump, made from leather, iron and wood (Anne Leaver); *b)* Detail of pump spear showing stitching pattern and the interesting second/inner cone of leather (Quita Mould and Anne Leaver); *c)* Foot valve with remains of leather claque or hinge. Striations are visible where the hemispherical object was turned on a lathe. (Anne Leaver)

Several artefacts and objects relating to the ship's pumps were found during the excavation. These items include four pump holes, a strum box, pump tube, pump base, various foot valves, pump spear (burr valve) with handle and assorted basketry fragments (Fig. 29). Pumps of the period consisted of hollowed-

out tree trunks with a cone-shaped upper (or burr) valve, and a lower foot valve. Bilge water was drawn up the tube, and prevented from leaking out the bottom by the one-way foot valve. Leather was the ideal material to make the durable hinges and cones necessary for the continuous operation of the pump. There was also a mortised block and associated stanchion that may have formed part of a trunk surrounding and protecting the midships pump tube.

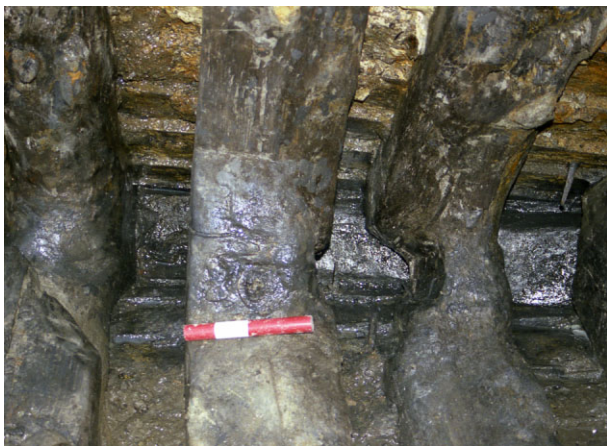
Figure 30. Roughly cut pump hole at F7/F8. (Nigel Nayling)

There was a pump hole crudely made by chiselling the after face of F7.0 and the forward face of F8.0 (Fig. 30). Near the stern of the vessel, at F58, the remains of a pump tube, pump base and associated wood and leather valves were found in a gap apparently created by the removal of the central part of the floor-timber at this frame station. Fragments of a probable pump basket were also found in the stern, near the remains of the pump tube. The amidships pump hole, at F33.0–F34.0, just off the centreline axis on the starboard side, contained a woven willow strum box, but no other pump-related artefacts (Fig. 24). This basket was designed to act as a filter, keeping mud and debris from entering and damaging the ship's pump. There was an additional pump hole at F33.0–F34.0, just off the centreline axis on the port side, but this area was sealed up at some point during the working life of the vessel. Other parts of pumps,

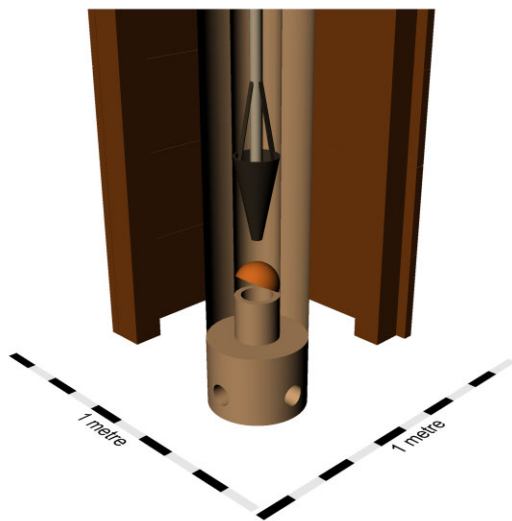
Figure 31. Schematic digital reconstruction of a ship's pump using disarticulated pump-related artefacts found during the ship excavation. (Toby Jones)

including several foot valves, were found scattered around the hull. The diverse nature of the pump-related artefacts made it possible to create a schematic reconstruction using the recovered components (Fig. 31). These pumps predate the earliest-known similar pumps, and shed light on the structure and function of medieval pumping technology and broader technological innovation in the late medieval period (Oertling, 1996: 20).

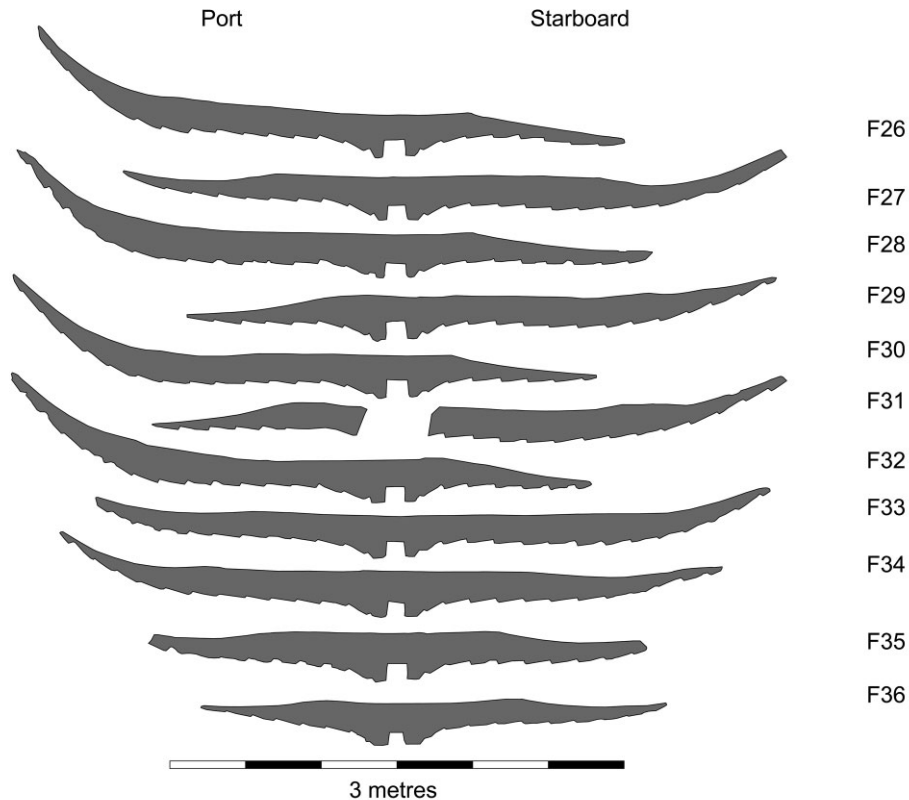
Figure 32. Alternating pattern of asymmetric floor-timbers amidships. (Nigel Nayling and Toby Jones)

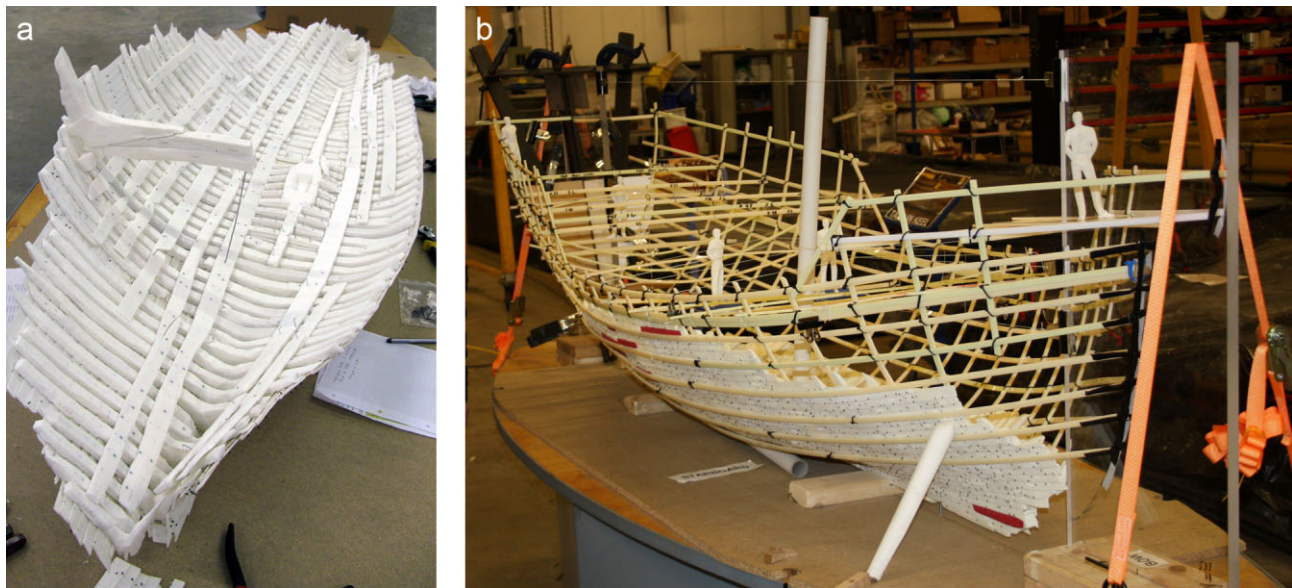
Figure 33. a) 1:10 scale model of the hull remains, with individual model pieces created by laser sintering and fastened with micro-fasteners; b) Physical model with ribbands added to ghost in missing areas of the hull. (Toby Jones)

then experimentally assembled with micro-fasteners to build an as-found model of the remains of the Newport Ship (Fig. 33).

Long plastic ribbands were then attached to the model along every fourth strake and were used to ghost in missing areas of the hull and determine the likely location of the stem and stern. Transverse ribbands were installed to approximate the position of selected frame stations. The use of temporary fasteners, such as bulldog clips and cable ties, allowed for easy adjustment of the ribbands. The physical model, complete with a sheer and castles, and representing a minimum reconstruction (Fig. 33b), was documented using a contact digitiser and laser scanner. The resulting 3D digital hull form data served as the foundation of the minimum reconstruction.

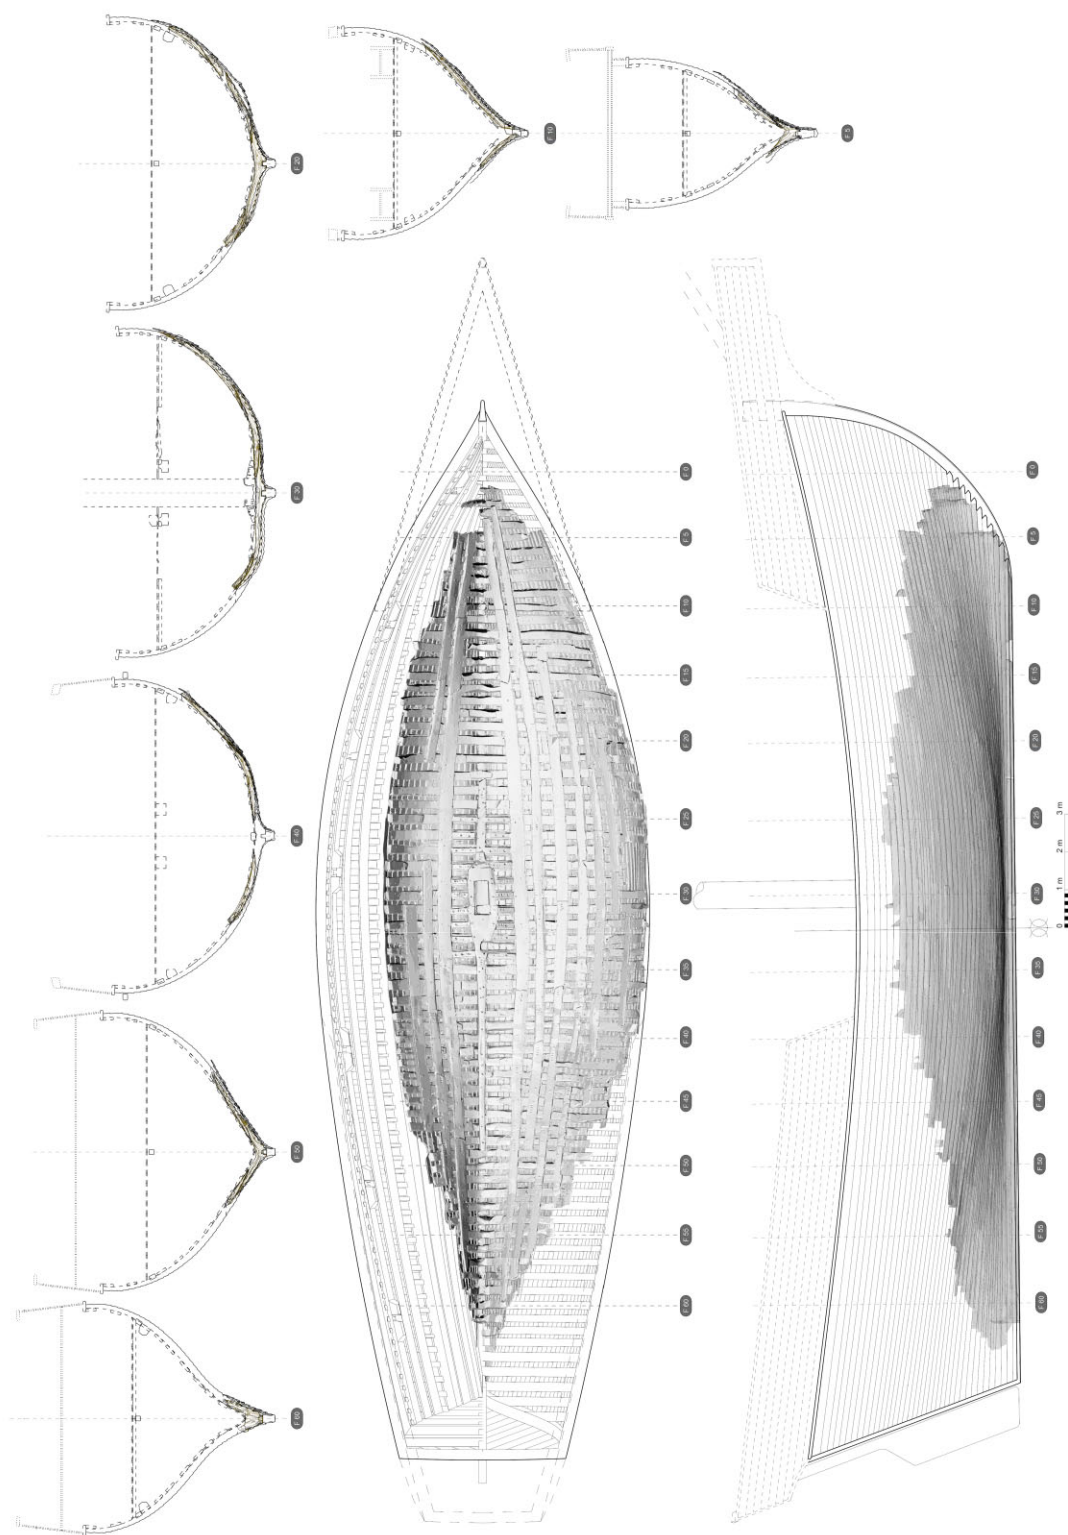
Figure 34. Torso drawing showing a laser scan of the articulated hull remains superimposed on the minimum reconstruction. (Pat Tanner)

(Tanner, forthcoming). A series of 3D models and drawings, including a torso/as-found drawing, a construction drawing, and a minimum reconstruction showing masts, rig and steering gear, were all produced using Rhinoceros3D and the associated OrcaMarine plugin (Figs 34–6).

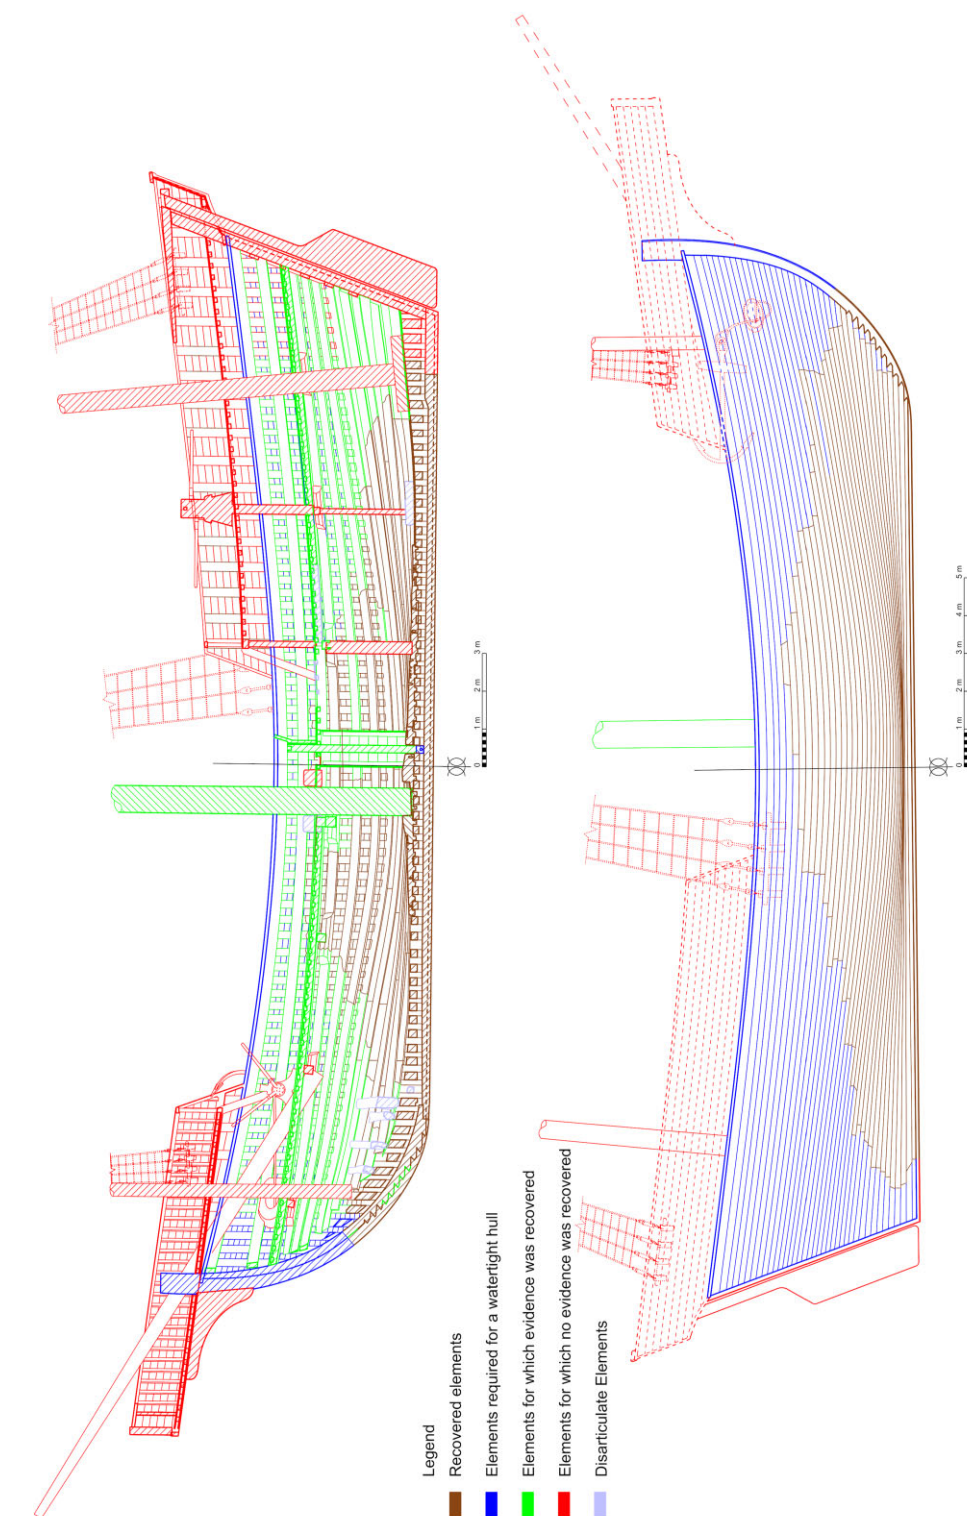
Figure 35. Drawing showing what parts of the reconstruction were based on direct archaeological evidence and what parts are conjecture. (Pat Tanner)

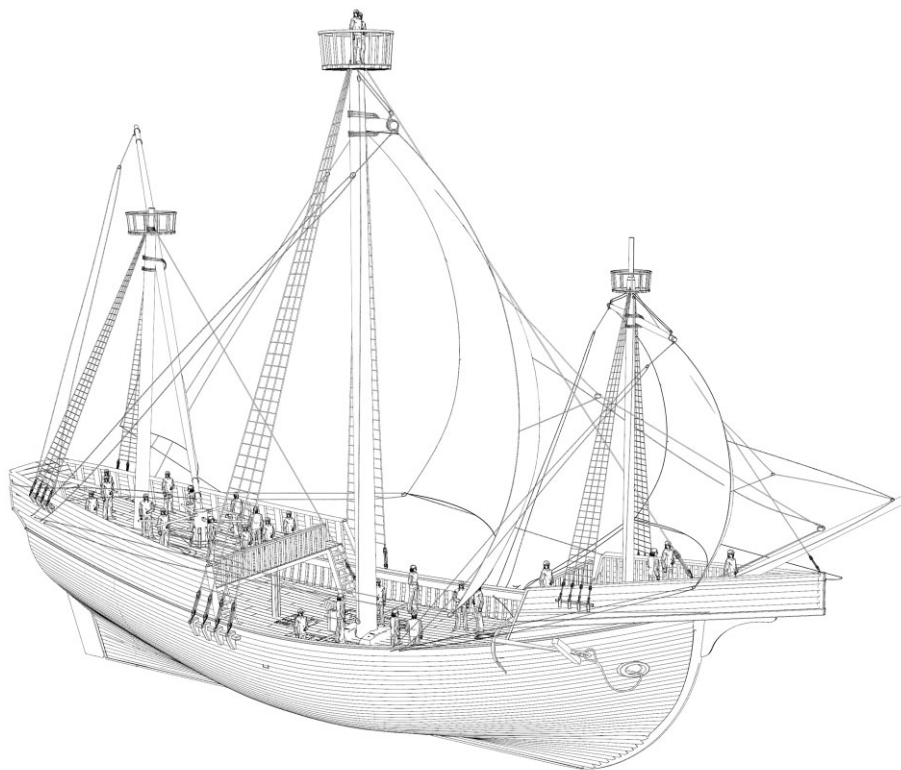
Figure 36. A perspective view of the minimum reconstruction drawing. (Pat Tanner)

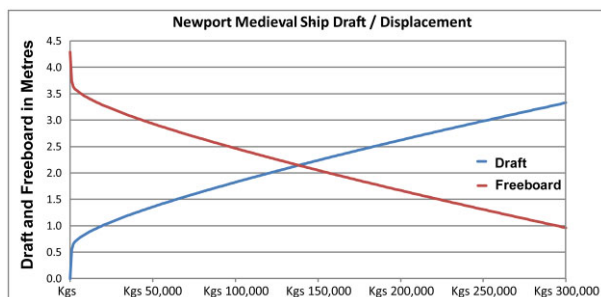
Figure 37. Graph showing the relationship between draft, freeboard and displacement. (Pat Tanner)

The recreation of the original hull form within a digital environment has allowed for the use of OrcaMarine to analyse the cargo capacity, sea-keeping characteristics and performance of the vessel in a variety of situations. The hull was tested as an empty shell, ballasted, and fully laden; all states that it would have regularly experienced during its working life. The vessel was found to have a notional cargo capacity of 107–141 metric tonnes, with an additional 17 tonnes of ballast. The total displacement of the ship, when fully loaded, would have been around 207 tonnes (Fig. 37). The total hold volume on the minimum reconstruction was estimated to be 225 m<sup>3</sup>. The inclusion of an aisle 900 mm wide running fore and aft would result in a reduced useable volume of 170 m<sup>3</sup> (Tanner, 2013: 101).

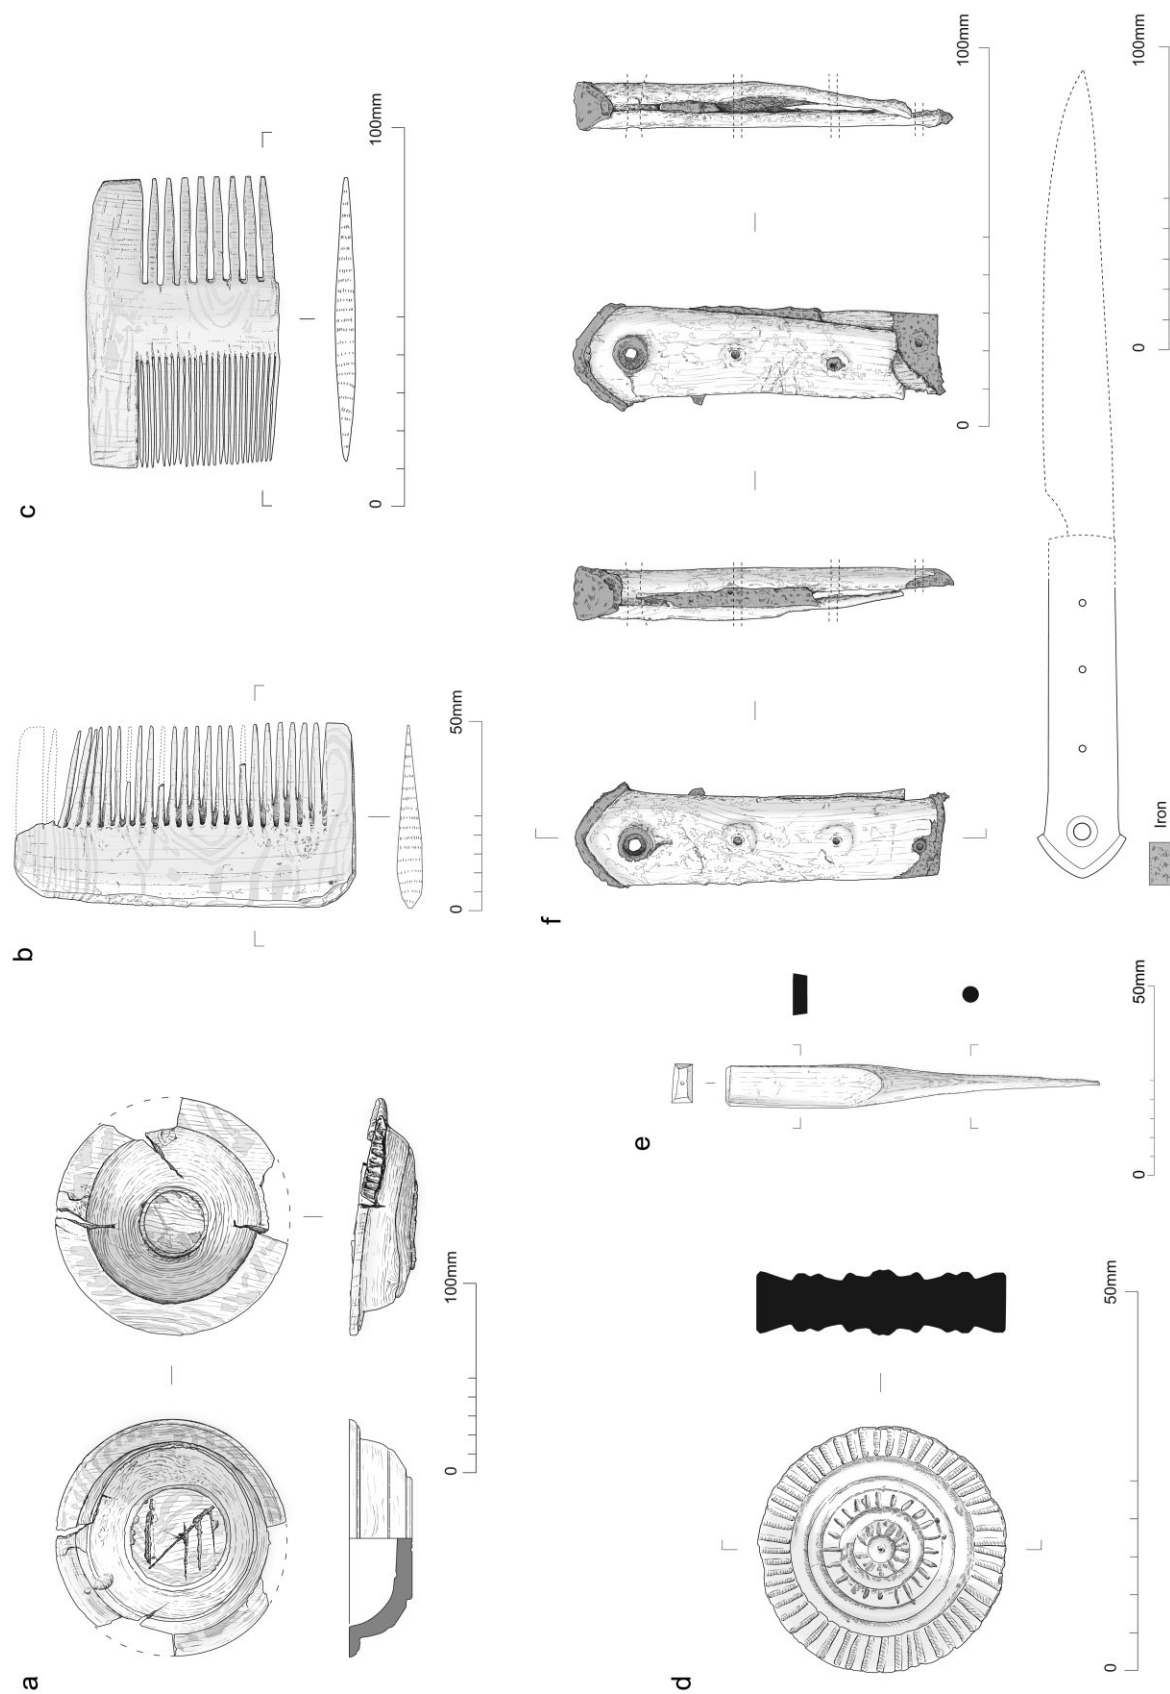
Figure 38. *a)* Turned ash bowl with possible ownership marks; *b)* Single-sided boxwood comb; *c)* Double-sided boxwood comb; *d)* Carved discoid boxwood gaming piece; *e)* Boxwood awl or fid; *f)* Boxwood knife handle with fragment of iron blade and bimetallic rivets. (Anne Leaver)

Several turned wooden bowls made from ash (*Fraxinus excelsior*) were recovered (Fig. 38a). Two boxwood (*Buxus sempervirens*) combs were found, with one comb double sided, with coarse and fine teeth, for straightening hair and removing lice, respectively, with the other comb a single-sided example with coarse teeth (Figs 35b, c). Similar combs were found on the Cattewater shipwreck and the *Mary Rose*, as well as slightly later shipwrecks, including the *San Juan* (AD 1560) and *Trinidad Valençera* (AD 1588). A boxwood knife handle corresponds closely with other early to

mid 15th-century examples found during excavations in London (Cowgill *et al.*, 1987: 102–3, fig 265), as well as handles found on the Cattewater wreck and *Mary Rose* (Fig. 38f). The wooden gaming piece is a finely crafted disc of boxwood that has been turned and carved with concentric decorations (Fig. 38d). Measuring 33 mm in diameter, the gaming piece or counter could have been used for games such as backgammon, *tabula*, or merels. An awl or fid was recovered near the mast-step. It is finely made from boxwood and measures 100 mm in length (Fig. 38e).

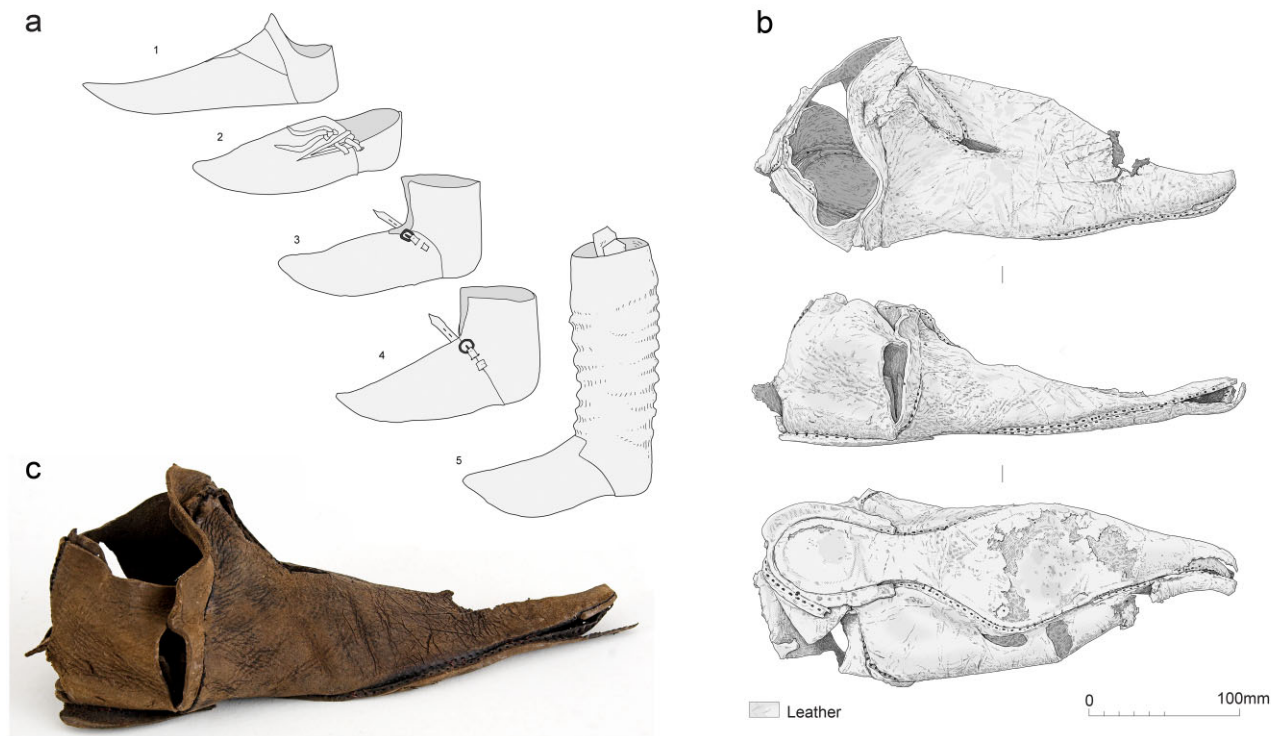
Figure 39. a) Types of footwear found during the excavation. (Quita Mould and Anne Leaver); b) Poulaine shoe with moss-filled toe. (Anne Leaver); c) Conserved poulaine shoe with moss-filled toe. (Rex Moreton)

Eight distinct leather shoes and three boots were recovered during the excavation (Fig. 39). Numerous other shoe parts were also found, drawing attention to the ubiquity of leather footwear during this period. Several of the shoes had long, pointed toes, which were stuffed with moss to hold their shape. Referred to as pikes or poulaines, these shoes were highly fashionable and subject to sumptuary laws in the medieval period. These laws were designed to enforce traditional social and economic hierarchies and limit expenditure on luxury items. The specific effect on the long-toed shoes was to limit the length of the toe to two inches. The long-toed poulaine shoe found on the Newport Ship exceeds this law by more than an inch (Mould, 2013).

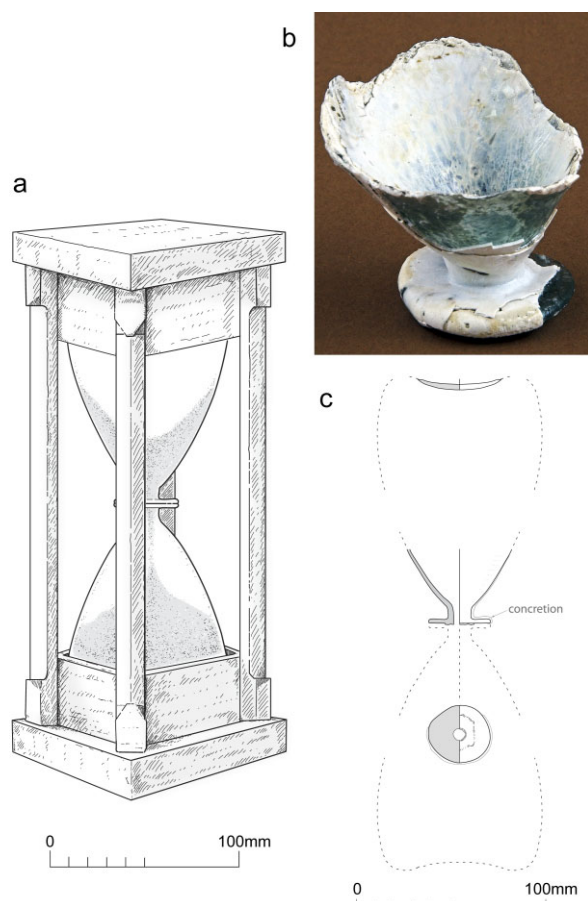
Figure 40. a) Reconstruction of a sandglass showing the probable origin of b) the recovered fragment (Anne Leaver); c) Fragment of a sandglass recovered near the mast-step. (Rex Moreton)

The sole item related to navigation was a fragment from the neck of a sandglass which was recovered near the mast-step (Fig. 40). Made from cloudy potash glass, it would have formed part of one half of the instrument, with the two halves being fitted into a wooden frame for protection.

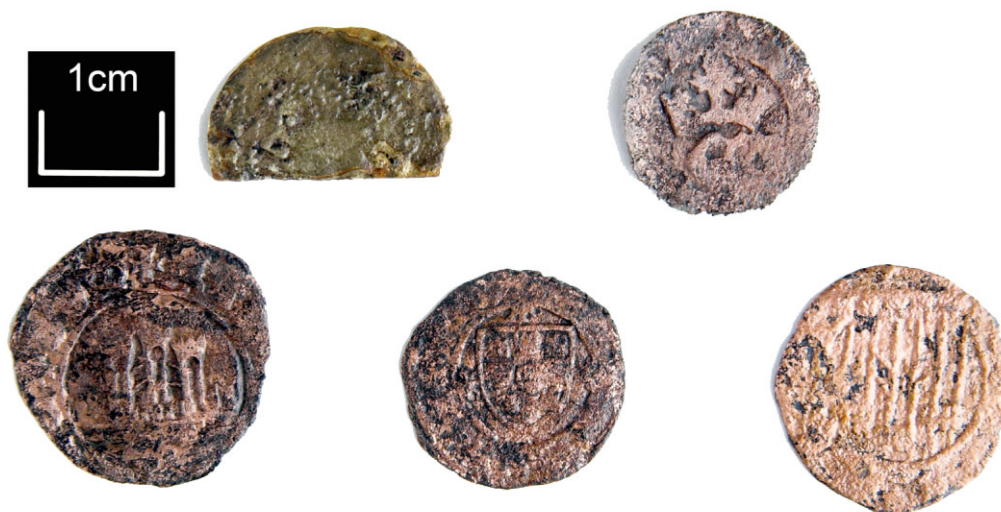
Figure 41. Portuguese ceitels, a real preto, and a folded jetton from Nuremburg. (Rex Moreton)

Six coins (five Portuguese and one French) and one jetton (from Nuremburg, Germany) were recovered, all dating to the 14th or 15th centuries. The Portuguese coin assemblage consists of one *real preto* of Duarte I (1433–1438) and four *ceitils* of Afonso V (1438–1481) (Besly, 2013) (Fig. 41). These coins were probably used by the crew and lost during voyages, becoming trapped

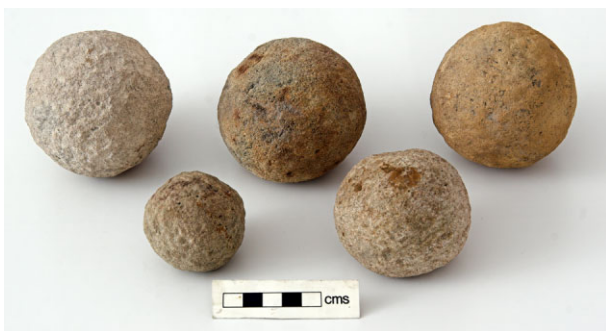
Figure 42. Five stone shot recovered during the excavation. They range in diameter from 55–82 mm. (Newport Museums and Heritage Service)

Five examples of stone shot were recovered, and can be divided into three size classes: 55 mm, 67/70 mm, and 80/82 mm. This size of shot would have likely have been used in light wrought-iron breech loading pieces, with the smallest diameter (55 mm) being similar to the bore diameter of three swivel guns found on the Cattewater wreck (Redknap 1984, fig. 47, nos 136, 137) (Fig. 42).

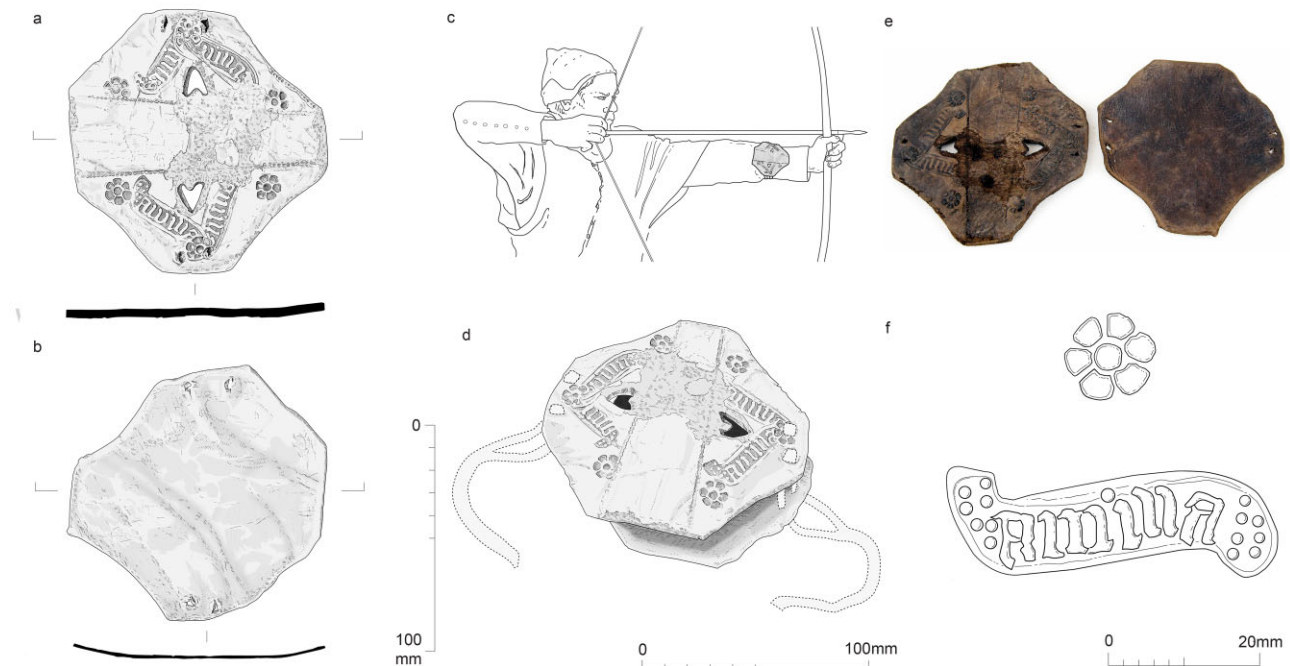
Figure 43. a–f) Bracer with stamped inscription. Note the wear caused by repeatedly being struck by bow string. (Drawing—Anne Leaver, photo Rex Moreton)

The archer's wrist guard, or bracer, is a fine example of medieval leatherwork, with embossed decorations and the Latin word *amilla*, which translates as bracer (Fig. 43). It shows wear marks consistent with the repeated shooting of a bow. The bracer is made from cattle hide, with a calfskin lining, and is similar to bracers recovered from *Mary Rose* (Soar, 2011).

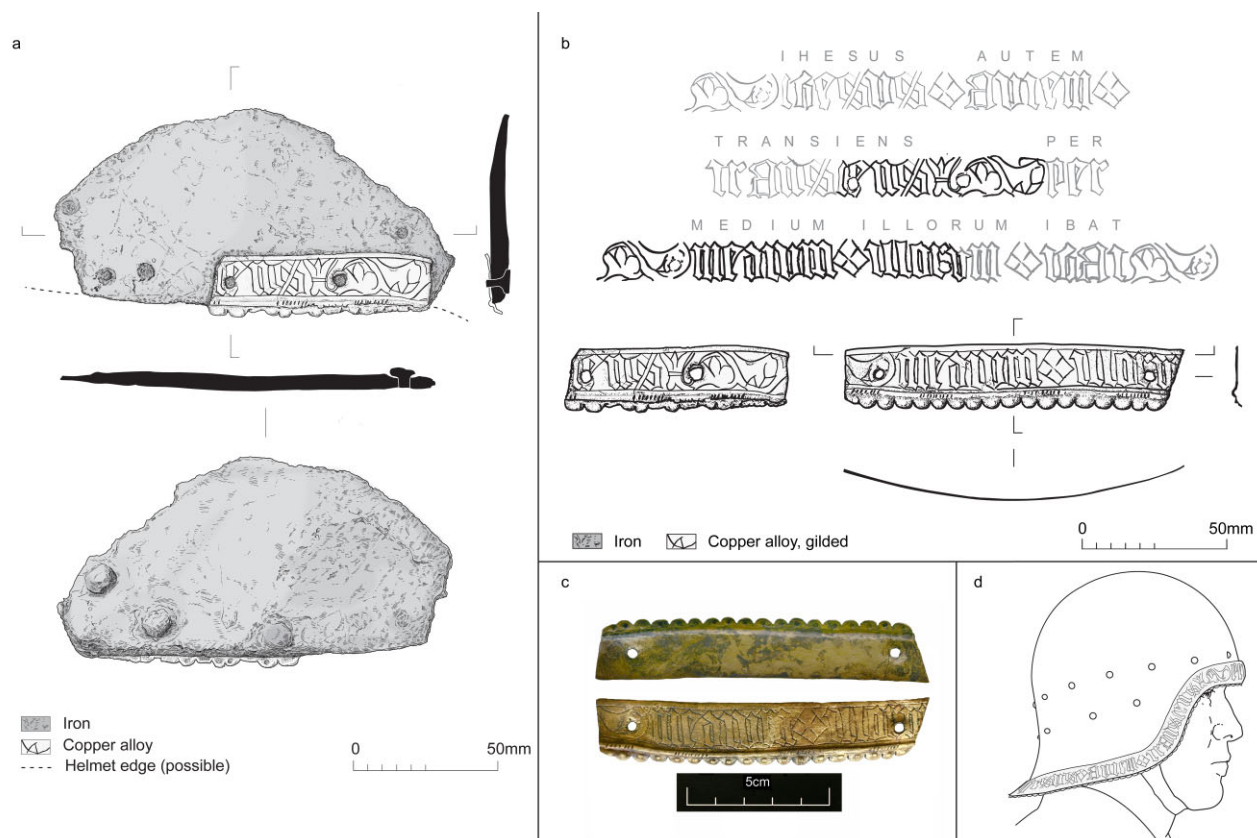
Figure 44. a) Fragment of an iron helmet with engraved brass decorative strips; b) Reconstructed engraved brass decorative strips; c) Engraved brass decorative strips from iron helmet; d) Reconstruction of iron helmet showing placement of engraved brass decorative strips. (Drawings Anne Leaver; photo Newport Museums and Heritage Service)

Fragments of a decorated iron helmet were also discovered (Fig. 44). The decoration consisted of two copper-alloy strips with engraved Gothic Latin texts quoting a biblical passage. The text (recovered portion in bold) probably read: **IHESUS AUTEM TRANSIENS PER MEDIUM ILLORUM IBAT**, which translates as 'But Jesus passing through the midst of them went on his way'. The passage is from Luke IV.30, and was used as a commonly quoted charm during the medieval period (Redknap, 2013b).

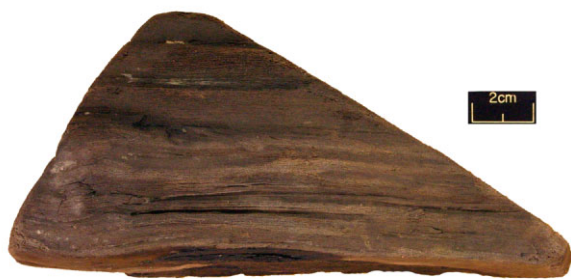
Figure 45. One of numerous triangular pieces of alder interpreted as chocks for stowage of casks. (Newport Museums and Heritage Service)
