Lean Six Sigma Project – BX Oven  
Section

Dissertation

BEng Mechanical & Manufacturing

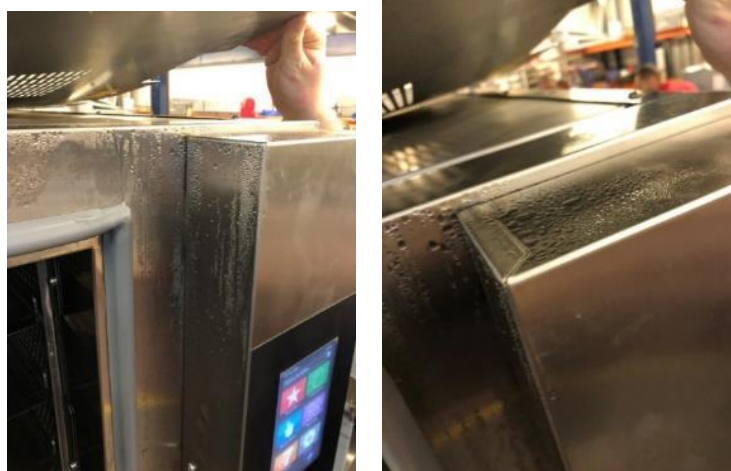
Figure 11: Steam Investigation

To fully understand why the controllers were failing an investigation was conducted to find the root cause of the failures. An oven was put on test and 20 seconds of steam was injected into the chamber with an oven temperature of 200°C.

Steam escaped the chamber and formed water droplets around the metal work. After repeating this multiple times it is possible for steam to get into the control panel. The example in *figure 12* was observed in a store. It shows moisture built up between the overlay and controller.

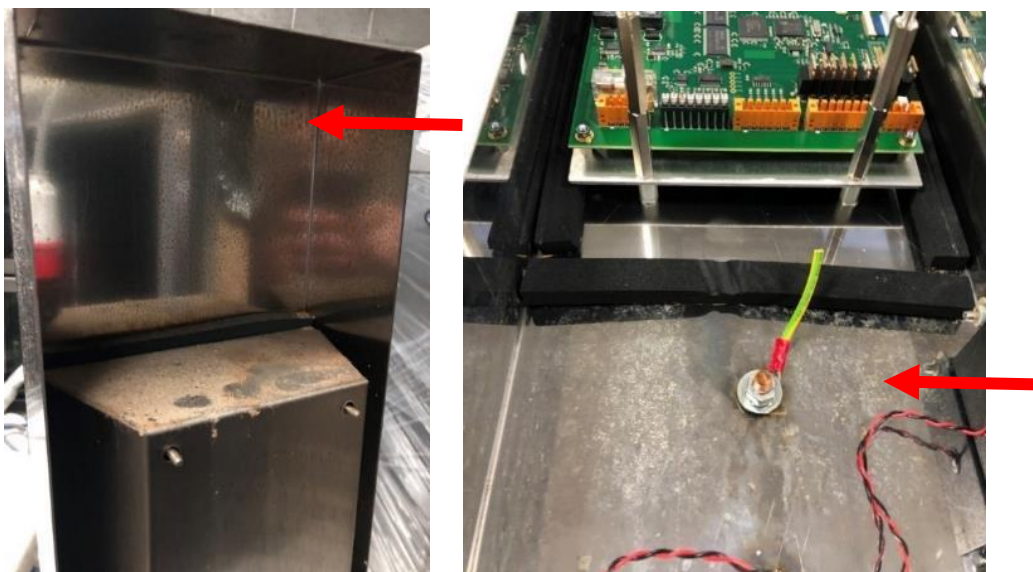
*Figure 13: PCB Operating Environment - High Humidity*

To fully understand the operating environment a oven was pulled from goods returned area, after removing the panel of an old style controller there was evidence of moisture and grease ingress. In this example the oven had a different pcb cover which offered good protection against the steam.

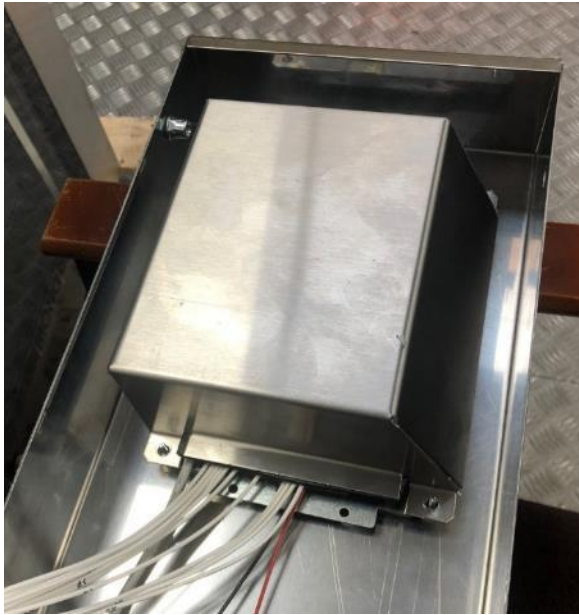
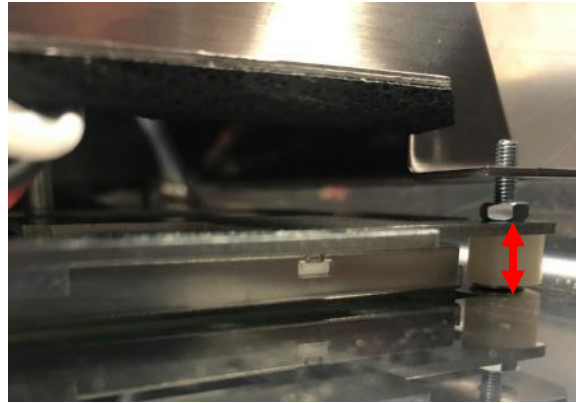
*Figure 14: Current PCB Cover*

The current controller cover in comparison had limited protection of the screen as it was surface mounted to the PCB leaving the screen exposed to any escaping moisture.

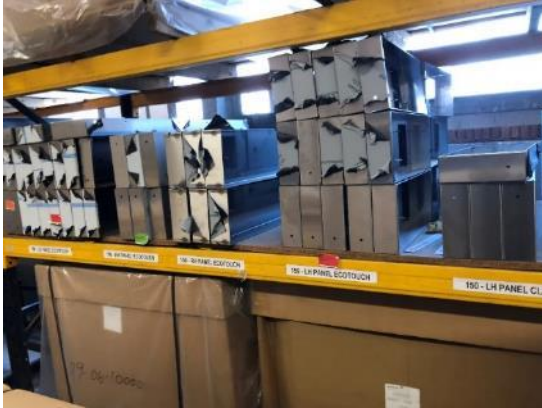
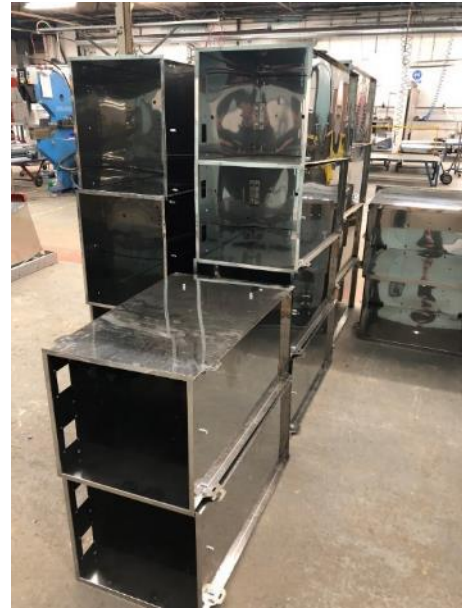
Figure 16: Overproduction

The next example is of oven chambers being produced these chambers are halogen light variants which are no longer produced. These chambers will sit here as WIP until a decision is made to build the ovens out and sell at a reduced cost to independent bakeries.

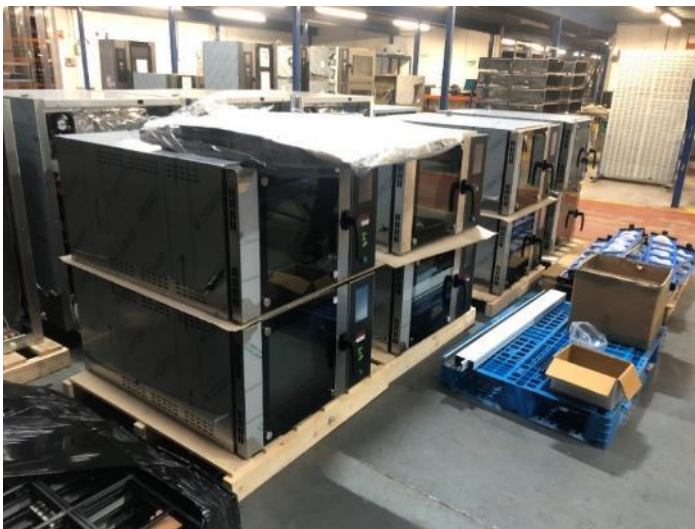
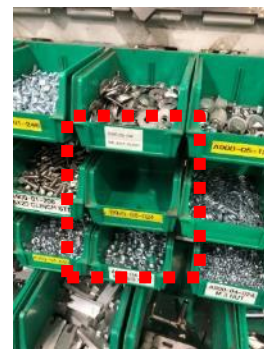
Figure 17: Waiting

Waiting on components was seen to disrupt the production process, as simple as technicians waiting on fixings would cause delays to production. The door section ran out of nylon spacers this resulted in a massive disruption. By not having these spacers resulted in doors being produced and fitted with incorrect spacers which needed to be replaced at a later date. A total of 28 ovens were backed up. It was then impossible for these to be tested as there was no time in the schedule to add an additional 28 ovens through the test bay. There was wider disruption to the machine shop also as these components needed to be urgently pushed through delaying the schedule in other areas.

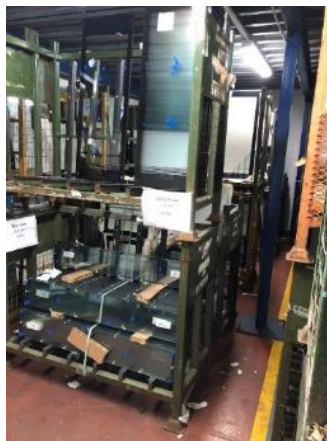
*Figure 21: Inventory Build Up Glass*

Excessive amounts of glass being stored taking up walkways with stillages, this excessive glass is difficult to track, when damaged it is typically thrown into the skip with no accountability.

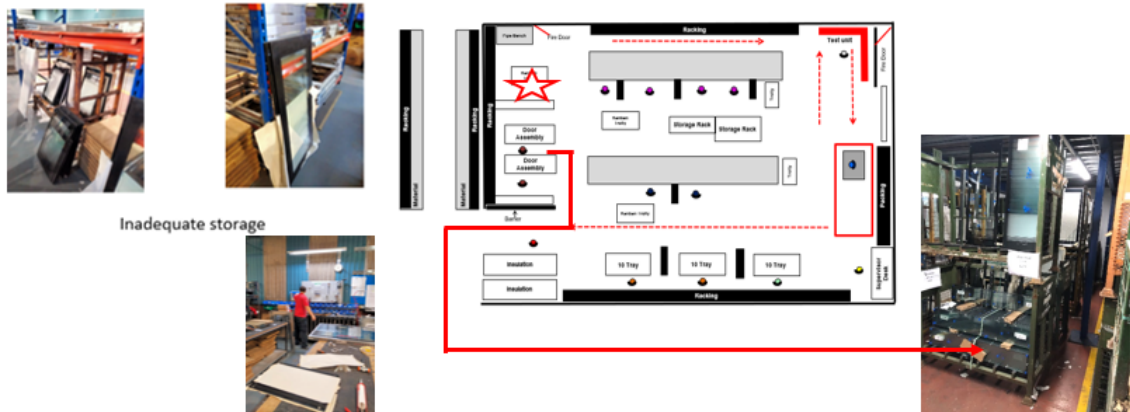
Motion waste like transportation waste is evident due to the complex layout at Mono equipment. The below example shows some of the motion waste generated by the door section when going to collect glass. This motion waste may seem insignificant to the production technician but over a period of time the waste mounts up to a considerable amount of waste.

| Section | Location | Reason | No. Steps | No. Journeys | M/Step | Meters | YearlyMeters | Av. Pace (M/s) | Time Taken | No. Ovens |
|---|---|---|---|---|---|---|---|---|---|---|
| Doors | Stores | Glass | 420 | 5 | 0.76 | 319.2 | 414960 | 1.2 | 138.320 | 38.422 |

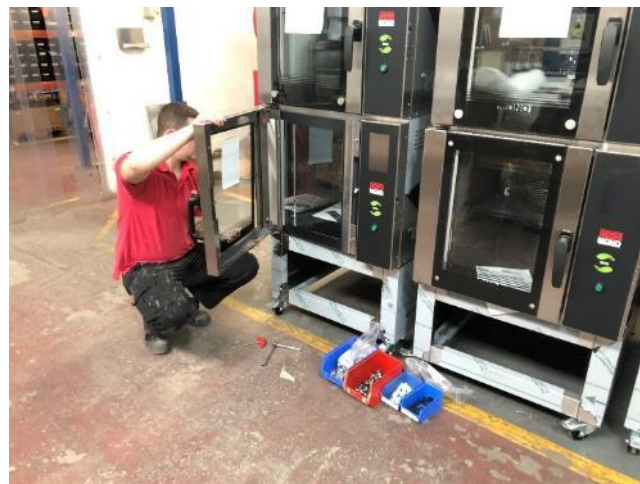
Figure 23: Extra Processing

Extra processing has been generated by a combination of design issues, waiting for components and defect. By inheriting these issues results in time taken to rectify these issues. The example below shows the door assembler having to replace the parts that were used temporarily, the technician then had to replace the temporary spacer with the correct part, this time is not accounted for and the customer does not pay for this additional work. This puts pressure on production and results in quality issues.

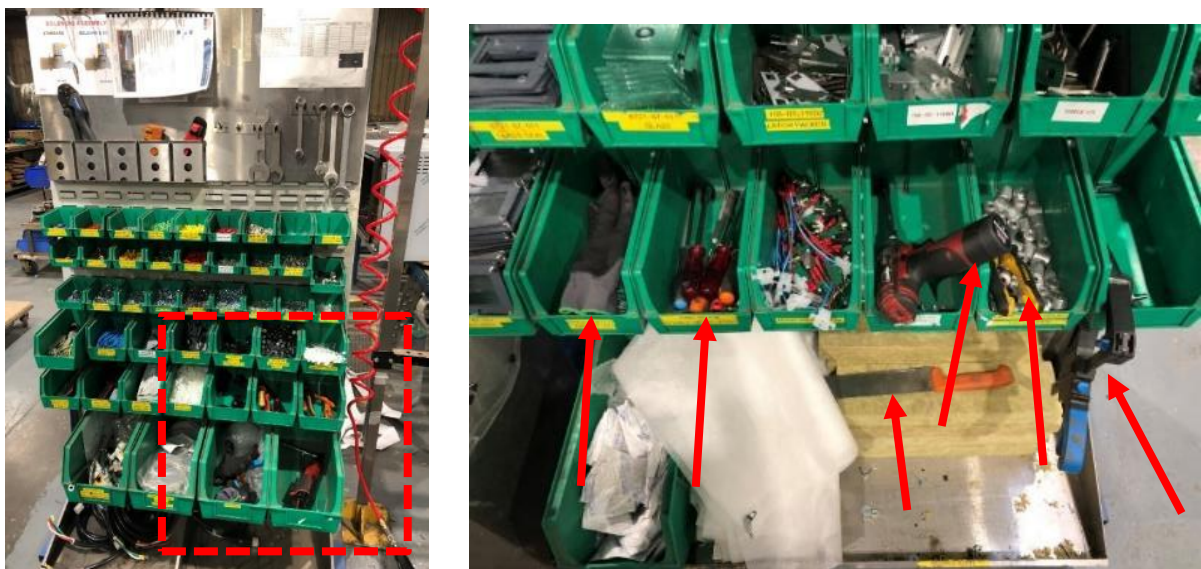
Figure 25: Tool Storage - Current State 5 Tray Line

Figure 25 show that the tool boards are inadequately laid out with limited space for the tools, the production technicians use component storage bins to hold the tools over using the tool boards. Another observation made is that there is no space for power tools used such as impact drivers, wrenches and cordless drills have no defined location.

During a production meeting, production operatives raised significant concerns relating to the tools within the BX oven section. Upon further investigation it became clear that there were various issues including, tool sharing, missing tools, poor tool organisation with tool boards that were inadequate for the tools being stored. Having no designated place for tools or accountability resulted in several lean wastes. The section required a system to manage the tools in an efficient way.

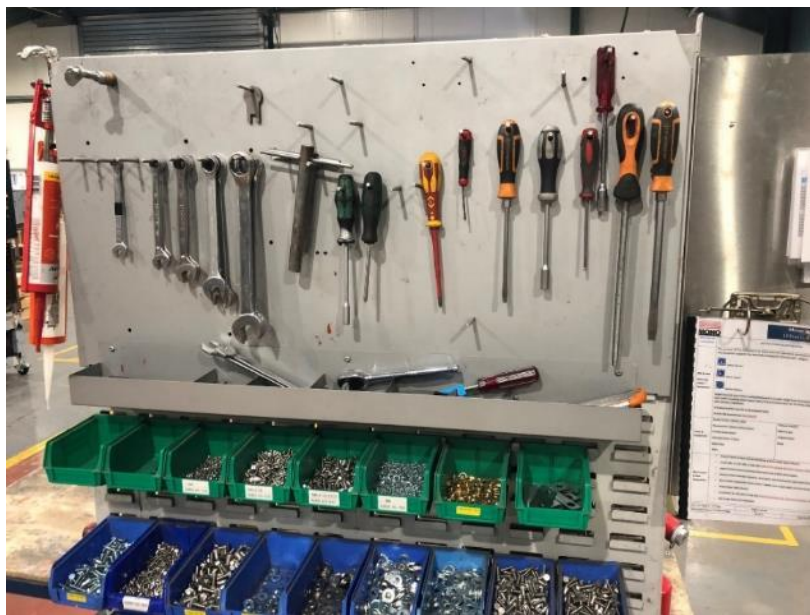
*Figure 26: Tool Storage Current State - 10 Tray Line*

The example in figure 26 is an image taken from the 10 tray line tool board. In this example there are several pegs welded to a board this layout draws confusion as no designate space is created for tools, many duplicates are stored.

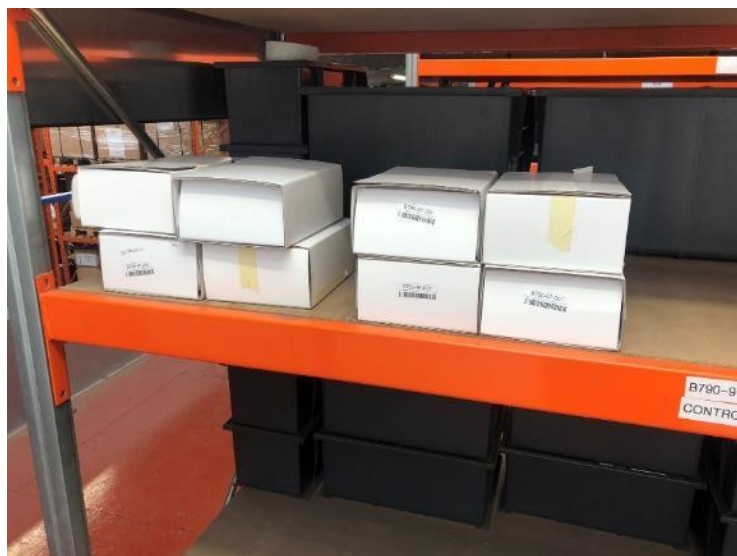
Figure 28: Returns Buffer Stock of PCB

The returns process was prioritised as it could be implemented with immediate effect and significantly reduce the impact on the customer. Using the previous calculations used in the define stage to measure the overall impact.

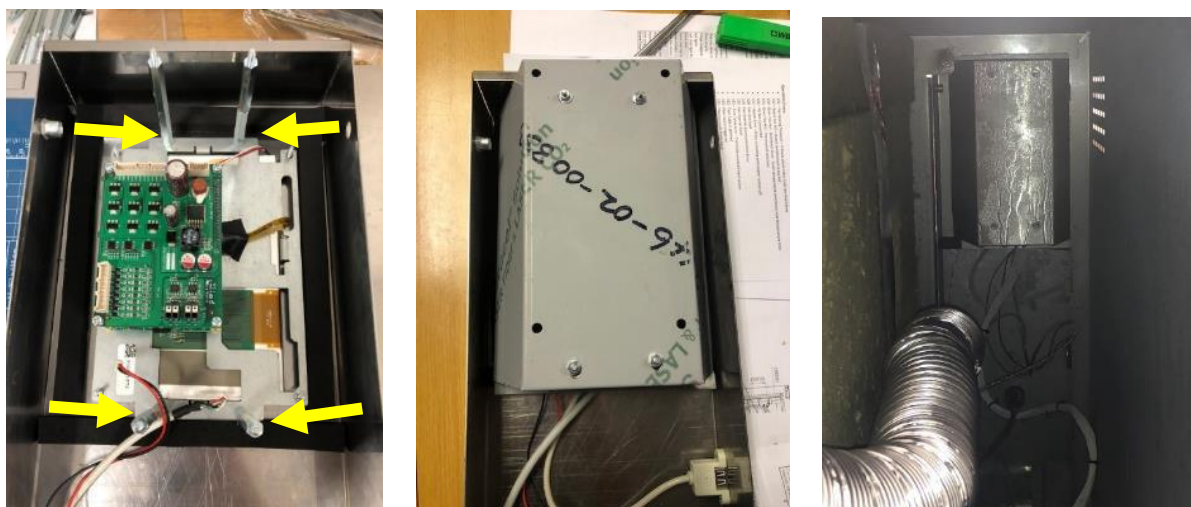
*Figure 32: New PCB Cover Trial*

A trial was conducted on the new cover to prove its effectiveness against steam, the trial was successful in protecting the screen and PCB.

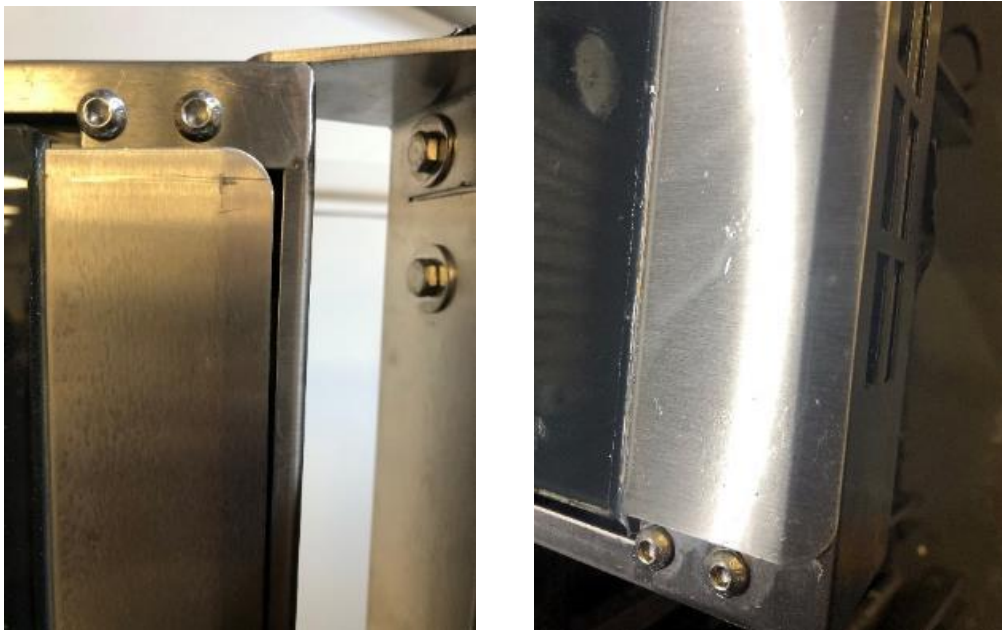
*Figure 36:Oven Door Catching Issue*

The door failure was the most challenging issue to diagnose and rectify as there was limited information and multiple factors, the door seal failing due to degradation was one failure mode. Another issue discovered relating to the inner door resulting from the redesign, this meant the door could fold in on itself preventing the operator from being able to separate the doors. A change was made to extend the inner door metal work by 3mm to remove this defect.

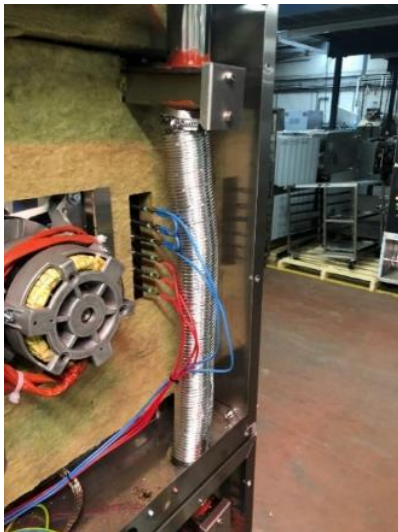
Figure 37:Aluminium Ducting

On investigation the current pipe showed signs of breaking down, becoming brittle, and developing holes, it was thought that the aluminium pipe became brittle due to a combination of thermal fatigue and galvanic corrosion. Galvanic corrosion occurs when there is a transfer of electrons from a metal acting as an anode to another metal as a cathode, in the presence of an electrode, the aluminium pipe in this case is the anode and is attacked by the stainless steel while the electrode is steam resulting in significant damage occurring.

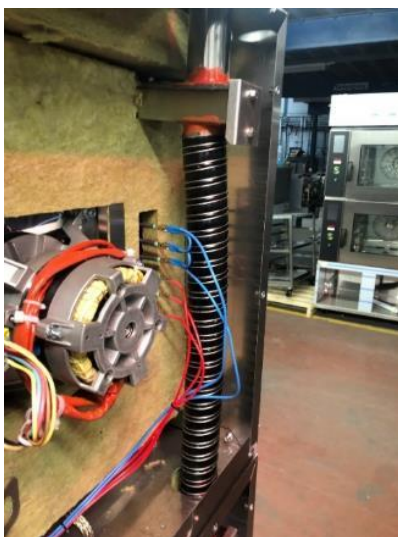
Figure 38:New Proposed Ducting

Temperature Max/ Min: +300°C / - 30°C

Price / Meter : £5.58

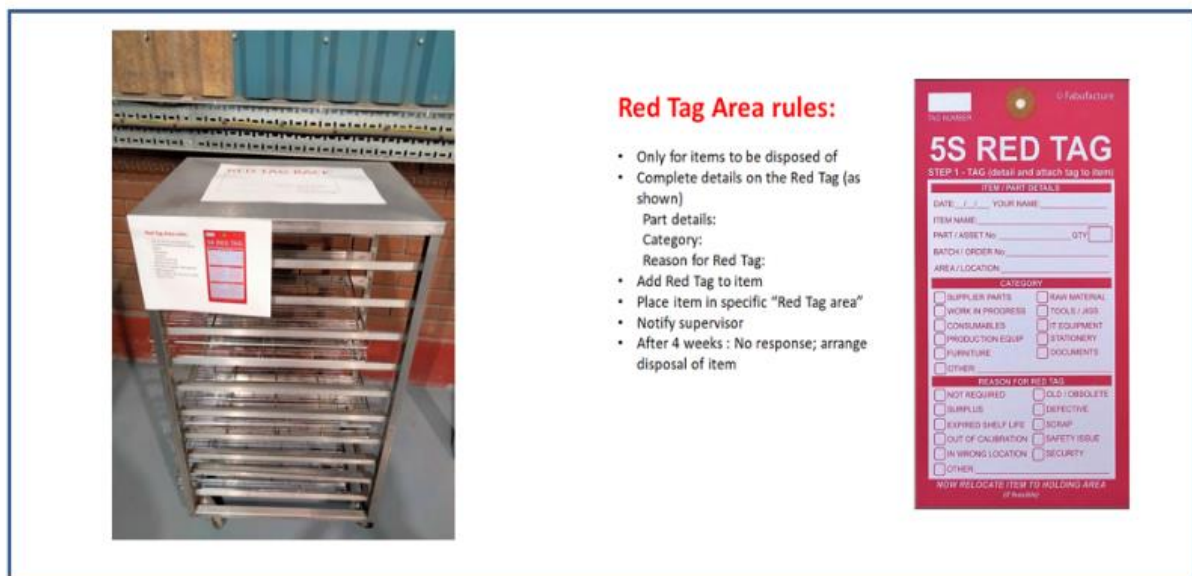
Figure 40: Red Tag Area

A red tag area was introduced creating an area dedicated to removing items from the work space which are no longer required and support the 5s activity.

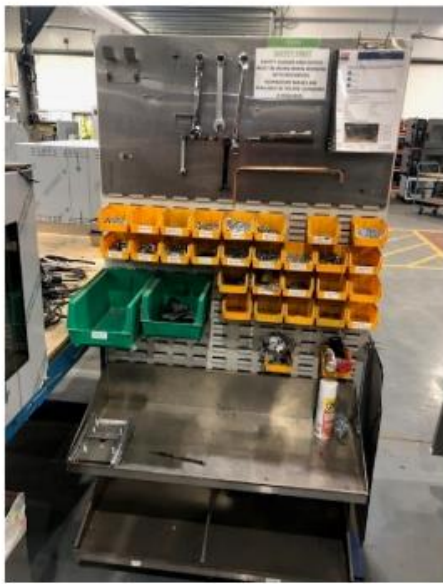
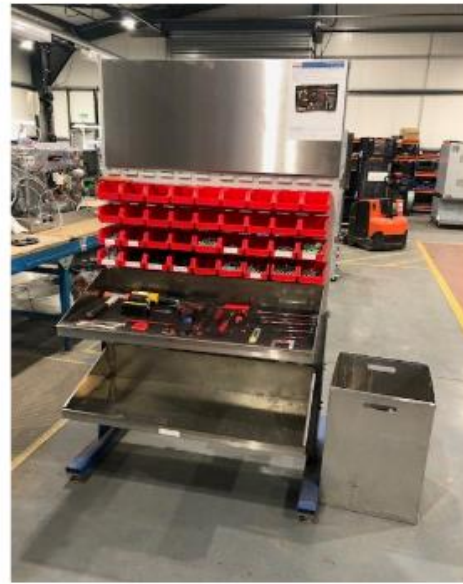
*Figure 44:5S Project Tool Station*

Our team was able to create a tool station with increased capacity for all tools, including power tools, thanks to the 5s activity. The space has been improved to provide a comfortable platform to work from, the foam cut outs added provide a shadow to easily identify tool location, the foam, fixing bins and tools were colour coded red for identification, making it unique to this section helps identify tool location should any go missing. By removing the old tool board and adding a new plain sheet created a space for information and feedback such as standardise and sustain audit sheets, the space can be used to communicate any process changes or quality issues using visual quality standards.

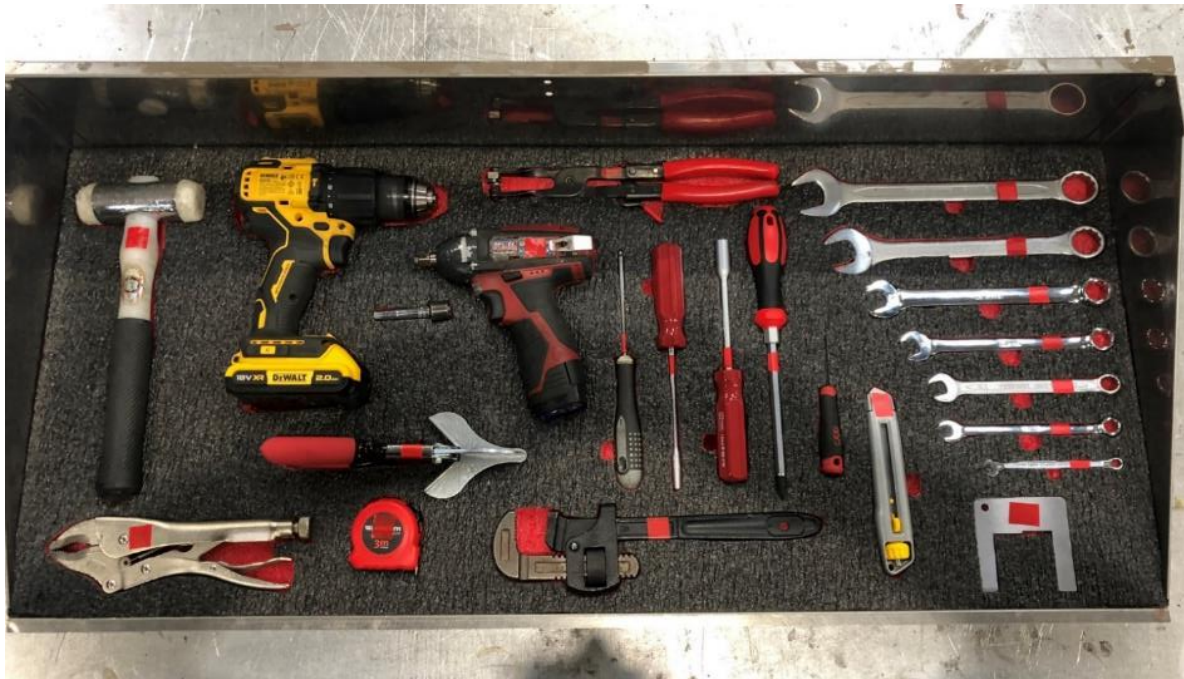
Figure 45: Tool Storage Layout

This system not only reduces motion waste but also offers a way of tracking tools in the most efficient way, operatives can identify any missing tools quickly and replacements can be ordered if needed, it gives ownership to each section and increases performance. The team were really pleased with the results improving employee satisfaction.

The analyse phase highlighted that tools had no location and tool boards were badly laid out which made for inefficient working methods. A new tool storage system was created using storage shelves which we used for holding parts. This freed up space and provided an ergonomic working platform, the shelf was filled with foam and tools used cut out to help identify any missing tools and the location of each tool. A 5S audit was conducted on 4 tray production line.

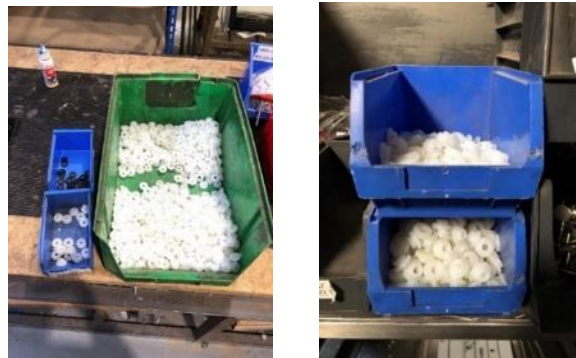
*Figure 46: Two Bin System*

The batch was split into two and an area created in the Kanban area to maintain the stock. This two-bin system enabled the team to maintain stock levels. The door assembly team ensured they had set a two-bin system in the production area. Once the top bins depleted, they draw more from the kanban. This buffer stock ensures no waste occurs, it puts ownership on the team to draw more once it has reached a level, reducing the impact on the machine shop.

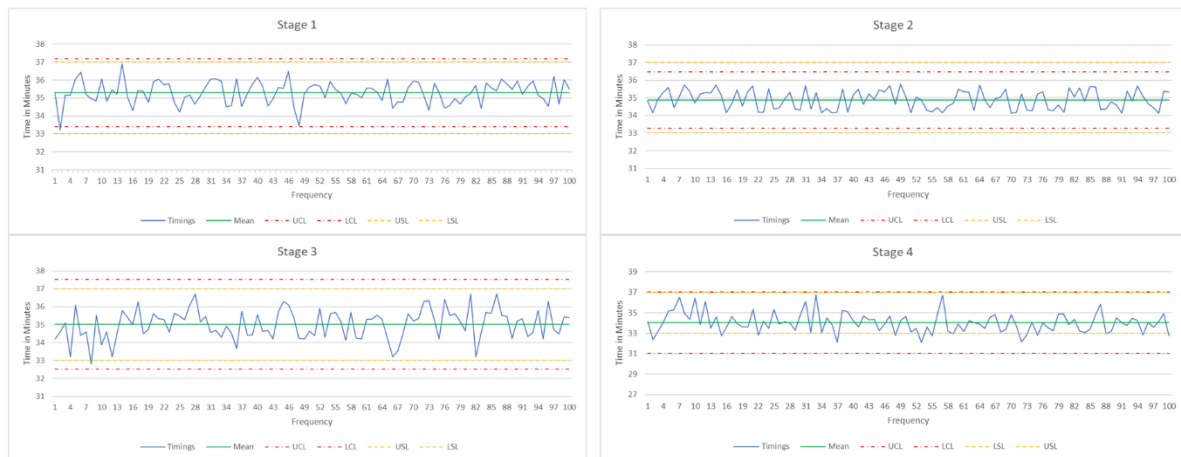
Table 54: SPC Stage 1-4 Post Improvements

The team reported there was an increased amount of control, the measurements now sit between the specified and control limits, there is also a standard deviation <1 on each stage this is another indication that the process is in control. (Oakland E. S., 1999) this can be seen in Table 54 and 55

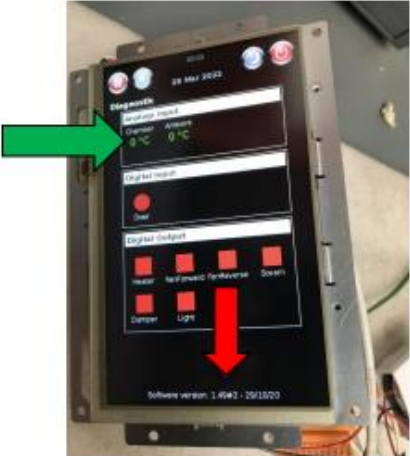
| <div> <div> Casualty Operating Procedure Guide Notes for Eco Ovens CJB </div> </div> | |
|---|---|
| Firmware Check & Diagnostics Screen | <p>To check the firmware version – use the diagnostic screen as shown below</p> <p>On an Eco controller - press "settings", enter 3142 and select "service settings" then "Service" then "diagnostics"</p> <p>The software version is shown at the bottom of the screen as shown below (Red Arrow).</p> <p>Note - In the pic above, chamber temp is reading 0°C (Green arrow) which means the thermocouple signal is not being received by the controller. Left like this, the oven will eventually trip it's overheat thermostat. To correct it check the thermocouple connections.</p> |

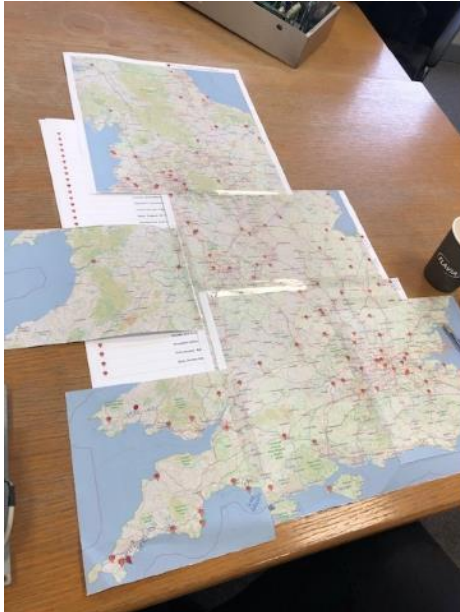
*Figure 55: Retro fit planning*

Despite the success of reducing the failures there were still many ovens with poorly protected controllers with the old-style PCB cover. A decision was made to retrospectively fit the new PCB cover to any oven without this protection to reduce warrant calls and controller failures.

A map was drawn up with the location of all known ovens and letters were distributed to stores notifying them of a pending visit to upgrade the PCB cover.
