University of Wales Trinity St. David

Sustainable Architecture

*“Lampeter University Sustainability Cold Bridge Upgrades”*

Ashley John Wood

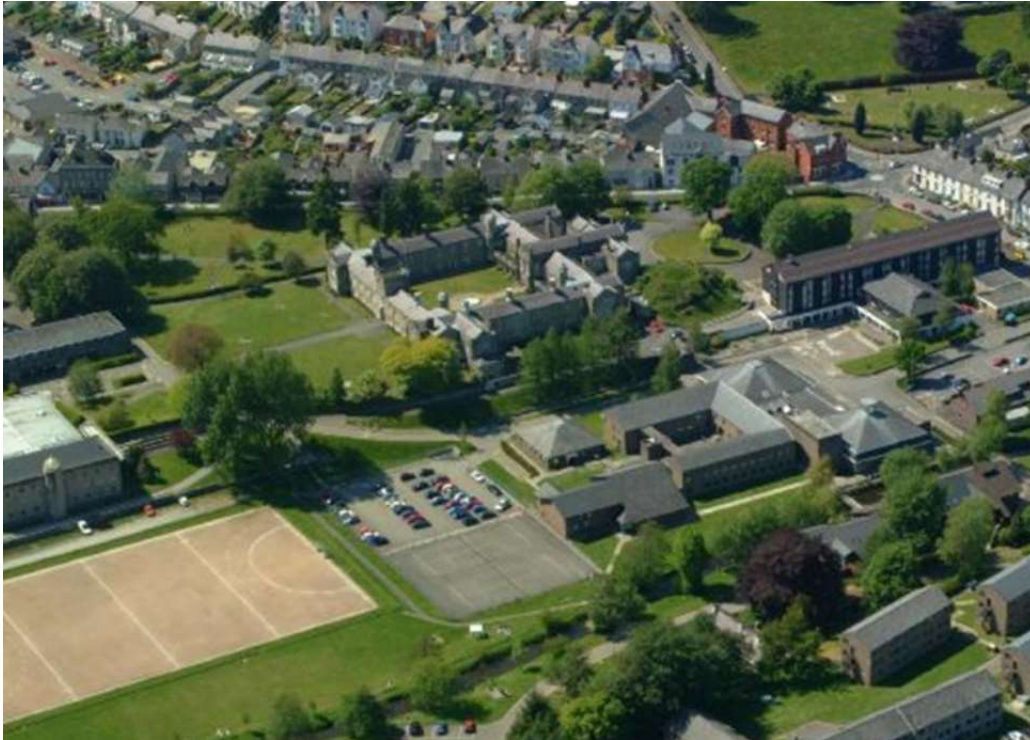
**Figure 2.2.1:** Aerial Photograph of the site (*Map.coflein.gov.uk, 2004*)

The main Lampeter University Campus is situated at grid reference SN 57917 48222, which consists of a rectangular form with each façade fronting the four poles. The structure allows a central courtyard to be created, thus sheltering occupants from weather conditions by inducing a micro-climate. This works in favour of its usage as

the site sits on a fairly-exposed elevated location, as prevailing south westerly winds that the site experiences are dampened by its form.

The site is also subject to historical importance, such as the proposed siting of an historic moat, referred to as Stephen's Castle. This is located on the northern side of the main building. The main building is also listed, however for the purposes of this research, we are to assume that the listed status does not have an overbearing effect on the energy efficiency proposals but it is considered for real life scenario.

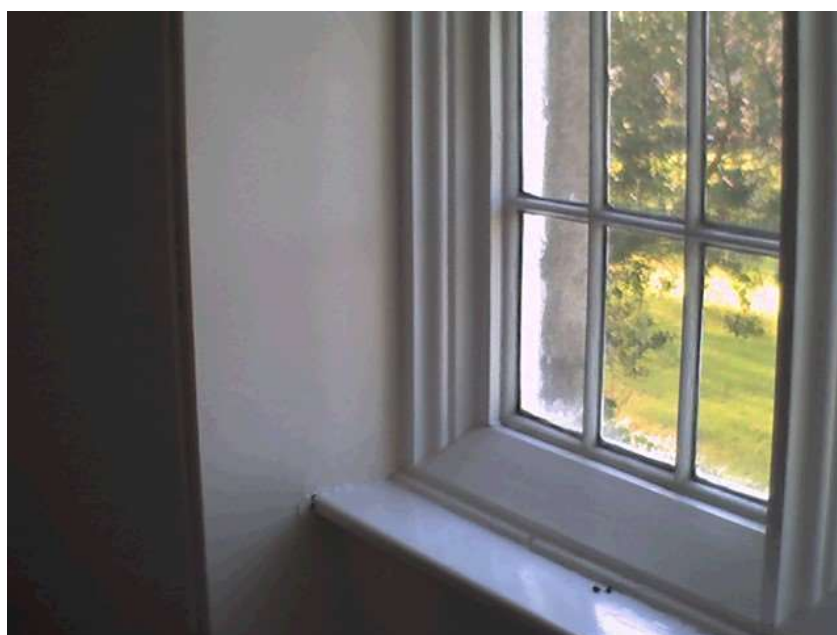
The existing windows are traditional timber double side hung windows with mullions between the single paned glazing panels. These units are typical of the buildings' era and have an estimated U value of  $5.4 \text{ W/m}^2\text{K}$ . (Curtis and Jenkins, 2014) Traditionally, these windows would often have a thick fabric curtain which would've reduced the U value to  $3.2 \text{ W/m}^2\text{K}$ , an equivalent reduction of 14% (Curtis and Jenkins, 2014).

**Figure 3.1.1:** Internal image of existing timber window (Author, 2018)

To meet the energy targets, a proposal of secondary glazing seems to be most sympathetic to the existing structure and give drastic improvements to the thermal efficiency of the opening. The installation would include a renovation and making good of the existing timber windows which reduces the heritage impact from thermal improvements; ensuring all glazing panes are sealed, wood jambs, heads and mullions are structurally sound and shows no signs of pest infestation or rot. Defects in the unit will allow water ingress and saturate reveals and inner wall structure, this dampness of material induces further heat loss. For example, saturated bricks convey heat 2.5 times faster than dry bricks (Rennergysolutions.co.uk, 2018). Therefore, insuring the inner fabric is dry, reduces heat loss. The reveals are also to be lined with 25mm of expanded cork boards to further decrease heat loss by reducing linear heat transfer through the wall structure via convection. The specification is as follows in the

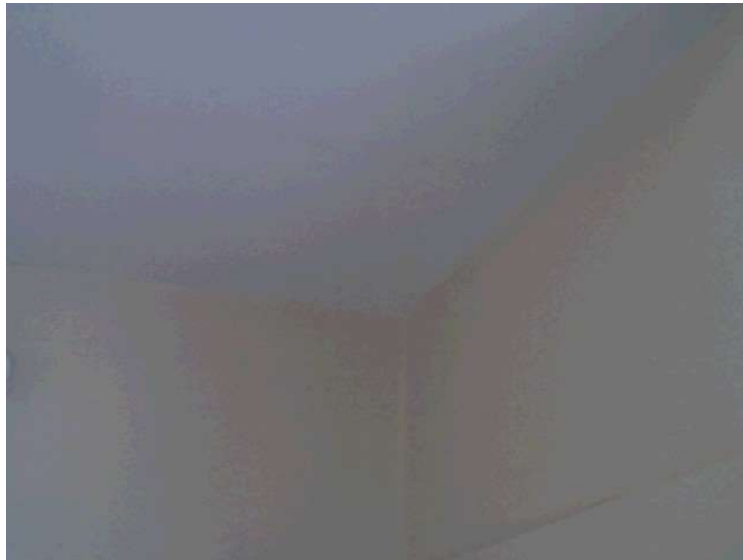
The existing external walls are consisted of a solid stone construction with a rendered outer and painted thistle skim internal finish. The internal partition walls are composed of a single brickwork skin with modern type F plasterboard facing either side. Traditionally this wall would've been rendered in breathable lime plaster, which is stated by rdSAP to have an estimated U value of 2.0 W/m<sup>2</sup>K. (BRE.co.uk, 2012) Laths would form the supports for the lime plasterwork – forming the internal finish. Current standards set by Part L1A of the building regulations 2010, *Conservation of fuel and*

**Figure 3.2.1:** Internal image external Wall Corner (Author, 2018)

To reduce heat loss through internal walls and meet a figure that meets modern standards, the Ty-Mawr internal wall insulation is to be applied. The proposal includes 40mm expanded cork boards, a LEED - rapidly renewable material (Green Building Team, 2016), to be fitted to the internal face of external walls with a lime finish. The calculated U value for this wall construction has been in-house electronically calculated by the manufacturers, T-Mawr, at 0.67 W/m<sup>2</sup>K. Although this does not meet modern standards set by Approved Document Part L1A of 0.18 W/m<sup>2</sup>K, the thermal measure still induces a 66.5% decrease in heat loss through the external wall. To further reduce heat transfer, there is scope to install thicker expanded cork boards. However, there is a downside to thicker insulation measures as space is lost to the internal of the rooms. The specification is as follows:

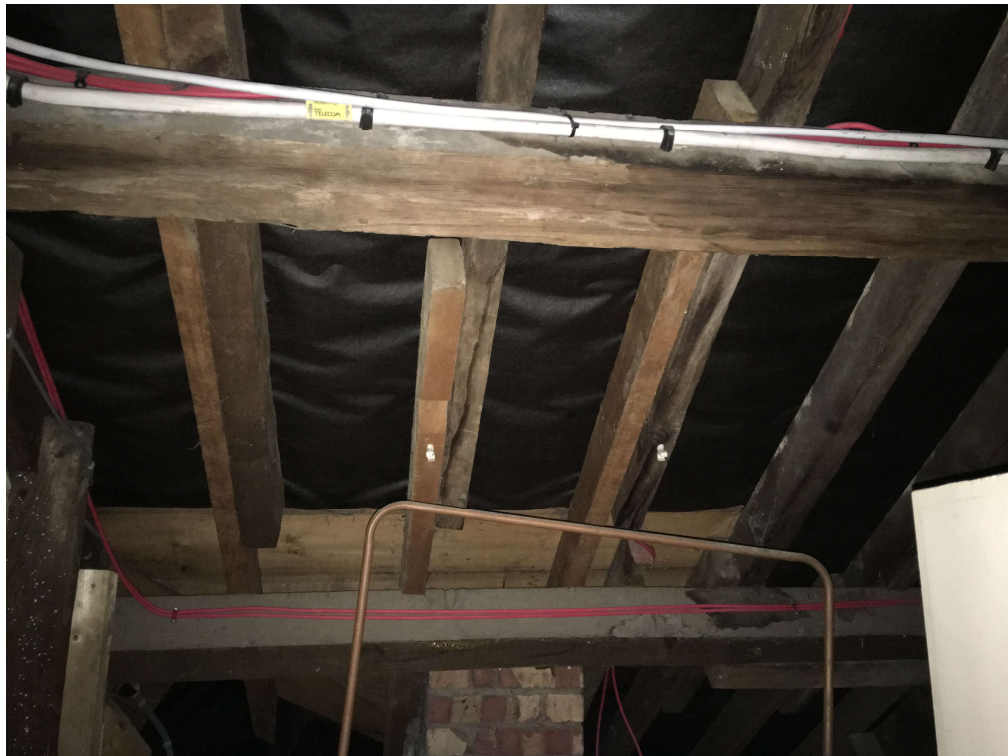
The existing roof space of the university harvests a typical apex roof construction forming of rafters with spanning purlins for further strength and stability through both live and dead loads. The roof is finished in a layer of slates, which would have traditionally sat on battens nailed directly onto the diagonal rafters. However, at some point during repair works, a modern vapor control membrane has been applied below the horizontal battens for insurance against water ingress as slates can sometimes suffer nail sickness which leads to slipping. Current standards set by Part L1A of the building regulations 2010, *Conservation of fuel and power*, state the proposed roof structure complies to a U value of 0.13 W/m<sup>2</sup>K (HM Government, 2010).

**Figure 3.3.1:** *Internal image between rafters (Author, 2018)*

To reduce heat loss through the uninsulated roof, the measures to be installed include 225mm of sheep's wool installed between the roof rafters. Sheep's wool is a highly breathable, sustainable material which is considered more renewable and recyclable (Saxena. et al. 2011). In sustainability terms, 1m<sup>3</sup> of sheep wool hosts 5.4kg of embodied CO<sub>2</sub>, whereas a close comparative, Mineral wool, retains 135kg of CO<sub>2</sub> (Korjenic et al., 2015). Sheep's wool also offers the ability to regulate temperature and harvest a natural resistance to fire due its hydrophilic composition. However, Borax, a non-volatile salt, is added to give greater repellence against pest infestations (Balson, 2013). To retain this wool in place, a polymer netting is to be fitted and fixed to the rafters. The roof structure as outlined below should achieve a calculated U value of 0.17 W/m<sup>2</sup>K, a large reduction from the 6.75 W/m<sup>2</sup>K of the existing rafter structure.

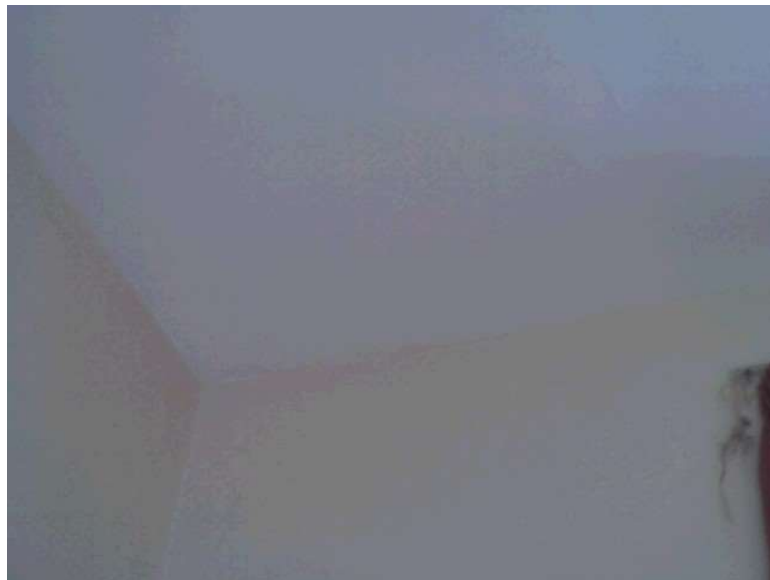
The student rooms in Block C are spread mainly over the ground floor and first floor, with some rooms utilising the apex roof space. The floor joists form a ceiling that separates the floors, which reached circa 3000mm. The construction operates on a spanning timber joist, supported at a load bearing, brick internal wall. The joists ends to each external wall would subsequently be set into a notch in the stone wall.

***Figure 3.4.1: Internal image of Existing Block C Ceilings (Author, 2018)***

The proposal harvests a similar remedy to that of the roof rafters, whereby 225mm of Thermafleece sheep's wool is to be laid between the spanning joists and held in place with a polymer netting below, which will be fixed to the joists. Threaded bar is to be fixed to the spanning timber joists and OSB3 board is to be installed with a counter sunk nut to form a ceiling void. This void can further be filled with sheep's wool for greater insulative effect.
