*Engineering Materials*

Materials and Manufacturing (ACHA4025)

The purpose of this report is to perform a tensile test on a material sample provided by a material manufacturer that produces driveshafts. These driveshafts have been used by a team in the Dakar rally, and failed on both vehicles during the later stages of the rally. The aim of the test is to investigate the cause of the failure, and analyse the material. The test will determine its young's modulus, yield strength and ultimate tensile strength. The report will also present ways to mitigate similar failures in the future.

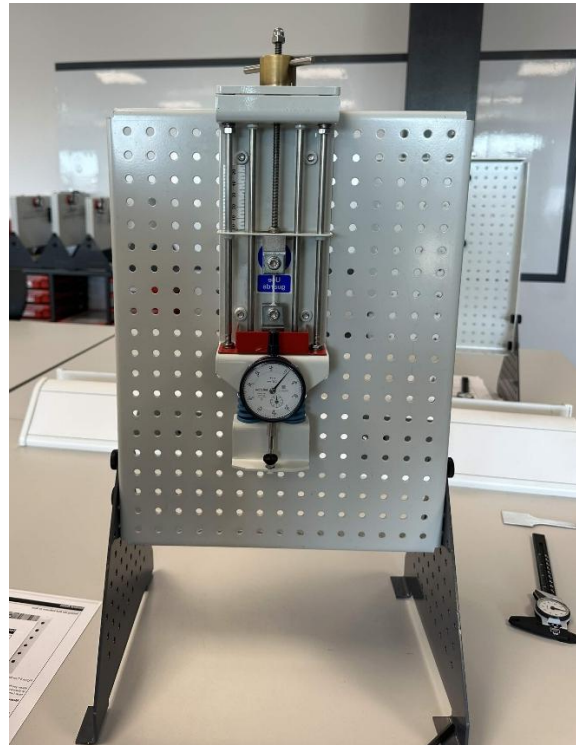
*Figure 4 - Complete apparatus*

Prior to testing, the apparatus must be set up. To begin, the large work panel must be screwed into the two supports with the provided thumbscrews. This will act as a base to mount the tensile testing apparatus, which is subsequently mounted to the work panel such that the dial indicator is towards the bottom and the load nut is at the top. It is important to note that it must be mounted in such a way that the load nut is above the top of the work panel and can therefore spin freely. Measure and record the original length of the specimen.

Next, the two nuts on the top and bottom chuck must be undone using the provided Allen key, and the provided specimen screwed into the top chuck. Then using the load nut, the top chuck is raised or lowered so that the specimen lines up with the bottom chuck and can be screwed in securely.
