# Characterisation and Preparation for the Demolition of an Explosives Facility Major Project Report

**CHARACTERISATION AND  
PREPARATION FOR THE DEMOLITION  
OF AN EXPLOSIVES FACILITY by  
Jordan Hayston**

Project submitted as part of the requirements for  
the award of BEng (Hons) OME

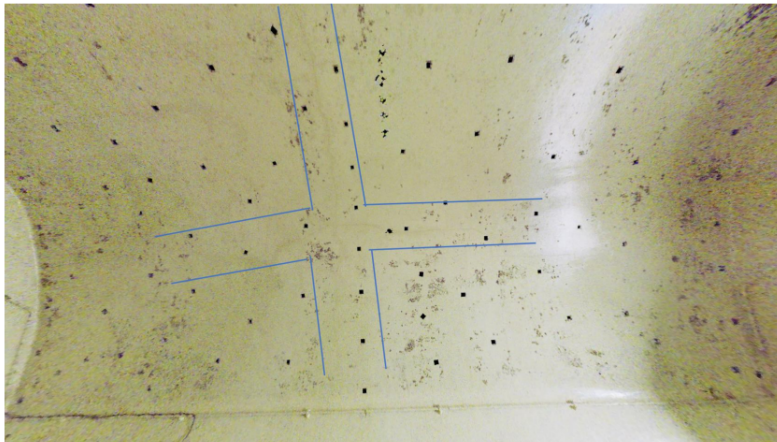
*Figure 3, Cracking in Room 1 (taken from 3D Scan)*

The 3D scan of the interior provides an insight into the condition of the building and has enabled the partial mapping of the cracking across the roof (see Figure 5). Due to insufficient lighting, only the first room is visible in the scans; the data from the second room proved to be unhelpful. As a result, further building visits had to be arranged to photograph the cracking. Figures 3 and 4 demonstrate the cracks in both rooms from images taken through 3D scanning and with a digital camera. The crack in the first room is indicated within the blue lines, as it is not fully clear in the screenshot of the 3D scan.

The extent of the damage looks to be severe and seems to extend beyond the surface of the concrete. The first room has two cracks in the ceiling spanning across its full length and width, intersecting at the middle. The second room has evidence of 5 core samples which have been taken in the past, unlike the first room, each around 50mm in diameter and 50mm in depth. The cracking has formed between each cut-out, creating a complex map of splits in the arched roof. The cause of the cracking is still unknown, and so it is suggested that further investigation is carried out after the removal of the earth over-mounding.

Ground Penetrating Radar (GPR) was considered whilst assessing the roof, to aid the decision process of demolishing or refurbishing. GPR can provide useful information on the depth of cracking in structures. Once the extent of the cracking was identified, GPR was disregarded for this stage of the project.
