An archaeological evaluation on former garages, Hare & Hounds Lane, Heath End, Nuneaton, Warwickshire.

ULAS Report No 2023-019

# An archaeological evaluation on former garages, Hare & Hounds Lane, Heath End, Nuneaton, Warwickshire.

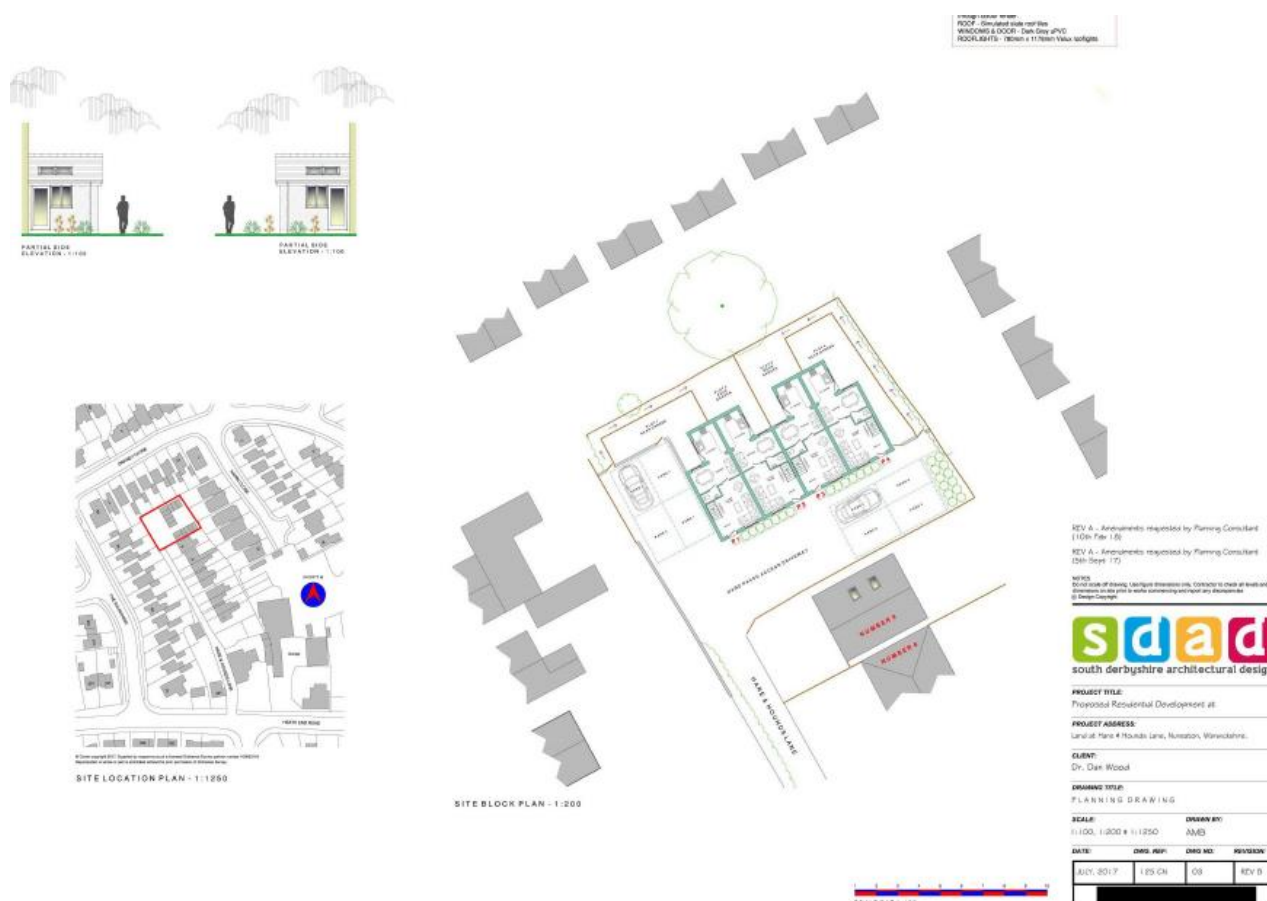
Figure 2: Detail of development area and proposals. Provided by client.

The proposed development area (PDA) consists of a rectangular site between residential dwellings, which formerly contained two groups of garages and an area of hard standing located at the end of Hare and Hounds Lane within the Heath End area of the town of Nuneaton, around 1.5km south-west of Nuneaton town centre (Figure 1).

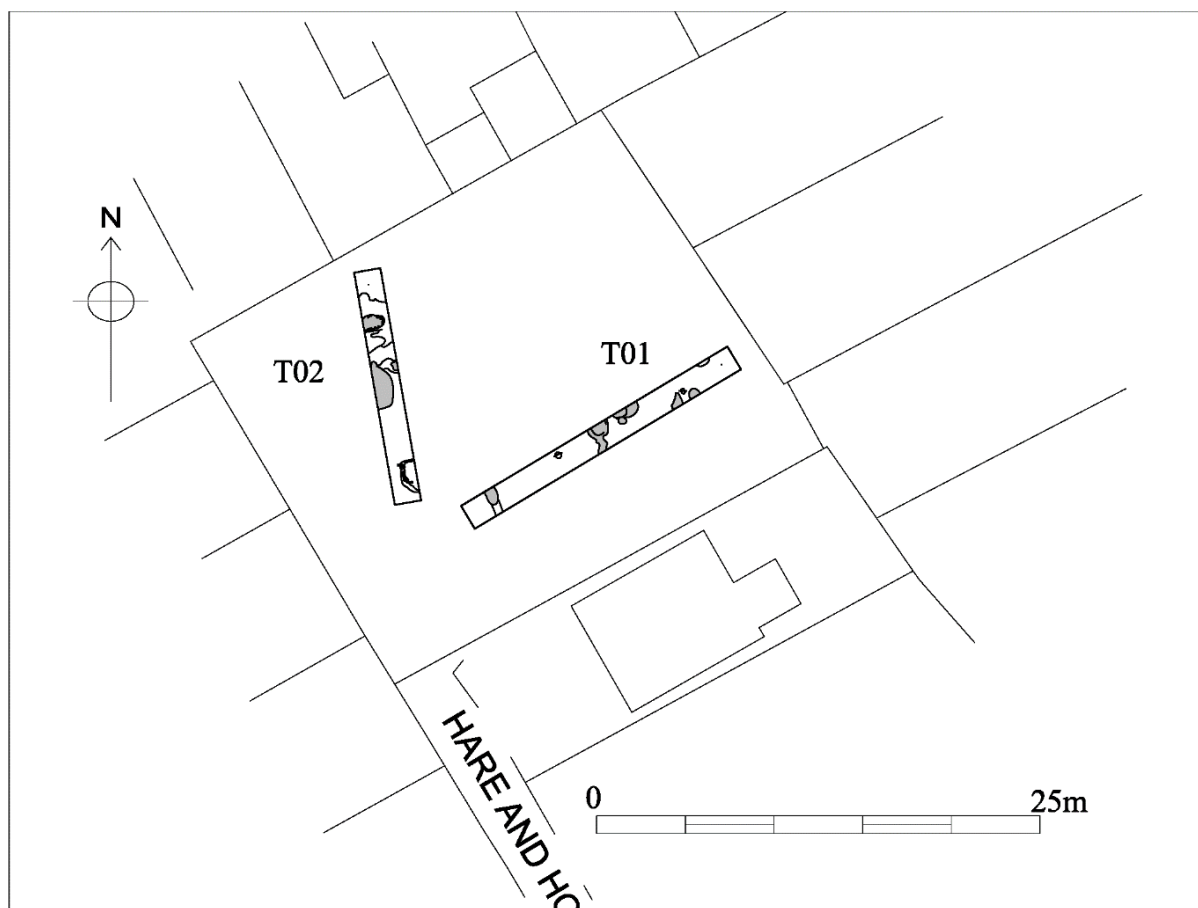
Figure 3: Location of Trenches 01 and 02.

Two trenches, one 17.5m and the other 13.3m in length, were excavated using a JCB 3x with a 1.8m ditching bucket (Fig. 3). Each trench was mechanically excavated until the first archaeological feature or natural deposit was encountered.

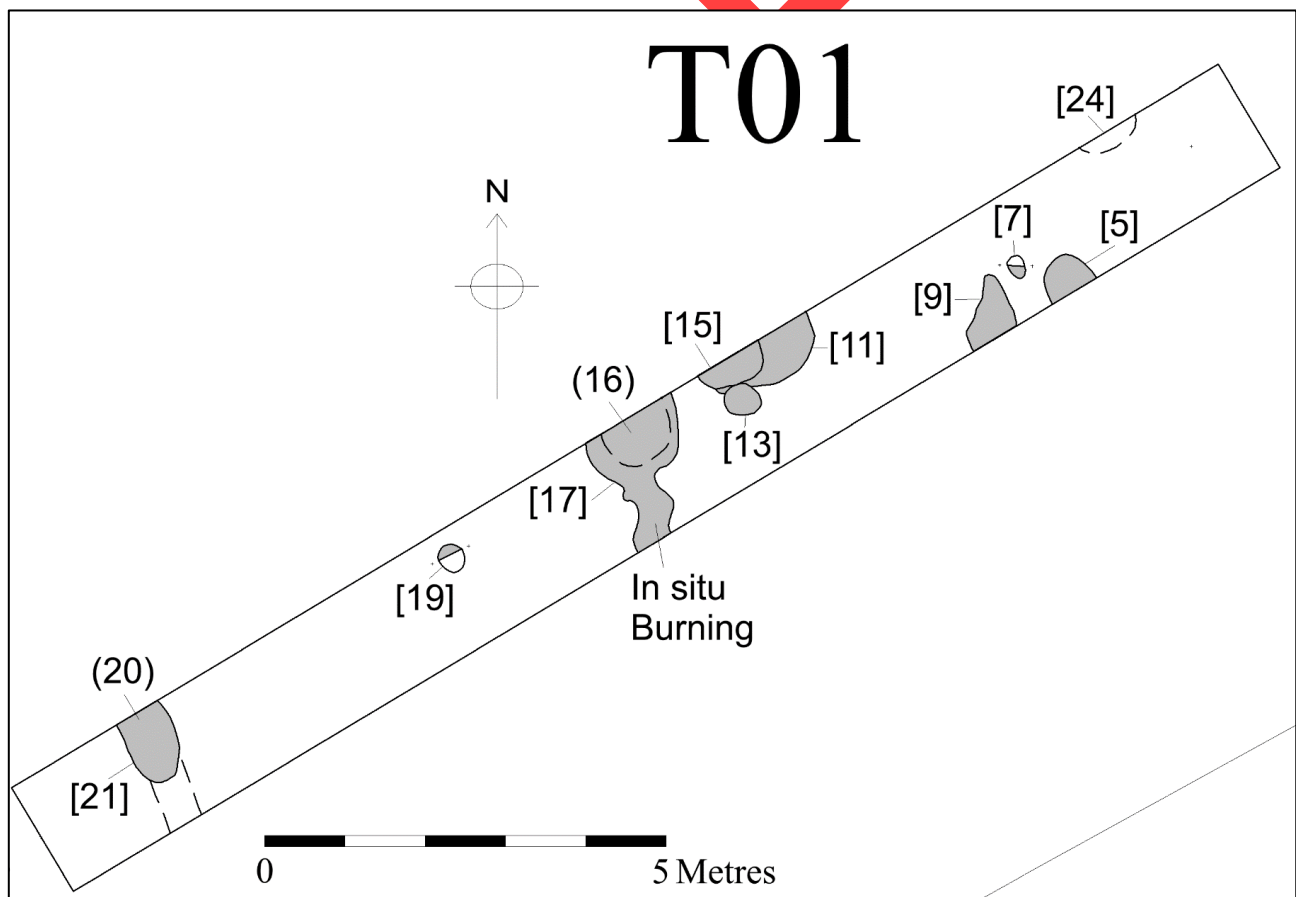
Figure 4: Trench 1 plan

Trench 1 was aligned north-east to south-west, measuring 17.5m long (Fig. 4). Natural geology consisting of pale mottled yellow sandy clay was uncovered at a depth of between 1-1.2m below ground level. Cut into this were several pits and postholes (Figs 4-5; [5], [7], [9], [11], [13], [15] & [19] [21]; Fig. 4). Near the middle of the trench was a key-hole shaped feature with evident burning probably a kiln [17] (Fig. 6). This appeared to have a possible working area or raking out layer at what might be the flue end of the kiln, to the south-east, seen in section. Another area of in situ burning was noted in the northern section at the north-east end of the trench [24] which could indicate another kiln or an oven/hearth feature (Fig. 7).

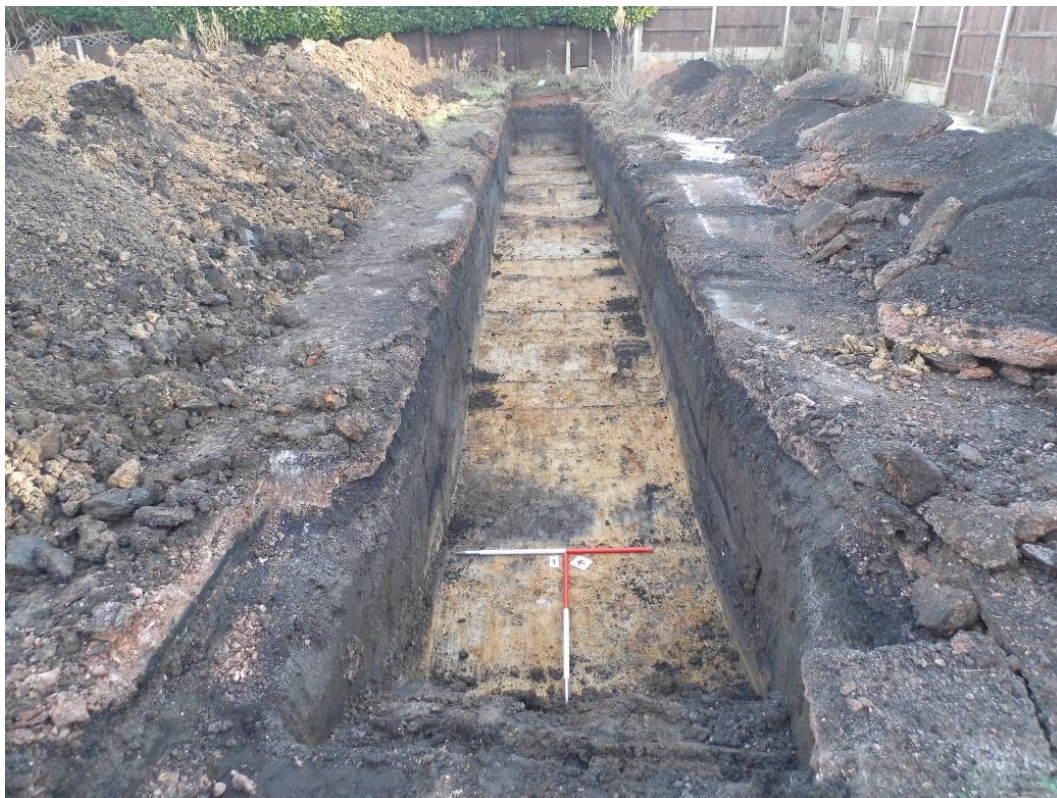
Figure 5: Trench 01 looking north-east.

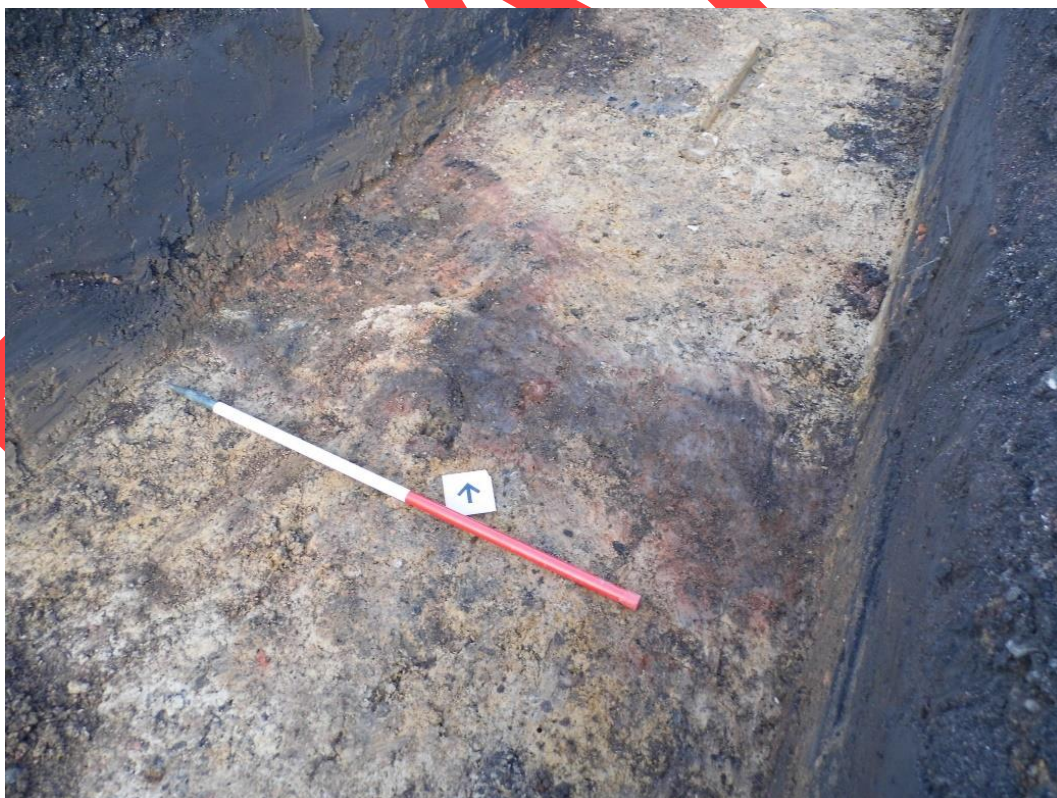
Figure 6: Trench 01 Kiln [17].

| Context | Cut | Below | Trench | Description |
|---|---|---|---|---|
| 17 | 17 | 16 | 1 | Kiln with in situ burning |

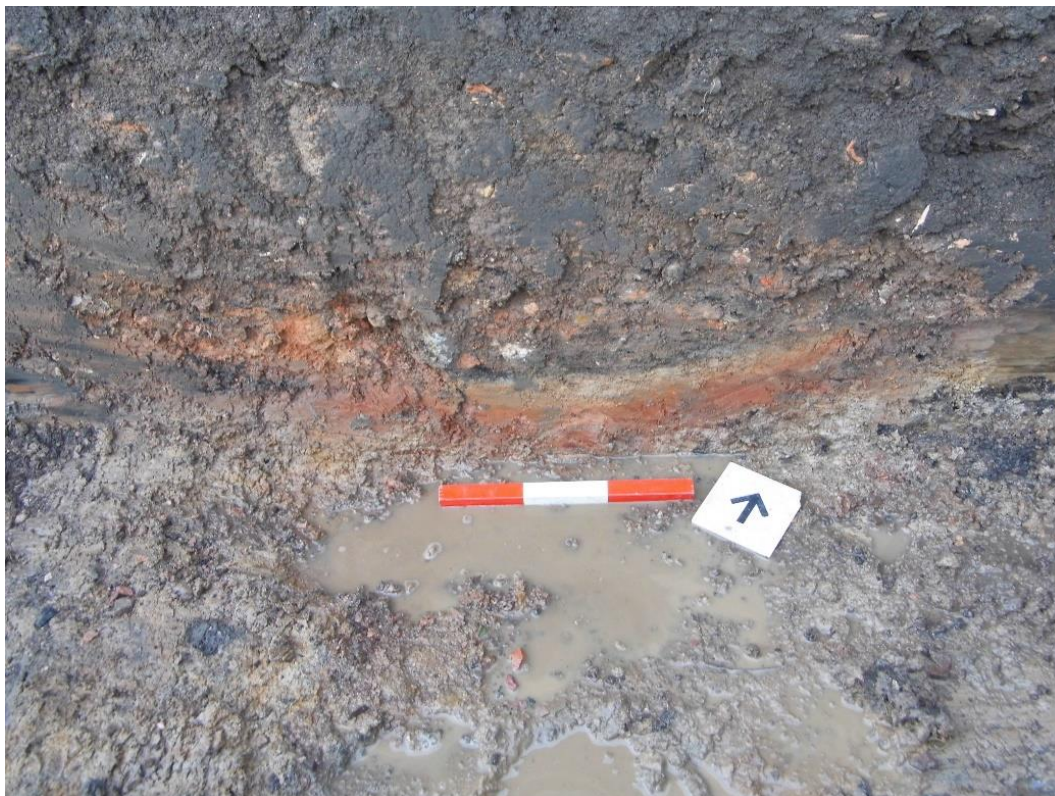
Figure 7: In Situ burning (23), [24] in section

| Context | Cut | Below | Trench | Description |
|---|---|---|---|---|
| 23 | 24 | 22 | 1 | Burnt orange sandy clay |

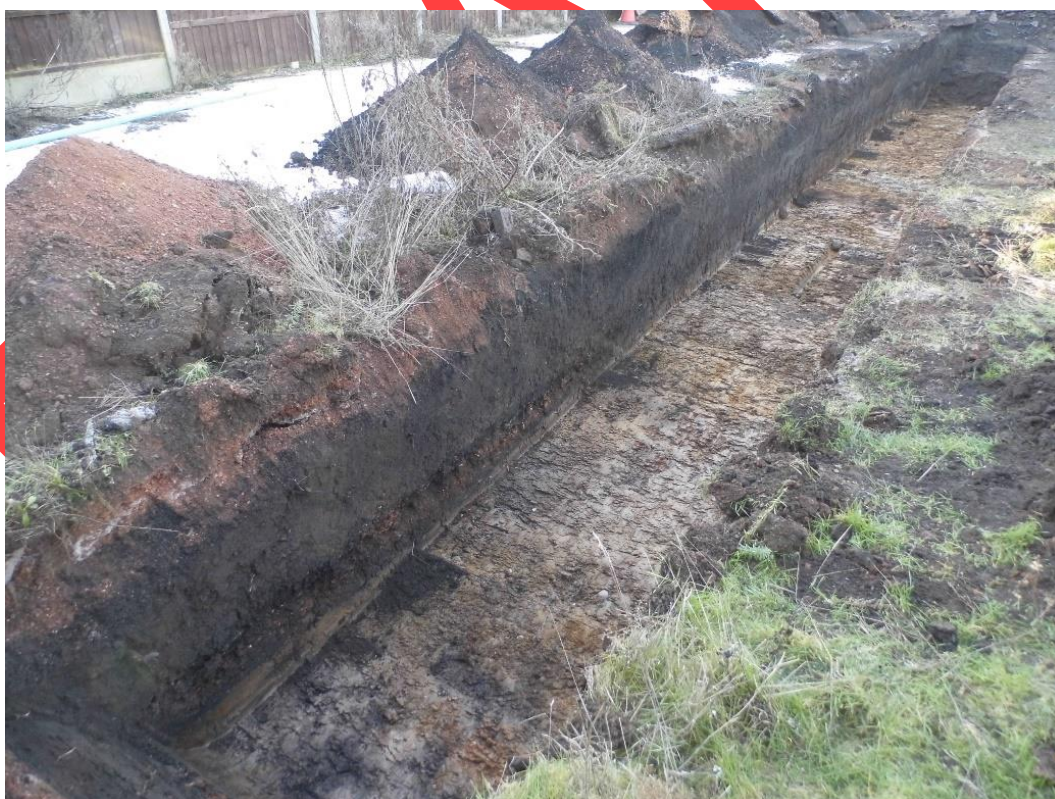
At the north-east end of the trench in the southern section was a mixed grey-brown silty clay layer and pottery (1) (Figs 8-9), approximately 0.2m thick. This could represent levelling of a pottery waste heap.

Figure 8: Layer (1) in section looking south

The majority of the assemblage is from context 001, a dump of material found within Trench 1. The sherds for the most part appear to be waster material, some of which are over-fired, others under-fired with fractured clay and burnt glaze. The sherds collected are a sample of what was present in the context. In total 146 sherds were recovered and include rim sherds and handles with slashed decoration from glazed jugs, as well as a large sherd from a saggar (kiln furniture). Additionally small amounts of roof tile and fired clay were recovered as part of this assemblage.

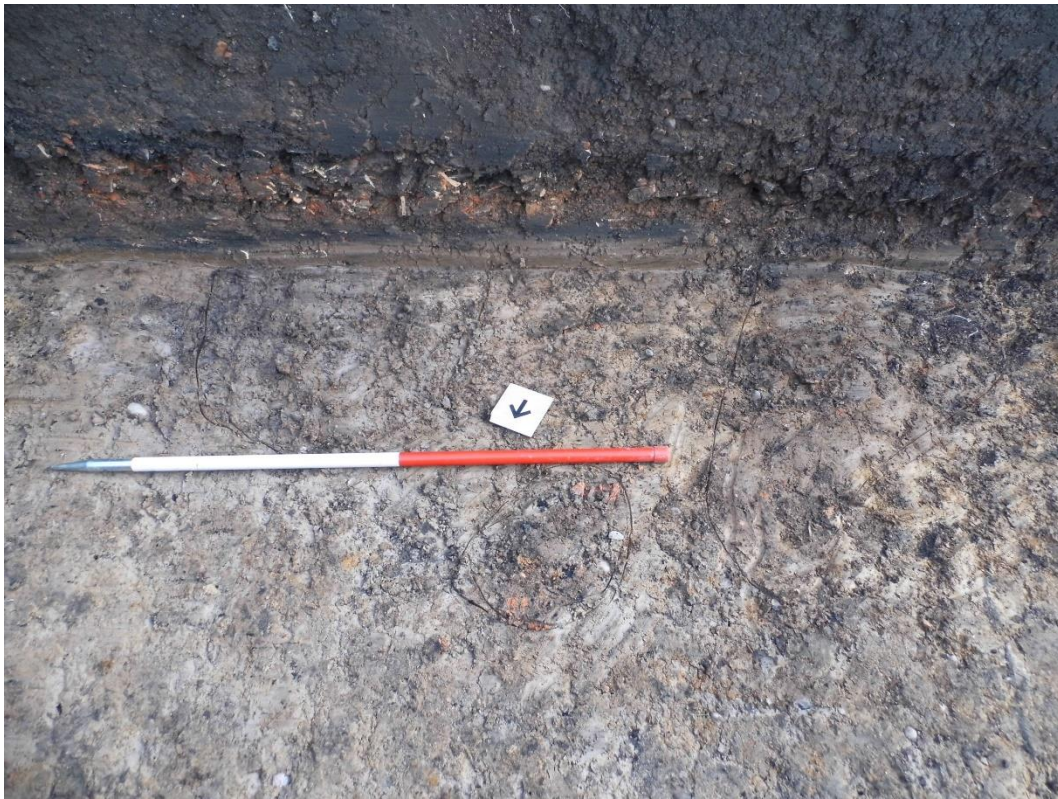
Figure 9: Detail of layer (1) in section looking south (Pit [5], posthole [7] and gully terminus [9])

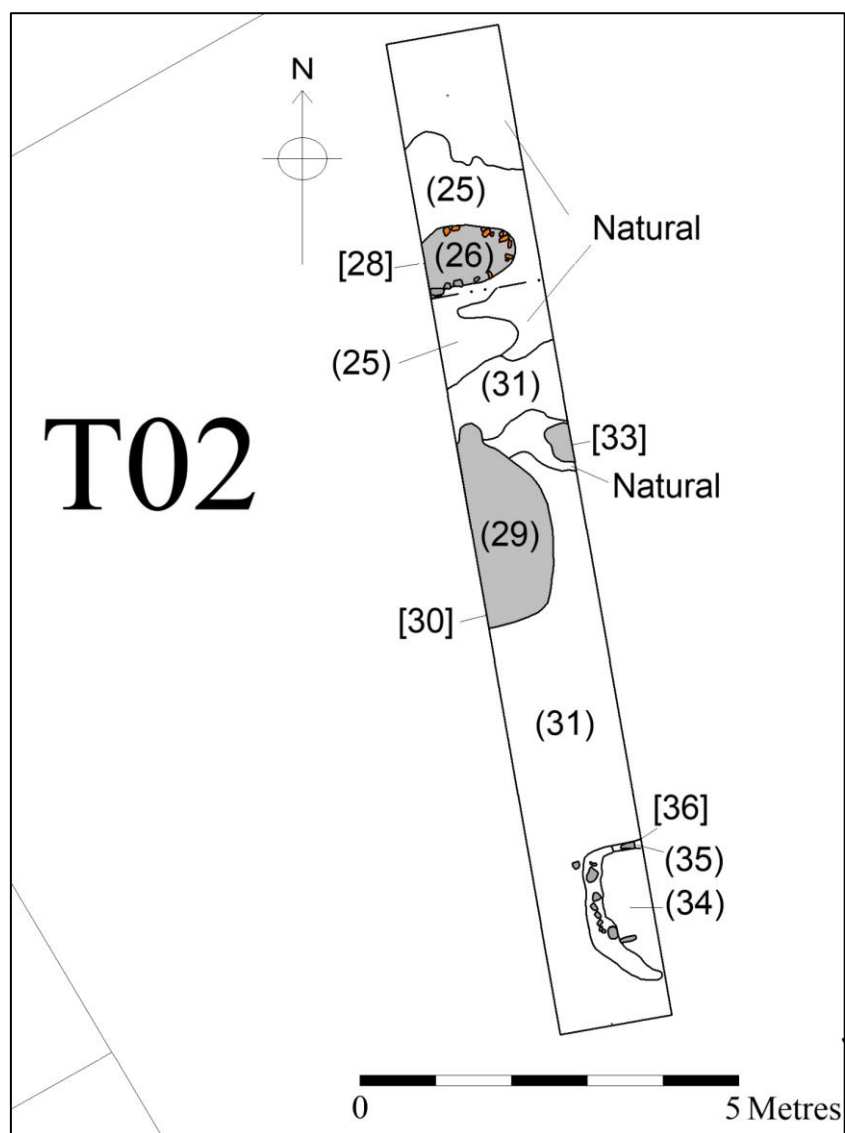
Figure 10: Trench 2 plan

Trench 2 was aligned north-west to south-east, measuring 13.3m long (Figs 10-11). The natural geology was the same as in Trench 1 but only observed at the north-west end of the trench at a depth of approximately 1.44m (Fig. 12). Cut into the natural substrata at the north-west end was a probable kiln [28], oval shape in plan, and with stone and tile suggesting structural elements (Fig.13). Surrounding it was a possible raking out layer (25) consisting of black-grey ash-soil.

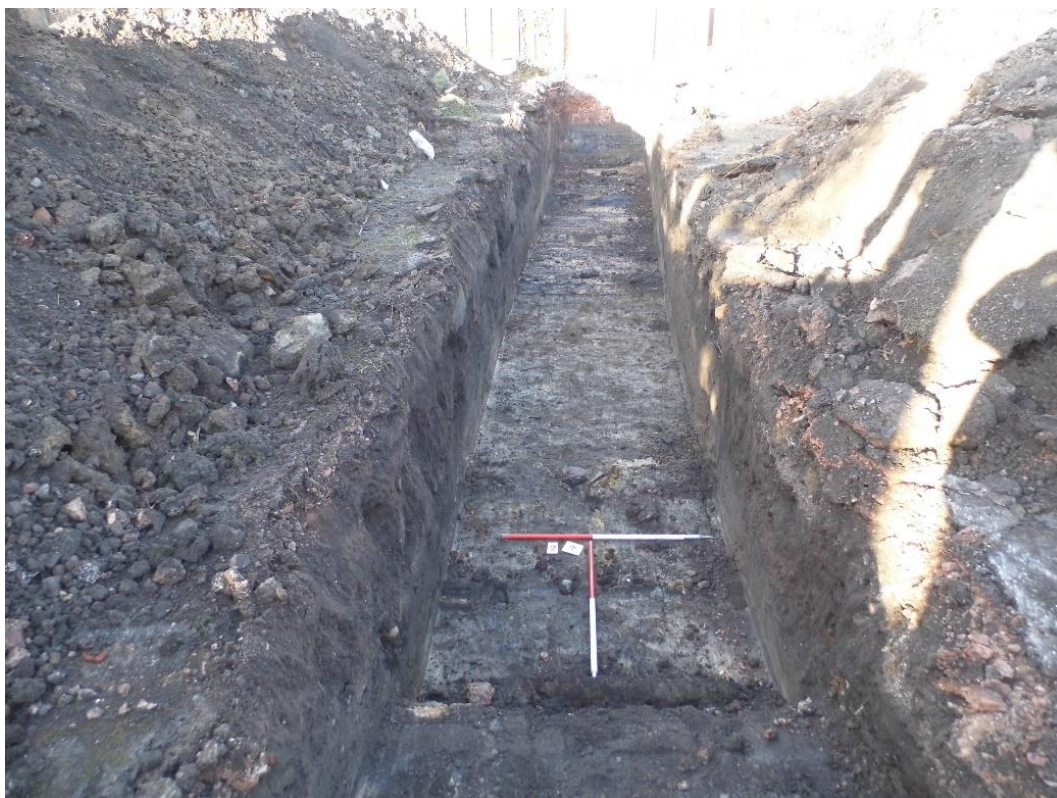
Figure 11: Trench 2 looking north-west

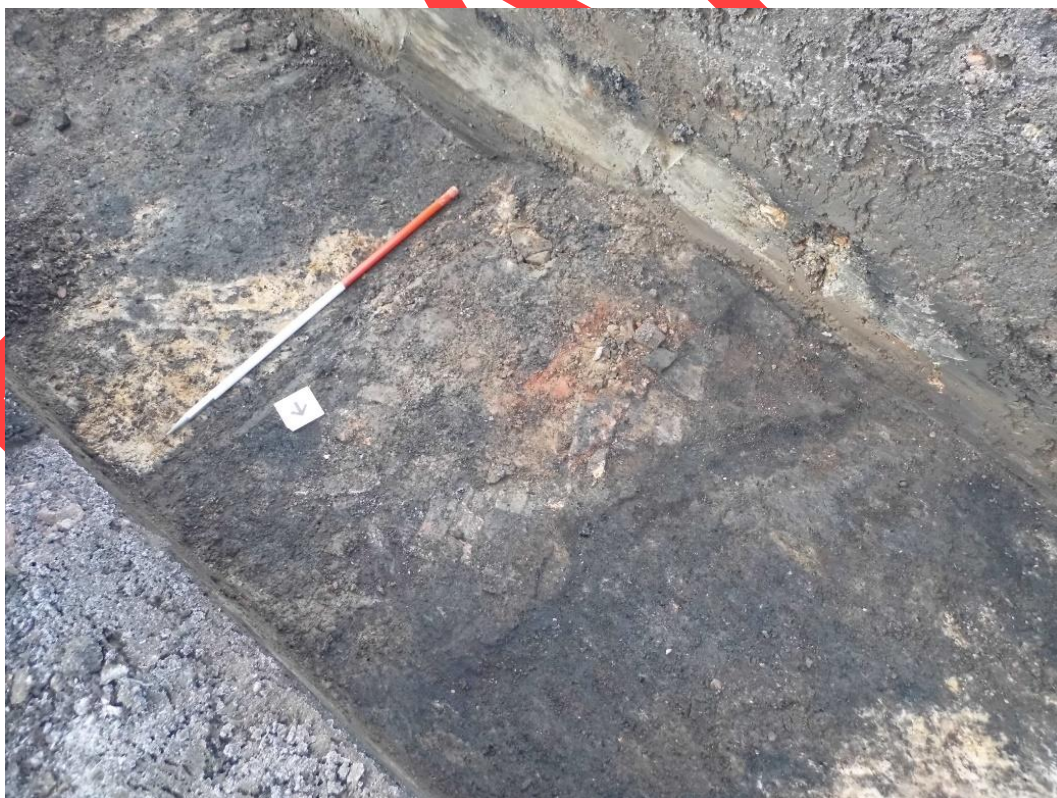
Figure 12: Possible kiln [28] looking south

| Context | Cut | Below | Trench | Description |
|---|---|---|---|---|
| 27 | 28 | 26 | 2 | Burnt stones and tile structure |

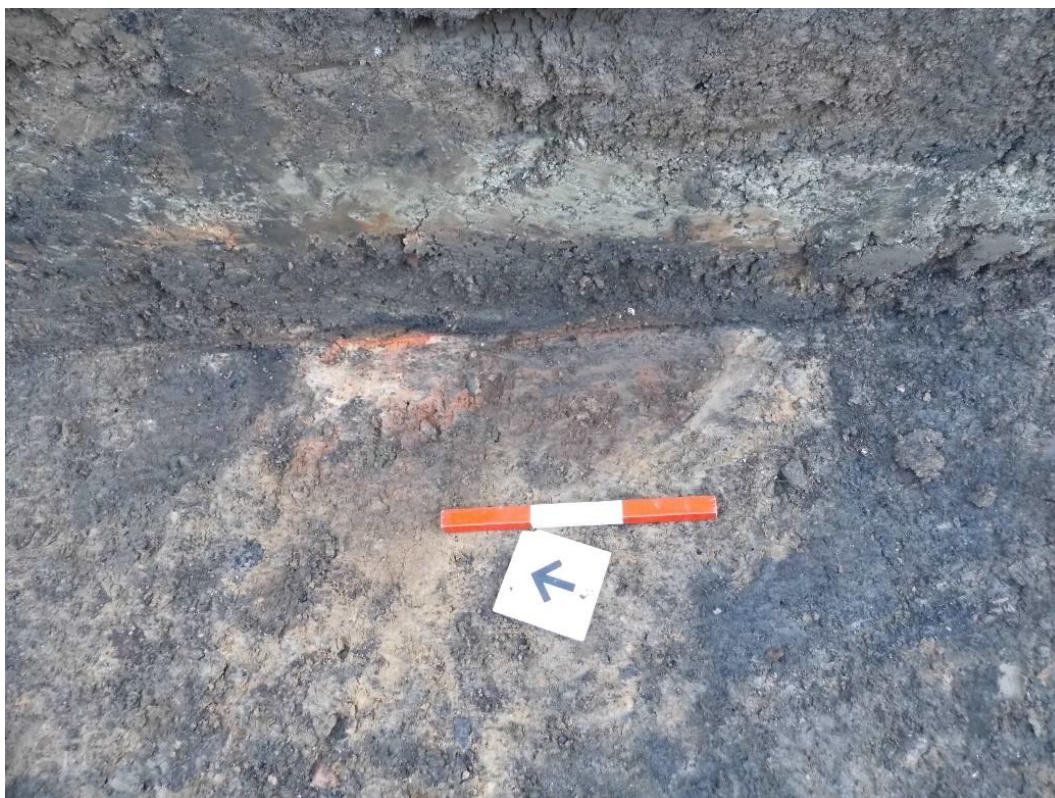
Another small area of in situ burning [33] was noted towards the centre of the trench on the eastern edge (Fig. 13). This could be another kiln feature or over/hearth. This appears to have been sealed by a working/trample layer (31) comprising grey silty clay with charcoal and pot inclusions, approximately 0.17-0.2m thick.

Figure 13: in situ burning [33] looking north-east

| Context | Cut | Below | Trench | Description |
|---|---|---|---|---|
| 32 | 33 | 31 | 2 | Burnt orange-brown clay |

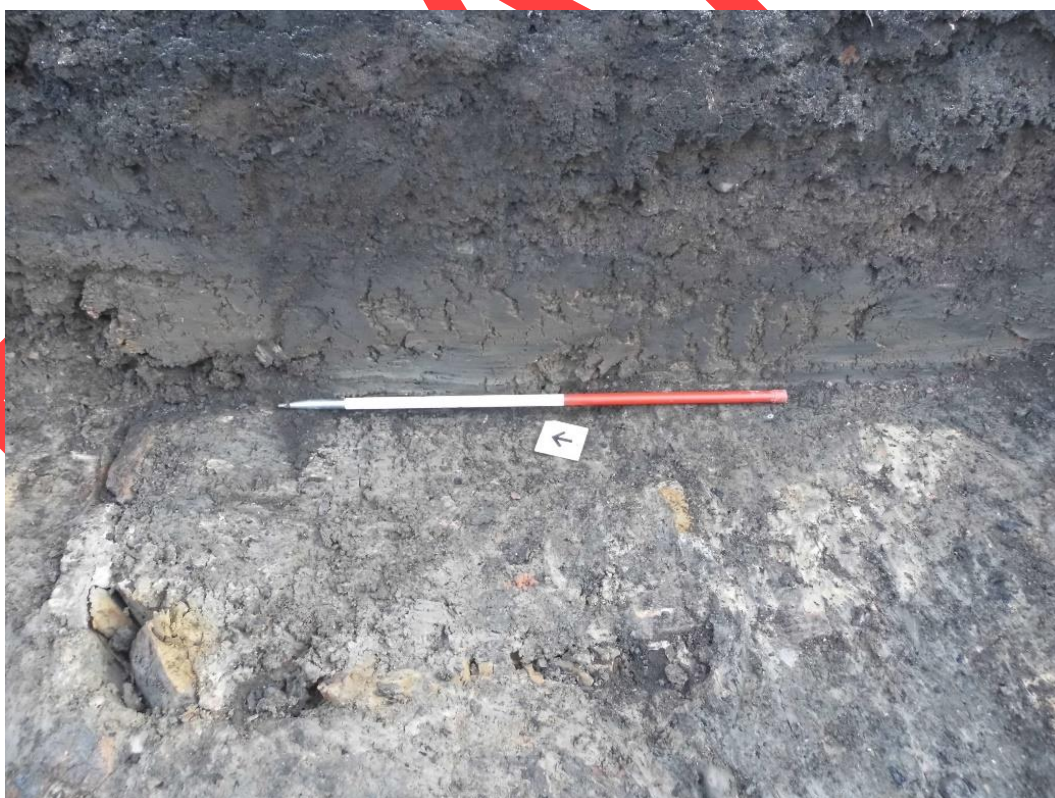
At the south-east end of the trench was a pit or structure with a mixed stone and clay lining [36] (Fig. 14). Another possible pit [30] in the centre of the trench appeared to truncate some of the post-medieval layers and is likely to be a later feature, possibly a quarry pit of some kind (Fig. 15).

Figure 14: Pit [36] looking north-east

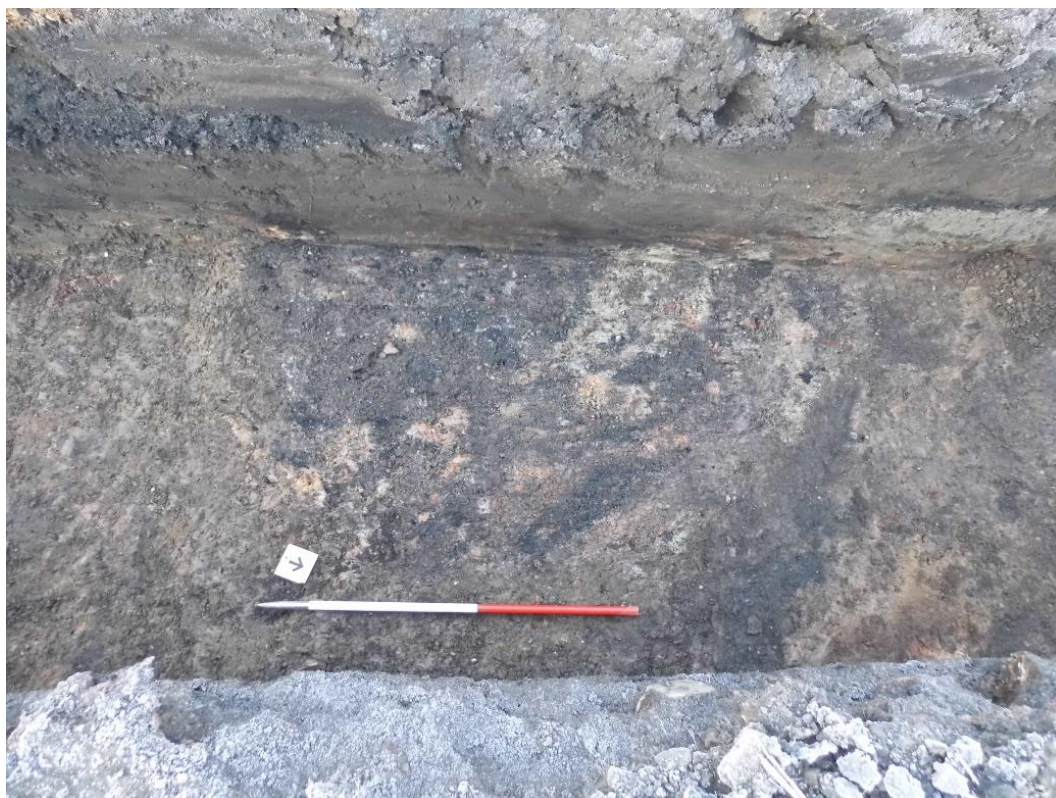
Figure 15: Pit [30] looking south-west

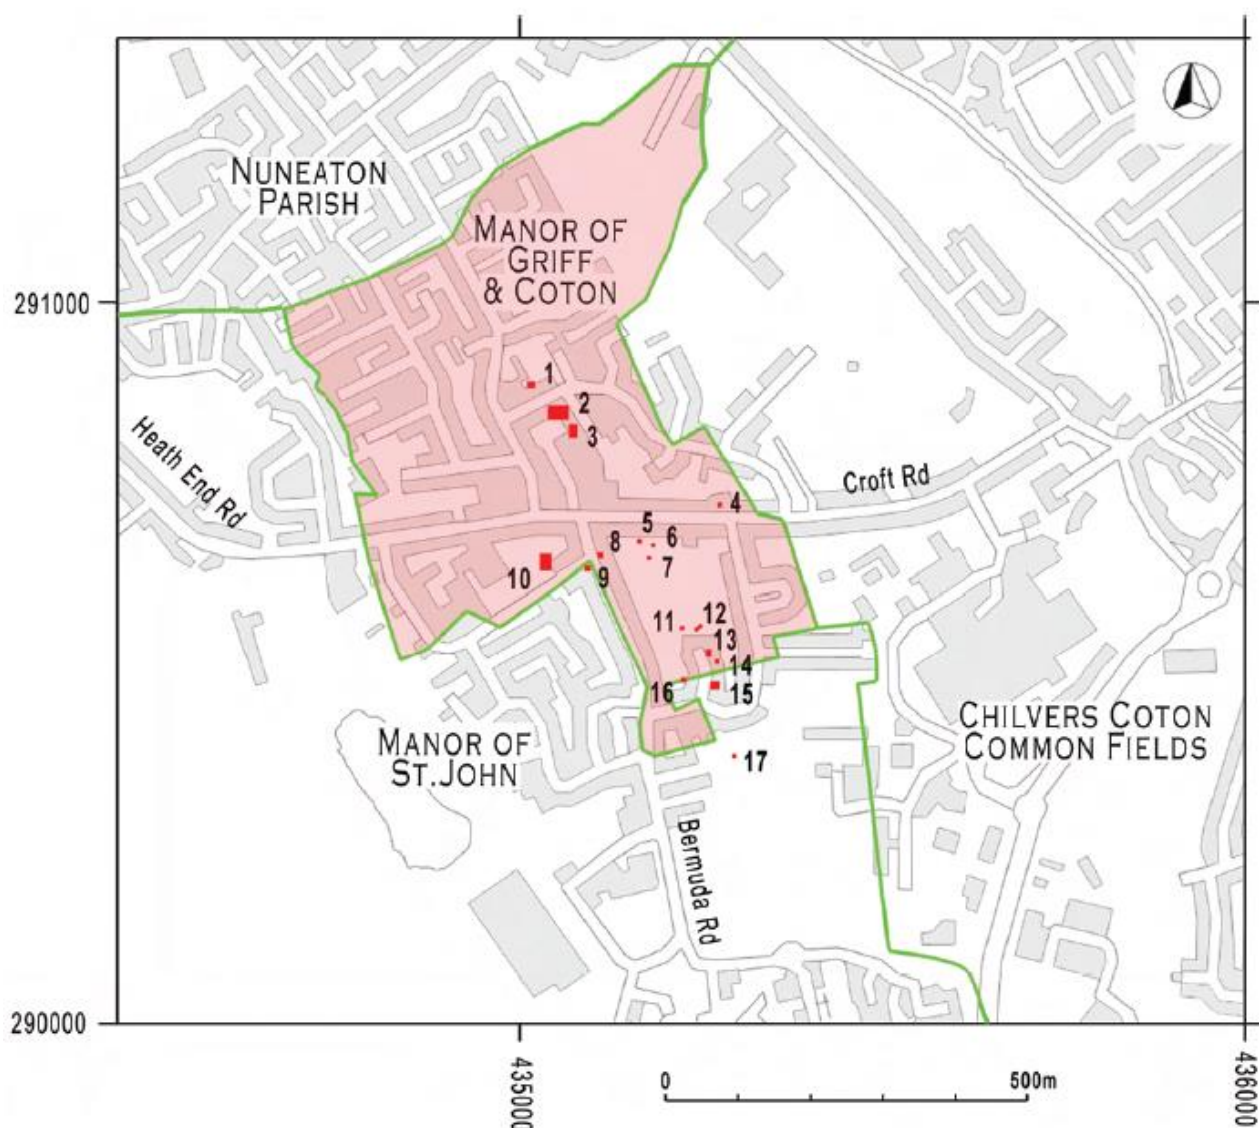
Figure 16: Location of known pottery kilns (from Wilson 2015, fig 2)

The area evaluated for this scheme of work lies adjacent to Sites 2 and 3 from the 1971 excavations (Myers and Scott 1984). Both sites contained extensive evidence for the production of medieval pottery with six and eight kilns excavated in these areas respectively. Large assemblages of pottery, tile and kiln furniture were recovered from both sites and the results of the current work would suggest that the proposed development site is likely to produce similar quantities of archaeological features and material associated with the production of pottery and tile.
