University of Wales Trinity Saint David

School of Engineering

*Major Project Exhibition Report –  
Effects of thermal cycling on surface flatness and electrical  
performance of EPAS power modules.*

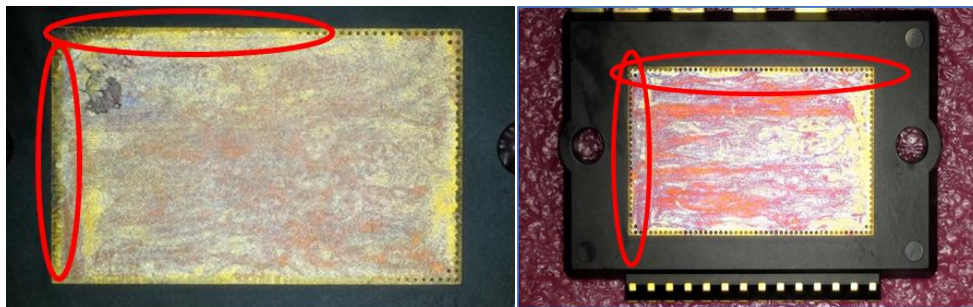
Figure 1: KSR power modules with defect DBC (left) and controlled DBC (right)

A sample of 6 defect parts as seen in figure 1 (left) have been selected for testing and analysis along with a sample of 6 controlled parts as seen in figure 1 (right) as a comparison. Using 12 parts in total provides extensive data on the effects of thermal stress on the power modules with a comparison to determine if the thermal relief dimples missing on the defect modules has any possible accelerated effects of thermal stress.

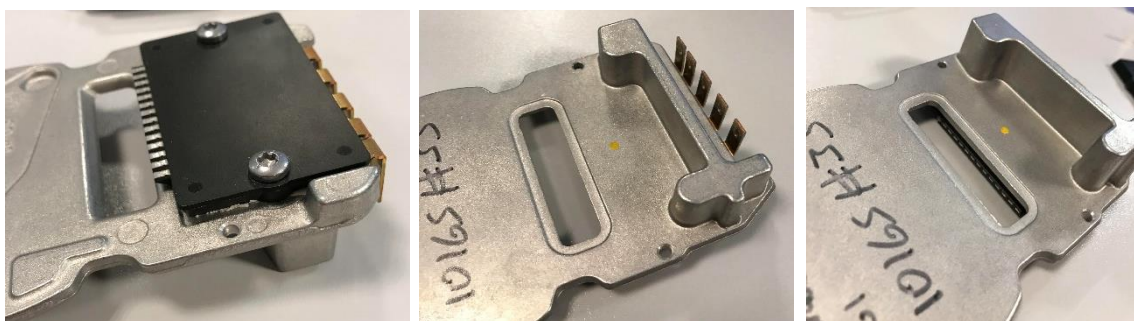
The flatness is significant to the customer, due to the connection of the power module to the customer's assembly – the power module is attached to a heatsink via thermal adhesive and bolt connections as shown in figure 4.

Figure 4: Power Module attached to customer's heatsink (Source: Thomas and KSR, 2018)

Flatness is extremely important as it ensures all sections of the power modules relationship face with the customer's heatsink component are in contact, if it wasn't micro pockets of air would form and would increase the thermal resistance between the heatsink and the module (Lutz et al, 2018).

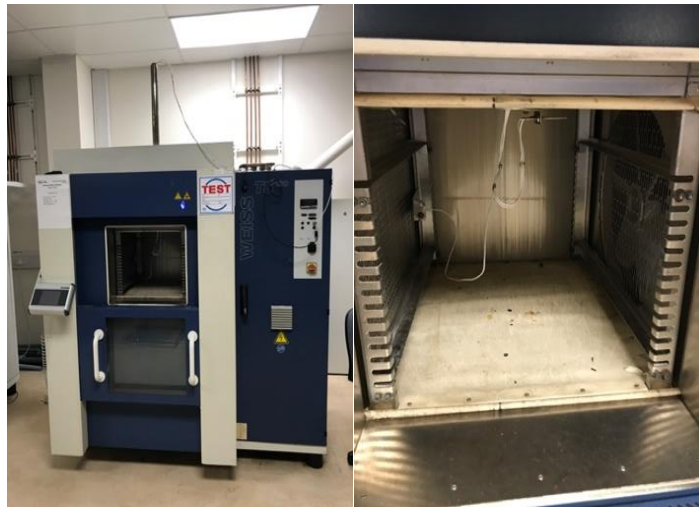
Thermal stress was induced using a thermal shock chamber (figure 5) for a total of 1000 cycles, completed in 250 cycle increments.

One cycle consisted of  $-40^{\circ}\text{C} \pm 5\%$  for 30 minutes with a maximum of 30 second transition to  $115^{\circ}\text{C} \pm 5\%$  for 30 minutes and maximum 30 second transition back to  $-40^{\circ}\text{C} \pm 5\%$ .

Figure 5: Thermal Shock Chamber (Source: KSR and Thomas, 2017)

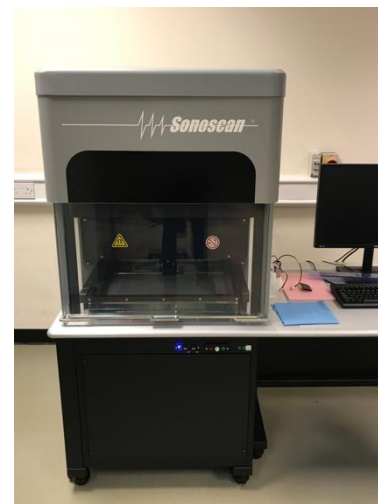
Following each 250 thermal cycles, the power modules were inspected by the failure analysis engineer, with the use of Scanning Acoustic Microscopy (CSAM), which uses ultra-high frequency ultrasound to identify any physical failures within the power modules. Other methods such as X-Ray could be used; however CSAM imaging provides clearer and more accurate analysis (Kessler, 2013).

Figure 6: CSAM ultrasound (Source: KSR and Thomas, 2017)

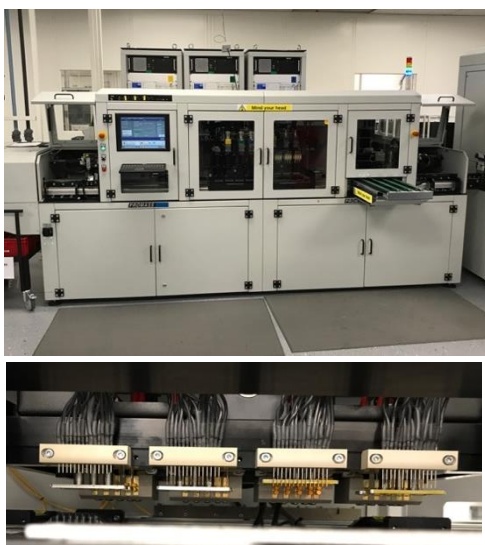
bespoke product with specific power terminals, a specific and custom-made electrical testing machine (figure 7) has been specially made. It has specific contact points which line up to each terminal on the power module keys, each key corresponds to specific MOSFET's, it is also automated, and therefore reducing human contact and subsequently reducing human error and increasing accuracy and validity of results (Cresswell, 2002).

Figure 7: Electrical Test Machine (top) and Internal contact points (bottom) (Source: KSR & Thomas, 2017)

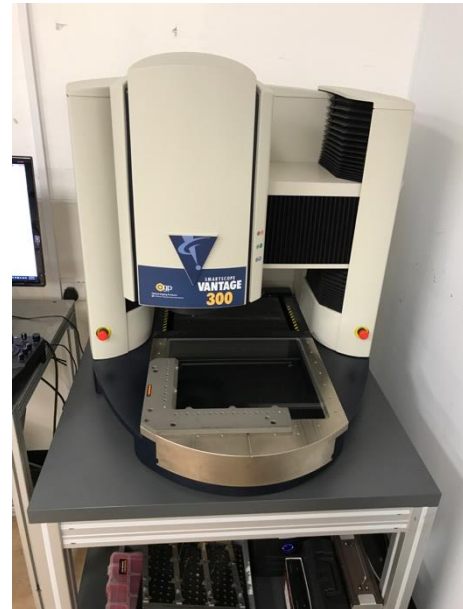
The flatness measurements were completed using a specialist coordinate measuring machine(CMM), produced by a company called Optical Gaging Products (OGP), this OGP machine (figure 8) uses specialist software which is programmed and calibrated every 6 months to ensure it is extremely accurate, the software is programmed with customers specified dimensions and tolerances and can therefore accurately measure the distance the surface differs from the specified plane – providing an accurate flatness measurement.

The OGP machine uses specially written programme software, relating to the drawing design and dimensions, with it being a bespoke automated programme, it reduces the possibility of human error, and there is increased accuracy due to laser measurement technology (Dhillon, 2013).

Figure 8: OGP machine (Source: Thomas, 2017)
