# Design and Validation of USB 3.0 Inserter for Use in Automated Test Equipment

Author: Michael Howells  
Supervisor: Gary Jones

Project submitted as part of the requirements for the award of *BEng (Hons) Electrical and Electronics Engineering*  
April 2024

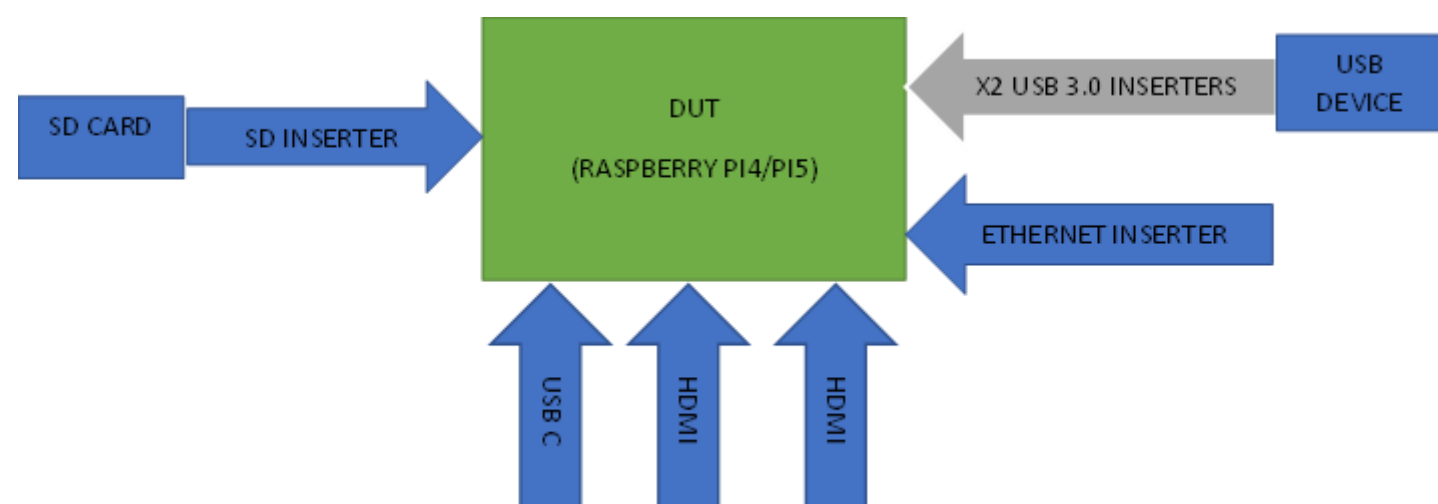
The Raspberry Pi test jig automatically connect 7 things to the DUT as part of the automated test. These can be seen in the diagram below. The USB inserter relevant to this project has been highlighted in grey.

Connected to each of the USB inserters is a USB device. This contains both a USB 2.0 device and a USB 3.0 device and is used to verify that the USB functionality on the DUT is working correctly. The pass condition at test requires 4 devices to be detected when the USB inserters are connected.

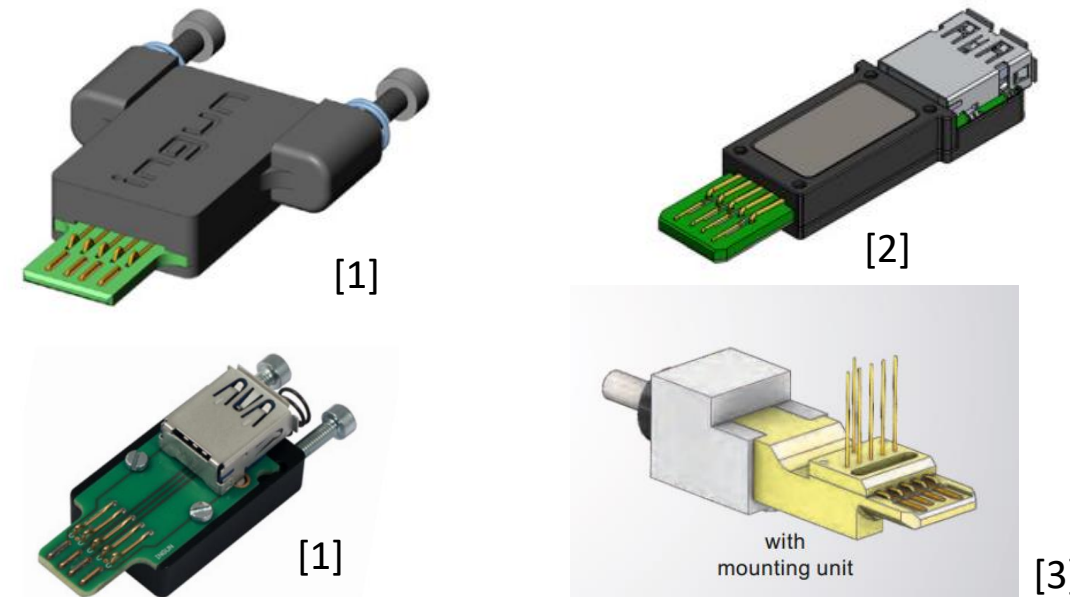
The research conducted was an evaluation of established designs for USB inserters that are available on the market. The characteristics of each were compared with the aim of identifying features that will help improve the design for this report. Example products show below.

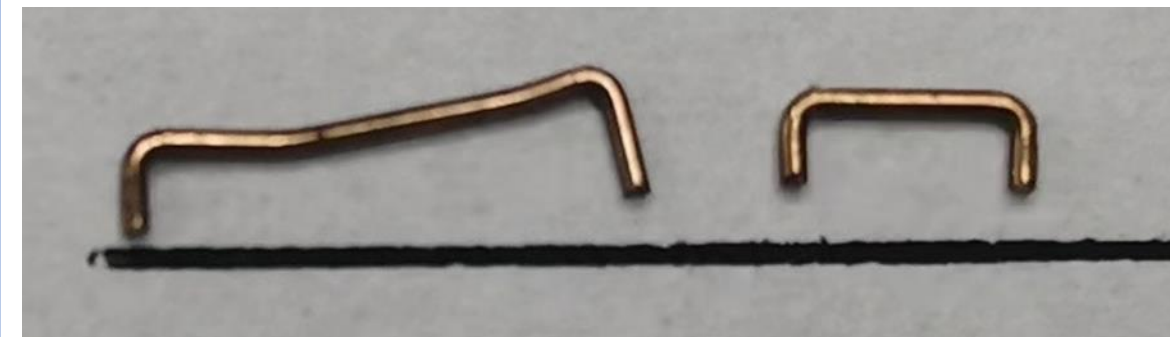
The literature review identified that all inserter products had springs that were used to connect to the USB 3.0 connections on the mating connector. This feature was a desirable feature to add to the new inserter. This was one of the most challenging parts of the project, however eventually, a method to manufacture very small custom springs was identified.

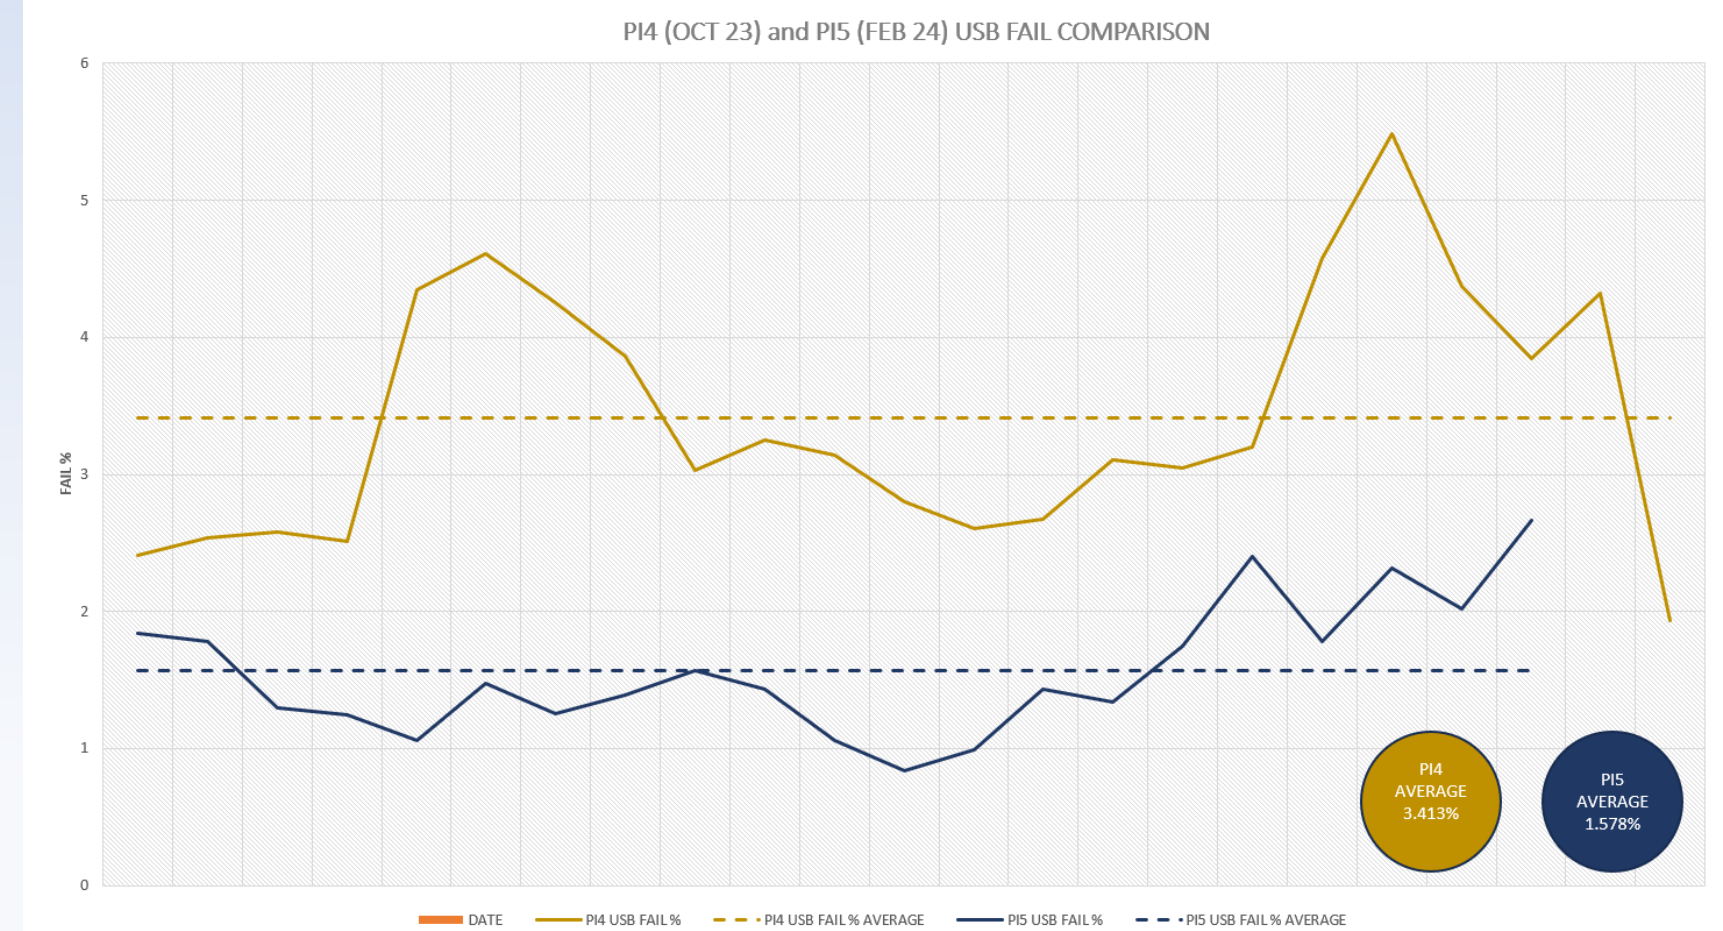
From the data gathered during the data study of the project, there was a reduction in USB failures by 1.835%. This was further quantified to show an estimated cost saving of £9,666.80 per year, based on the time that would be saved retesting 1.835% of boards.

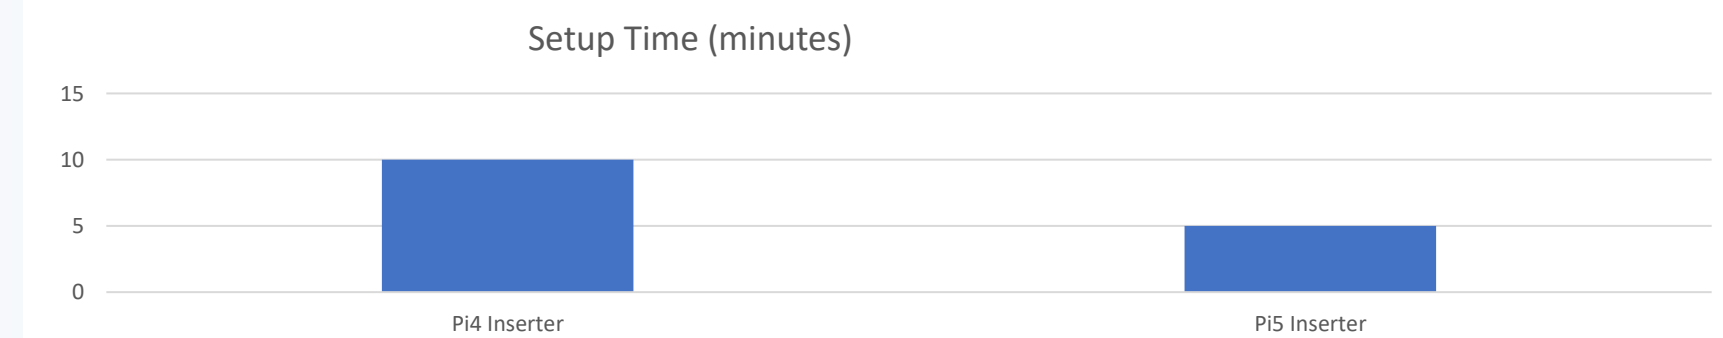
To evaluate the maintainability of the new inserter, the setup time was measured for the old and new design (V3.4.5) and compared, the results are shown below.

The main reason for the increased setup time for the Pi4 inserter is that there was far more adjustment in the setup, which required some time to get aligned correctly, whereas the new style inserter was much closer fit into the connector and did not have this issue.

The reduced setup time shows that the new style of inserter is more maintainable.
