# The Graveney Boat: a Tenth-Century Find from Kent

Excavation and recording; interpretation  
of the boat remains and the environment;  
reconstruction and other research;  
conservation and display

Edited by  
**Valerie Fenwick**

National Maritime Museum, Greenwich,  
Archaeological Series No. 3

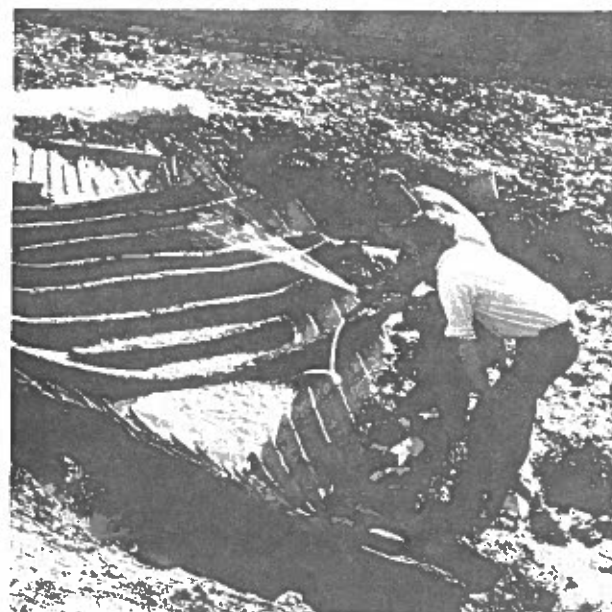
Fig. 1.2.2 To prevent waterlogged wood from drying out, water from the bottom of the channel was circulated with a sludge pump.  
© V. H. Fenwick

As the ship had to be uncovered during recording it was very important to keep the wood as wet as possible. At this time the site could not be reached by vehicles, so that in the absence of any alternative supply, water, which had collected in puddles and in a sump dug in the bottom of the channel, was circulated with a sludge pump (Fig. 1.2.2). Making a measured drawing on site had to be abandoned because of the difficult conditions and the need for speed. Instead, as described on p. 25, some 700 measurements were taken, using plumb-line and measuring tape and standing inside the ship. These were noted in diagrammatic form, so that a measured drawing could be made later. (Fig. 1.2.4). Waterproof copies of Miss Millard's sketch plan were made on which to record specific aspects. The bottom of the channel around the ship soon became a treacherous morass. Duck-boards were laid around the hull and these also provided a foundation for scaffolding to support an awning,<sup>5</sup> which was so expertly erected that measuring could continue uninterrupted.

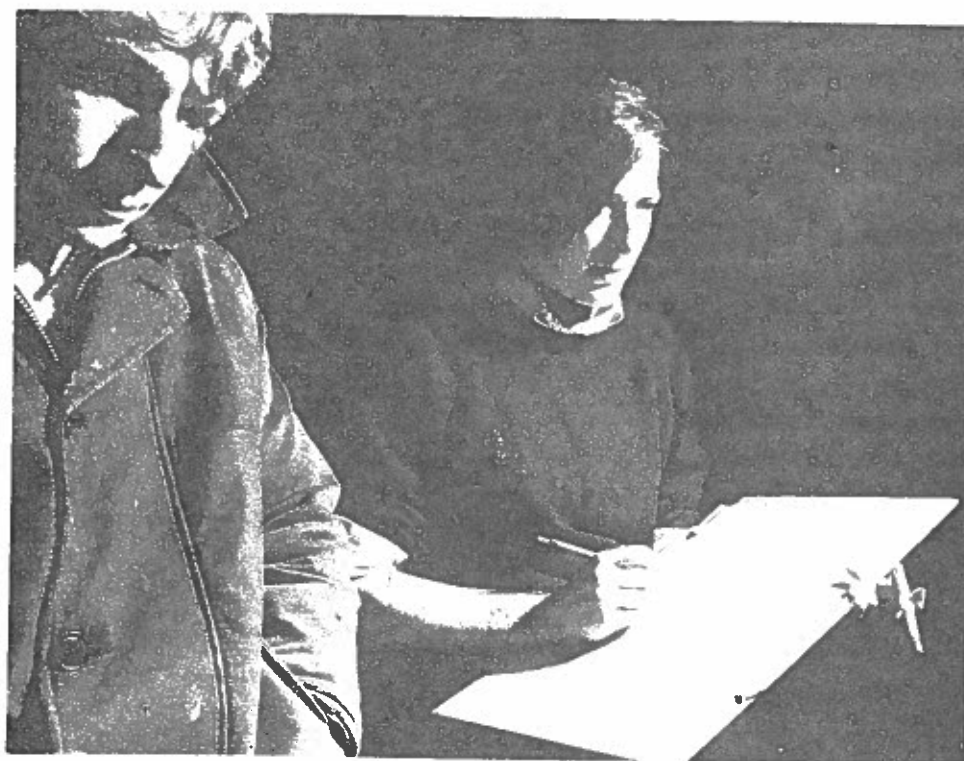
Fig. 1.2.4 Diagrams on washable plastic film supplemented photographs  
© National Maritime Museum

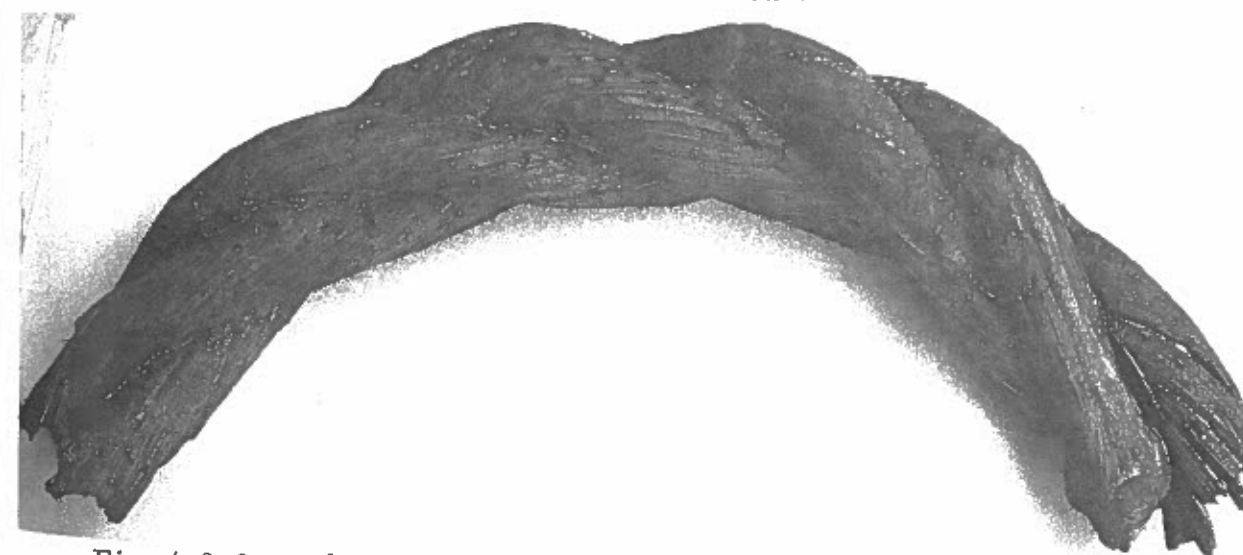
Fig. 1.2.6 Three-strand rope, Gr15 (0.14 m long) from beneath port side. After impregnation with polyethylene glycol it was strong enough to handle. The structure of vegetable fibres was too incoherent for identification  
© National Maritime Museum

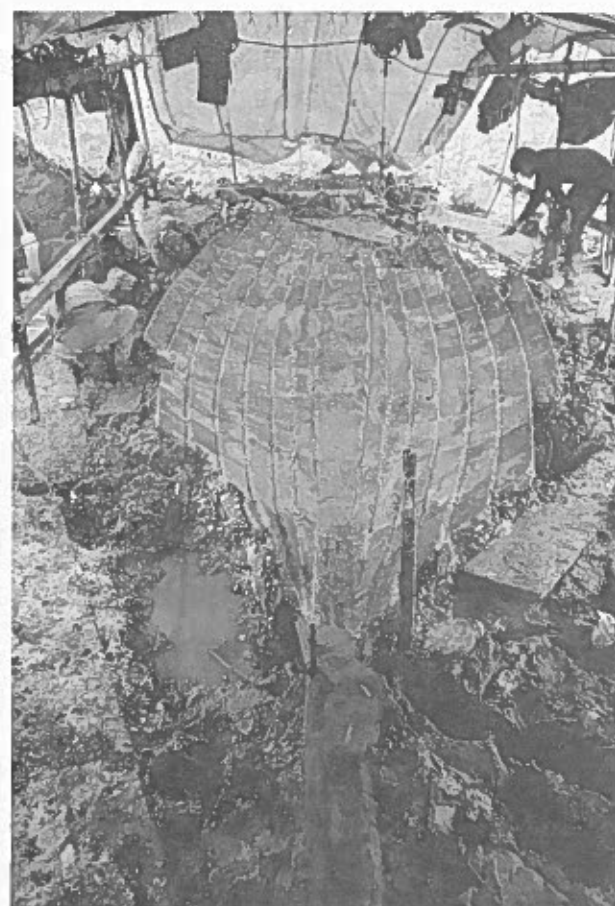
Fig. 1.3.2 Plaster mould of the inside of the planking before removal

After the plaster mould had been removed, spraying of the hull with water was re-started and the strakes were lifted one at a time. The exact length of wood to be lifted in each operation was determined by the position of joints or breaks. A sheet of plywood, 5 mm thick, was cut to the approximate length of the section of the strake, and the mud below the strake was dug away carefully by hand. At the moment when the part of the strake was about to come away from that next to it, the plywood was inserted underneath and used to lift the wet timber on to a scaffolding plank, upon which the curvature was maintained by chocking up the plywood with blocks of wood (Fig. 1.3.4). The strakes were recorded photographically and then packed, like the frames, in wet plastic foam and polythene sleeving. Specially made crates were used to transport them in a lorry lined with plastic foam to the storage tank in the National Maritime Museum. These crates were not unpacked but were loaded into the tank as they had left the site, although slits were cut in the polythene to allow circulation of water. The crates were so buoyant that they had to be wedged under water. All trenails and small fragments of strakes were packed separately in polythene bags.

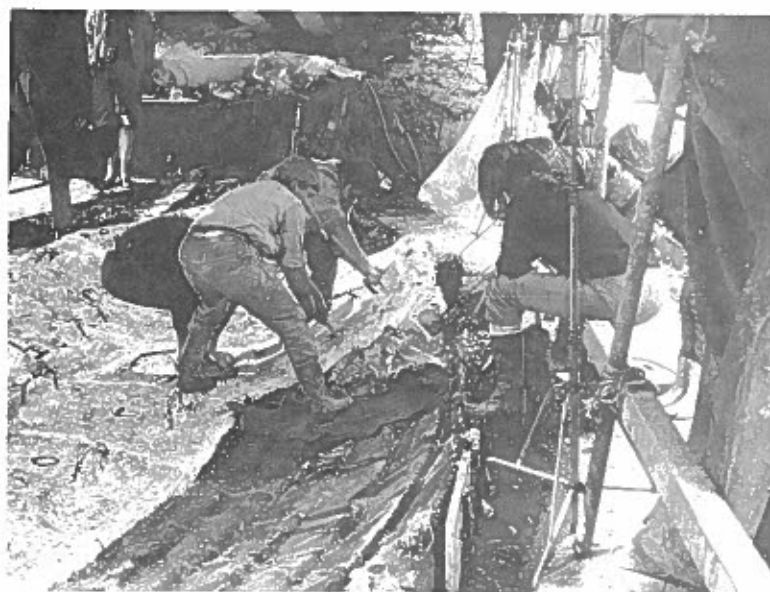
Fig. 1.3.3 Plaster mould being lifted from the planking in small manageable sections  
© A. Oddy

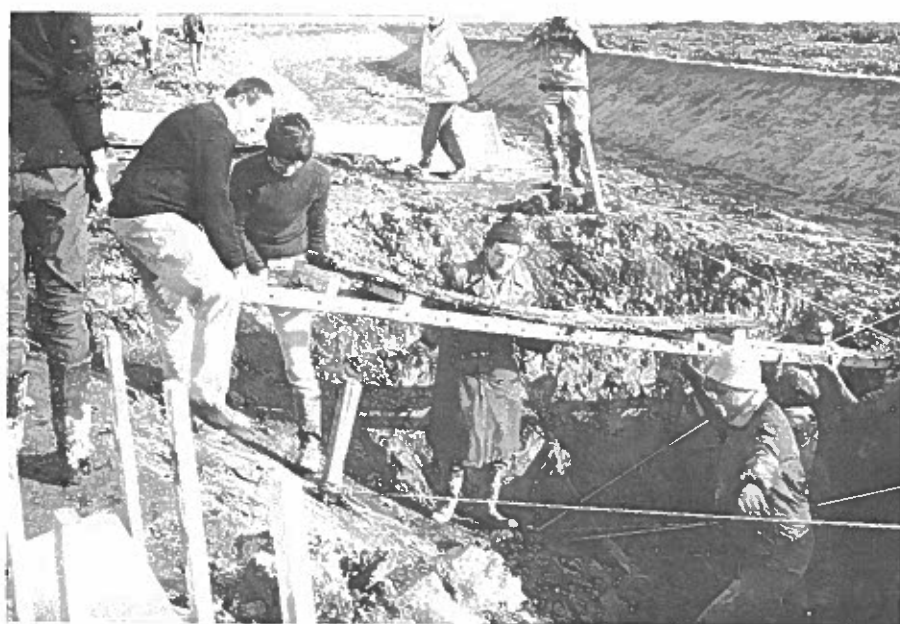
Fig. 1.3.4 Each plank was slid on to a plywood support for removal; blocks of wood maintained curvature.  
© National Maritime Museum

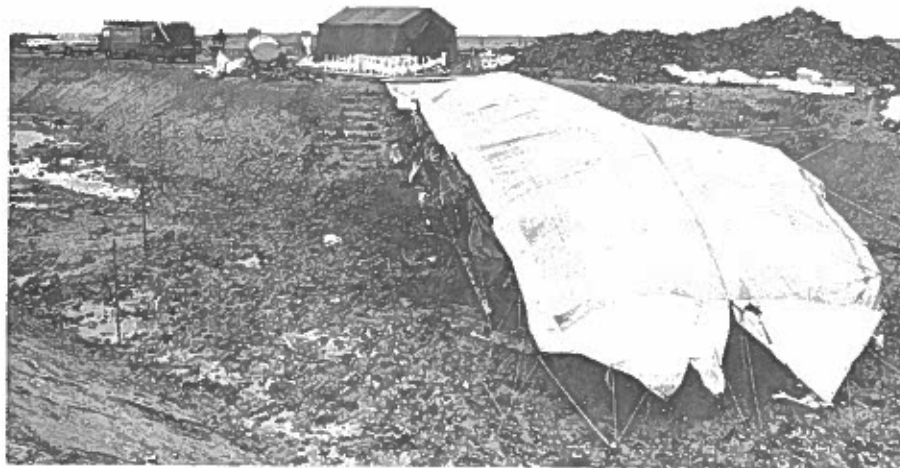
Fig. 2.2.1 Awning over the boat made photography difficult.  
National Maritime Museum

In order to have a complete coverage in plan it was necessary to take vertical photographs of each part of the hull. These were taken from planks which were placed across the scaffolding supporting the awning over the whole boat (Fig. 2.2.1). The position of the photographer squeezed between the planks and the canvas roof of the awning which vibrated in the wind made it extremely difficult to hold the camera steady. A tripod was out of the question because of the awkwardness of the position and the very muddy conditions. As fast a shutter speed as possible had therefore to be used; when lighting conditions deteriorated (late afternoon to evening), it was necessary to use flash.

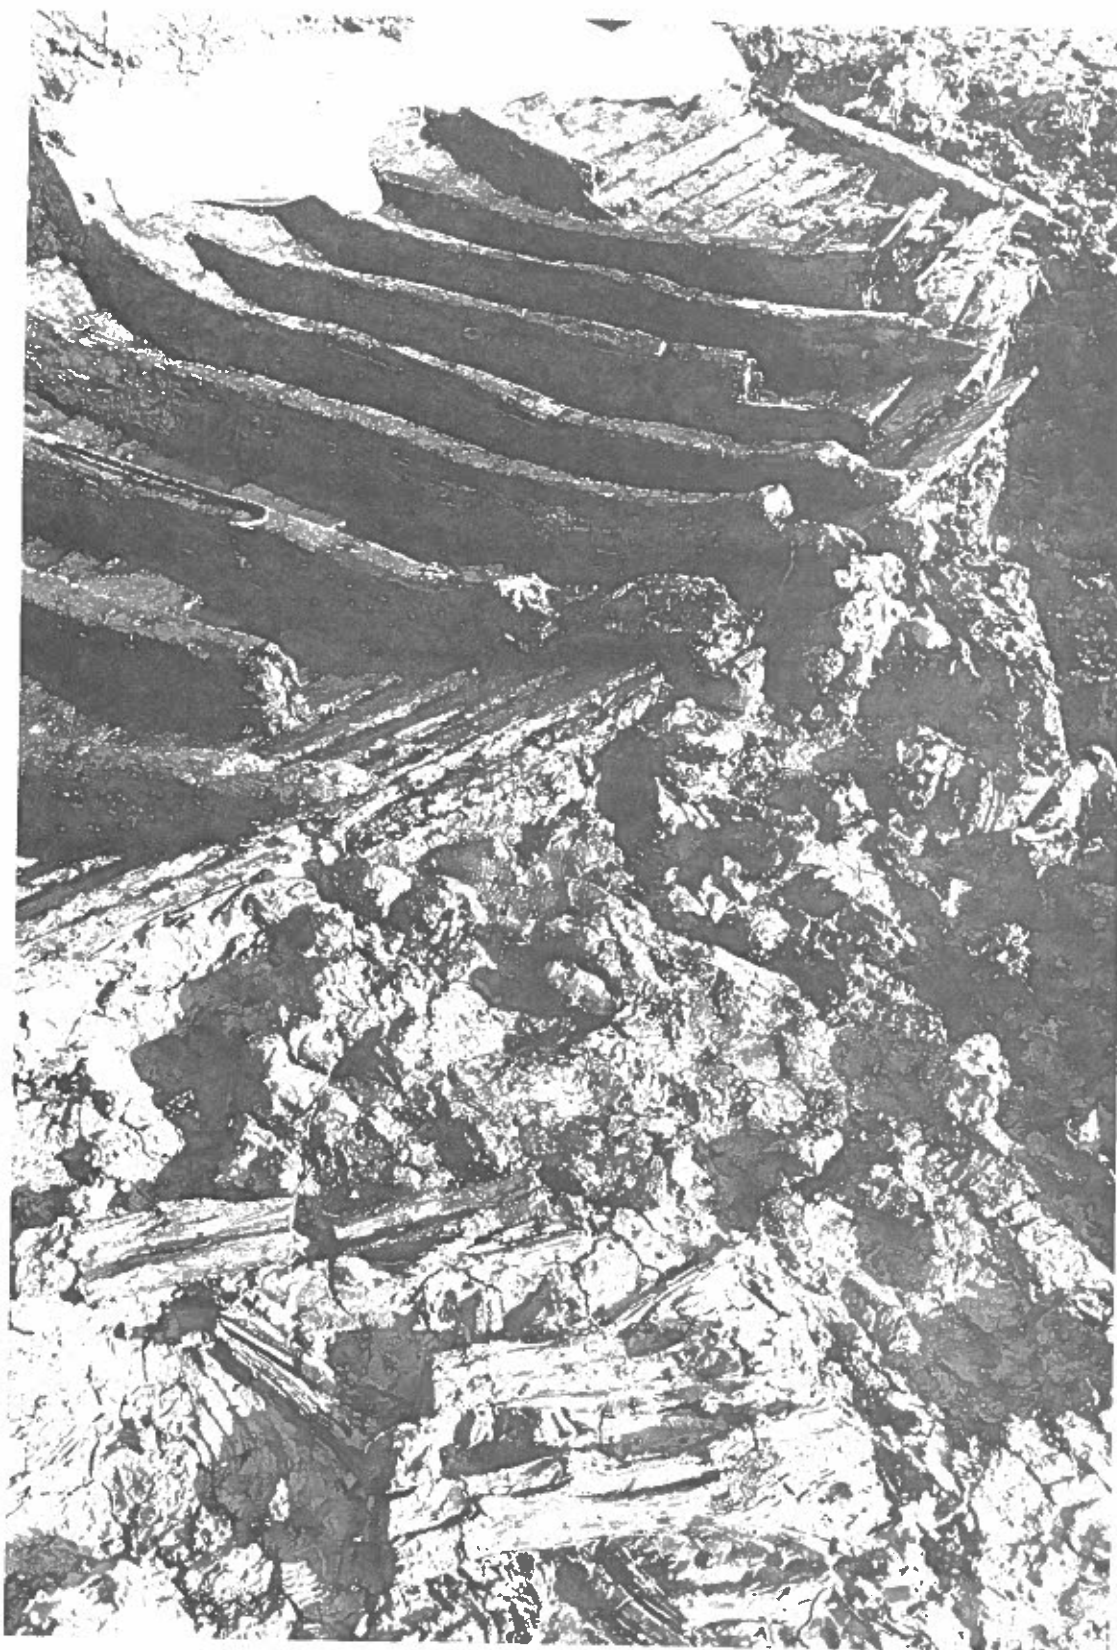
Fig. 2.2.3 Remains of timber hard or standing (foreground), and the massive frames of the boat are thrown into relief by cross-to-slightly-behind light  
© National Maritime Museum

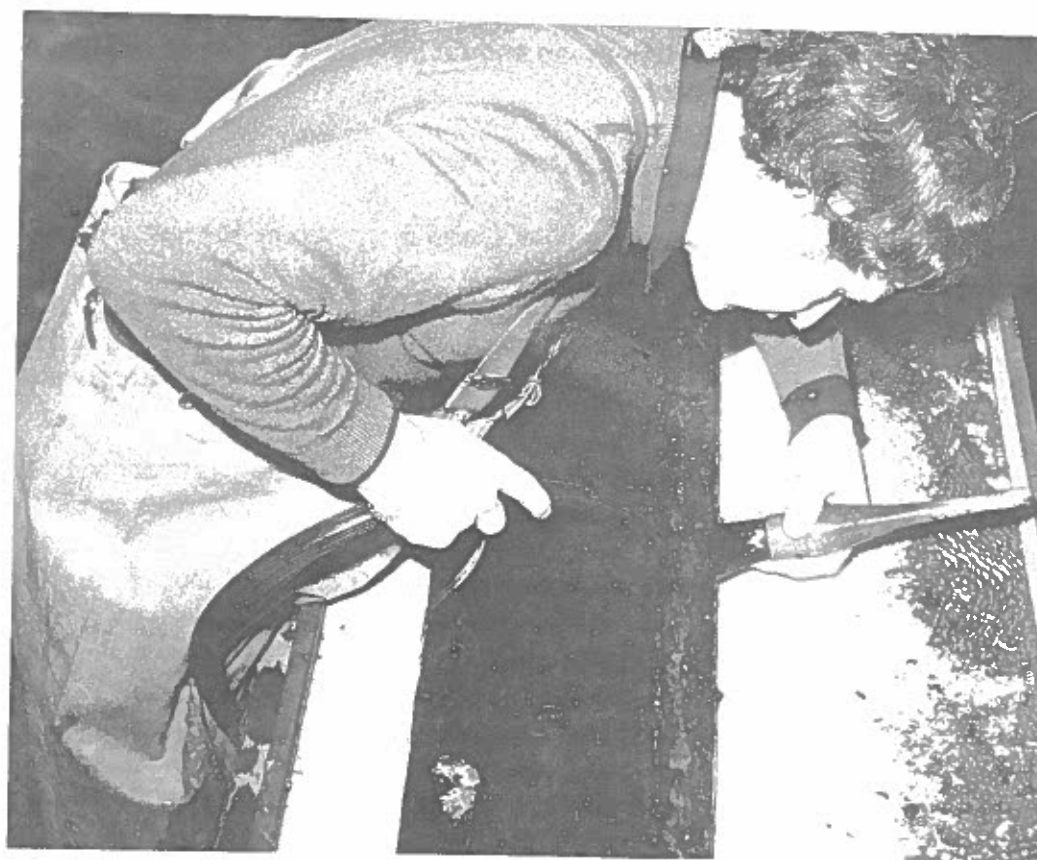
Fig. 2.3.2 Thorough washing of planking with a soft brush in gently running water revealed details of construction.  
© National Maritime Museum

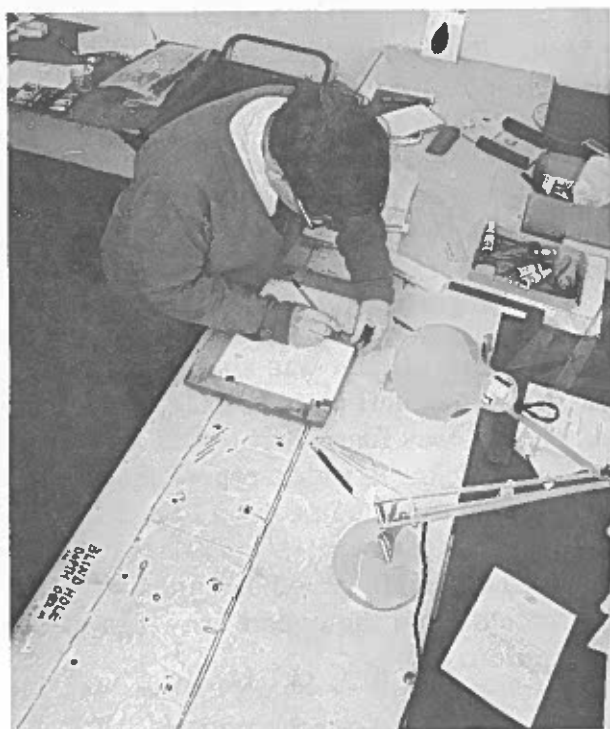
Fig. 2.3.7 Reducing full-scale tracing of a plank to a 1:10 scale drawing  
© National Maritime Museum

record the data and work on the drawings, that is, about two important pieces per week. The keel took two weeks and larger items like the sternpost and ribs one week each. However extravagant of effort this may seem in comparison with photogrammetry, it is not as much as it might appear. Photogrammetry would have produced only projections and would have saved only one member of the Unit. Without the experience of handling and examining every part of the boat, the work of reconstructing it from photographic evidence alone would have been even more difficult.

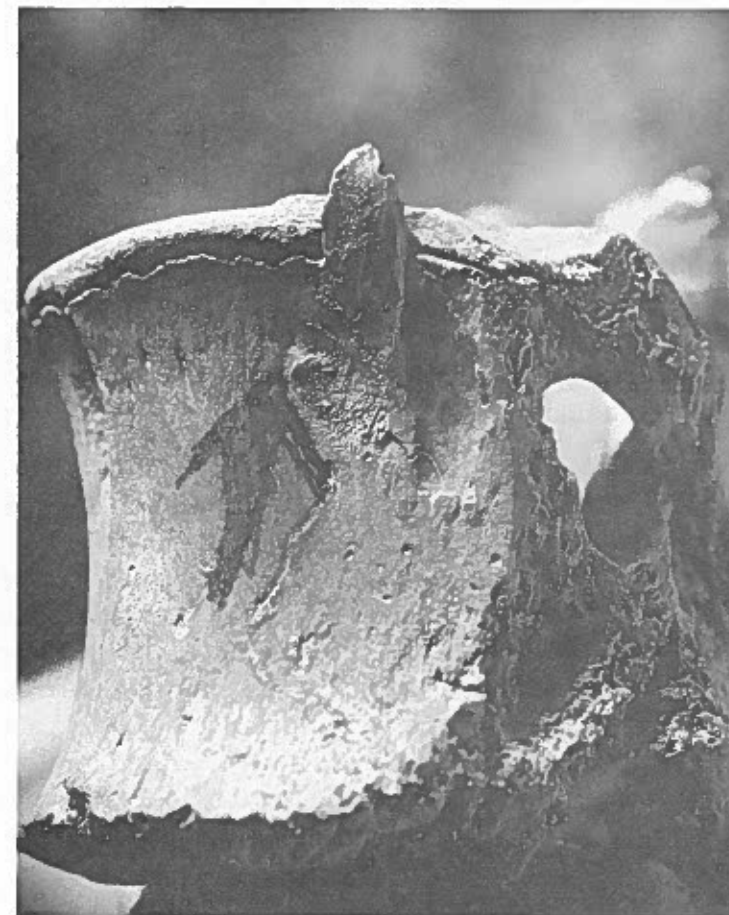
Fig. 5.4.1 Lumbar vertebra of a pig from inside the boat, exhibiting spondylosis with some exostosis  
© National Maritime Museum

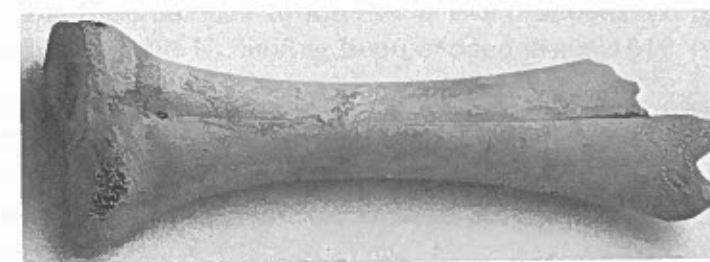
Fig. 5.4.2 Tiny bovine metapodial, perhaps from a dwarf animal. Actual size 94 mm  
© Barbara Noddle

| Graveney no. of sample | Position | Identification (l. = length, w. = width) | Notes |
|---|---|---|---|
| Gr119 | Beyond broken end of boat, probably once inside | <ol style="list-style-type: none"> <li>1. Cattle, metacarpal, distally immature (Fig. 5.4.2), l. 94 mm, proximal w. 27 mm, midshaft w. 13 mm rib tibia fragment } could be of horse</li> <li>2. Sheep or goat, 10 ribs scapula fragment femur distal epiphysis thoracic vertebra mature } larger than lumbar vertebra mature } Soay type</li> <li>3. Pig, sacrum mature thoracic vertebra mature pelvis fragment tibia proximal fragment, w. 39 mm 2 lateral metapodials mature l. 44.5 and 60.6 mm 1st phalanx mature, max. l. 40 mm 1st phalanx lateral mature</li> </ol> | |

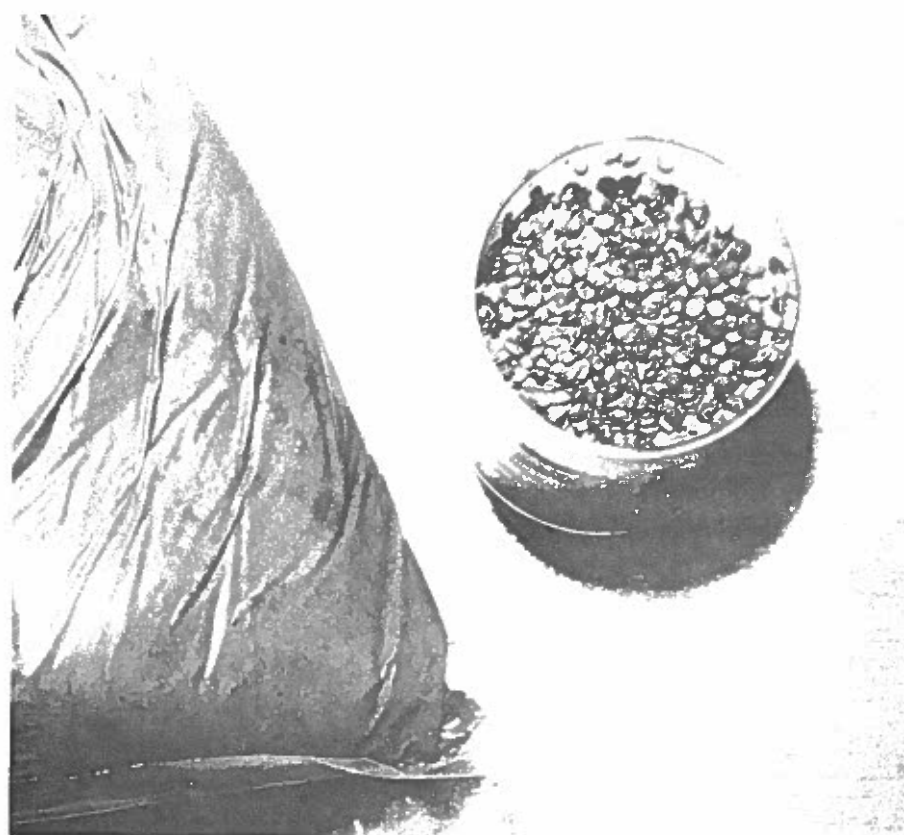
Fig. 6.5 Hop seeds from inside the ship  
© Author

While the shells sieved from the mud samples failed to provide a connexion with the local industry, the mud itself provided evidence of a quite unexpected kind to link the trade ship with a specific cargo (Fig. 6.5). It contained pollen which had been blown from plants growing near by and some distance away (pp. 142-3). Mixed oak forest with quite a high percentage of beech indicated by the tree pollen confirms the plentiful evidence from elsewhere for the former extent of the forest of Blean (e.g. Southouse, 1671:121). Plant remains found in the mud around the ship reveal the nature of the local environment. Seeds and other plant remains had also been washed with the mud into the hull (pp. 143, 147). The immediate environment was, as expected from the geographical situation, estuarine in the period before the marsh was inned. Species from the brushwood platform again supported the general picture of dry-land vegetation in the vicinity, which included weeds perhaps from cultivated ground round the manor of Graveney on the W. or Hernhill on the S. This is consistent with evidence for eustatic change and with documentary evidence for pasture land before the Conquest (pp. 165, 167, 179).

There were no traces of hop in any of the samples taken from outside the hull, with the exception of the brushwood immediately beyond the broken starboard side. In view of the heavy concentration of hop seeds inboard these latter have probably spilled from beneath frames R4 and 5 when the ship broke up. The sample from beneath frame R6 produced the greatest proportion of hop remains. As this frame lay amidships, it would have collected sludge containing fragments of its cargo beneath it. It is interesting that this frame also trapped many plant remains not found in other samples. These must have been collected on voyages, or in the place where it was built. Samples from beneath frame R1 did not have the same quantity of hop seeds (this frame was certainly removed at a late stage in the vessel's life in order to repair the keel, p. 221); the other main collection of seeds came from a sample taken from between overlapping strakes on the port side near frame R4. This again came from low down in the hull, where dirt derived from its cargo could well have collected.

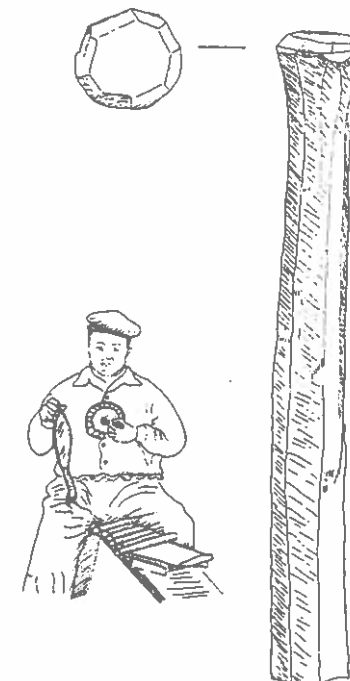
Fig. 7.9 Unused trenail with faceted expanded head, produced by a 20th-century *xavega* builder with a knife pivoting on his right thigh and a wooden disc held against his chest. Scale 1:2  
© Jane Weeks

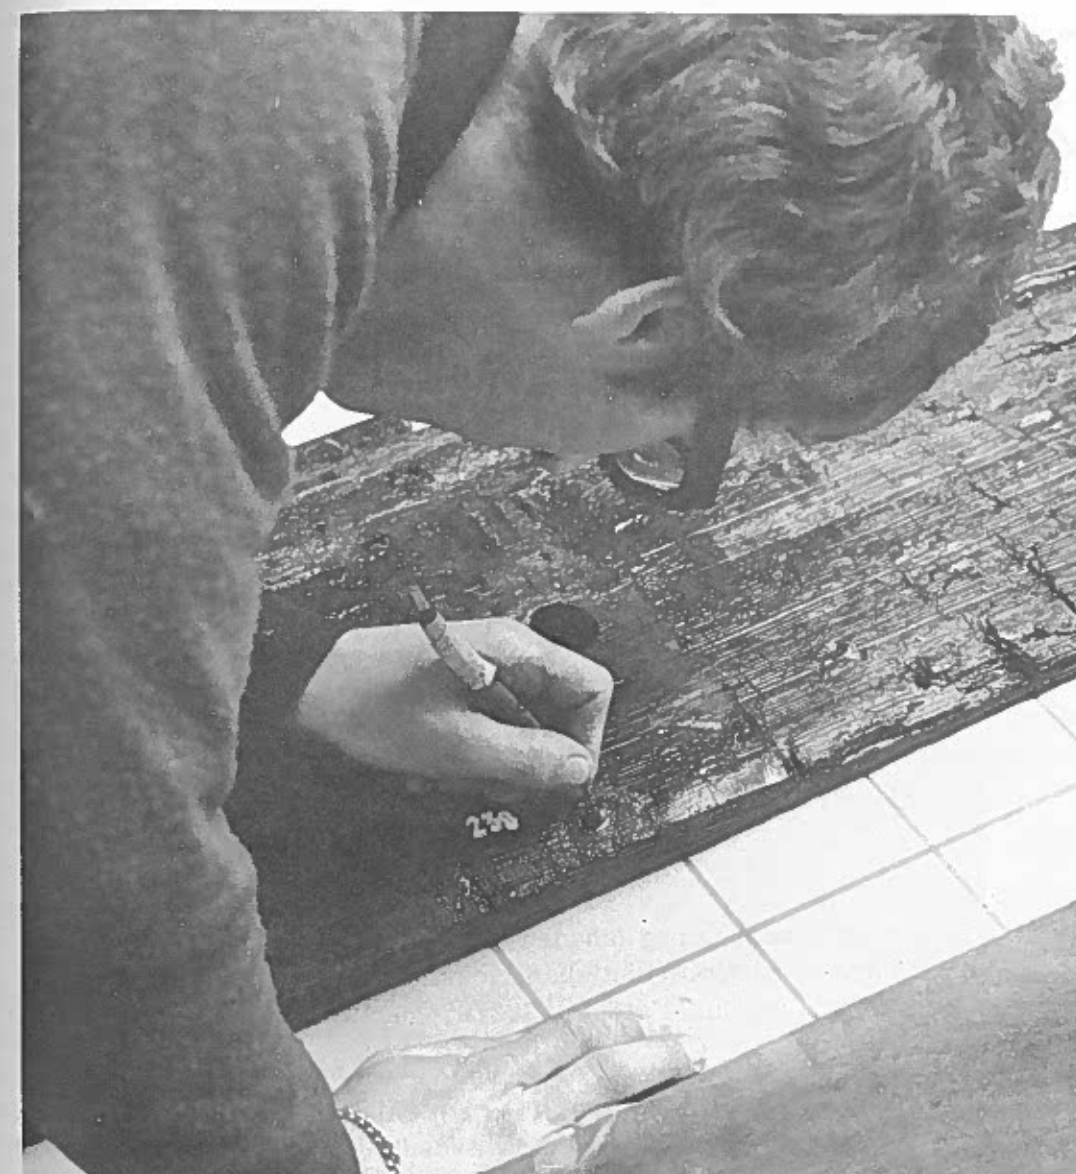
Fig. 8.17 Details of construction, such as wooden pegs inserted in the strake-fastening holes before iron rivets driven in, were revealed by careful cleaning.  
© National Maritime Museum

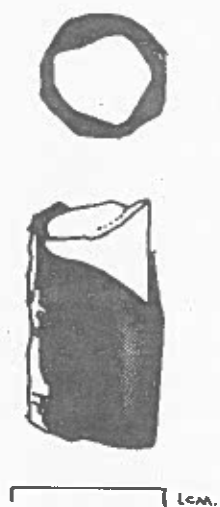
Fig. 8.18 Form of a wooden peg (shaded) preserved by the corrosion products of an iron rivet shank (centre); part of an oak strake adheres on l. side. Gr279. Scale 1:1. Drawn by C. W. Gregson  
© National Maritime Museum

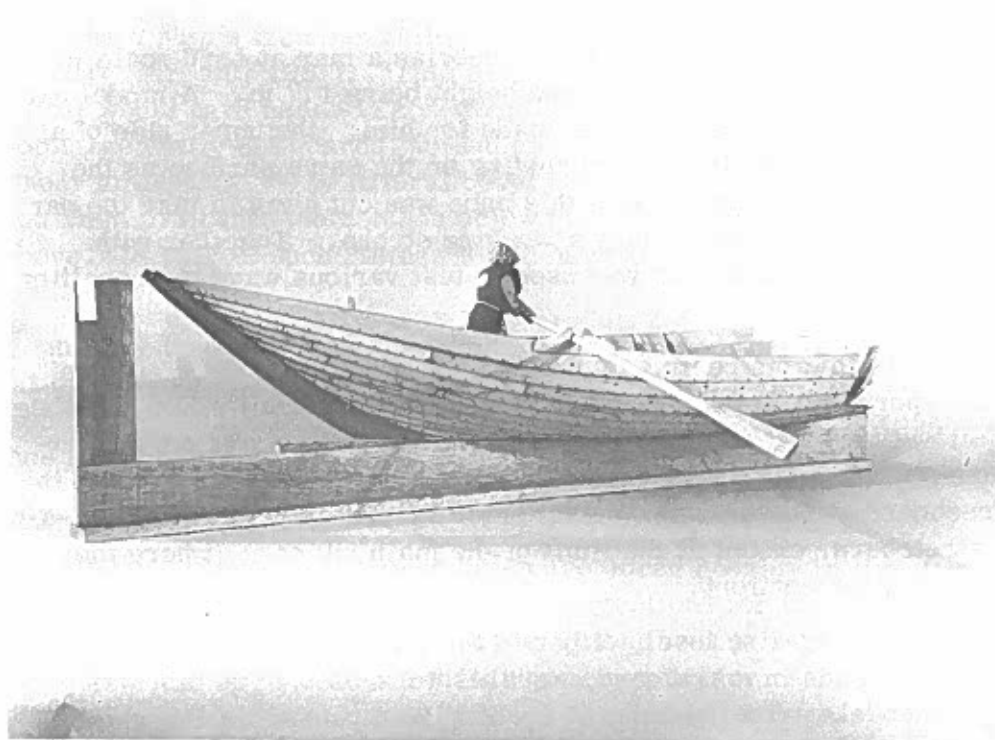
Fig. 9.1.10 Model of the minimum solution, or a reconstruction of the missing parts on the assumption that the vessel was an estuary lighter. Scale 1:10 Model by Eric McKee  
© National Maritime Museum
