# Neighbours: Negotiating space in a prehistoric village

David Frankel\*<sup>1</sup> & Jennifer M. Webb\*<sup>2</sup>

ANTIQUITY 80 (2006): 287–302

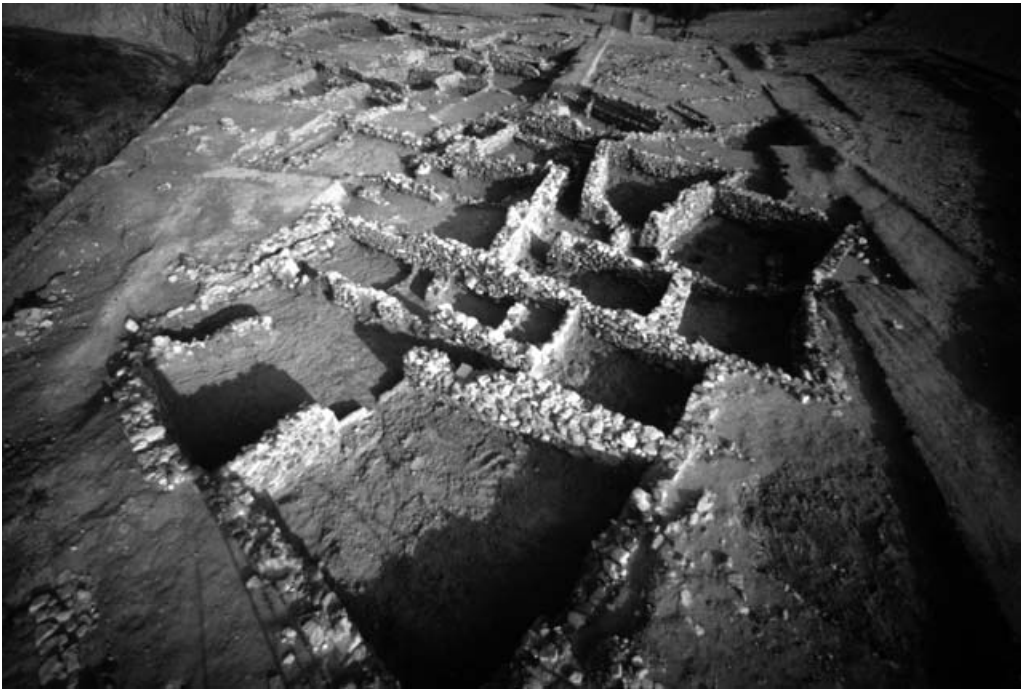
*Figure 1. Marki-Alonia: looking east across the excavated area with Compound 7 in the foreground.*

The site of Marki in Cyprus was occupied for 500 to 600 years from the beginning of the Bronze Age (about 2400 BC) through to Middle Cypriot II (about 1800 BC) (Frankel & Webb 1996, 2000) (Figure 1). During this time the village grew in size from a small community of a few households to a larger settlement with streets, before declining in size and finally being abandoned. This expansion, and an analysis based on the associated cemeteries, suggests a founding population of a few dozen people, expanding to reach a maximum of about 400 inhabitants (Figure 2; Frankel & Webb 2001; Webb & Frankel 2004). The excavated area covers about 2000m<sup>2</sup> of the 6 hectare site and includes evidence of all periods from the earliest occupation to final phases, by which time the focus of settlement had shifted some hundreds of metres to the south-east. Site economy was linked to nearby copper ore deposits in the northern foothills of the Troodos Mountains. From the beginning, however, the community was fully self-sustaining, with a focus on cereal agriculture, animal husbandry and the local production of ceramics, textiles and ground and chipped stone tools.

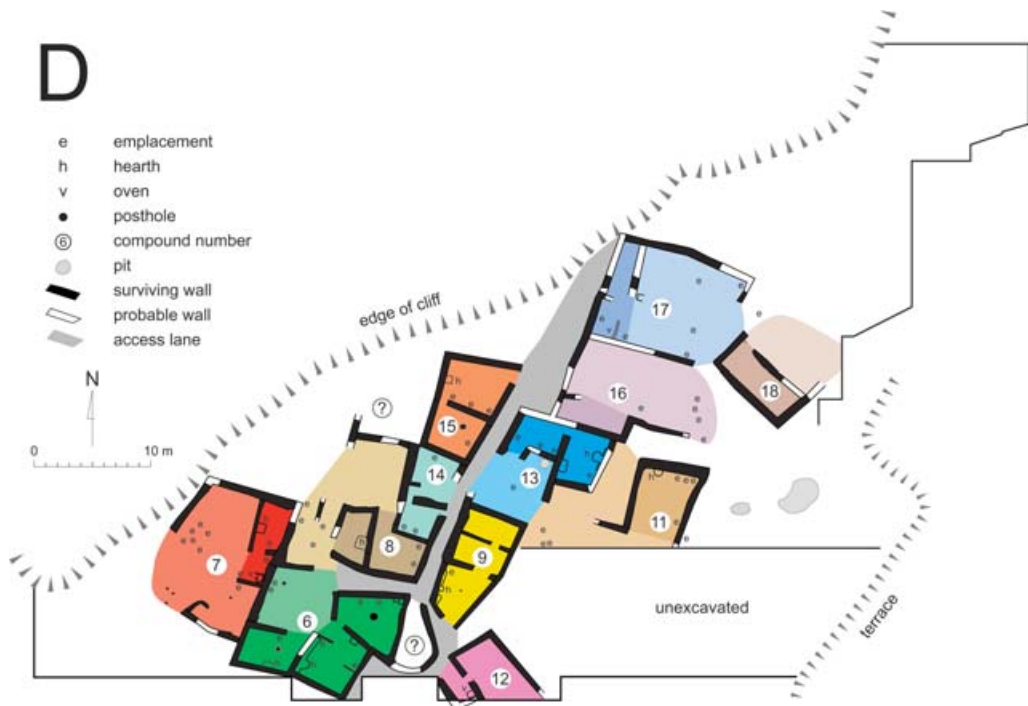
Figure 9. Plan of Marki during Phase D (Early Cypriot I–II).

The agglomeration of building apparent in the preceding phase was carried further in Phase D, considerably expanding the built-up area and requiring the establishment of a formal north/south laneway to provide access through this part of the settlement. This must have involved considerable re-negotiation of spatial boundaries and, presumably, of property rights.

Compound 9 was substantially restructured, losing its western courtyard, and re-oriented to become a three-roomed house entered directly from the laneway to the south. It does not appear to have had an associated courtyard, although it is possible that the (unexcavated) space east of Compound 6 served this purpose. Compound 8 was enlarged to the north and east, taking in some of the area previously held by Compound 9.

Compound 6 retained its overall size and position with some modification. There were, however, considerable changes within this space. The older eastern courtyard was now fully enclosed and roofed over to form two rooms, taking in previously open space on the south, and the north-western area, which had previously been roofed inner space, was opened up to become the courtyard. This reorganisation resulted in a significant increase in the overall area occupied by interior rooms with a consequent reduction in courtyard space. Compounds 6 and 8 were both now entered via a short passage leading in from the main laneway. This shared passage and continued direct access from the new courtyard of 6 to that of 8 again suggest close co-operation between these two families. With the expansion of Compound 8 to much the same size as Compound 6, however, the earlier dependent relationship has altered to one of at least spatial equality.

A number of new compounds were constructed on either side of the laneway. Two two-room compounds without associated courtyards on the west (14 and 15) and a larger, more traditional compound comprised of two inner rooms and a courtyard on the east (13) were entered directly from the lane. Another three newly

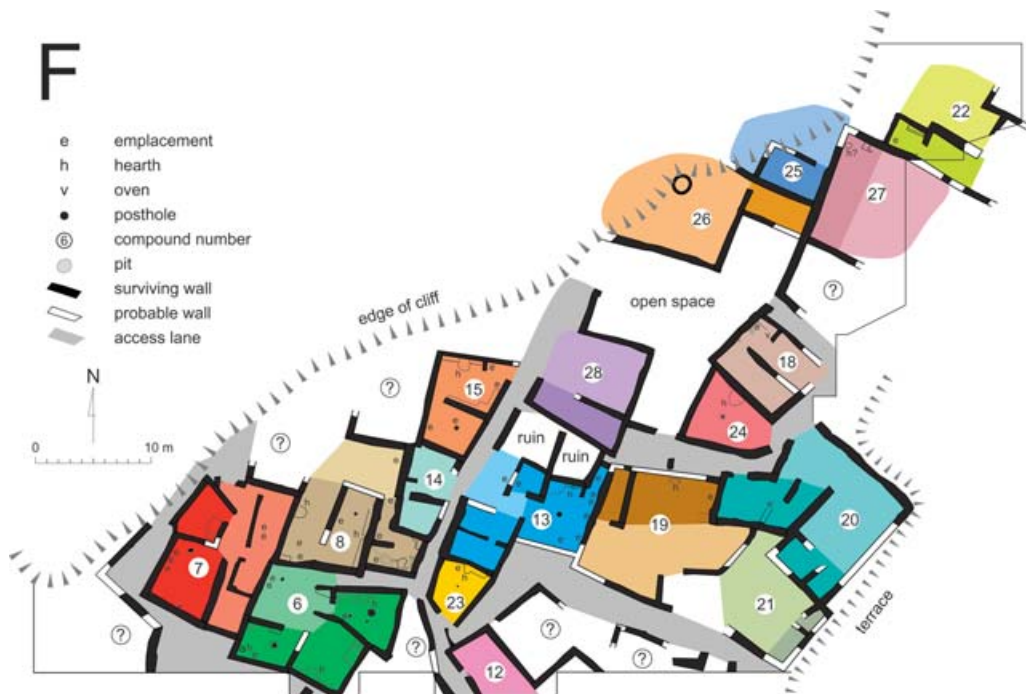
Figure 11. Plan of Marki during Phase F (Early Cypriot III).

A variety of aspects differentiate Phase F from E. Compounds 6-8, 14-15 and 19-21 remained unchanged in size, structure and orientation, with some minor renovation of internal facilities. New compounds (25, 26 and 27) were constructed to the north on what may have been open ground. Smaller areas of open space were also enclosed, as in the case of the single room Compound 24. Major changes also occurred in the centre of the excavated area, with the construction of a substantial raised platform forming Compound 28. This partly took in what was at this time open space on the north, but on the southern side it necessitated the partial demolition of the two interior rooms of Compound 13, constructed originally in Phase D. These remained in place as abandoned ruins, while Compound 13 expanded to the south and east, taking over two rooms of the

old Compound 9 (leaving a single residual room, Compound 23, to the south) and the access way between Compounds 13 and 19. The incorporation of the latter suggests that Compound 13 may have retained 'rights' to the use of this space, which it shared with Compound 11 in Phase D.

The restructuring of Compound 13 led to an overall increase in size and a substantial increase in the ratio of roofed to courtyard space. The loss of the two original inner rooms, effectively forced by the builders of Compound 28, was amply compensated for by the appropriation of two rooms belonging previously to Compound 9 as well as open space to the east. Thus Compound 13, which had been a two-roomed household in Phases D and E, became a three or even four-roomed unit in Phase F. The losers, if there were any, in this process appear to have been the owners of Compound 9, which was now sub-divided to produce a new phenomenon: that of the single room household, evident in the case of both Compounds 23 and 24.

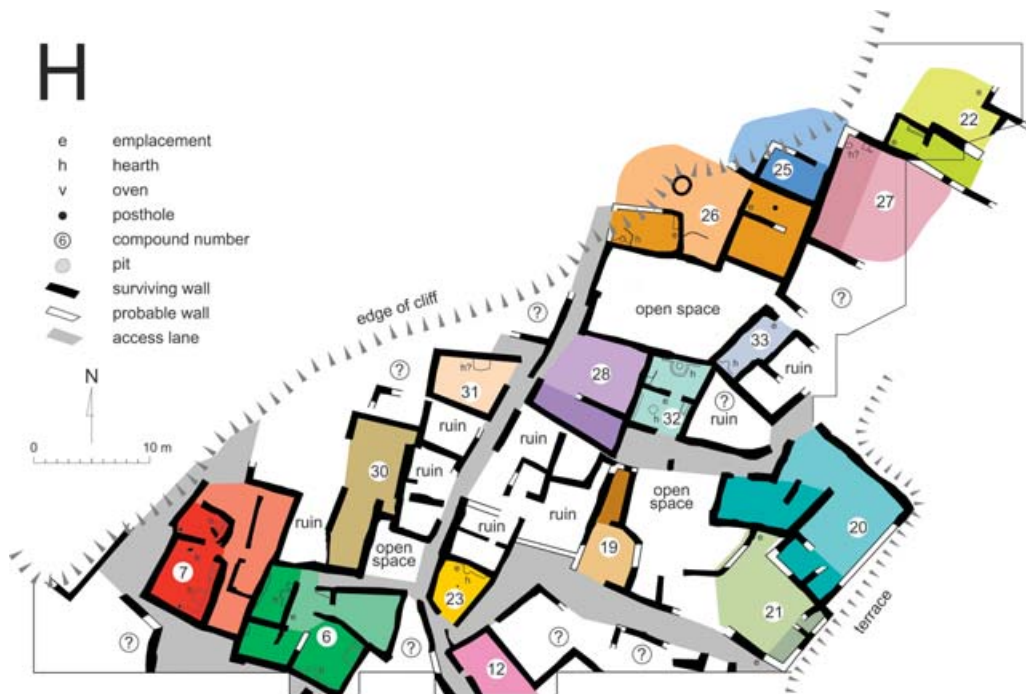
Figure 13. Plan of Marki during Phase H (Middle Cypriot I-II).

The overall density of occupation was now significantly lower. The long-lasting Compounds 6 and 7 continued in use with some minor internal restructuring in Compound 7. The remainder of the excavated space to the west of the north/south laneway, which had been abandoned in Phase G, saw some re-use in the poorly preserved Compounds 30 and 31. To the east of the laneway, Compounds 13, 18, 24 and the recently built Compound 29 were abandoned. Two rooms of Compound 29, however, continued in use in new configurations: one as part of a two-roomed Compound 32 to the south and one as an isolated hearth room, Compound 33, to the east. Further to the north, the south-western area of the courtyard of Compound 26 was enclosed to create a third interior room. At this time only Compounds 6, 7, 22, 23, 25, 26, 32 and 33 show evidence of substantial use and only Compounds 26 and 32 show significant structural development.
