| Property Title<br><b>ACBA4020</b> | Detail<br><b>As-Built GNSS Survey:<br/>Trinity Gardens</b> | Property — Originator — Zone Functional Breakdown — Level Spatial Breakdown — Form — Discipline — Number — Description — Status — Revision | | | | | | | | | | scale<br><b>2:1 @ A3</b> | drawn<br><b>L.J</b> | Prifysgol Cymru<br>Y Drindod Dewi Sant<br>University of Wales<br>Trinity Saint David | <b>(S1) UNCONTROLLED ISSUE</b><br>NOT TO BE USED AS A<br>REFERENCE DOCUMENT<br>CHECK STATUS BEFORE QUOTING | rev/date/by<br>revision |
| | | <b>4020 — UWTSd — .XX — .XX — .D — .B — 0001 — . GNSS Survey — . S1 — . V1</b> | | | | | | | | | | date<br><b>27/04/2026</b> | checked<br><b>H.W</b> | | | |

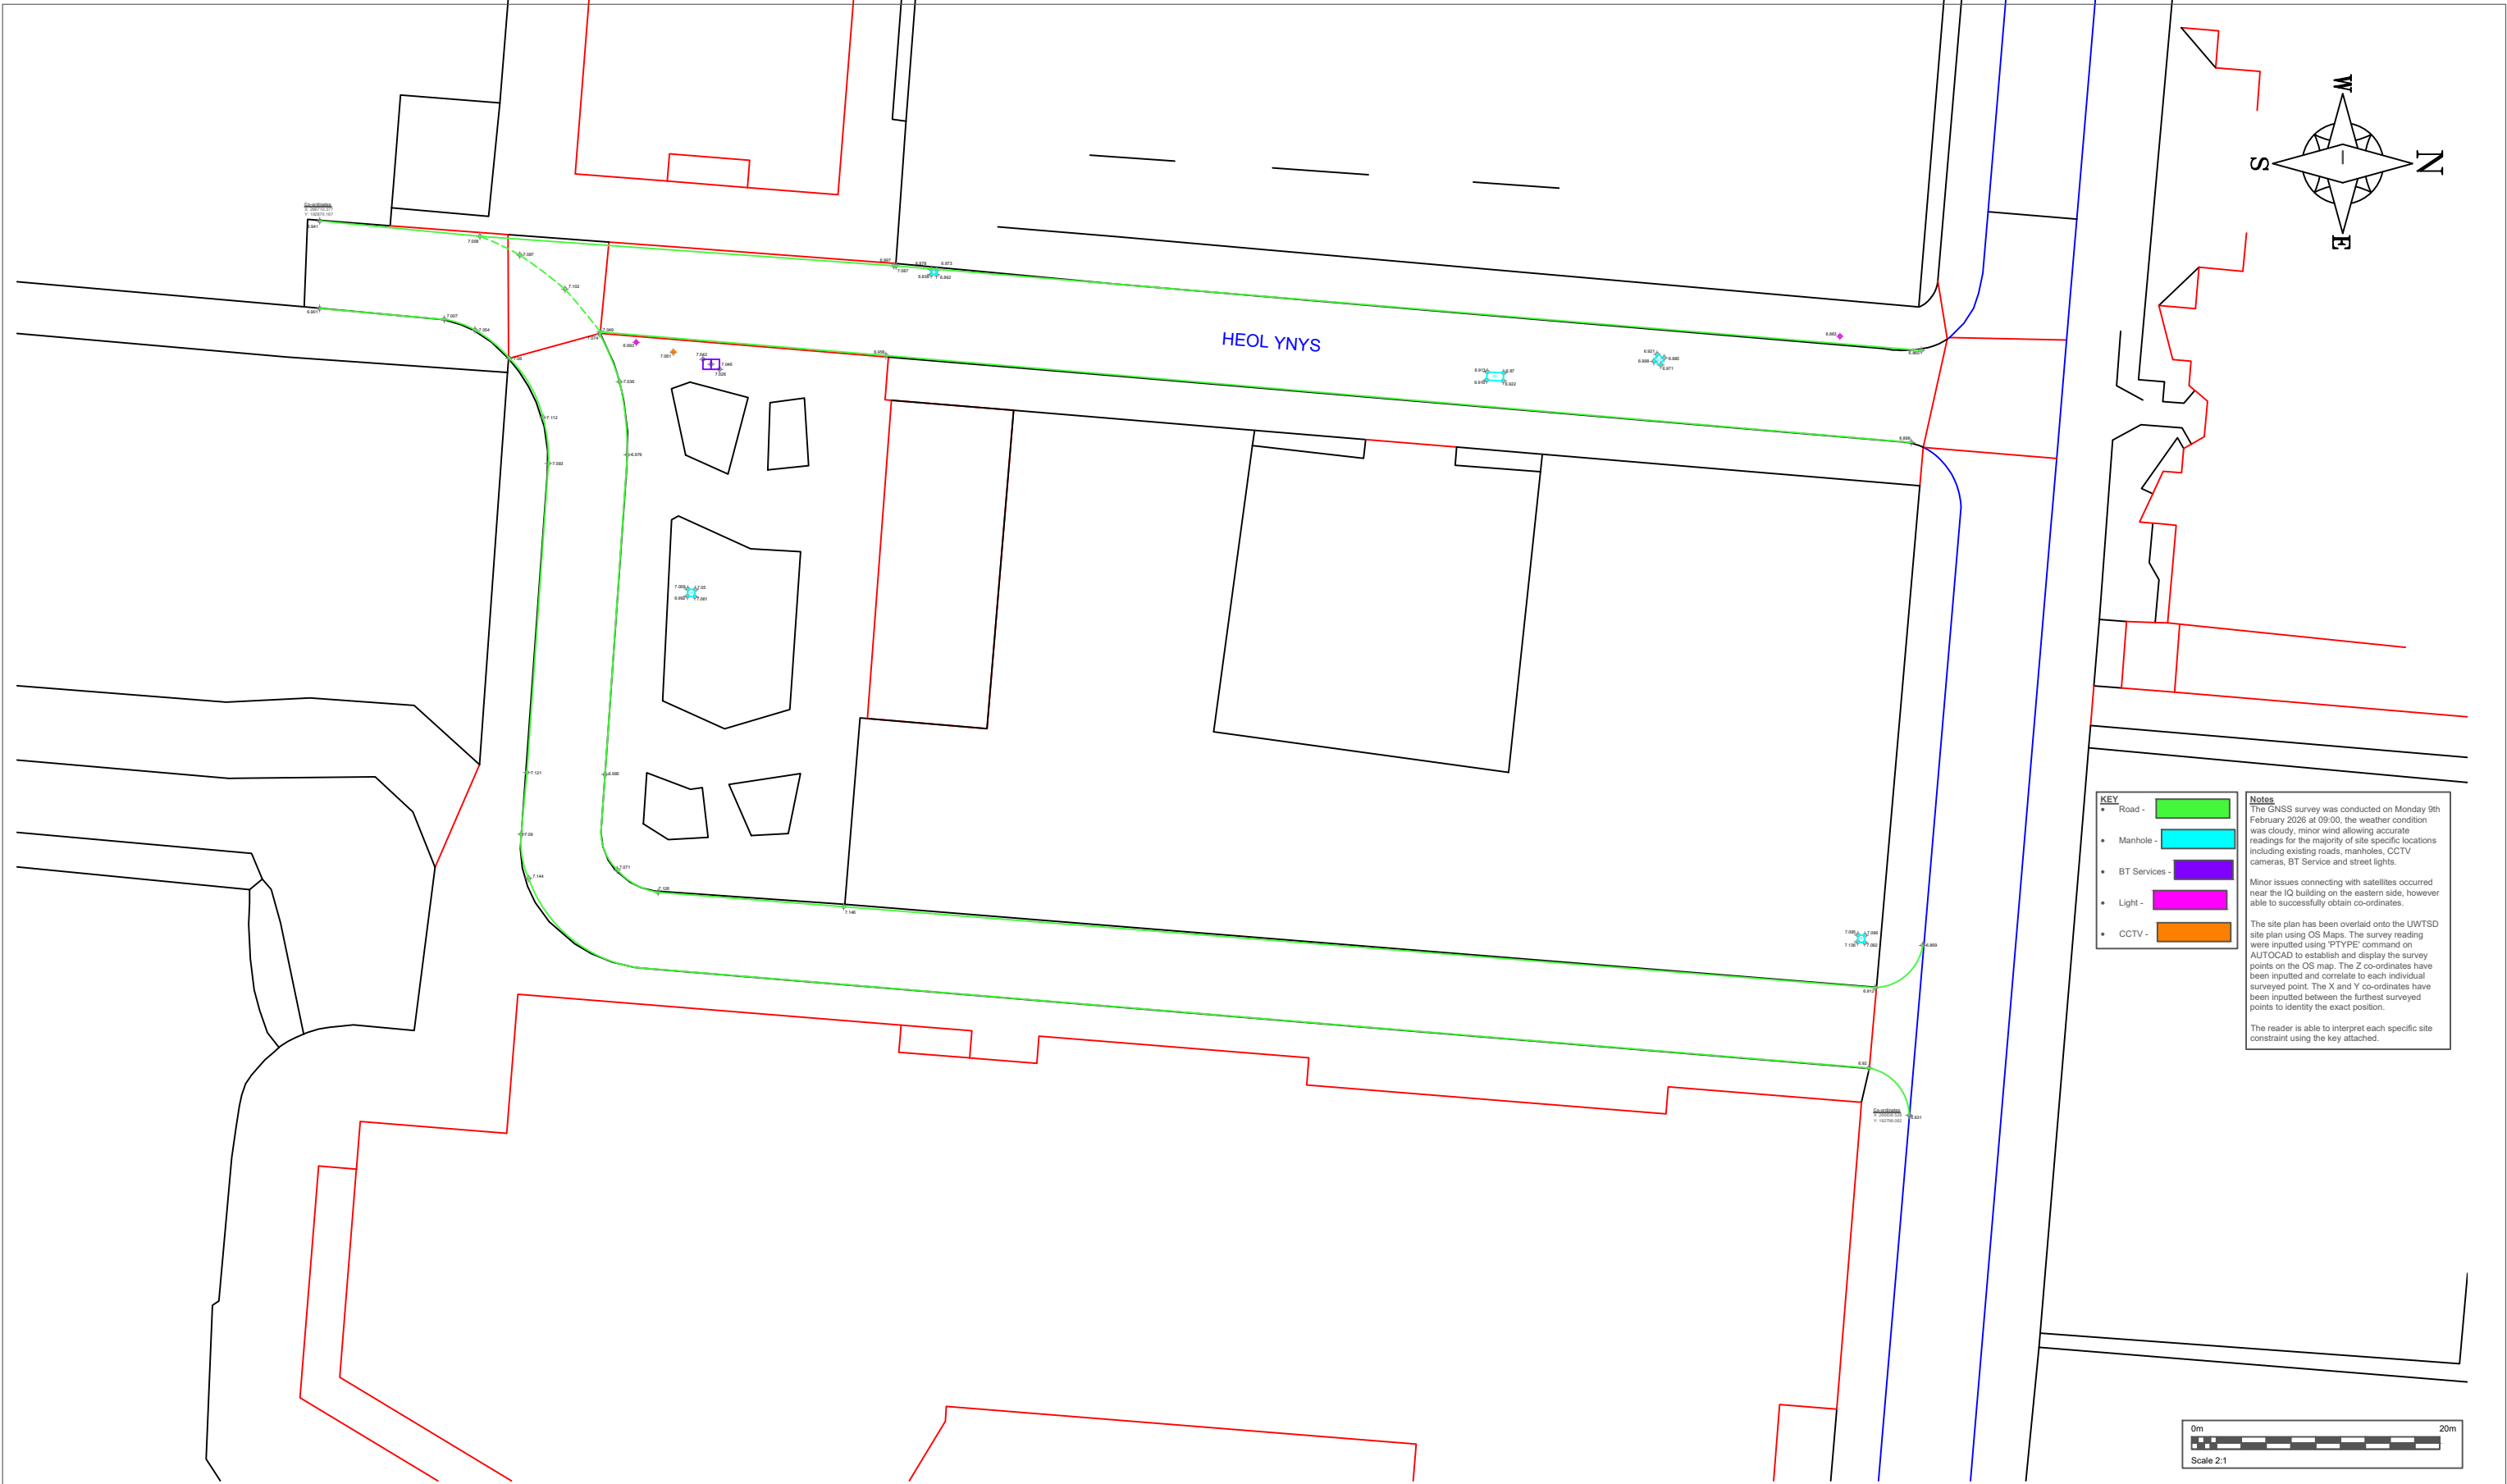
**Notes**  
The GNSS survey was conducted on Monday 9th February 2026 at 09:00, the weather condition was cloudy, minor wind allowing accurate readings for the majority of site specific locations including existing roads, manholes, CCTV cameras, BT Service and street lights.

Minor issues connecting with satellites occurred near the IQ building on the eastern side, however able to successfully obtain co-ordinates.

The site plan has been overlaid onto the UWTSd site plan using OS Maps. The survey reading were inputted using 'PTYPE' command on AUTOCAD to establish and display the survey points on the OS map. The Z co-ordinates have been inputted and correlate to each individual surveyed point. The X and Y co-ordinates have been inputted between the furthest surveyed points to identify the exact position.

The reader is able to interpret each specific site constraint using the key attached.
