# Chapter 17

## Shoreline Stabilisation: Lessons from South Wales

Michael R. Phillips

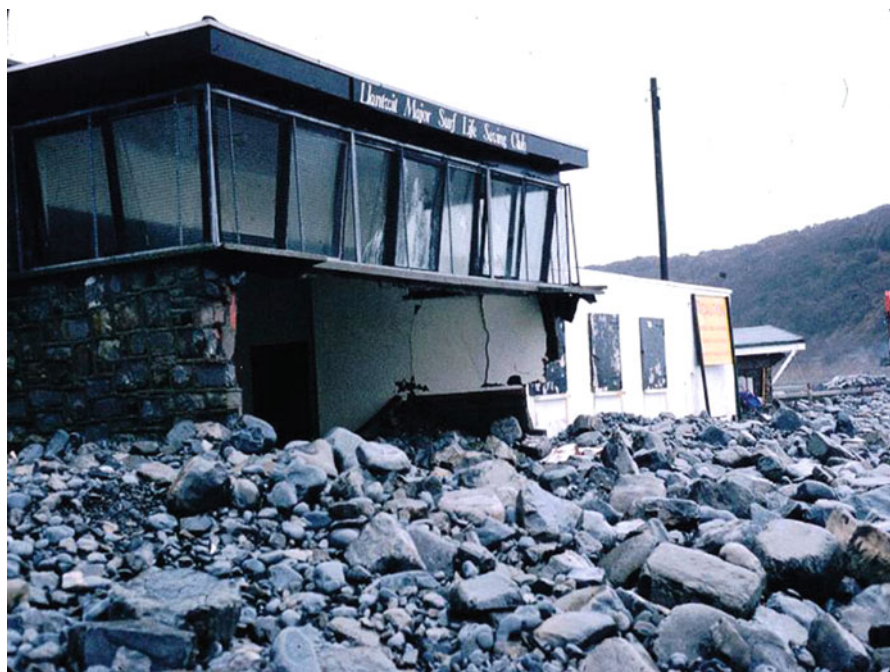
**Fig. 17.2** Storm damage to Surf Life Saver Club

many coastal defence measures. In the early 1990s, storms severely damaged the Surf Lifesaver building, cafe and car park (Fig. 17.2). Several options in response to coastal retreat were considered, including doing nothing except rebuild the Lifesaver club, but the chosen solution was partial setback and upgrade of the building with substantial hard engineering protection. This consisted of a curved, convex Carboniferous Limestone block revetment, approximately 80 m in length, 20 m in width and 6 m in height (Fig. 17.3). It was constructed with 2,900 tonnes of hardcore and 6,000 tonnes of armour stone, made up of *circa* 7 tonne blocks. It incorporated a concrete beach access ramp and is the largest engineering structure along this coast (Williams et al. 2002). However, in severe south-westerly storms, the revetment is frequently overtopped and outflanked (Fig. 17.3).

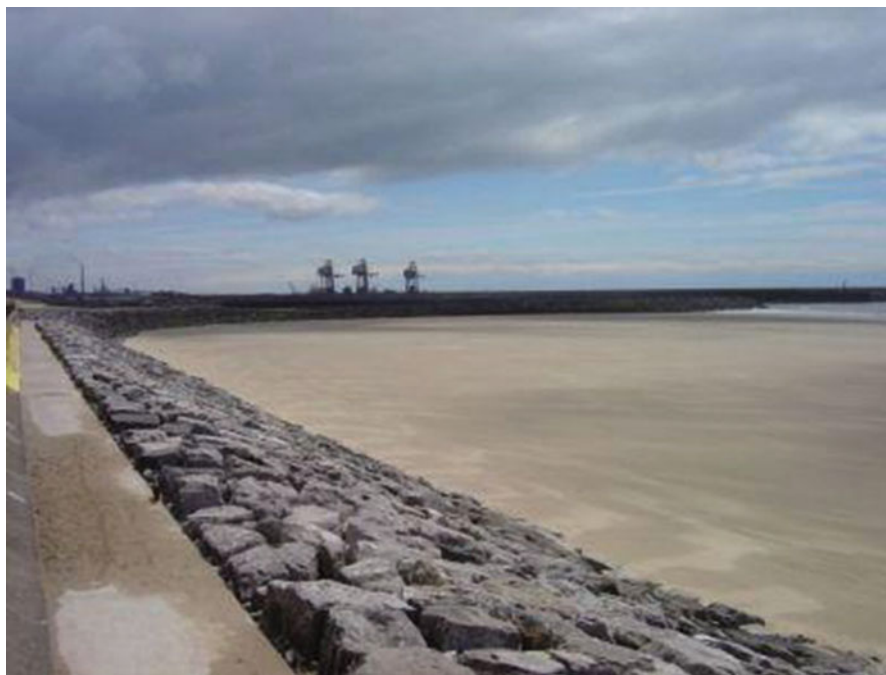
**Fig. 17.7** Aberavon seawall

In January 1991, as a result of many internal voids that had developed within the seawall, a section collapsed in a not-very-severe storm (Bullen 1993). The south-eastern part was built seawards of high-water and toe erosion is on-going due to wave reflection and turbulence. This is exacerbated by the adjacent tidal harbour which interferes with northerly longshore transport and starves the fronting beach of sediment. Conversely, the north-western half of the seawall was constructed landwards of high-water. Here the fronting beach is outside the tidal harbour's influence and receives sediment recharge from the south, resulting in dry sand being blown against and over the wall. Therefore, adjacent to the tidal harbour beach levels have continued to fall resulting in exposure of sheet piles at the seawall toe and this has led to rock armour protecting the seawall which in turn is protecting the promenade (Fig. 17.7).

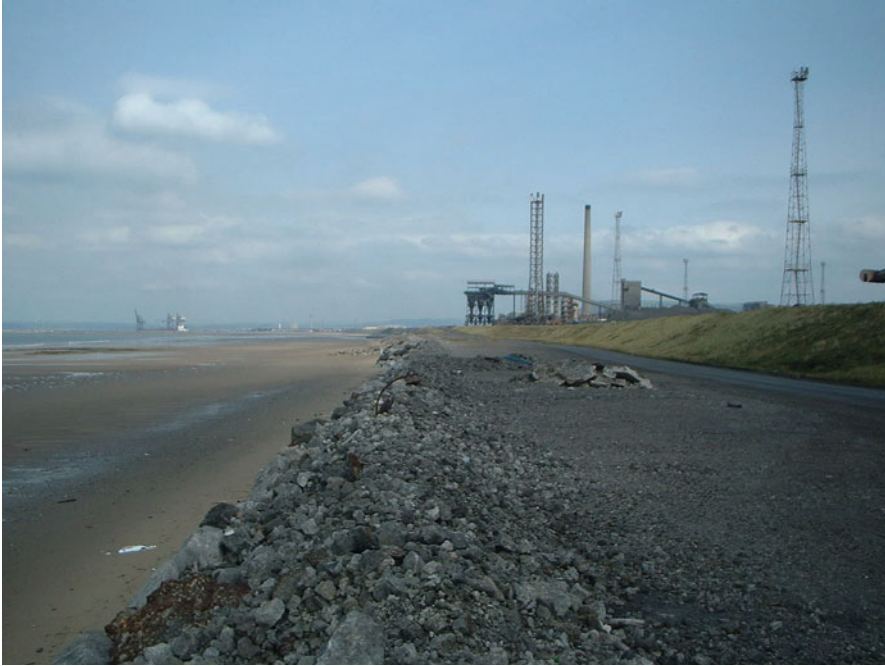
**Fig. 17.8** Blast furnace slag revetment

Margam Sands (OS ref: SS768855), south-east of the tidal harbour (Fig. 17.6), was once an extensive dune line and is now a 3 km length of slag (waste from steel-making processes) and rock armour revetment (Fig. 17.8; SBCEG 1999). The Tata Steel frontage had experienced erosion over many years and between 1975 and 1991 there was a maximum beach level fall of 1.1 m (Bullen 1993). The 1991 aerial survey showed a back beach/dune line recession of between 20 and 40 m and Bullen (1993) concluded that during this 16 year period there had been significant sediment loss, equating to  $950,000 \text{ m}^3$  from back beach recession and eroding foreshore. This was equivalent to an average beach level fall of 0.7 m and parallels were drawn with

similar losses experienced between 1830 and 1870 due to disruption caused by the construction of Port Talbot docks. The slag revetments which protect the steelworks and other infrastructure such as access roads (Fig. 17.8) are themselves susceptible to erosion and sections have been reinforced with stone armour revetments. Consequently, this particular shoreline was recommended for priority monitoring (SBCEG 1999).

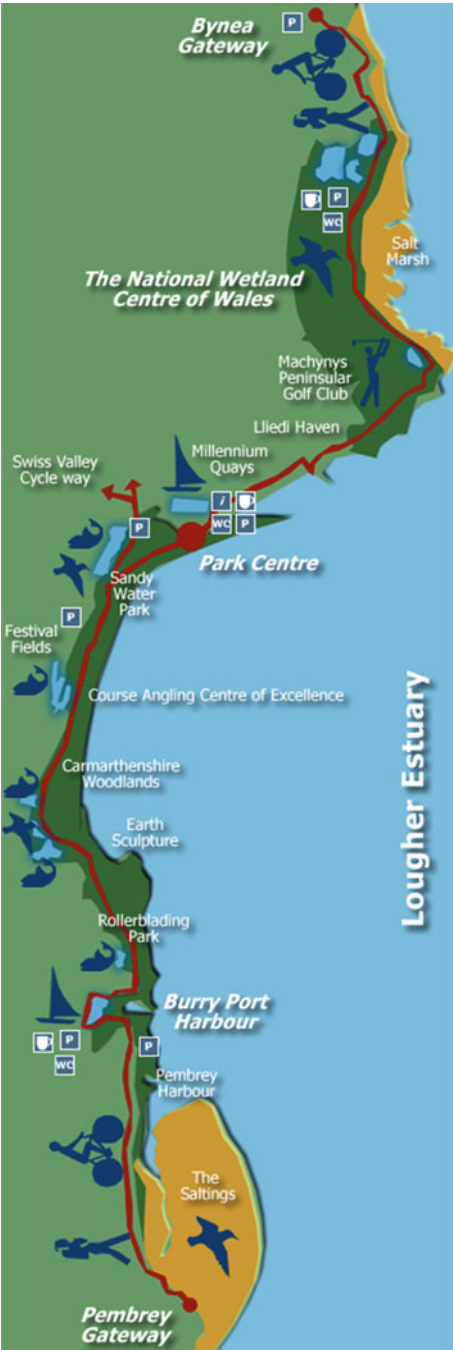
**Fig. 17.10** Millennium coastal park

Therefore to facilitate regeneration, funding from the National Lottery, Carmarthenshire County Council and the Welsh Government enabled >800 Ha (2,000 acres) of contaminated industrial wasteland to be converted into the Millennium Coastal Park (MCP, Fig. 17.10). The development objective was to improve housing, commercial accommodation and recreational facilities, including construction of the 22 km Millennium Coastal Path. There are 75,000 people living in the surrounding areas (BBC 2004a) and in 2004, the area received over 500,000 tourists (BBC 2004b). The MCP gives views over the Burry Inlet and Gower Peninsula (Fig. 17.9) and a signature structure, the Earth Sculpture 'Walking with the Sea', was specifically designed to be seen from land, sea and air. It is located on the coastal path between Burry Port and Llanelli (Fig. 17.10) and previously, this coastal section had no sea defence. Constructed from Pulverised Fuel Ash (PFA), an extremely fine waste product from the old coal-fired power stations, it extends seawards into the coastal environment (Fig. 17.10). The use of PFA was seen as an environmental benefit i.e. reuse instead of disposal. Beaches were incorporated into the Earth Sculpture's western and eastern flanks while silt from Burry Port Harbour and sewage sludge facilitated rapid natural re-vegetation (UKQAA 2003). Redevelopment included new houses and seafront apartments adjacent to Llanelli Beach, such as the Millennium Quay (Fig. 17.10). High-quality housing has been constructed on floodplains to the east and further housing and office buildings have been located around the path.
