***Crude Gas Main through-wall failure  
investigation, identification and root cause  
analysis***

***Study Skills (ACMA4039)***

Ryan Tamlin

November 2025

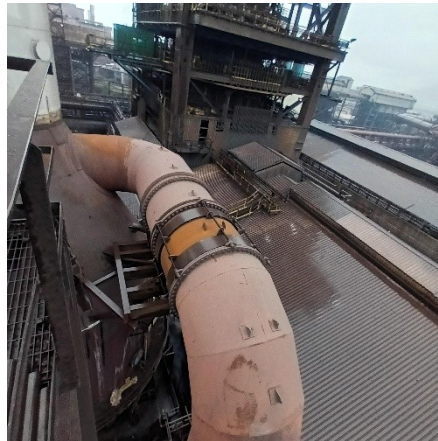
A localised loss of containment was identified on the Blast Furnace 5 Crude Gas Main which resulted in a Blast Furnace Gas mixture of CO, CO<sup>2</sup>, H<sub>2</sub>, N<sub>2</sub>, Steam & Nitrogen being released into the local atmosphere in low quantities. The Crude Gas Main (see *Figure 1 below*) serves to transport gases from the furnace top to a downstream cleaning cycle.

*Figure 1: Crude Gas Main Column (Source: TATA Steel Internal Image)*

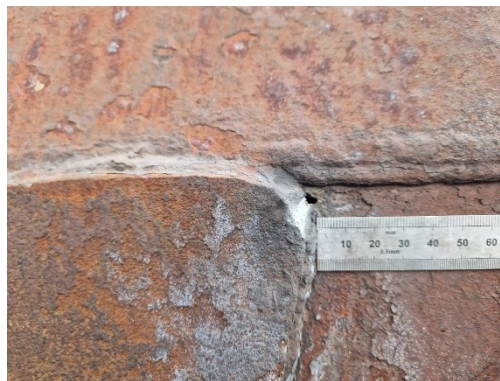
The area of loss of containment was located as a small hole measuring approximately 3mm x 3mm (9mm<sup>2</sup> area opening) and adjacent to an area of previous through-wall failure (see *Figure 2 below*). Given the previous failures within this area, internal erosion was identified as a potential cause of the problem.

*Figure 2: Localised through wall failure (Source: TATA Steel Internal Image)*

Based upon this brainstorming event and the knowledge of previous through-wall failures in the same area caused by internal erosion, it was concluded that this would be the likely cause.

- 1) Why did the pipework section lose containment? Because the pipe wall section was eroded internally until it became thin enough to fail under normal operating pressure.

- 2) Why was the internal wall eroded? Because deposits associated with the cleaning cycle impacted the internal walls at high velocities, uniquely in this bend section.

- 3) Why are deposits causing erosion at this specific area? Because of the pipework geometry, this area would be more prone to deposit impacts.
- 4) Why was there higher than expected velocities within this section or excess process deposits? The design of the pipework has underestimated the rates and velocities of deposits within this section.

- 5) Why were design measures deemed adequate for the velocities and process deposits? The initial design of the process vessel did not account for excessive process deposit velocities and therefore no protective layer added.

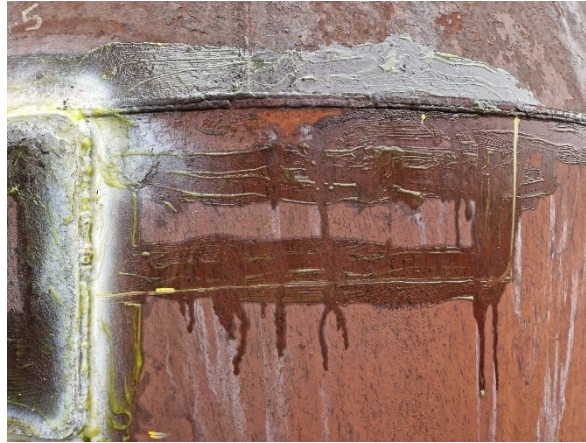
*Figure 4 – Identified thinned area (Source: TATA Steel Internal Image)*

- Perform Ultrasonic Thickness Measurement (USTM) grid scans over a wider area to map remaining wall thickness against the 8mm design value and complete overplate repairs on identified thinned sections (see Figure 4).

Severity was scored 4 because over-plating restored the pipework to the 8 mm design thickness, grid scans confirmed no further thinning and any future failure would likely be limited to a minor pinhole leak with minimal gas-exposure risk.

Occurrence was scored 3 because the grid scan USTM and overplate repairs mitigated the risk of re-occurrence within this isolated area.

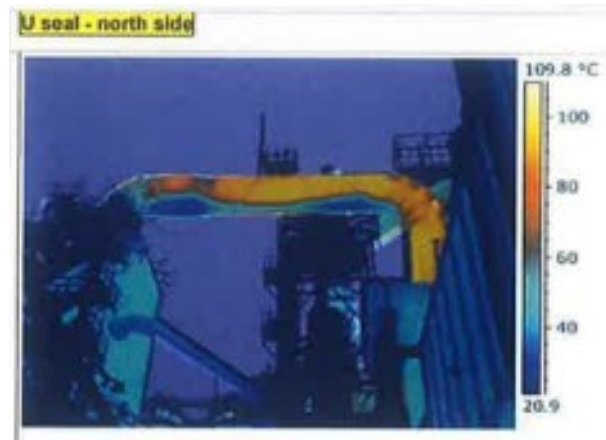
*Figure 5 – IR camera recordings (Source: TATA Steel Internal Image)*

- Increase visual inspection frequency whilst using infrared (IR) cameras to detect changes in material surface temperature (see Figure 5).

Detection was scored 8 because the increased inspection frequency has increased and now incorporates the use of Infrared (IR) camera technology to detect surface temperature anomalies which would indicate potential defects. These Infrared thermographic inspections was in adherence with ISO 18434-1 and ISO 18434-2, and all qualified to ISO 18436-7.

The excess process deposits were correctly identified using infrared (IR) camera scans which were an implemented further control measure from the RPN assessment.
