U.S. CHEMICAL SAFETY AND HAZARD INVESTIGATION BOARD

INVESTIGATION REPORT

REFINERY EXPLOSION AND FIRE

REPORT NO. 2005-04-I-TX

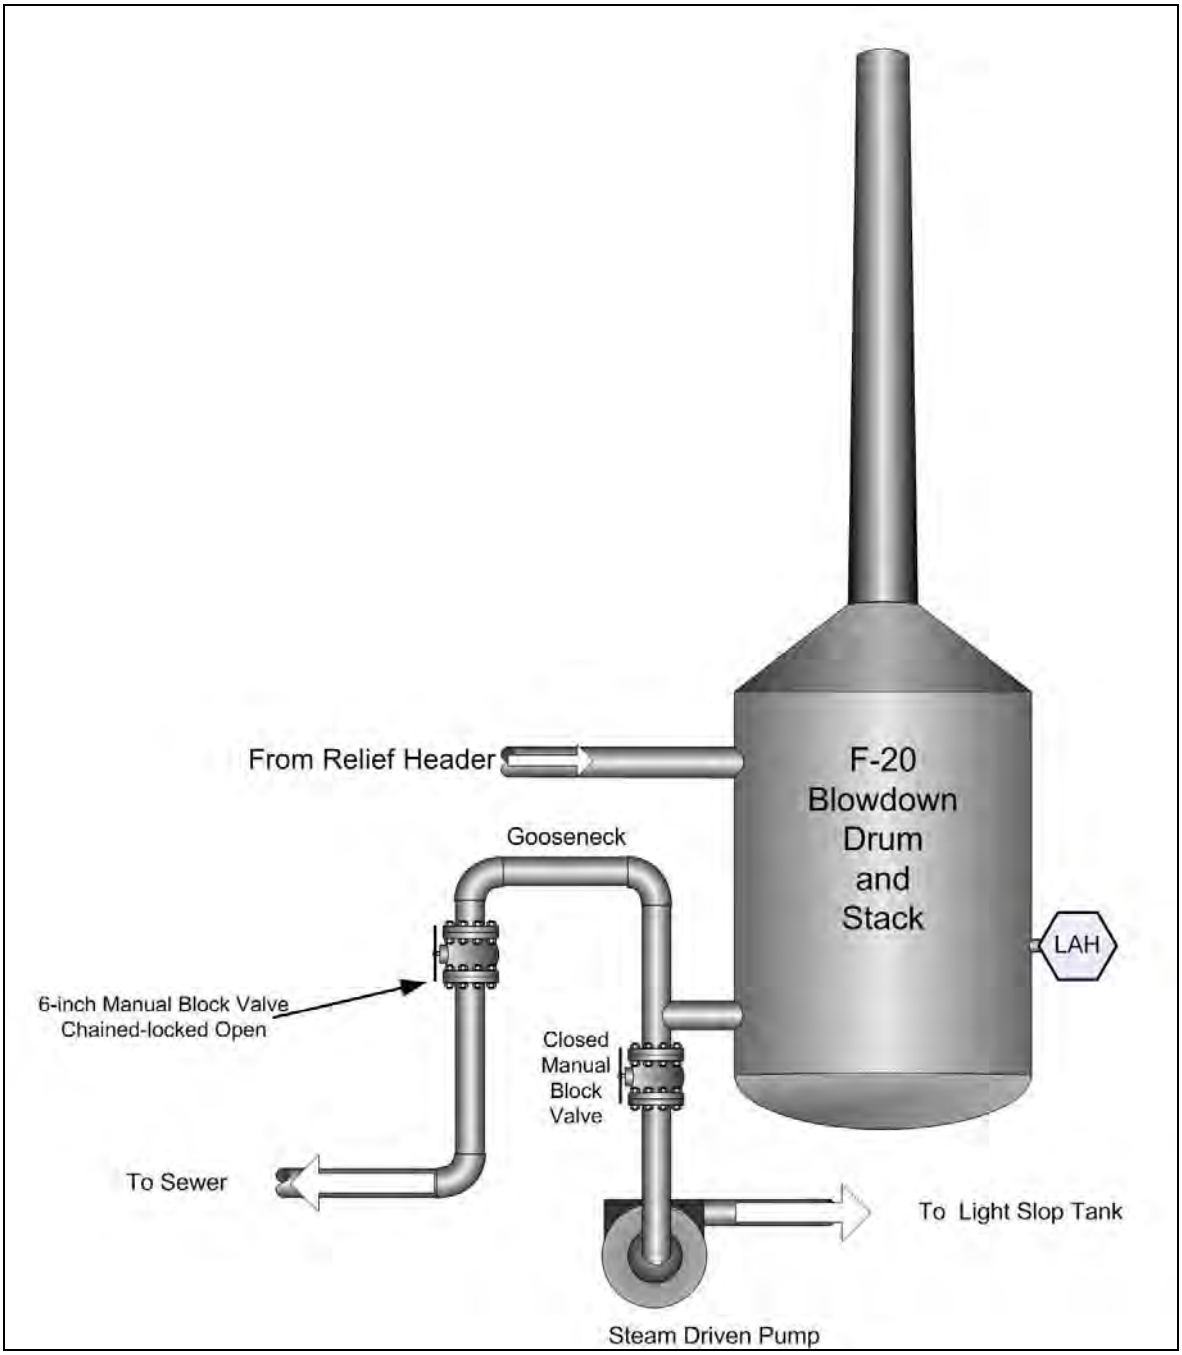
Figure 3. Blowdown drum and gooseneck

light hydrocarbon vapors disengage from liquids, rise through a series of baffles, and disperse out the top of the stack into the atmosphere. Any liquids or heavy hydrocarbon vapors released into the drum either fall, or condense and then fall, to the bottom of the drum where they collect. Liquid would then be discharged from the base of the blowdown drum into the ISOM unit sewer system because a 6-inch NPS (6.625 inches; 15.24 cm outer diameter) manual block valve was chained open (Figures 3 and 4). This practice of discharging to the sewer was unsafe; industry safety guidelines recommend against discharging flammable liquids that evaporate readily into a sewer.[21]

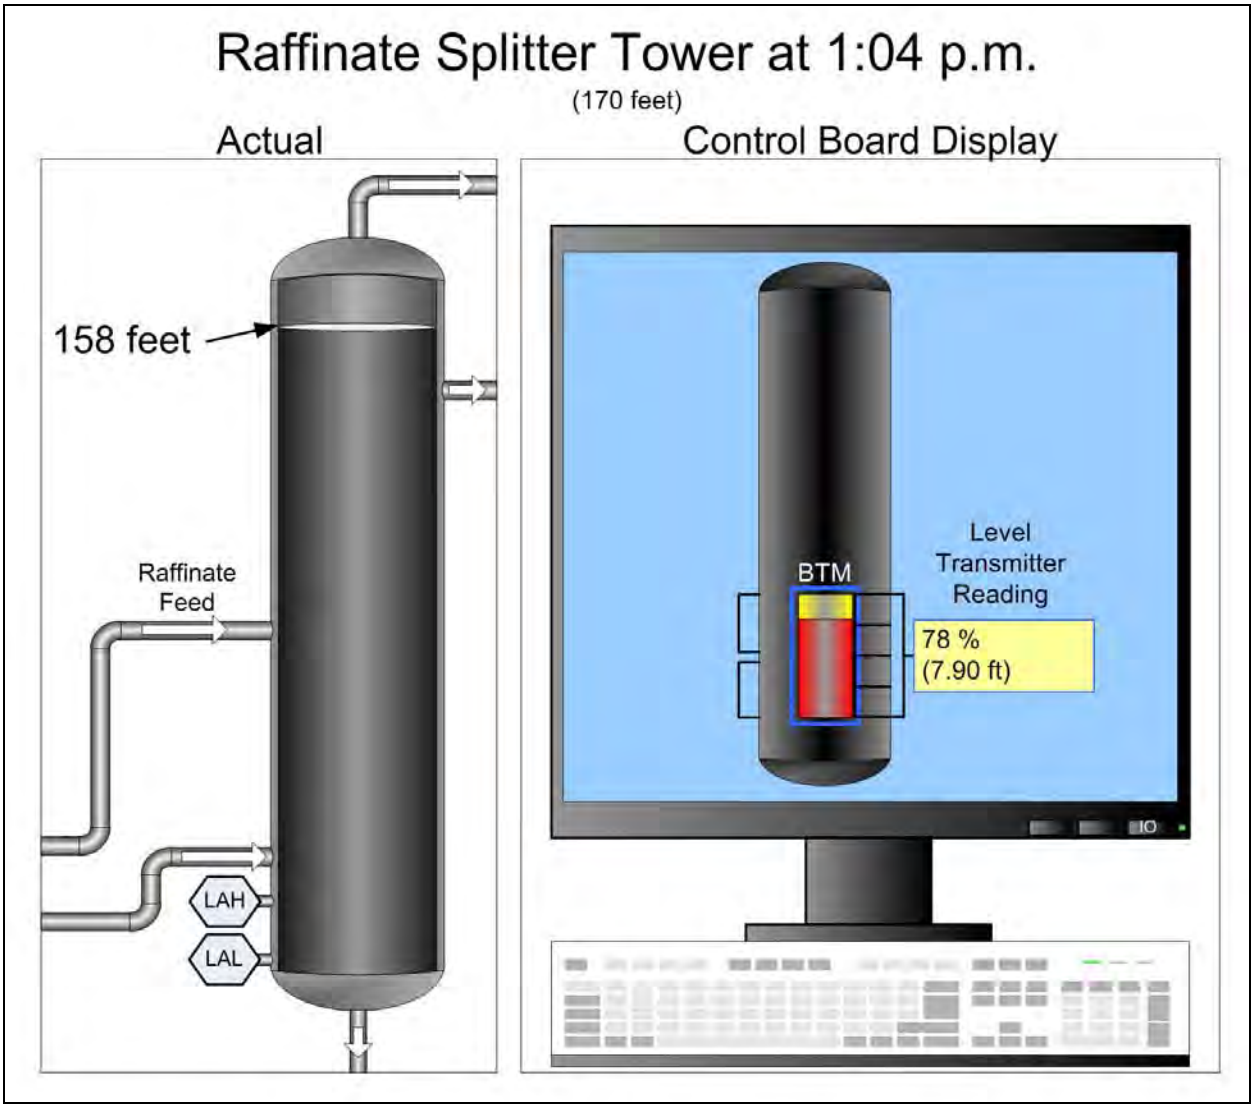
Figure 6. At 1:04 p.m. the liquid level in the tower was 158 feet (48 m), but the computerized control system indicated to operators that the level was at 78 percent of the level transmitter (7.9 feet, or 2.4 m, of liquid in the tower).

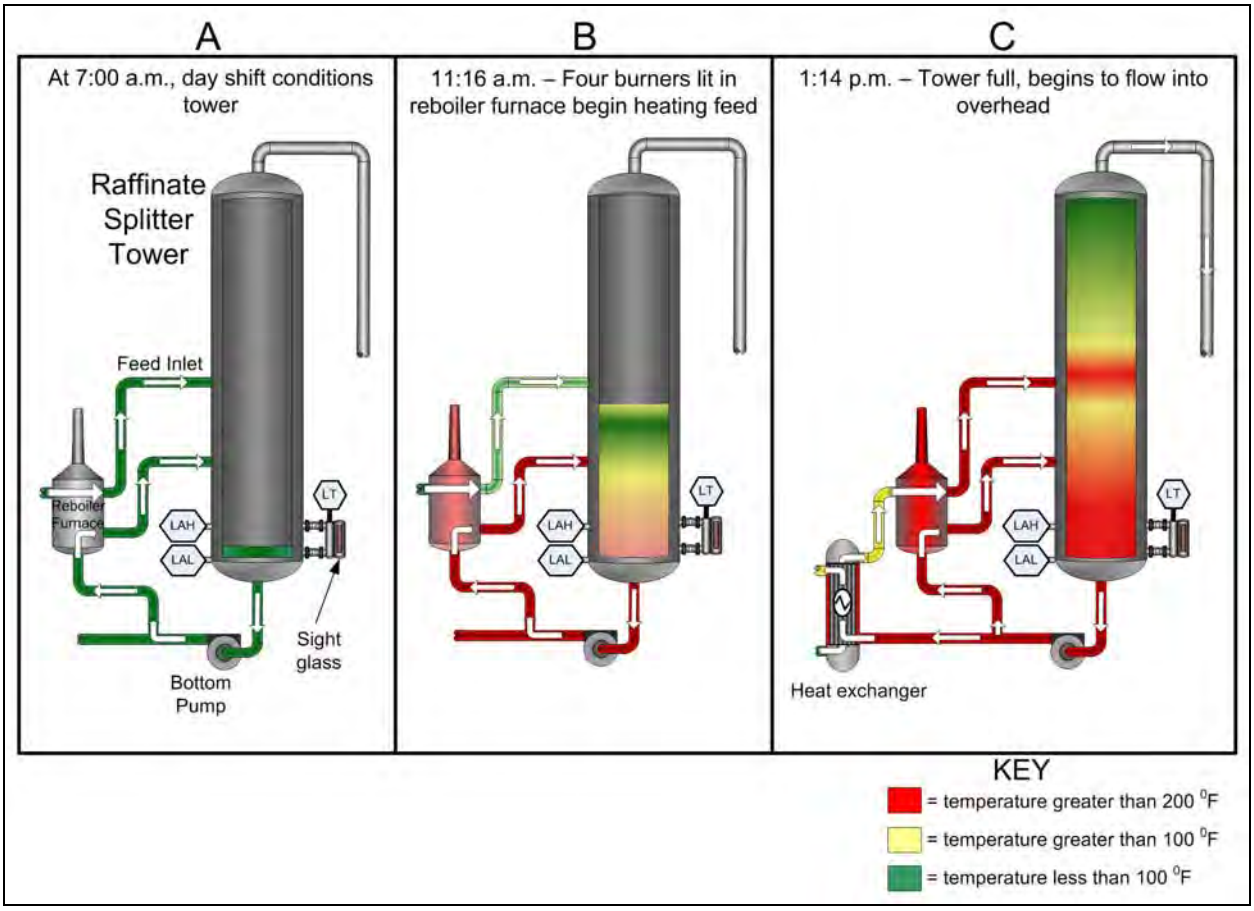
Figure 7. Heating of feed in the splitter tower

At 1:14 p.m., sub-cooled[43] hydrocarbon liquid flowed out of the top of the raffinate splitter tower and into the vertical overhead vapor line, due to overfilling and rapid heating of the column (Figure 7).

Heating from the furnace had created a temperature profile in the raffinate splitter column, such that cold liquid was on top and hot liquid was in the lower section (Figure 7B). Bubbles of hot vapor rising through the column contacted the overlying cold liquid, rapidly condensing the vapor and heating the liquid. At the time of the incident, the resulting hot liquid reached nearly to the level of the feed inlet. Hot liquid

raffinate leaving from the bottom of the column after 12:59 p.m. transferred additional heat to the column feed through the heat exchanger, leading to rapid heating of the section of the raffinate splitter column above the feed inlet. By the time of the incident, most of the column was rapidly heating, although a cold layer of liquid remained at the top (Figure 7C).

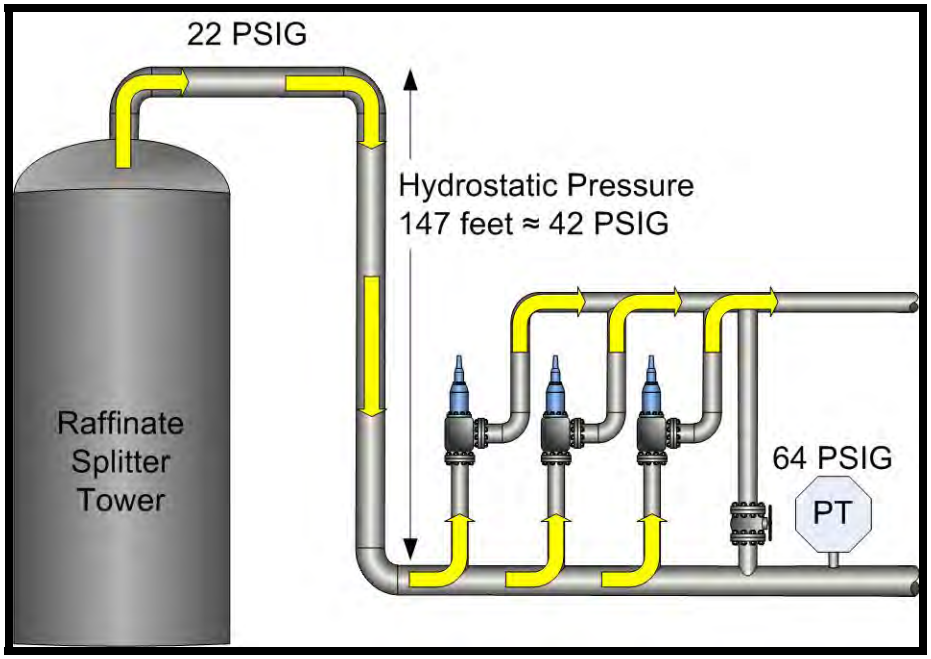
Figure 8. Hydrostatic head of liquid in overhead piping leads to the three relief valves opening

The minimum closing (blowdown) pressure for the three safety relief valves to stop flowing was 37.2 psig (256.5 kPa). Computerized control system data indicate that all three safety relief valves were fully open and flowing at capacity for slightly longer than six minutes. An average pressure of 61 psig (421 kPa) at

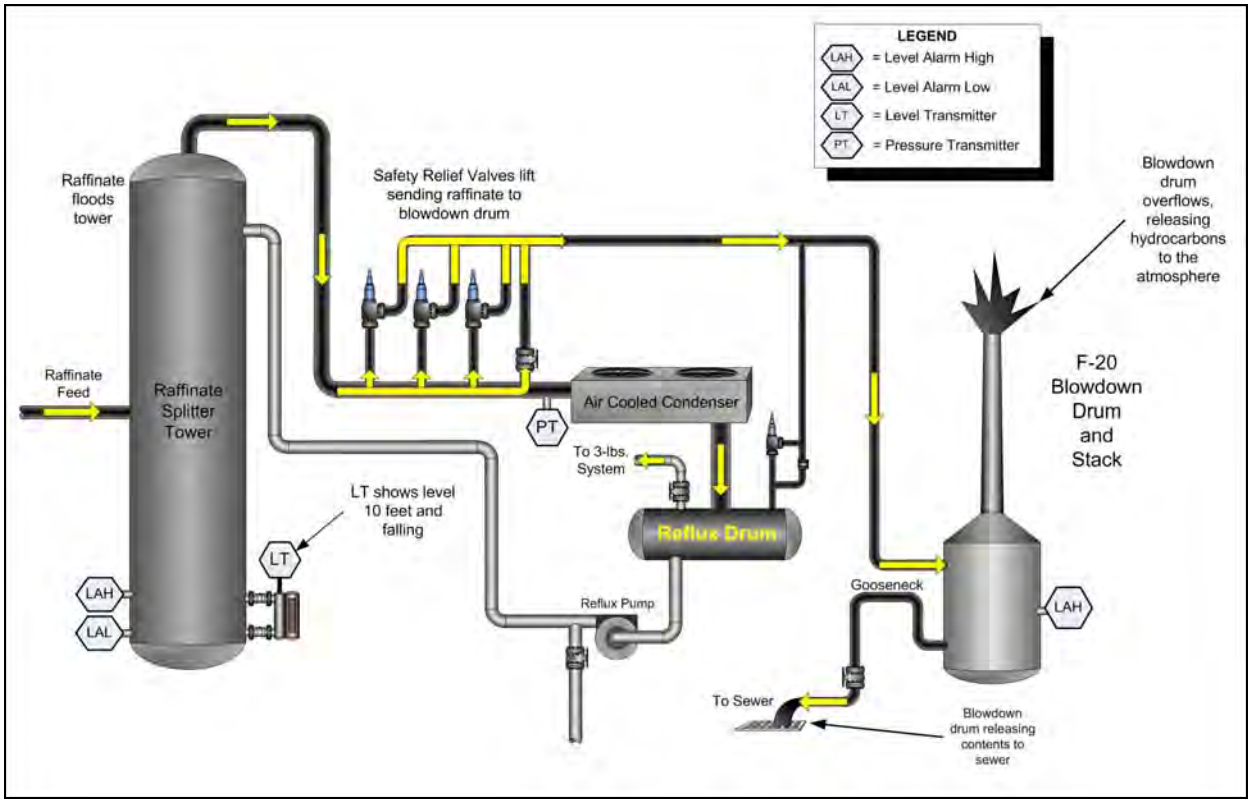
Figure 9. Tower overfills and blowdown drum releases hydrocarbons

Once the blowdown system filled, flammable liquid discharged to the atmosphere from its stack as a geyser and fell to the ground (Figure 9). Shortly after the ISOM operators began troubleshooting the pressure spike, they received, via radio, the first notification that the blowdown drum was overflowing. In response to the radio message, the Board Operator and Lead Operator used the computerized control system to shut the flow of fuel to the heater, while the other operators left the satellite control room and ran toward an adjacent road, Avenue F, to re-direct traffic away from the blowdown drum, as required by BP's "Emergency Response Procedure A-7."

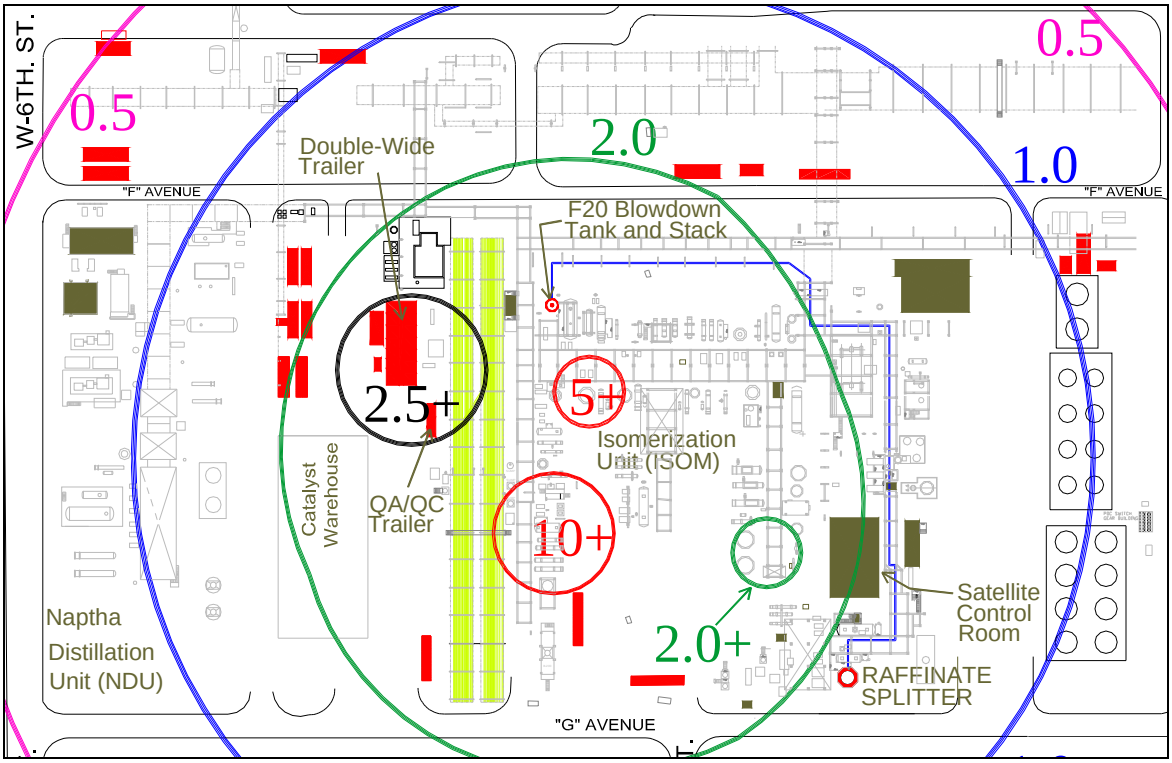
Figure 12. Blast overpressure map depicting the areas of highest blast pressure (10+, 5+, and 2.5+ psi)

congestion/confinement and flammable mix allowed, greatly intensifying the blast pressure in certain areas. These intense pressure regions, or sub-explosions, produced heavy structural damage locally and left a pattern of structural deformation away from the blast center in all directions. A computer simulation[49] and a blast overpressure map (Figure 12) were developed based on site observations, structural analysis, and blast modeling (Appendix H).

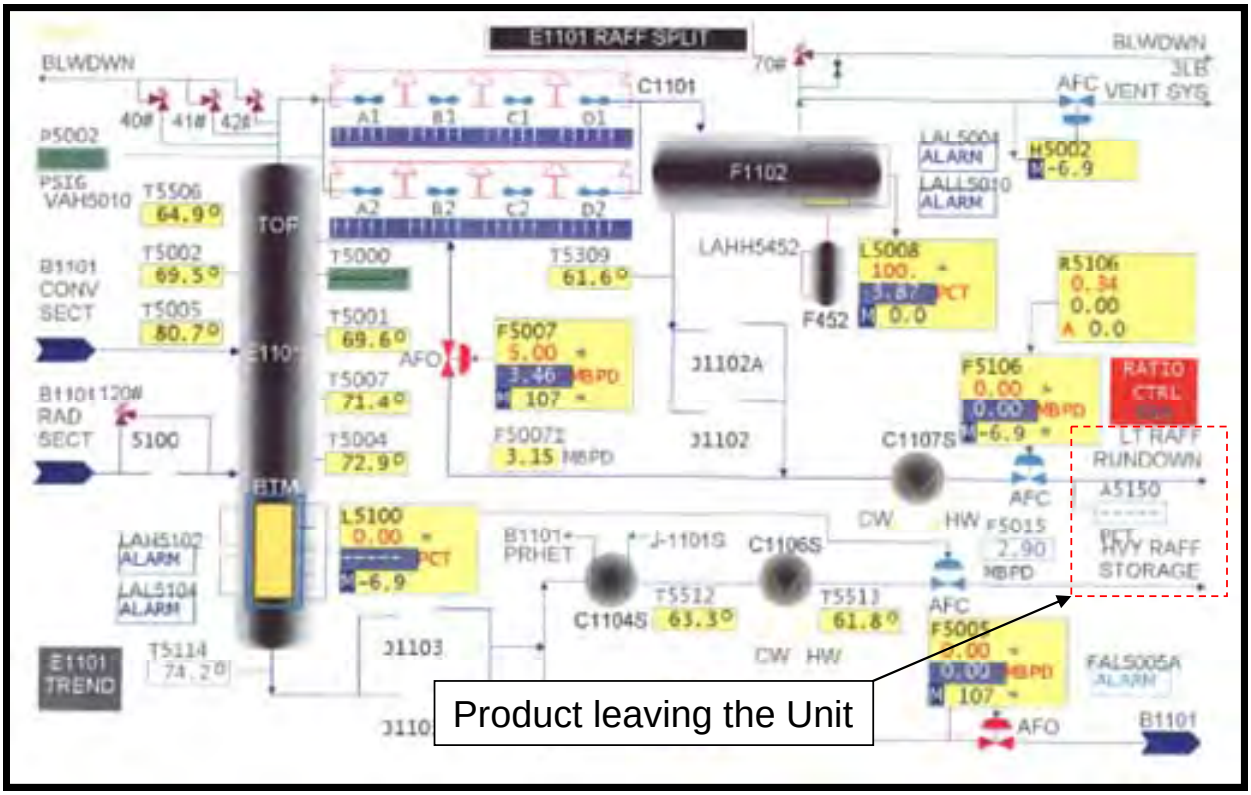
Figure 14. The Board Operator viewed this screen, which provides information on raffinate product leaving the unit but not the liquid being added to the unit.

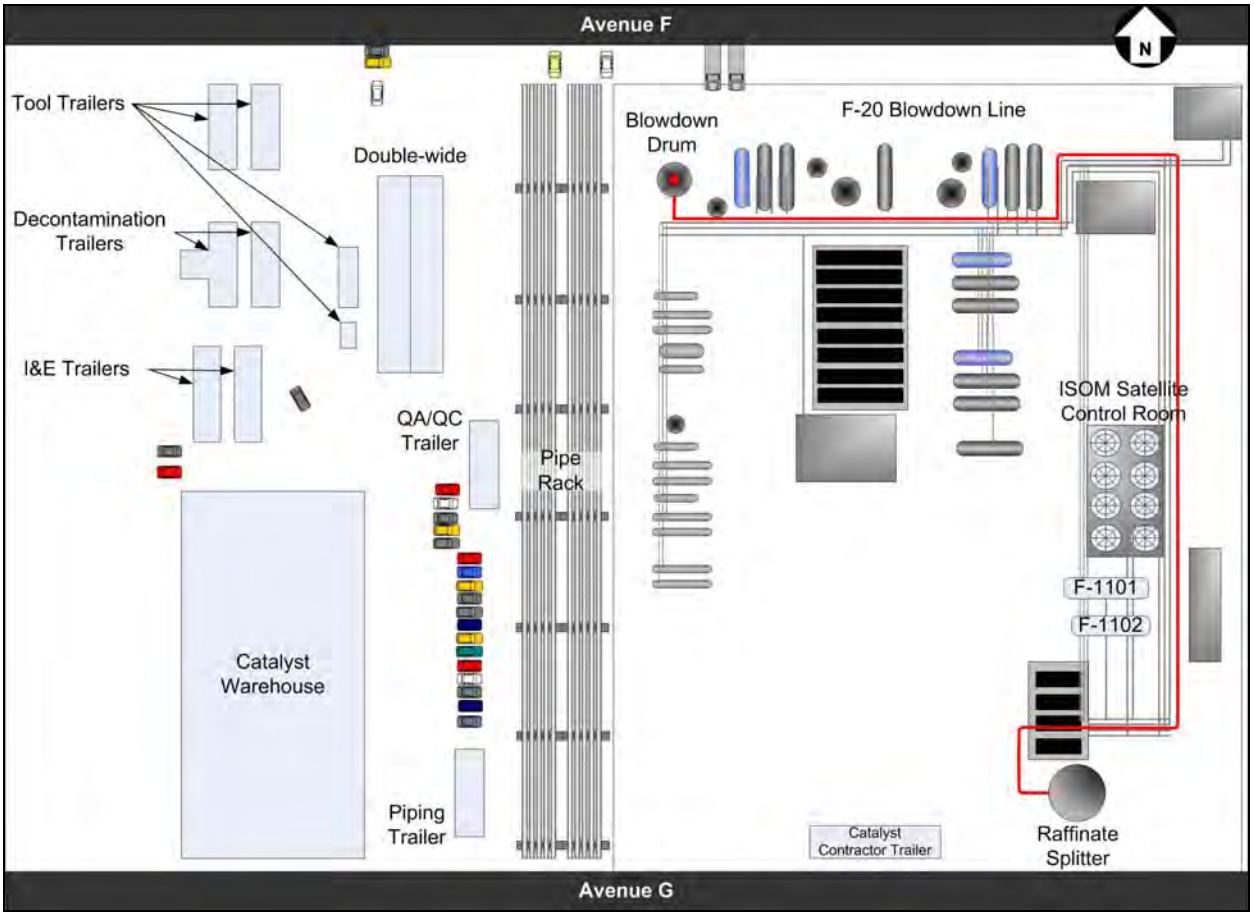
Figure 15. Trailer area and adjacent ISOM unit

5. Occupied trailers were sited too close to a process unit handling highly hazardous materials. All fatalities occurred in or around the trailers.

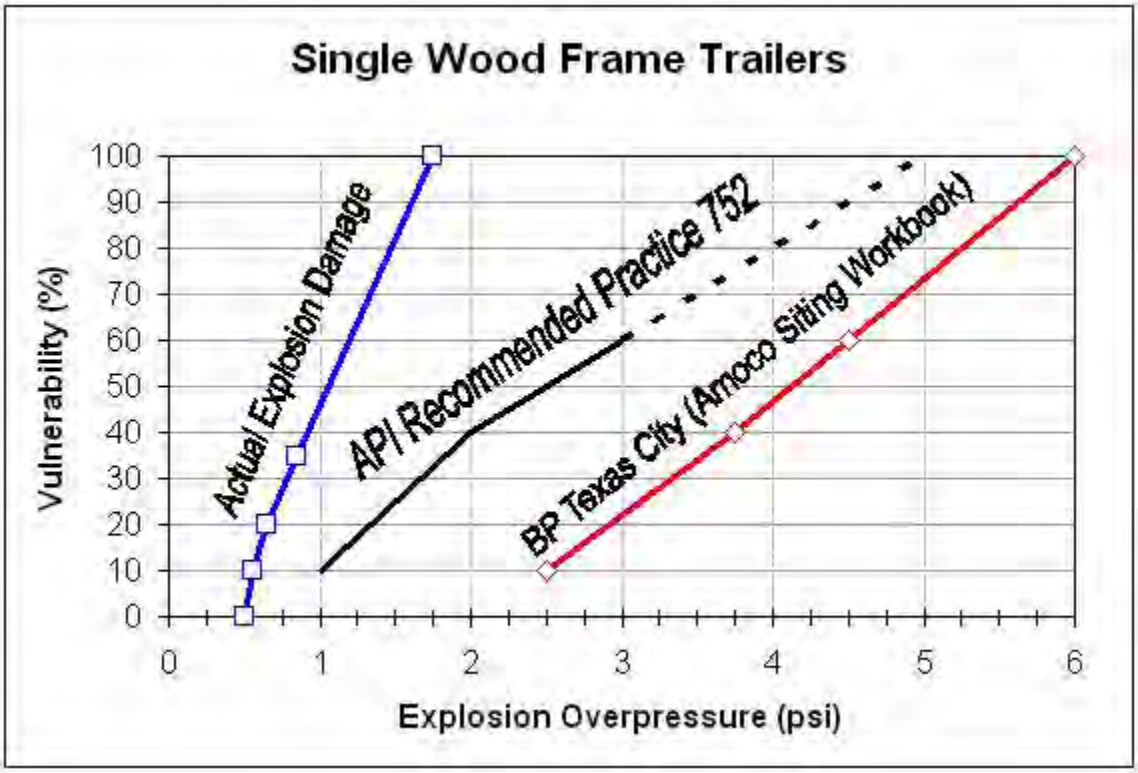
Figure 16. Comparison of explosion damage based on API and BP Texas City criteria

The data API uses to assess vulnerability of building occupants during building collapse is based mostly on earthquake, bomb, and windstorm damage to buildings. However, as vapor cloud explosions tend to generate lower overpressures with long durations (and thus relatively high impulses) (Gugan 1979), the mechanism by which vapor cloud explosions induce building collapse does not necessarily match the data being used in API 752 to assess vulnerability. The CSB found that this data is heavily weighted on the response of conventional buildings, not trailers, which are not typically constructed to the same standards. Thus, when the correlations of vulnerability to overpressure from the March 23, 2005, explosion (Figure 16) are compared against the API and BP criteria (Section 6.3.1), they were both found to be less protective in that both under-predict vulnerability for a given overpressure. Also, the data used by both API and BP to estimate vulnerability[133] does not include serious injuries to trailer occupants as a result of flying projectiles, which are typically combinations of shattered window glass and failed building components, heat, fire, jet flames, or toxic hazards.

In light of these findings and because API 752 is commonly used as a basis for facility siting, the CSB made an urgent recommendation to API regarding trailer siting and recommended either revising API 752 or issuing a new standard to address the issues (Appendix C).

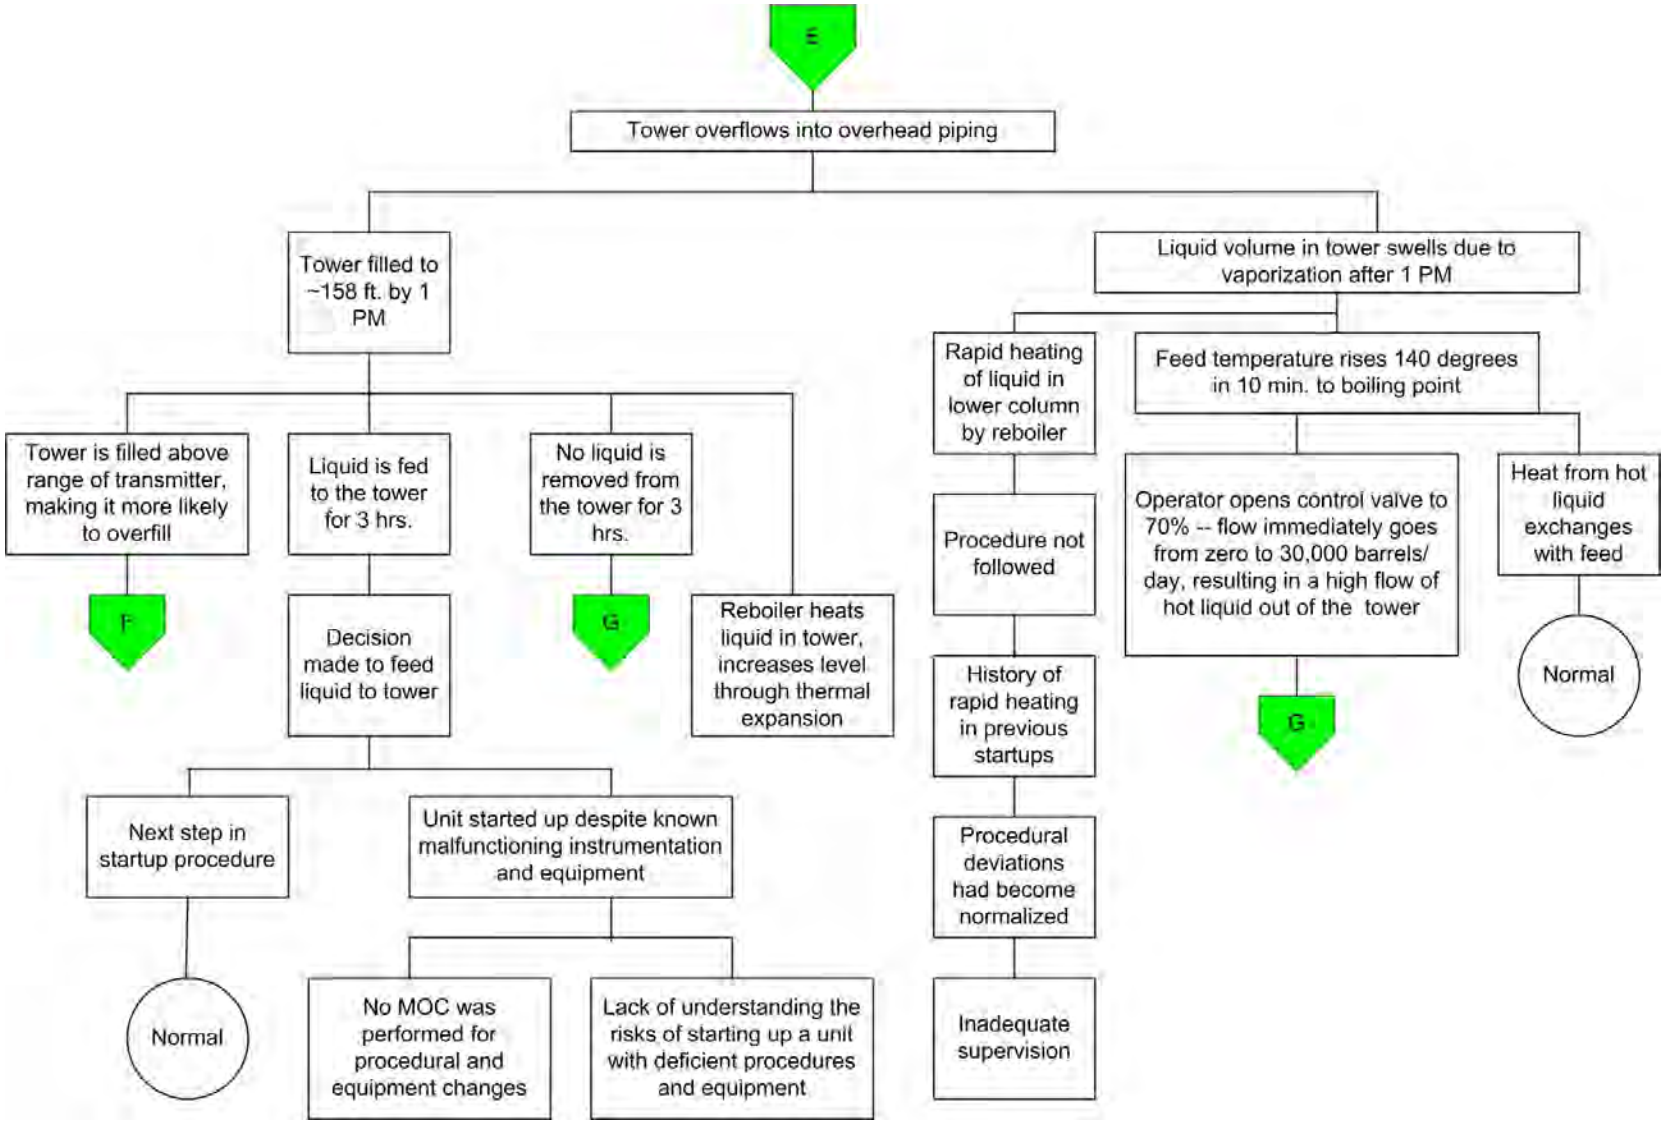
E
Tower overflows into overhead piping
Tower filled to ~158 ft. by 1 PM
Liquid volume in tower swells due to vaporization after 1 PM
Tower is filled above range of transmitter, making it more likely to overfill
Liquid is fed to the tower for 3 hrs.
No liquid is removed from the tower for 3 hrs.
Reboiler heats liquid in tower, increases level through thermal expansion
F
G
Decision made to feed liquid to tower
Next step in startup procedure
Unit started up despite known malfunctioning instrumentation and equipment
Normal
No MOC was performed for procedural and equipment changes
Lack of understanding the risks of starting up a unit with deficient procedures and equipment
Rapid heating of liquid in lower column by reboiler
Feed temperature rises 140 degrees in 10 min. to boiling point
Procedure not followed
History of rapid heating in previous startups
Procedural deviations had become normalized
Inadequate supervision

Operator opens control valve to 70% -- flow immediately goes from zero to 30,000 barrels/ day, resulting in a high flow of hot liquid out of the tower
Heat from hot liquid exchanges with feed
G
Normal

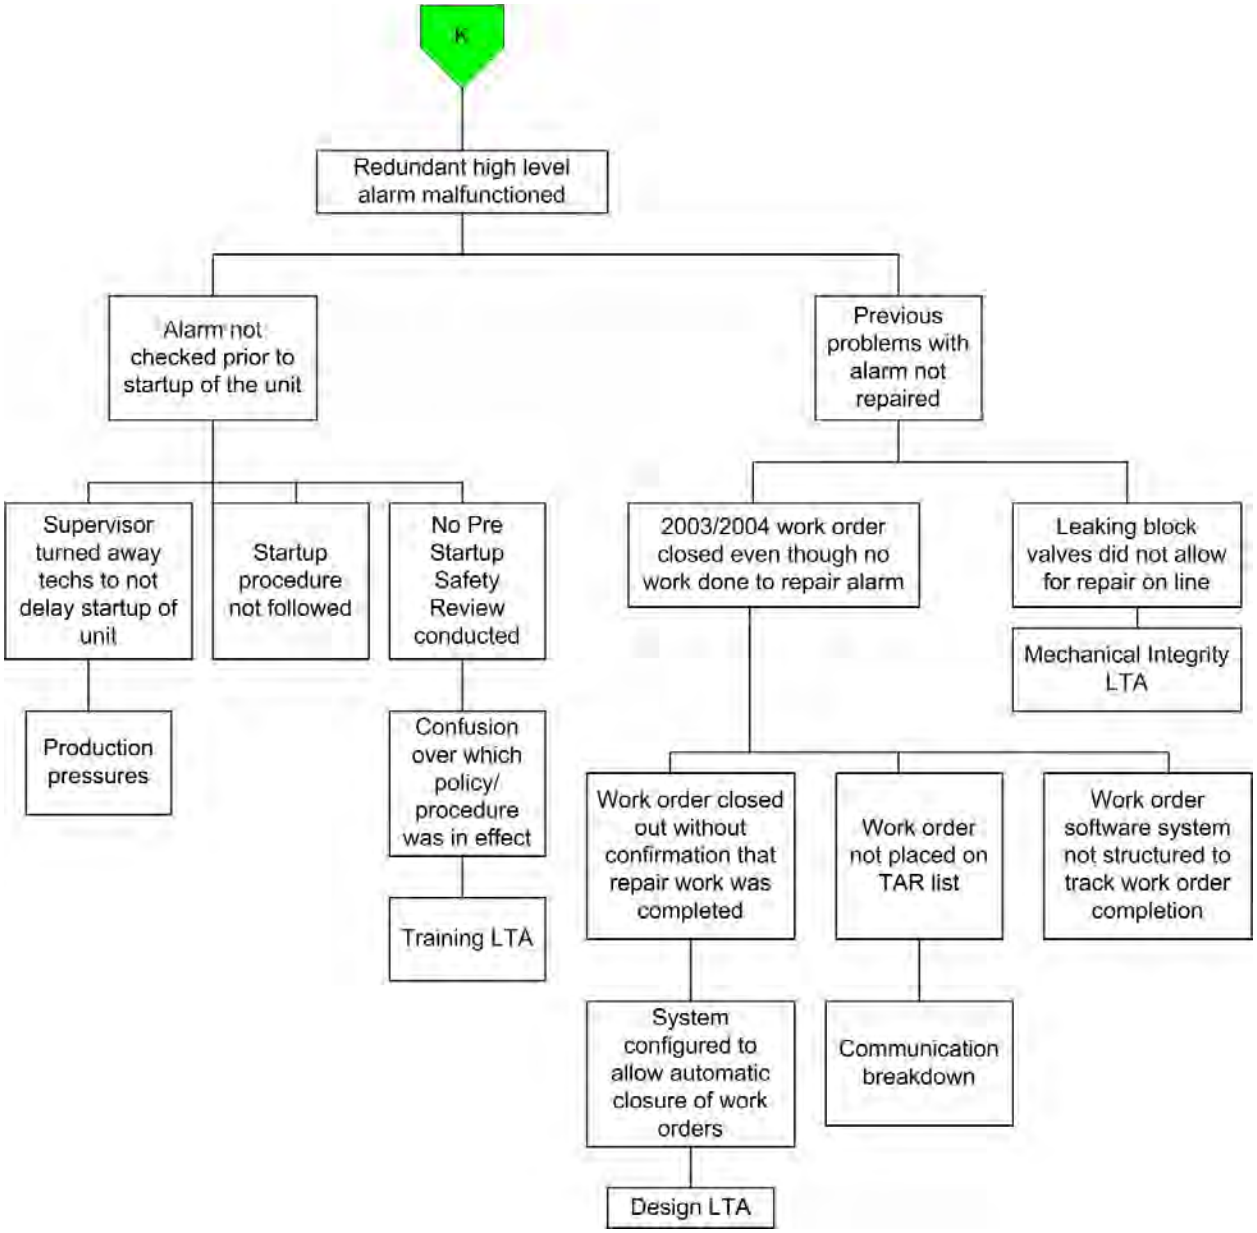
K
Redundant high level alarm malfunctioned
Alarm not checked prior to startup of the unit
Previous problems with alarm not repaired
Supervisor turned away techs to not delay startup of unit
Startup procedure not followed
No Pre Startup Safety Review conducted
2003/2004 work order closed even though no work done to repair alarm
Leaking block valves did not allow for repair on line
Mechanical Integrity LTA
Production pressures
Confusion over which policy/ procedure was in effect
Training LTA
Work order closed out without confirmation that repair work was completed
Work order not placed on TAR list
Work order software system not structured to track work order completion
System configured to allow automatic closure of work orders
Communication breakdown
Design LTA

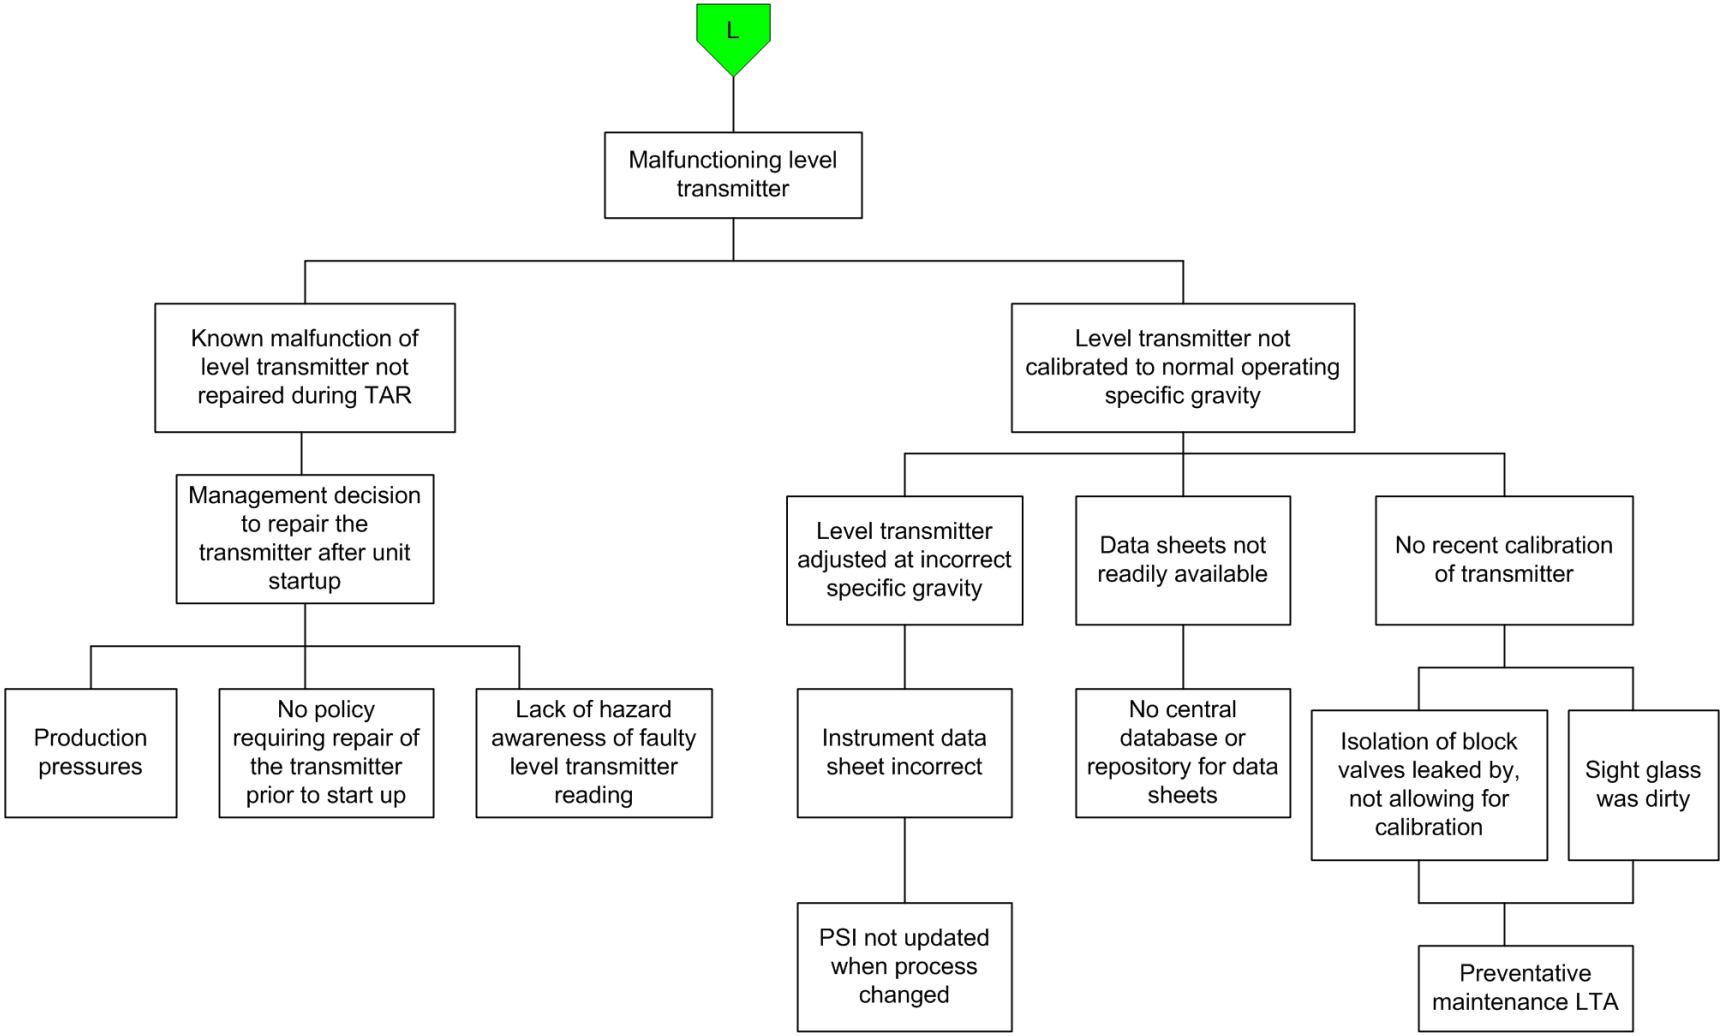
L
Malfunctioning level transmitter
Known malfunction of level transmitter not repaired during TAR
Level transmitter not calibrated to normal operating specific gravity
Management decision to repair the transmitter after unit startup
Level transmitter adjusted at incorrect specific gravity
Data sheets not readily available
No recent calibration of transmitter
Production pressures
No policy requiring repair of the transmitter prior to start up
Lack of hazard awareness of faulty level transmitter reading
Instrument data sheet incorrect
No central database or repository for data sheets
Isolation of block valves leaked by, not allowing for calibration
Sight glass was dirty
PSI not updated when process changed
Preventative maintenance LTA

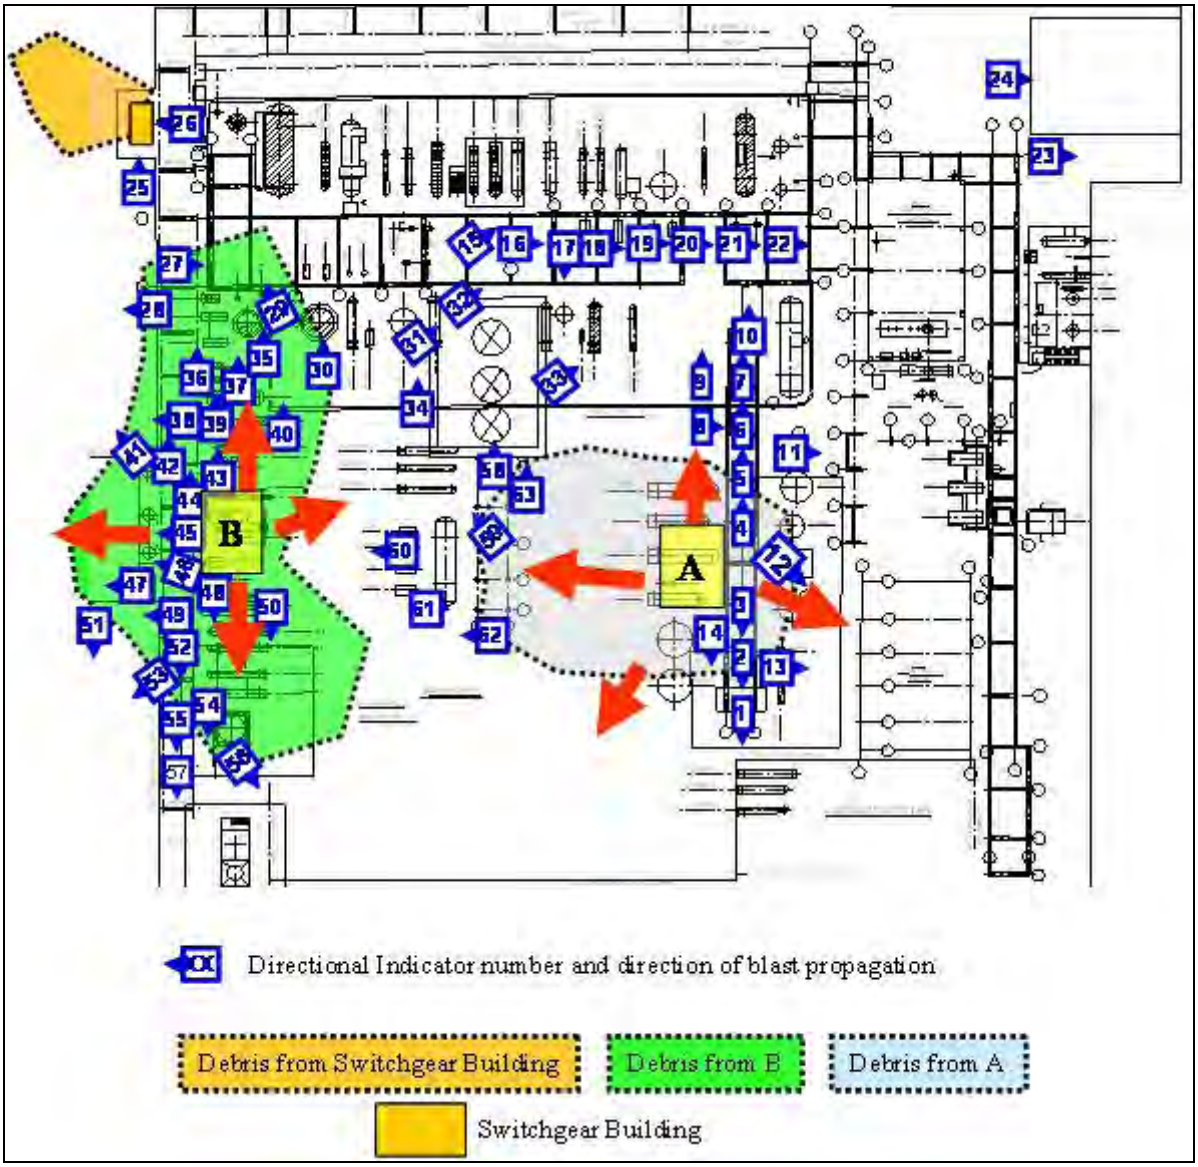
3.7.2 Operator Performance Impaired by Fatigue

- Areas surrounding the intense pressure regions in the ISOM unit, including the satellite control building, experienced 5 psi and greater overpressures.
- The catalyst warehouse and the six temporary trailers sited directly north of it experienced approximately 2 to 2.5 psi overpressure.
- The east edge of the NDU, first layer of storage tanks south of Ave. G, and the south edge of the ULC unit experienced about 1 psi overpressure.
- The west edge of the NDU, second layer of tanks south of Ave. G, the south portions of ULC and ARU units, and the western edge of the ARU unit experienced 0.5 psi and greater overpressures.
- Five ULC turnaround trailers sited west of Sixth Street; the remainder of ULC and ARU units, and storage tanks farther south experienced 0.25 psi and greater overpressures.

Figure H- 1. Intense blast regions in the ISOM unit

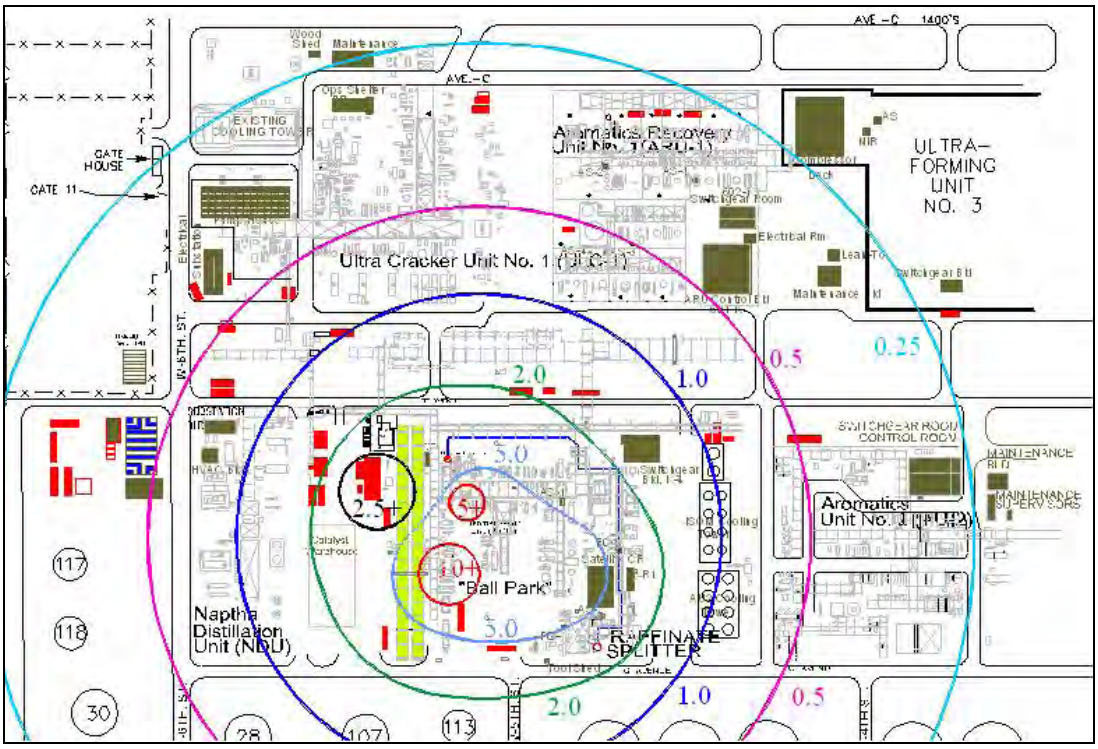
Figure H- 2. Blast overpressure map

The blast overpressures presented on the map are free-field values and do not address blast wave reflections. Objects facing the blast can experience applied blast wave pressure higher than the free-field values.

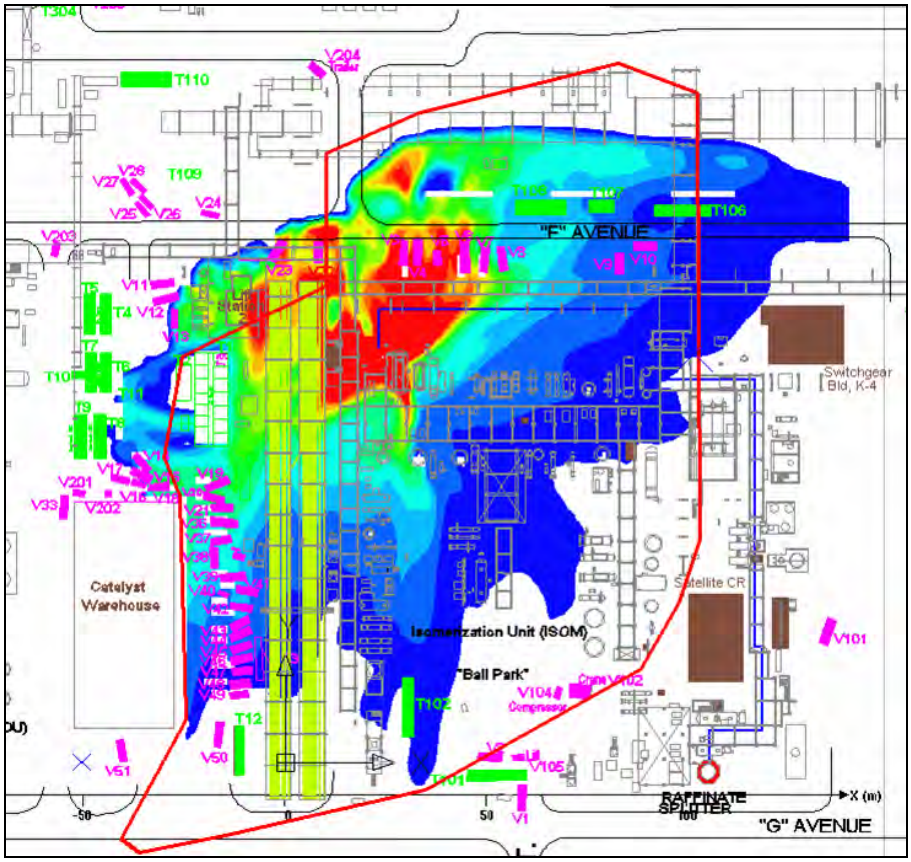
Figure H- 3. Cloud extent comparing field observations (red line) to dispersion modeling

A large domain was chosen that exceeded the expected extent of the flammable dispersion. The domain was also large enough to address sizeable objects around the perimeter of the ISOM unit that would affect wind patterns and ultimately dispersion of flammables. Steady-state wind conditions, as described, were established prior to beginning the dispersion of flammable materials. The dispersion grid was set at 1 meter in the X, Y, and Z directions for the bulk of the model. A tighter grid was chosen at low elevations where the heavy flammable vapor cloud was expected to settle. The CFD modeling attempted to simulate the release conditions and source terms described previously. The CFD model included several vapor source terms that represent vapor generated from evaporation of falling liquid, vapor generated through evaporation when liquid interacted with elevated equipment, and vapor generated by evaporation from liquid pooled on the ground. The numerically discrete nature of CFD allows specifications of definite leak locations; therefore, vapor sources were placed in the model at various locations to represent potential sources. A total of 16 discrete “leak” locations were selected that would be vapor sources in the model, including four sets, placed at various elevations, of four leaks located about the perimeter of blowdown drum. A parameter study that varied the rate of vapor generation for the source terms was then conducted and comparisons made against field data and observations. A comparison (Figure H-3) shows reasonable agreement.

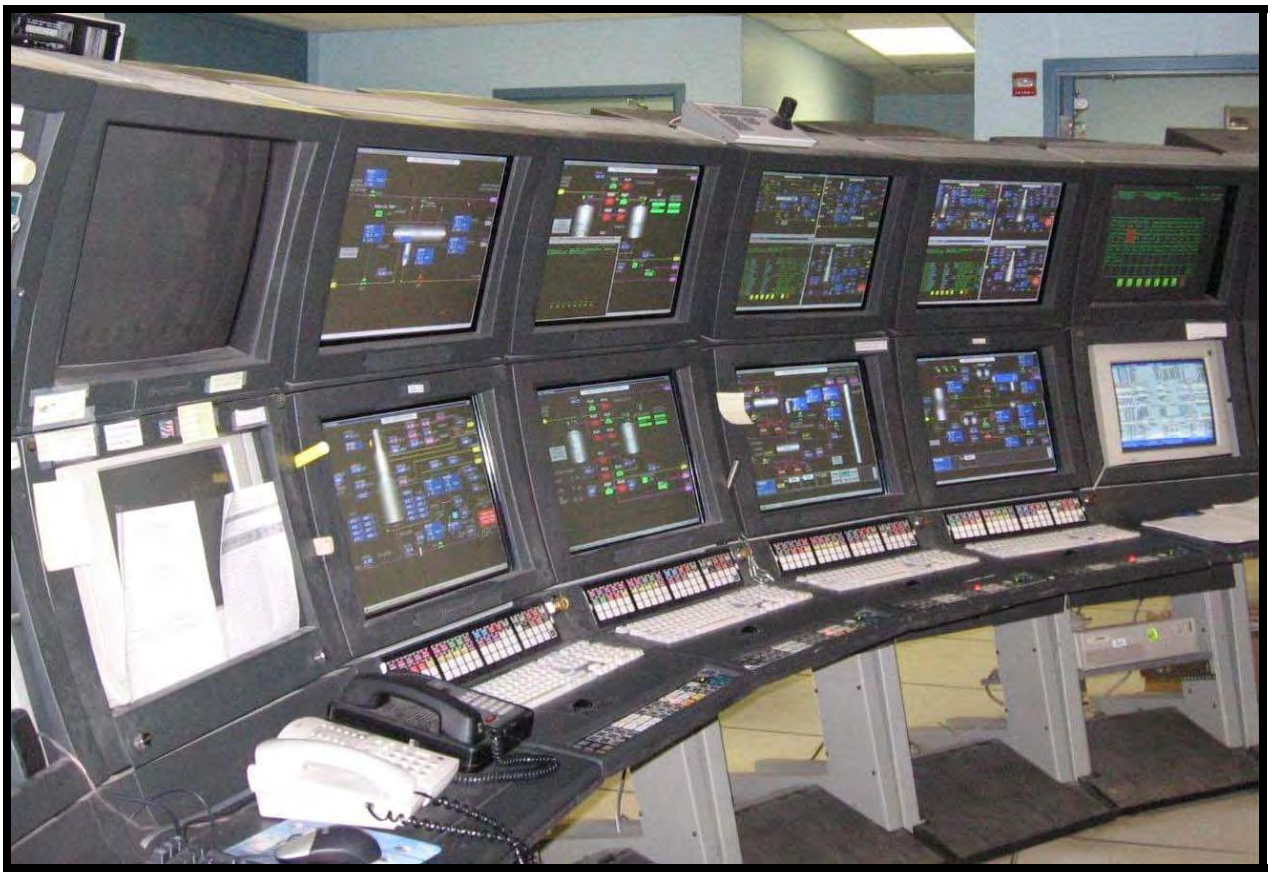
Figure K- 1 The computerized control system for the AU2/ISOM/NDU complex

The control board for the ISOM/NDU/AU2 complex (Figure K-1) consisted of eight computerized control board monitor screens, four of which could be subdivided into four smaller display windows, for a total of 20 screen windows. Additionally, four additional monitors (two on either side of the eight monitor screens) displayed the critical unit alarms.

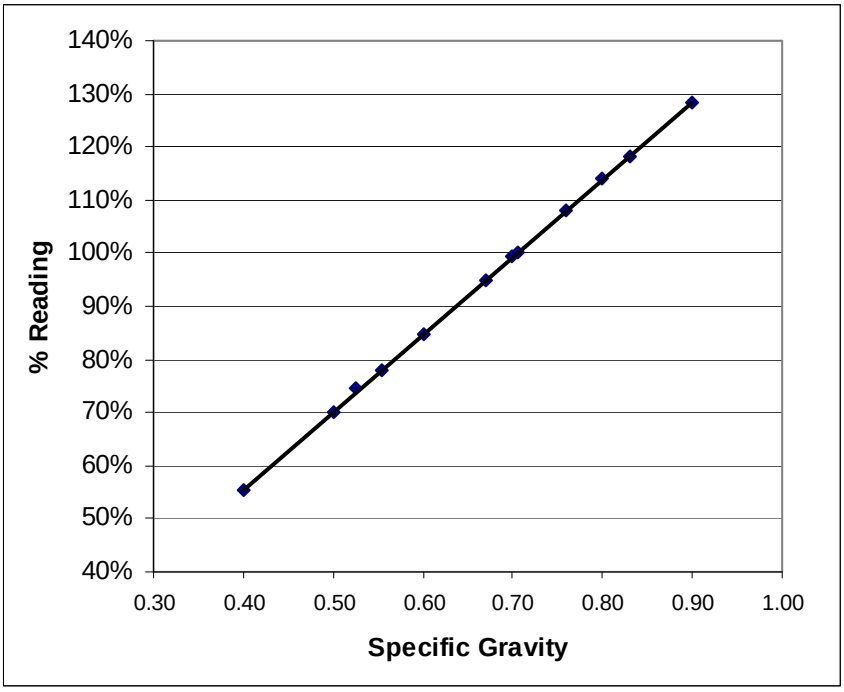
Figure S- 1. Calculated LT-5100 flooded reading versus specific gravity

The specific gravity of the hydrocarbon liquid in the raffinate splitter tower is strongly temperature-dependent. At 300°F, the temperature in the base of the raffinate splitter when it overflowed, the specific gravity is about 0.55 (Figure S-2). As Figure S-1 shows, at a specific gravity of 0.55 the transmitter would indicate a level of 78 percent when flooded, which matches the value observed when the raffinate splitter tower over-filled. The CSB concludes that the level transmitter was not calibrated for the specific gravity of fluid at its normal operating temperature.
