U.S. CHEMICAL SAFETY AND HAZARD INVESTIGATION BOARD

INVESTIGATION REPORT

REFINERY EXPLOSION AND FIRE

REPORT NO. 2005-04-I-TX

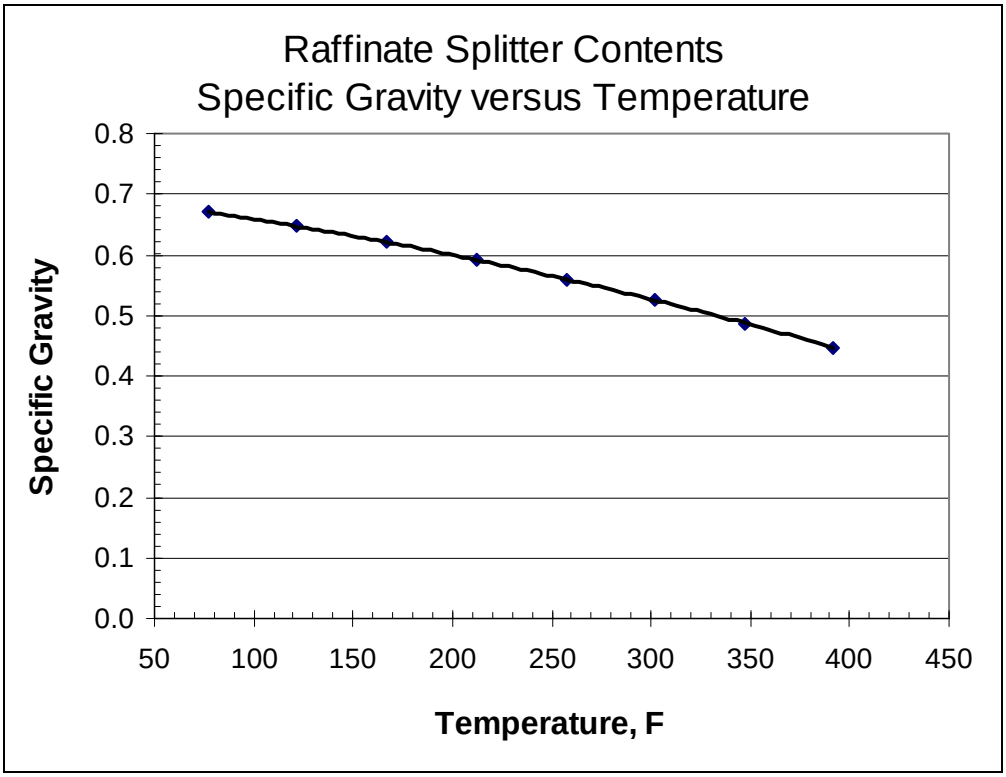
Figure S- 2. Calculated raffinate splitter feed specific gravity as a function of temperature

The specific gravity of the hydrocarbon liquid in the raffinate splitter tower is strongly temperature-dependent. At 300°F, the temperature in the base of the raffinate splitter when it overflowed, the specific gravity is about 0.55 (Figure S-2). As Figure S-1 shows, at a specific gravity of 0.55 the transmitter would indicate a level of 78 percent when flooded, which matches the value observed when the raffinate splitter tower over-filled. The CSB concludes that the level transmitter was not calibrated for the specific gravity of fluid at its normal operating temperature.

The CSB investigators learned that the instrument data sheet, which should have been used for calibrating the transmitter, had not been updated since 1975 when the tower was part of a different process with a different feed fluid. The data sheet had never been changed to reflect the operating specific gravity in the ISOM process; furthermore, instrument technicians responsible for maintaining and calibrating the transmitter stated that the data sheets—even if they had been updated—were unavailable to them. The CSB learned that these data sheets were filed in an engineer's office and were not typically given to technicians with work orders for instrument calibration.

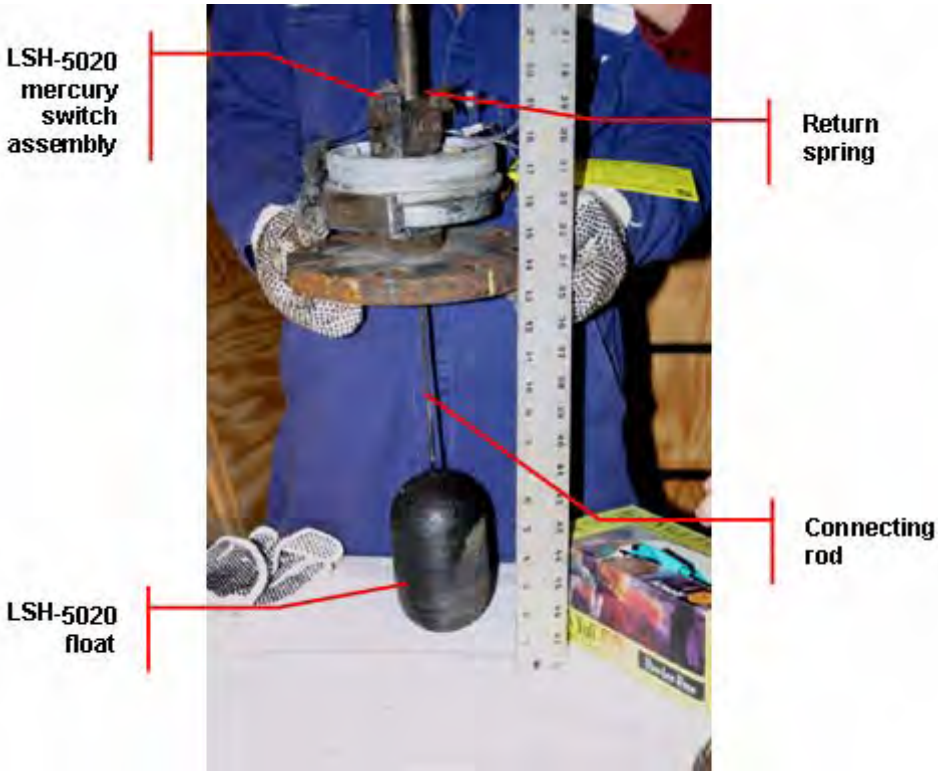
Figure S- 5. Internal components of LSH-5020 blowdown drum high level alarm

Figure S- 6. Close-up of LSH-5020 float, showing corrosion and hole

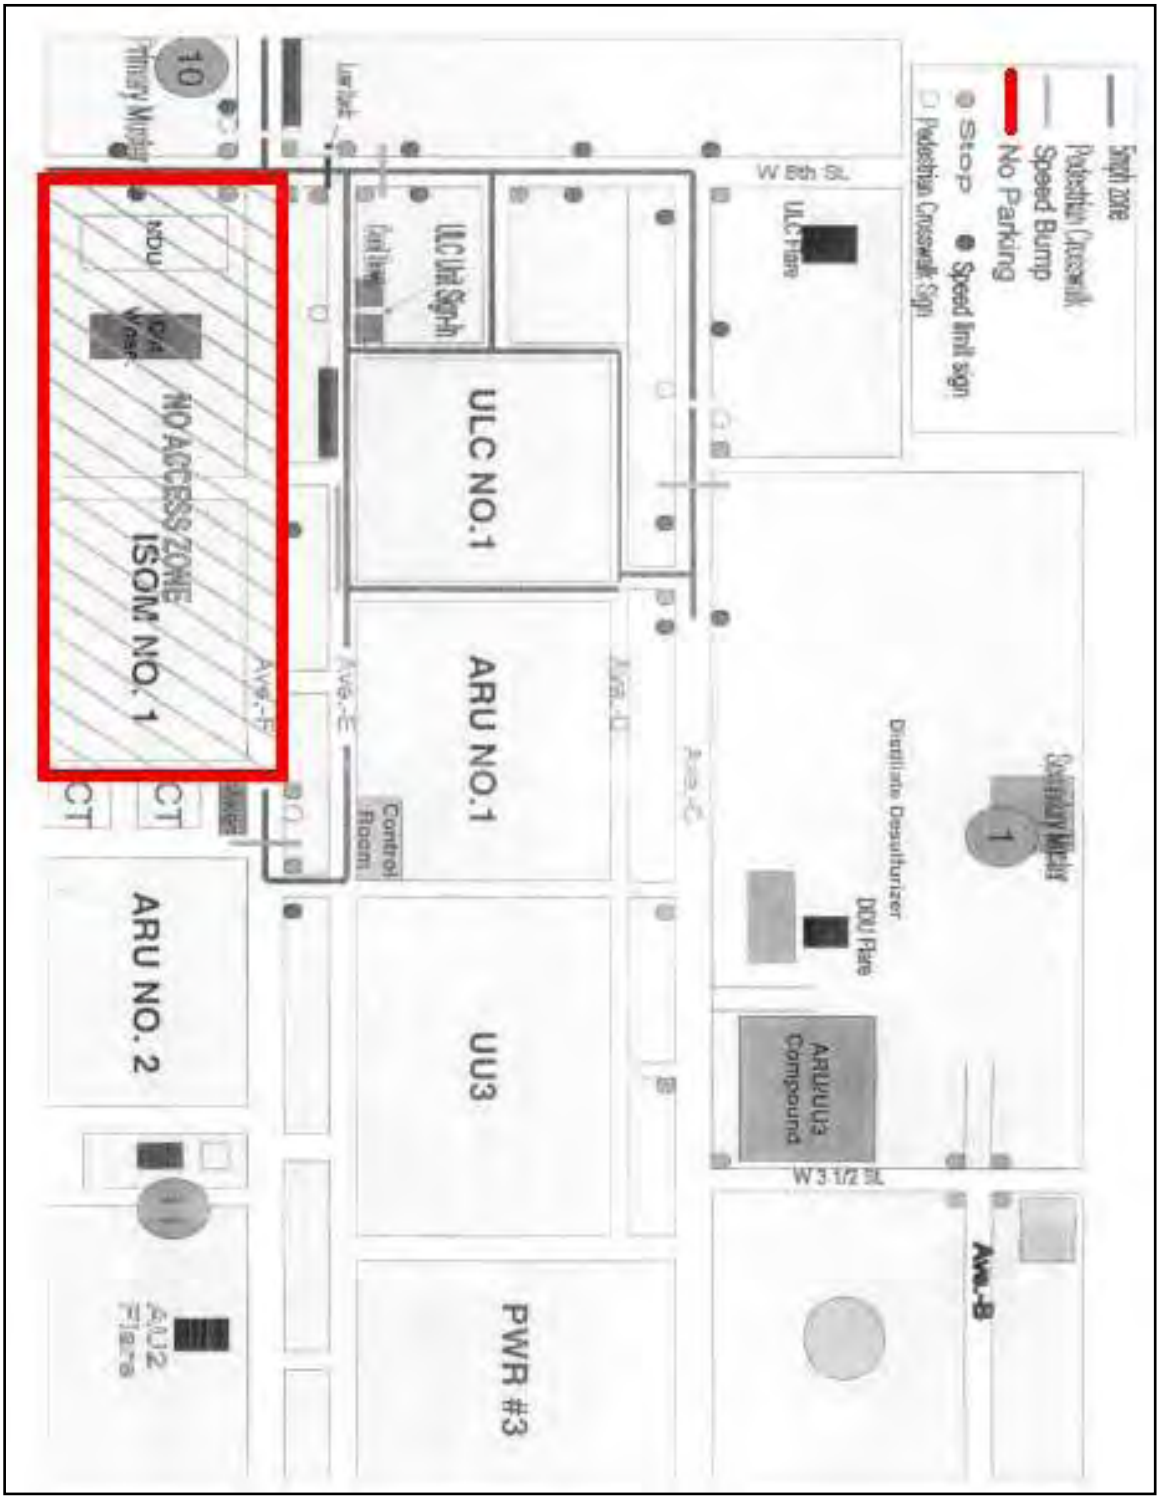
APPENDIX U: BP turnarounds traffic control map*

As Section 6 discussed, mobile trailers were not sited in accordance with MOC policy. Insufficient training for PHA leaders in the use of the MOC policy and its various checklists, a lack of identified responsibilities for the refinery's turnaround organization, trailers being occupied before PHA all action items were resolved, and lack of review of MOCs all prevented the MOC policy from being implemented as was intended.

*The red outline has been added by CSB to highlight the "No Access/Parking" area.
