Tehidy Kennels, Cornwall
Historic building record

Report No: 2023R002

Tehidy Kennels, Cornwall

Historic Building Record

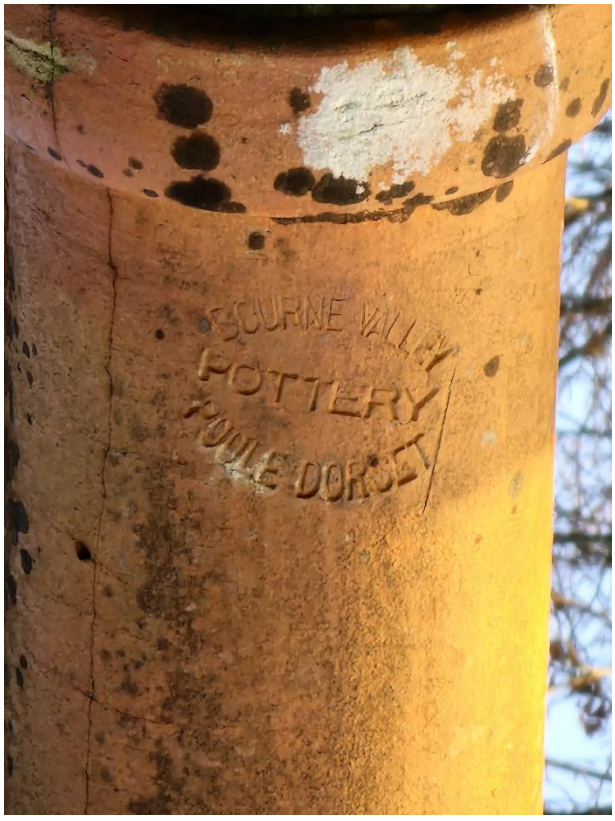
Fig 18 Building A: maker's mark for Bourne Valley Pottery, Poole, Dorset on chimney pot.

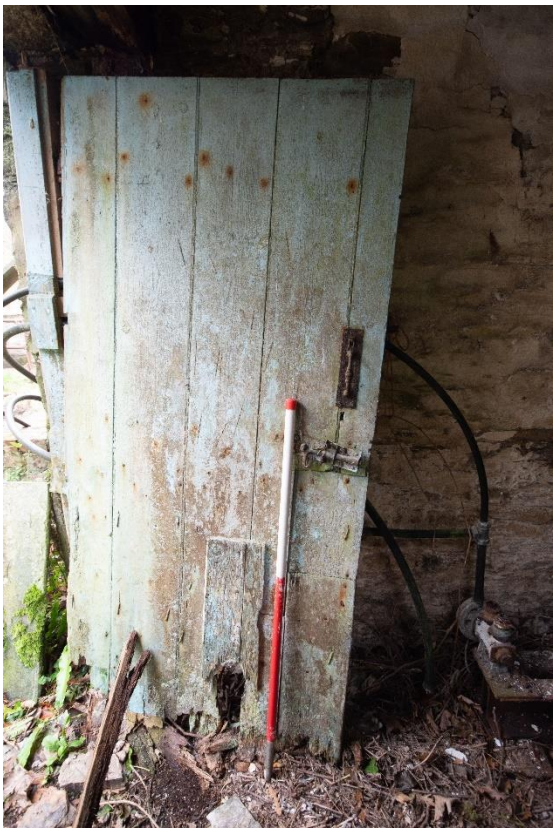
Fig 31 Building A: Room 1, door in northeast wall.

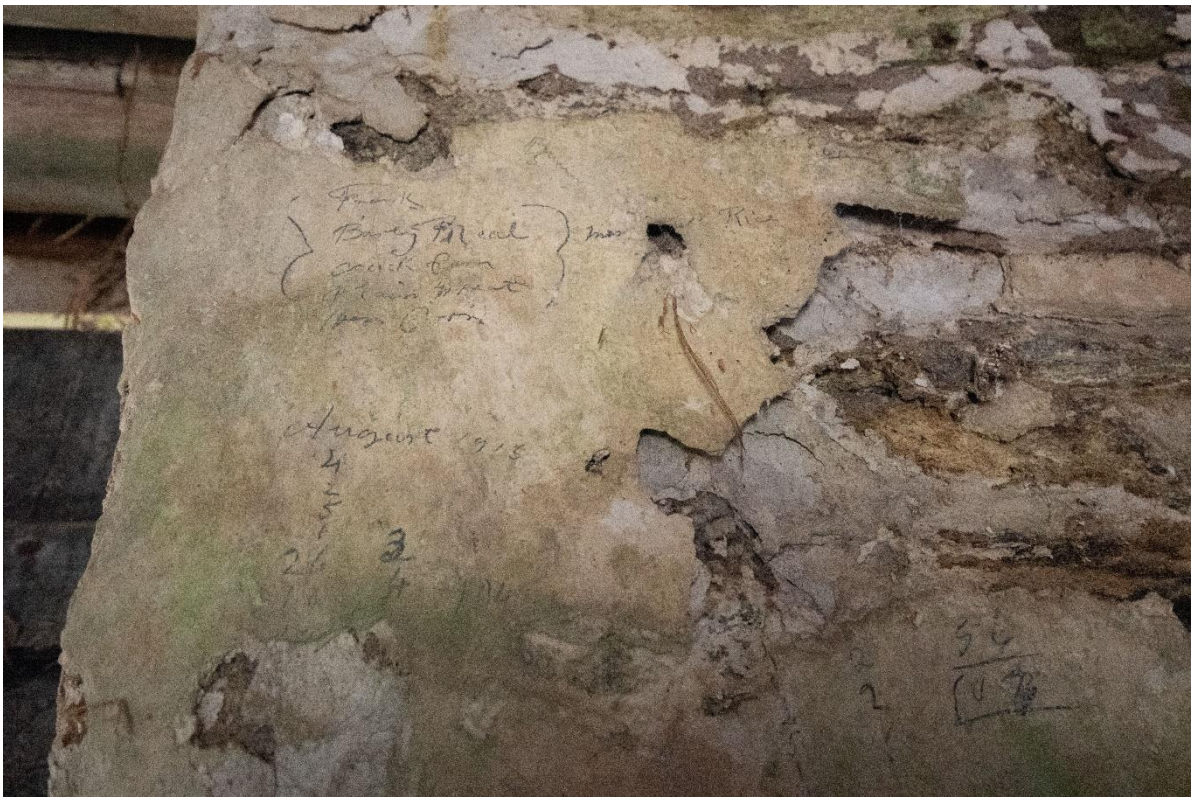
Fig 43 Building A: Room 2, Graffiti on the southwest wall listing barley meal, rice etc and dated August 1913 or 1915.

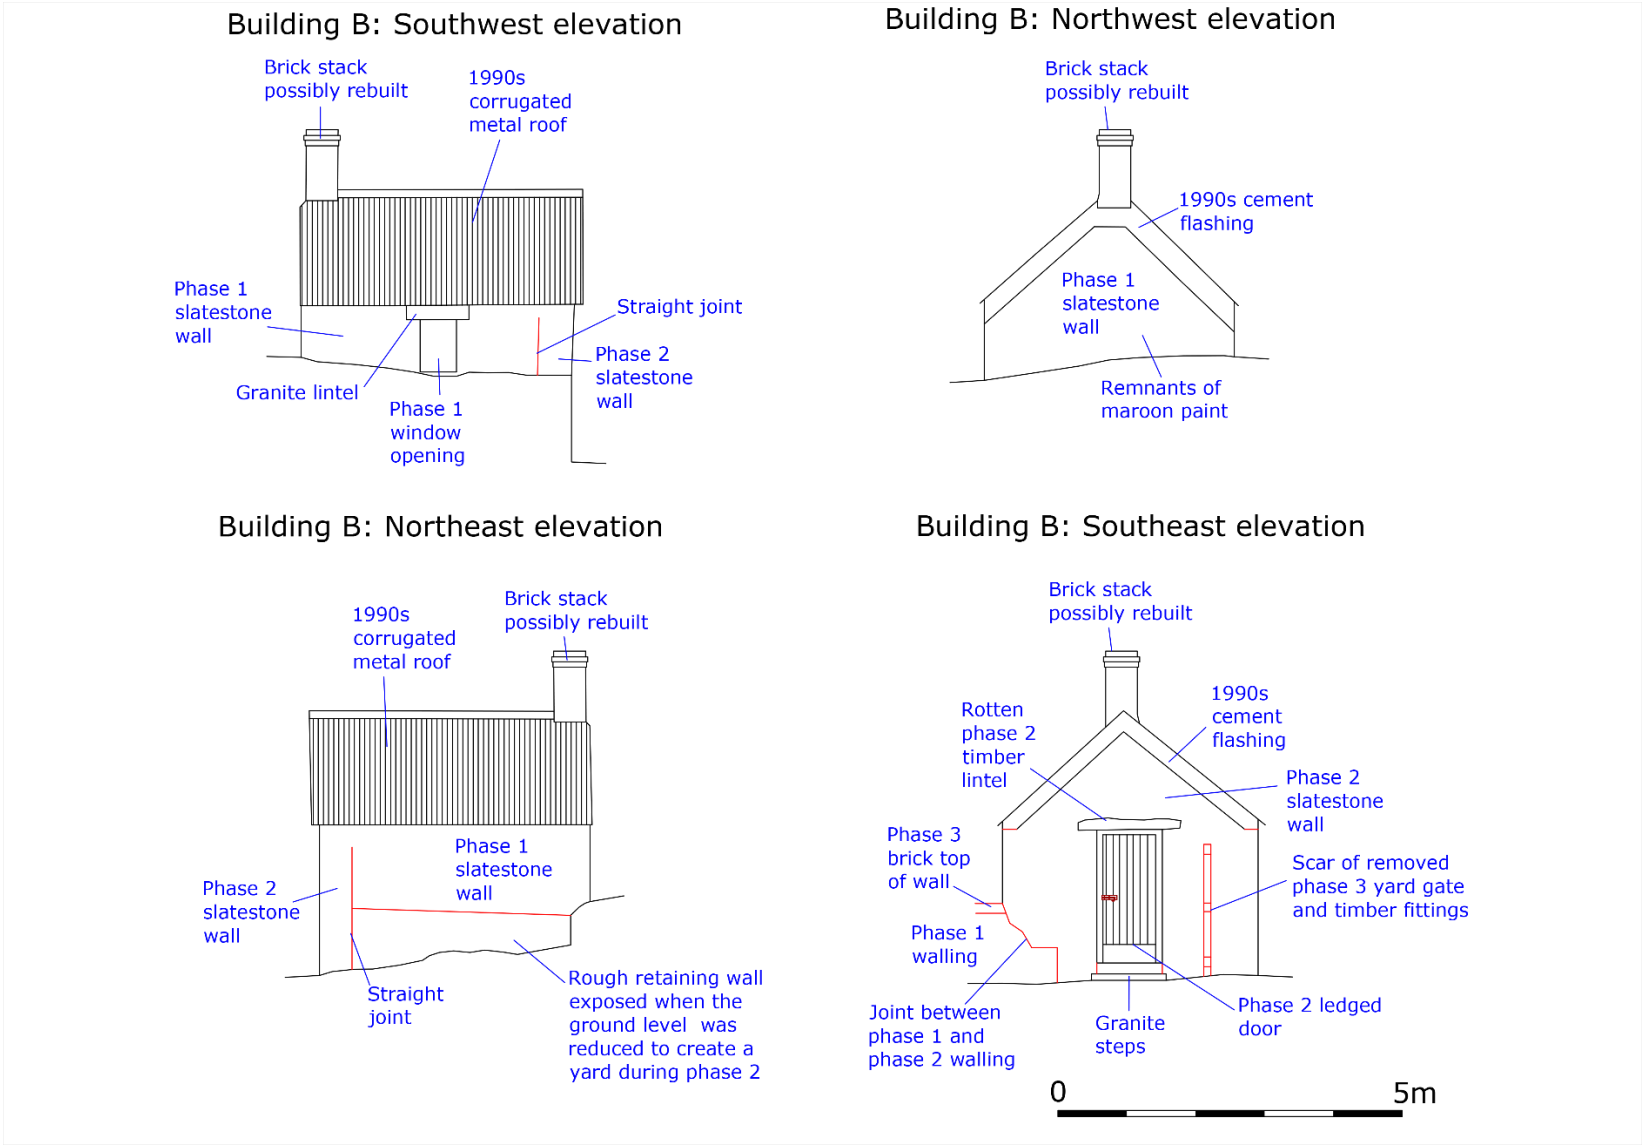
Fig 136 Building B: elevations.

The corrugated metal roof is a 1990s replacement. The top of the wall under the eaves was either repointed of rebuilt when the new roof was added.
