# CDS Rolls Royce Bushing Bearing Blistering Analysis

Independent Project

5/9/2024  
Bodycote LLC  
David de Vall

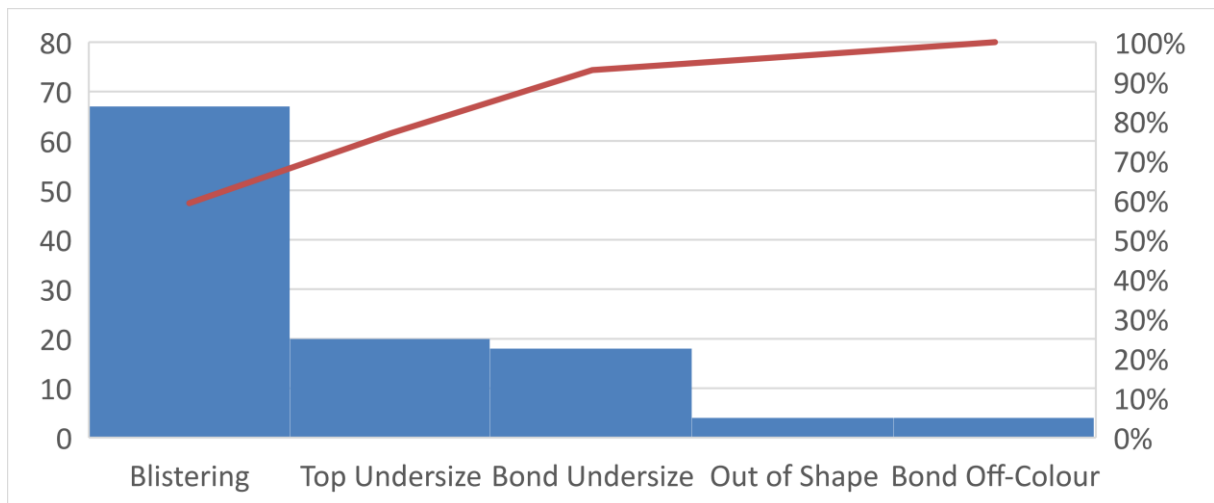
Figure 6: Pareto Analysis of Failure Modes

As can be seen, blistering does indeed account for roughly 80% of failures on CDS-1 parts, making it clear that resolving this problem will have the biggest impact in reducing failure rates and increasing profitability.

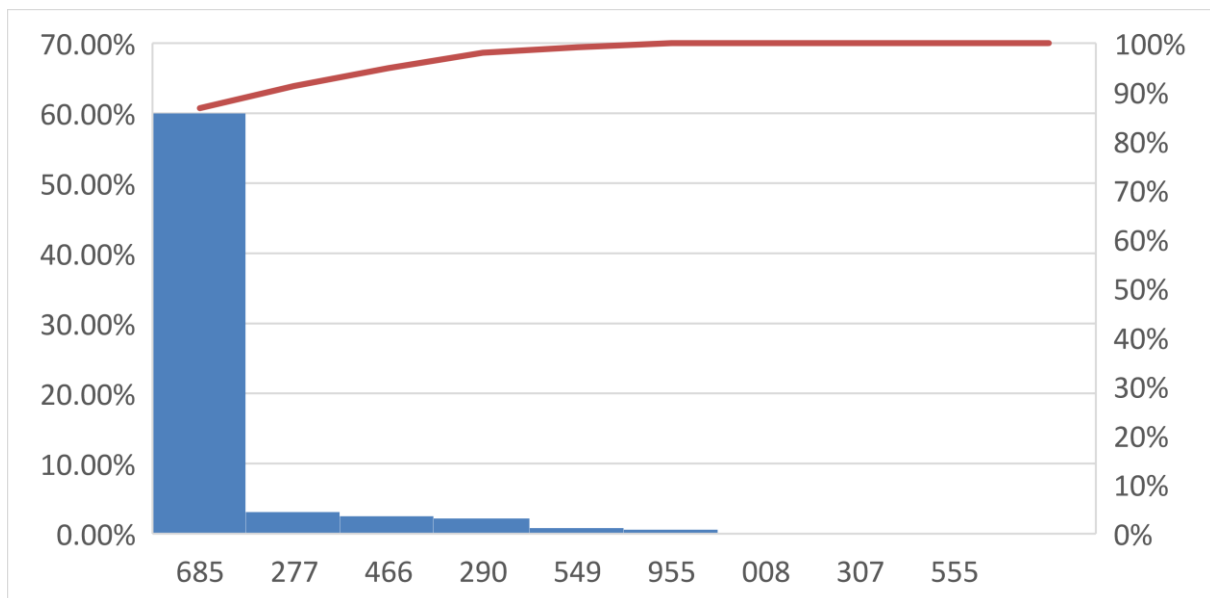
Figure 8: Pareto Analysis of Failures by Part (Rate)

As can be seen, part type 685 suddenly becomes a much more pressing issue under this revised study. However, as a grand total of 10 of them were produced during the study, they are a much rarer part and account for a lower percentage of lost profit and rework costs than other parts. 466s also become a slightly more pressing issue than 290s, giving weight to the argument that they should also be considered even though on frequency analysis the 80% mark was reached almost entirely just on 277s and 290s.

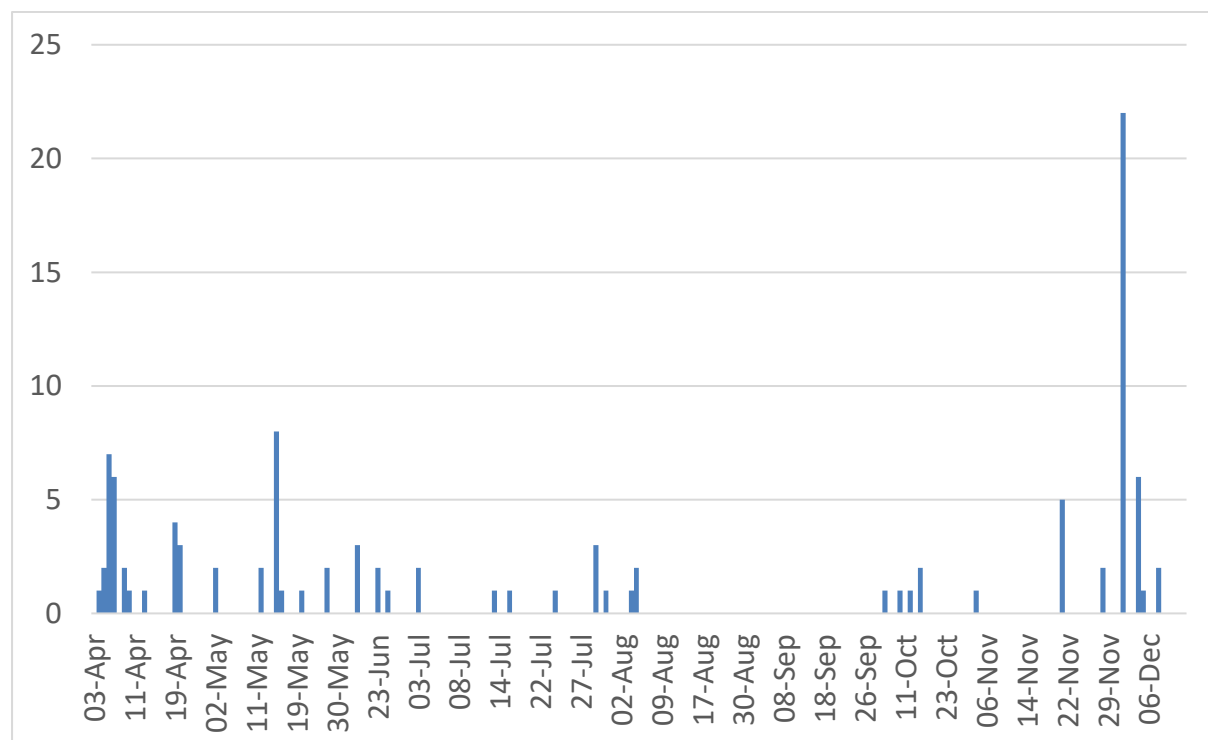
Figure 9: Failures over Time

It is immediately noticeable [no failures in august and September – hypothesise why]

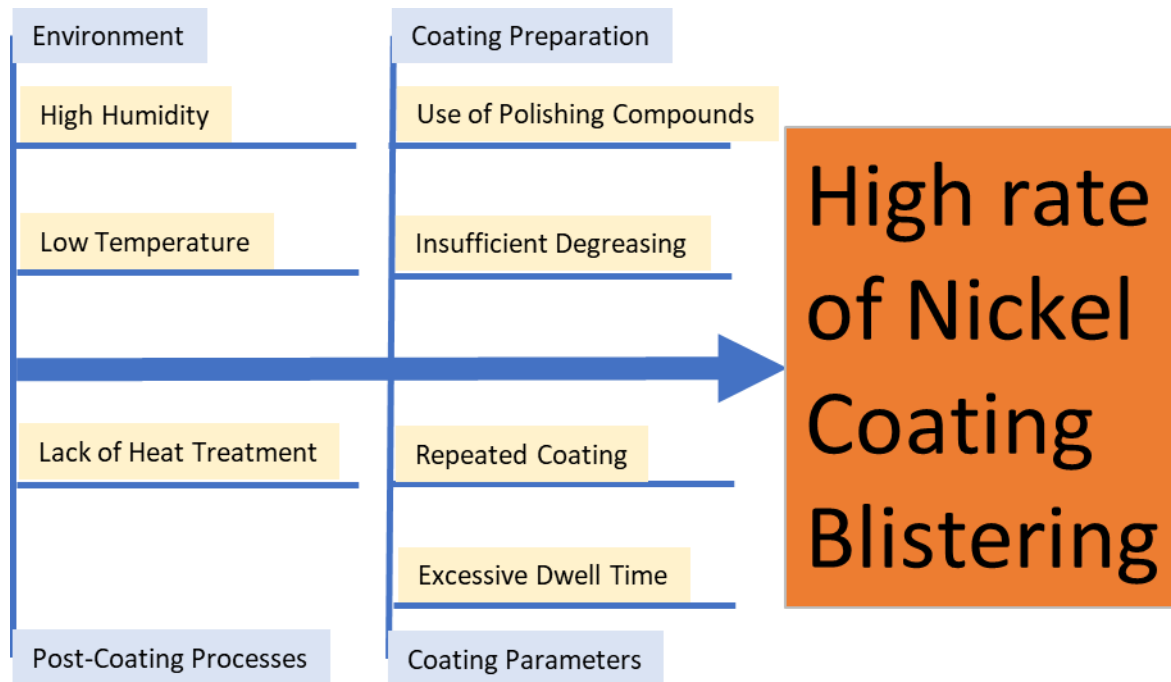
The following diagram displays a summary of the potential reasons for blistering failure as discovered by the literature review:
