Fracture/Fatigue Failures of Products and Components In-Service

University of Wales Trinity Saint David  
BEng Bachelor of Engineering Program, Ordnance, Munitions and  
Explosives (Safety)

This report presents a materials failure analysis of an in-service Boeing 737 next generation main landing gear wheel hub, a safety critical aluminium alloy component (typically AA7075-T6), that failed due to high-cycle fatigue. The investigation identifies fatigue crack initiation at the bearing bore shoulder radius, a region of high geometric stress concentration, followed by progressive crack growth (characterised by beach marks and multiple axial/circumferential cracks), and final ductile overload fracture, evidenced by a rough, fibrous surface with micro void coalescence.

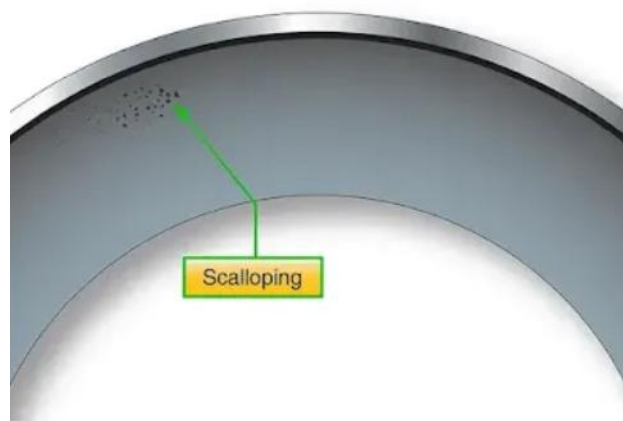
Correct axle nut torque is essential for safe wheel operation. Under-torquing can allow excessive bearing movement '**scalloping**', seen in Figure 6, leading to abnormal contact stresses and accelerated damage within the wheel hub, while over-torquing restricts bearing load distribution and lubrication, increasing friction and heat generation.

**Figure 6 Scalloping, Eventually Leads to Wheel Bearing Failure [1]**

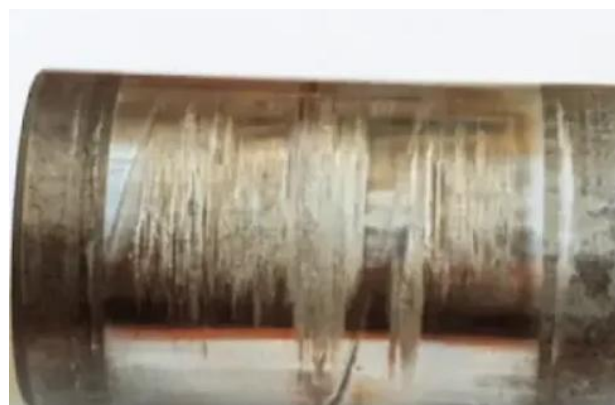
**Figure 7 Galling, Mechanical Wear Leads to Surface Tearing [1]**

**Galling**, seen in Figure 7, arises from severe adhesive wear between contacting surfaces, typically caused by insufficient lubrication or excessive contact stress. Localised frictional heating can result in micro-welding at asperity junctions, which are subsequently torn apart during relative motion, leading to significant surface material loss aligned with the direction of sliding [1].

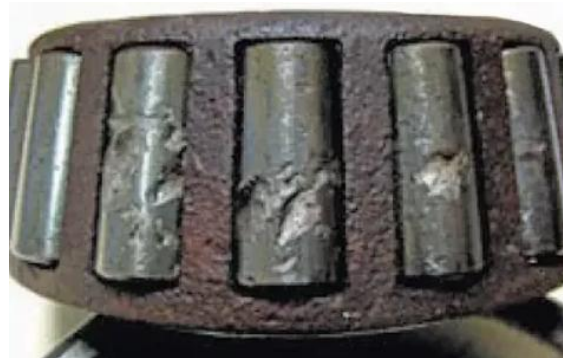
**Figure 8 Spalling, Sub-surface Cracks Leads to Surface Fatigue [1]**

**Spalling**, seen in Figure 8, is characterised by the detachment of small fragments from the hardened surface of bearing rollers or raceways. This form of surface fatigue is driven by repeated cyclic contact stresses and indicates subsurface crack initiation and propagation. Once spalling is present, stress redistribution and debris generation accelerate bearing degradation.

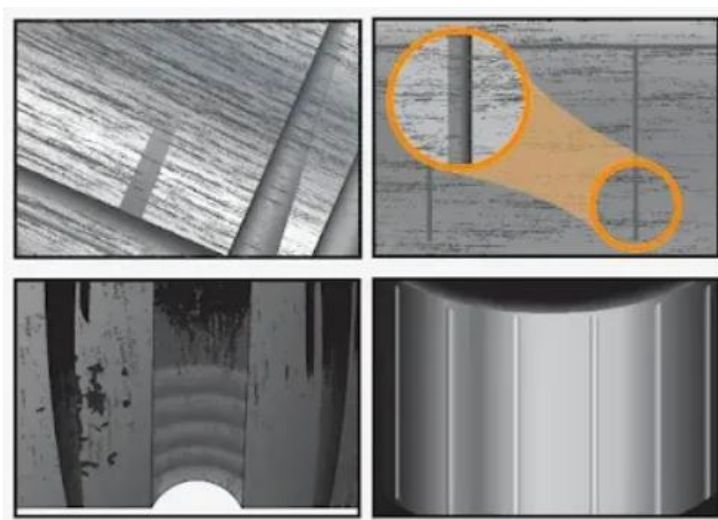
**Figure 9 Brinelling, Excessive Load Leads to Mechanical Indentation Failure [1]**

**Brinelling**, seen in Figure 9, refers to permanent indentations formed in bearing raceways due to excessive static or impact loading. Such indentations disrupt smooth rolling motion, generating vibration and stress concentrations that promote early fatigue failure. Brinelling is frequently linked to improper installation, handling, or severe operational impacts.

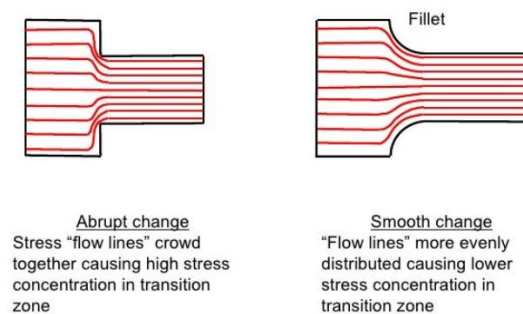
**Figure 19 Stress Concentrations [16]**

Features such as sharp fillets or bore shoulders create elevated local stresses, reflected in a higher stress-concentration factor, seen in Figure 19. Under landing loads that can approach several times the aircraft's static weight, these localised stresses may repeatedly exceed the material's fatigue endurance limit, despite remaining below yield strength.

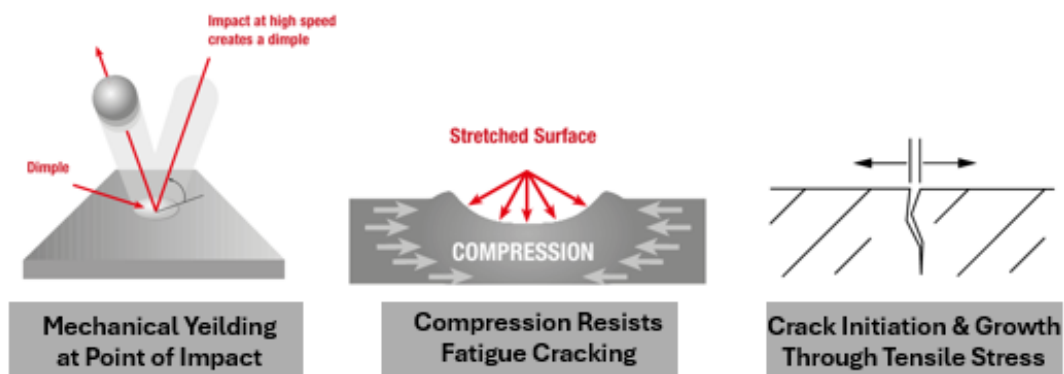
**Figure 21 Shot Peening Process [21]**

Surface condition also plays a critical role. Shot peening introduces a layer of beneficial compressive residual stress that suppresses crack initiation, but in this case the bearing-bore radius was not treated. As a result, this transition region lacked the protective compressive layer and remained vulnerable to fatigue under service loading. The presence of multiple radial and circumferential cracks around the bore is consistent with a highly stressed, un-peened region subjected to complex cyclic loading [13].
