# Retrofit Coordination and Management

HND / BSC CONSTRUCTION MANAGEMENT

By Aaron Griffiths (2223674) | **ACBA5026** | 10/01/25

14 Norgans Terrace, Pembroke is a terraced house built in “1906 which is the last map in which the house was last seen on” - (Maps.nls.uk. (2025). *Map Finder - with Marker Pin - Map Images - National Library of Scotland*. [online] Available at:

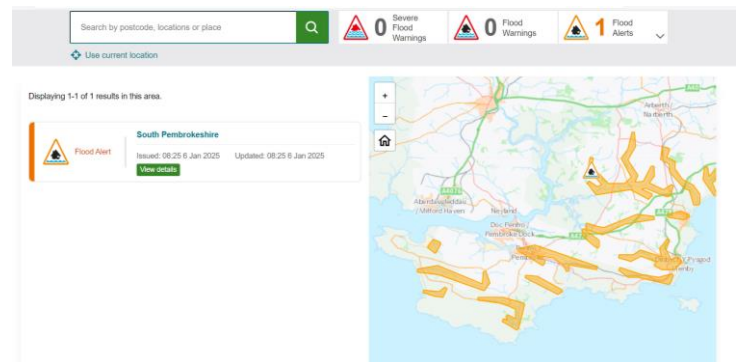
Fig 3 - Naturalresources.wales. (2020). Flood warnings and alerts. [online] Available at: <https://flood-warning.naturalresources.wales/?centre=eyJlIjpbNTEuNjkzMzUzMDE4OTMyMjgsLTQuODkoNTY3NTIzMjIyODAoXSwieiI6MTYuMjV9> [Accessed 8 Jan. 2025].

Also, looking at the flood map on the natural resources Wales website it shows that the property is not in risk of flooding. This is because the property is elevated from the main road, which puts it in the category of low risk of flooding
