Building Conservation Asset and Facilities Management

| Llanelly House – Llanelli..... | 6 |
| Former Water Works – Broadside Court, Denny..... | 16 |

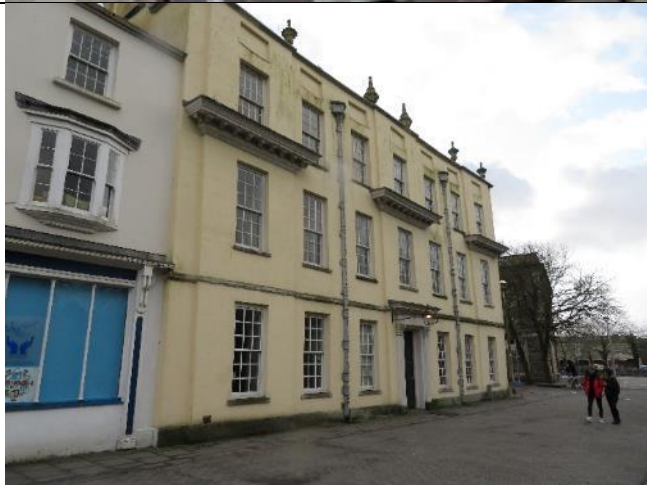
| | <p>Llanelly House –<br/>Hotel, conference<br/>facility, restaurant,<br/>and café.</p> | <p>2020: Access now<br/>directly onto<br/>public pedestrian<br/>path and<br/>shopping area in<br/>Llanelli.</p> <p>(Photograph by<br/>Heritage and<br/>Design Ltd, 2020)</p> |

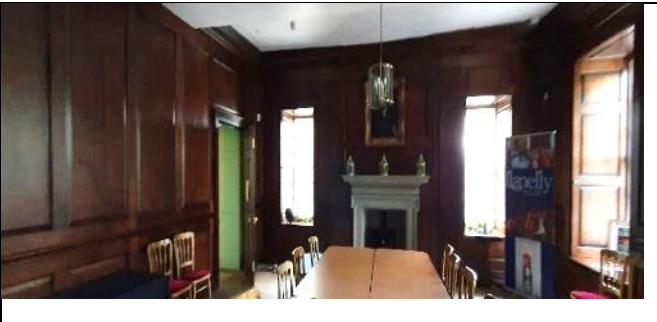
| | <p>Internal rooms not inspected – photographs to demonstrate level of specialist contractor to undertake works.</p> | <p>Original timber panelling in dining room at Llanelly House.</p> <p>(Photograph by Heritage and Design Ltd, 2020)</p> |

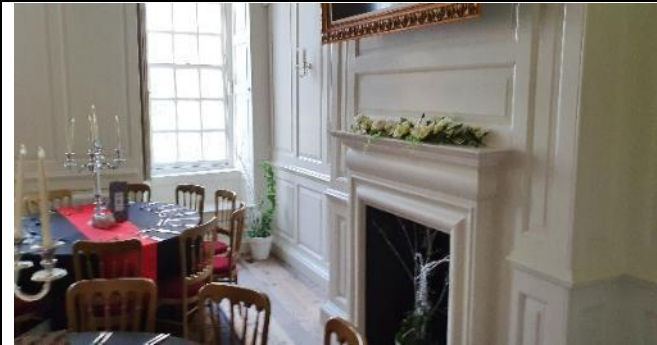
| | <p>Hotel restaurant dining room at first floor showing original painted panelling.</p> | <p>Photograph to show level of timber detail at panelling, fireplace and windows.</p> <p>(Photograph by Heritage and Design Ltd, 2020)</p> |

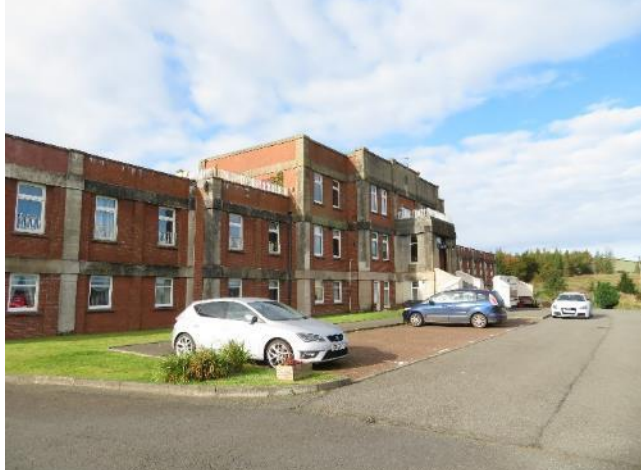
| | <p>Broadside private housing development. Main three storey section at centre former office block now split into flatted dwellings with additional wings forming town houses</p> | <p>(Photograph by Heritage and Design Ltd, 2020)</p> |
