| <b>Hybrid Civil Inspection Report</b> | | Sheet: <b>1 OF 24</b> | |
| Report Reference Tracker No: 12001120348<br>M3 Notification: 15399813<br>SAP PM O/No: 27714331<br>SAP Maintenance Plan No: 54163 | | Date of Inspection – February 04 <sup>th</sup> 2021 | |
| Inspection Location – <b>THE ABBEY GENERAL OFFICE BLOCK<br/>(FLOC 3001-320-0500-0001)</b> | | | |

## CIVIL INSPECTION FOR ABBEY GENERAL OFFICE BUILDING

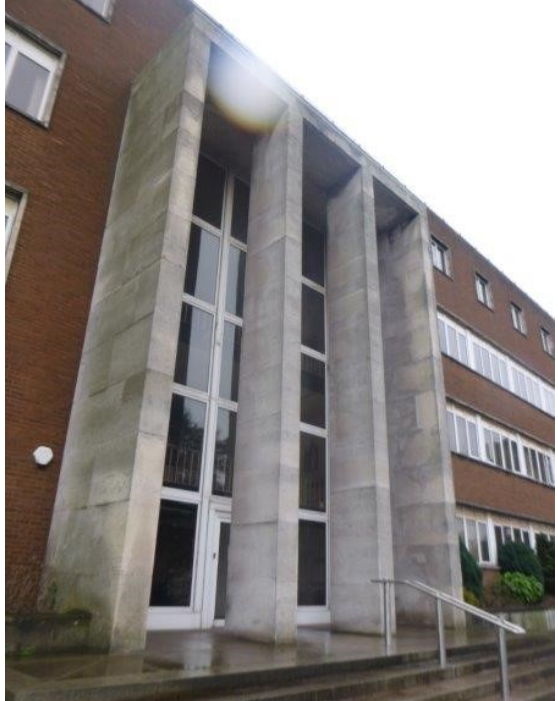
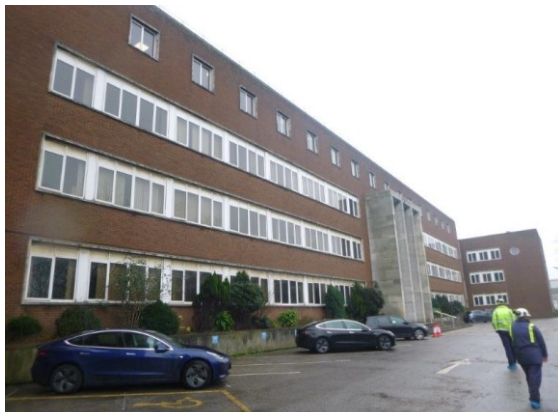
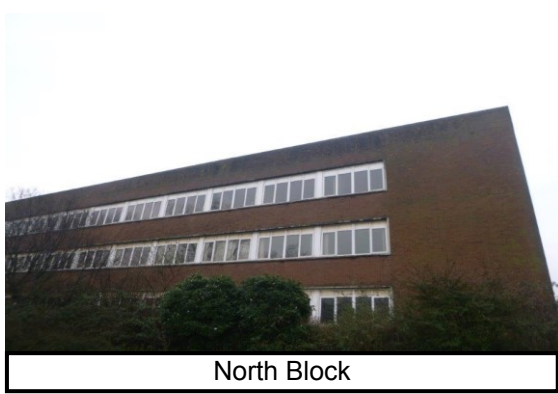
| Item No. | Observations/ Defects Found | Action Required/ Comments | Priority RAM Matrix Rating P1, P2, P4 or M3 notification with (Photograph evidence if required) |
|---|---|---|---|
| N/A | Overall condition of the building is appeared to be fair. Parking area in front of the building appears to be in fair condition. | For Information Only | <p><b>For Information Only</b></p> <p>Main Entrance: West Face of the building</p> <p>Central Block: West Face of the building</p> <p>North Block</p> |

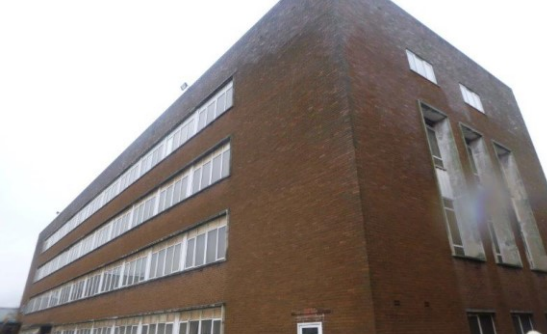
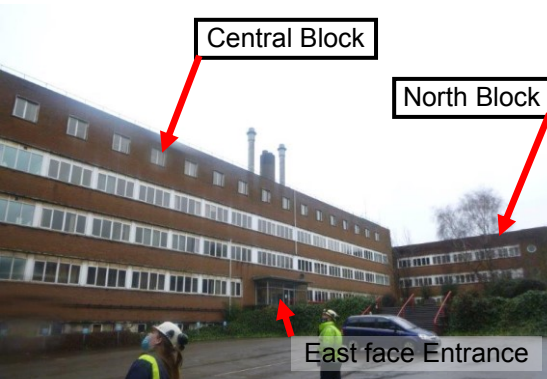
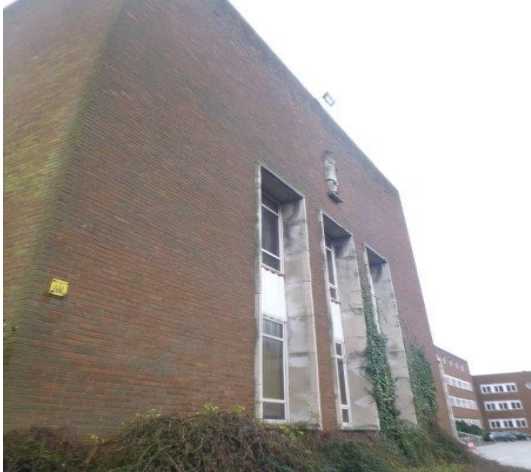
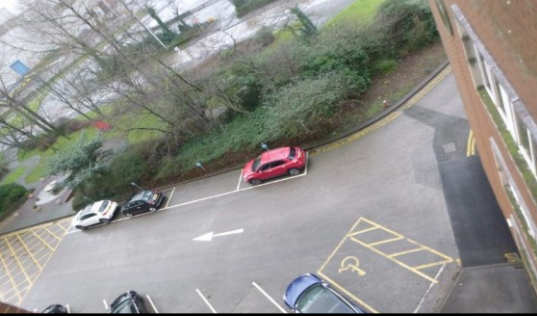
| Item No | Observations/ Defects Found | Action Required/ Comments | Priority RAM Matrix Rating P1, P2, P4 or M3 notification with (Photograph evidence if required) |
|---|---|---|---|
| | | | <p data-bbox="1046 633 1193 663">South Block</p> <p data-bbox="1046 701 1209 730">Central Block</p> <p data-bbox="1246 757 1385 786">North Block</p> <p data-bbox="1145 1014 1374 1043">East face Entrance</p> <p data-bbox="975 1070 1262 1099">East face of the building</p> <p data-bbox="983 1615 1254 1644">North Block: West face</p> <p data-bbox="911 1977 1321 2007">Parking area in front of the building</p> |

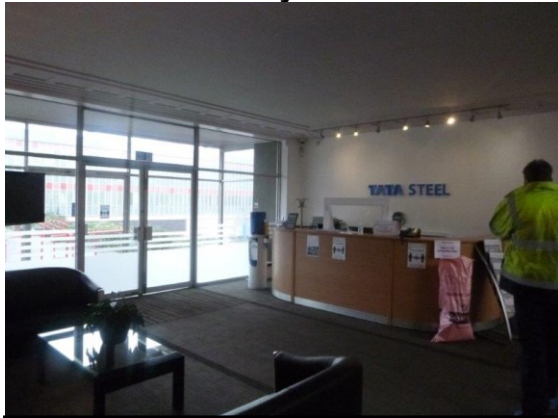
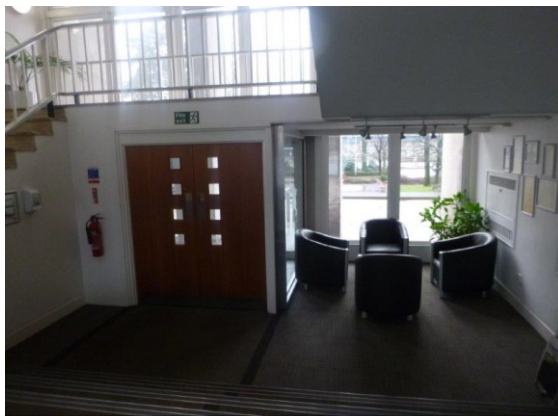
| Item No | Observations/ Defects Found | Action Required/ Comments | Priority RAM Matrix Rating P1, P2, P4 or M3 notification with (Photograph evidence if required) |
|---|---|---|---|
| 2,6,1<br>4,15 | Main entrance area appears to be in fair condition. | For Information Only | <p><b>For Information Only</b></p> <p>Main Entrance Area</p> <p>Main Entrance Area</p> |

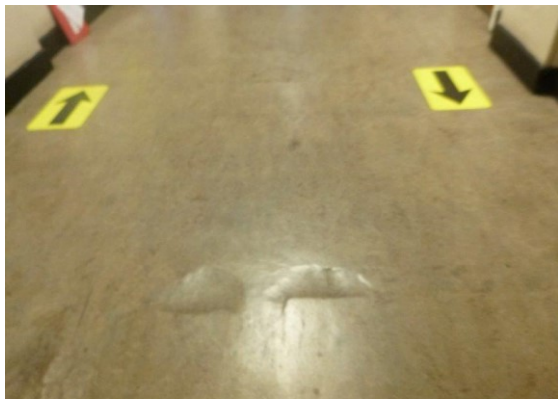
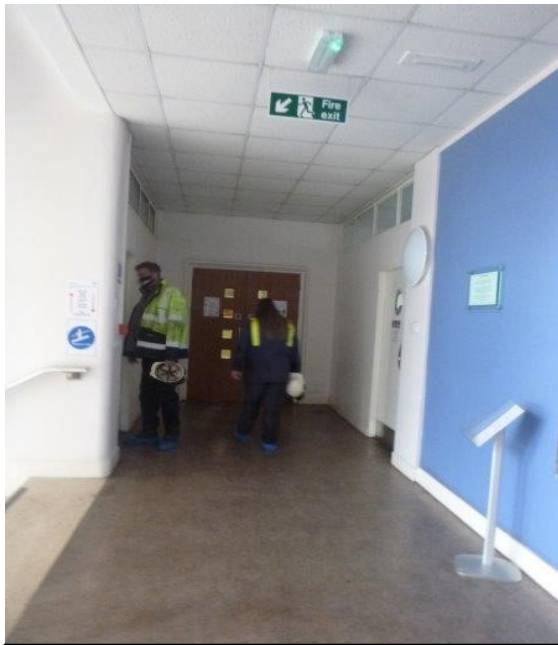
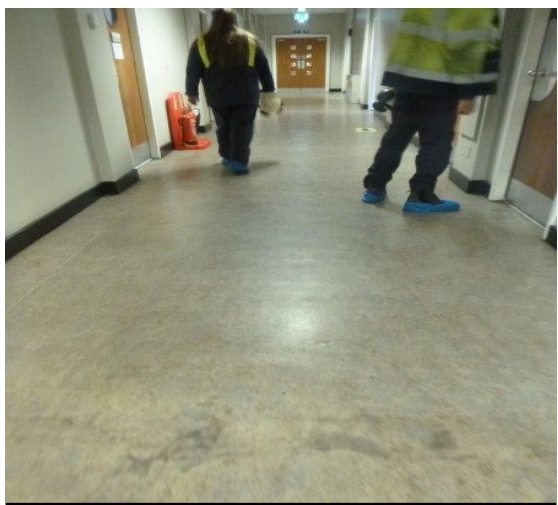
| Item No | Observations/ Defects Found | Action Required/ Comments | Priority RAM Matrix Rating P1, P2, P4 or M3 notification with (Photograph evidence if required) |
|---|---|---|---|
| 6,9,14,18 | Floor corridors appear to be in fair condition except undulations at few places mainly on first & second floor. This does not appear to be a matter of concern at present. Also there is not much deterioration in condition compared to previous inspection. | Information Only | <p><b>For Information Only</b></p> <p>North Block Ground Floor-Corridor</p> <p>South Block Ground Floor-Corridor<br/>-In front of Store Room</p> |

| Item No | Observations/ Defects Found | Action Required/ Comments | Priority RAM Matrix Rating P1, P2, P4 or M3 notification with (Photograph evidence if required) |
|---|---|---|---|
| | | | <p>First floor Corridor</p> <p>Central Corridor floor</p> <p>Second floor south block corridor floor</p> |

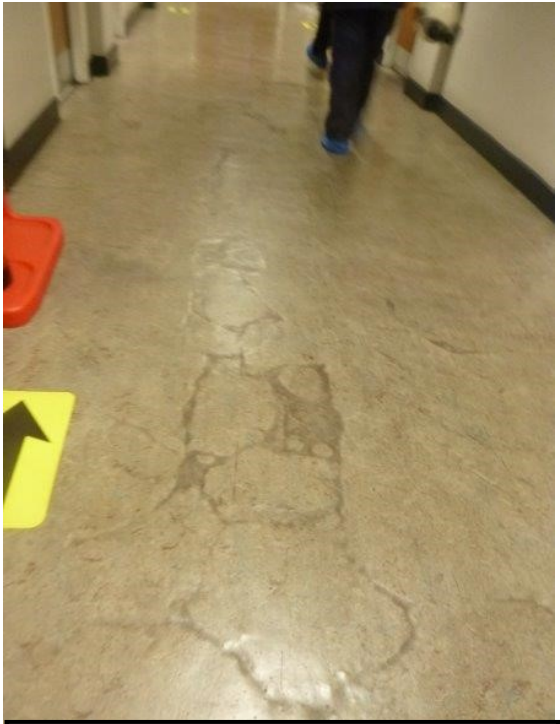
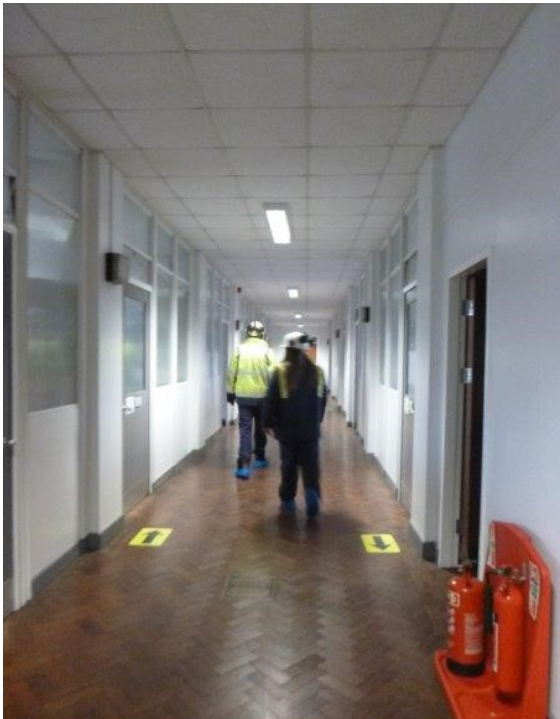
| Item No | Observations/ Defects Found | Action Required/ Comments | Priority RAM Matrix Rating P1, P2, P4 or M3 notification with (Photograph evidence if required) |
|---|---|---|---|
| | | | <p data-bbox="839 1048 1401 1081">Second floor-Central Block corridor</p> <p data-bbox="839 1809 1401 1843">North block second floor corridor floor</p> |

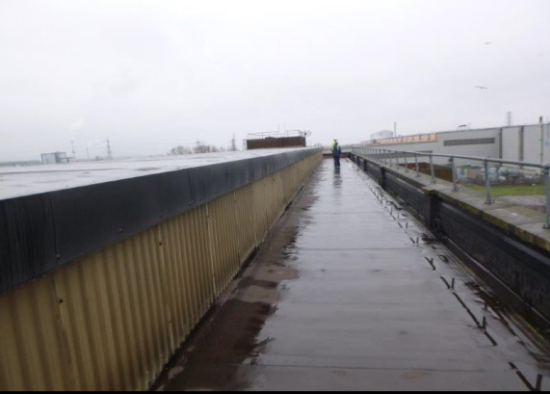
| Item No | Observations/ Defects Found | Action Required/ Comments | Priority RAM Matrix Rating P1, P2, P4 or M3 notification with (Photograph evidence if required) |
|---|---|---|---|
| 7 | <p><u>North Block Roof:</u></p> <ul style="list-style-type: none"> <li>➤Roof area appears to be in fair condition.</li> <li>➤No leakage is reported.</li> <li>➤Moss growth is visible at different locations.</li> <li>➤Standing water is visible within a small area at north-west and north east corner.</li> </ul> <p><u>South Block Roof:</u></p> <ul style="list-style-type: none"> <li>➤Roof appears to be in fair condition.</li> <li>➤Moss growth is visible at different locations.</li> </ul> <p><u>Central Block Roof:</u></p> <ul style="list-style-type: none"> <li>➤Roof appears to be in fair condition.</li> </ul> | Information Only | <p>Information Only</p> <p>Roof: North Block (West side view)</p> <p>Roof: North Block (East side view)</p> <p>Roof: South Block (West side view)</p> <p>Roof: South Block (East side view)</p> |

| Item No | Observations/ Defects Found | Action Required/ Comments | Priority RAM Matrix Rating P1, P2, P4 or M3 notification with (Photograph evidence if required) |
|---|---|---|---|
| | | | <p data-bbox="842 712 1393 748">Roof: Central Block</p> |
